# VEHICLE INSPECTION REPORT

**ST20SBU**

## Vauxhall Corsa 1.2 Turbo Elite Nav Premium 5dr

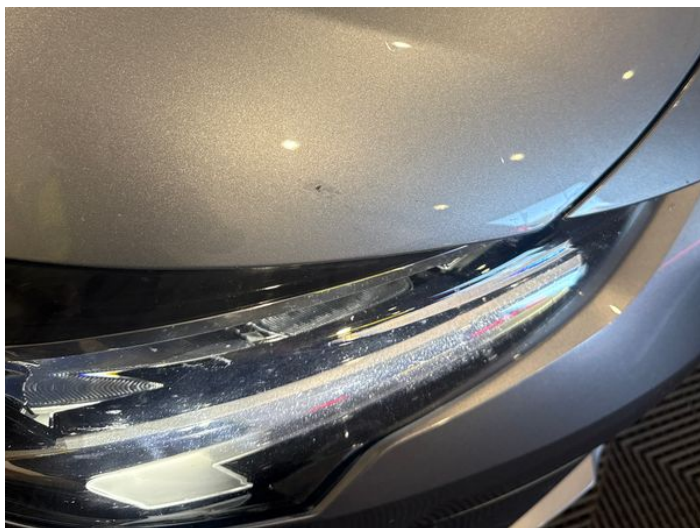
1: Bonnet  
Chipped  
Multiple Chips

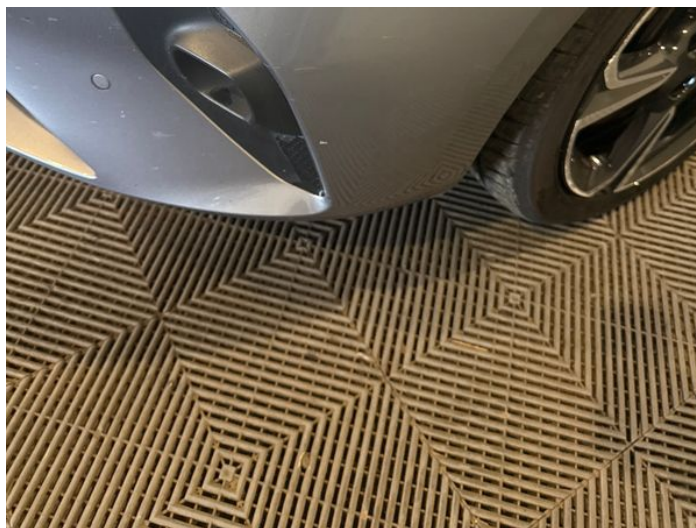
2: Bumper Front  
Scratched  
25 to 100mm Thru Paint

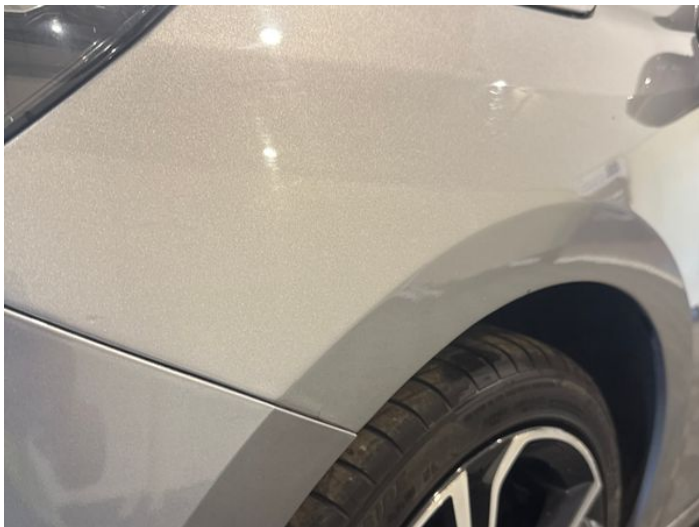
3: Wing nsf  
Poor Previous Repair  
Rippled UpTo 30%

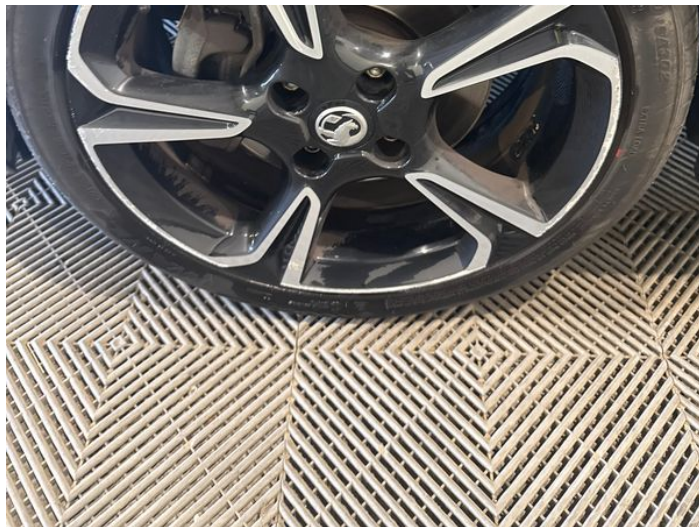
4: Wheel nsf  
Scratched  
Over 50mm

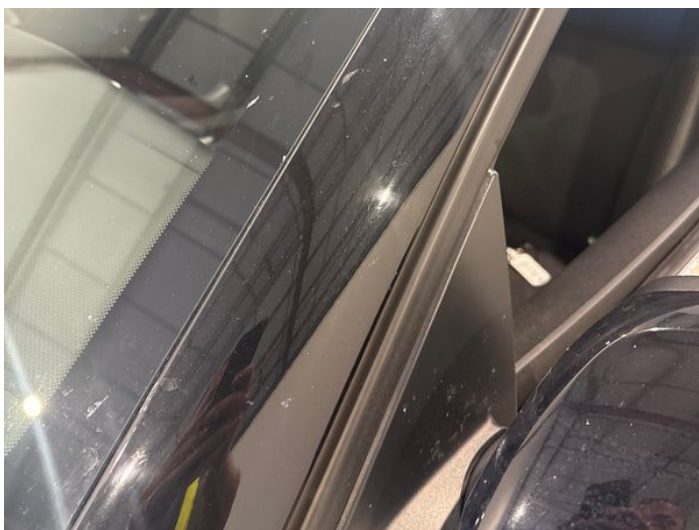
5: A Post ns  
Chipped  
1 To 5

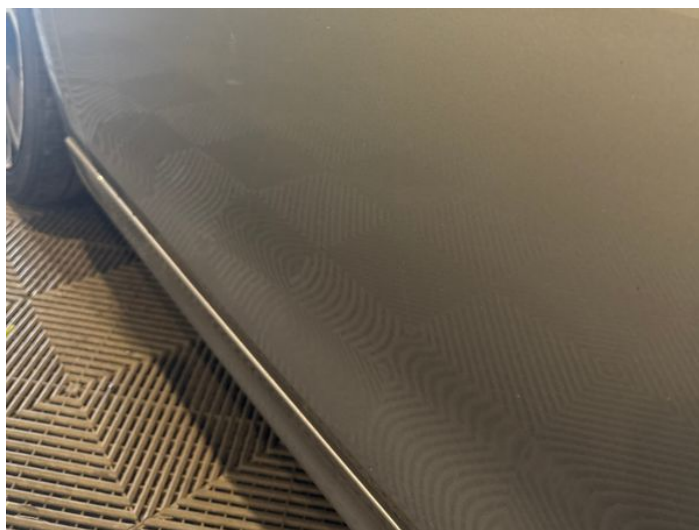
6: Door nsf  
Dented  
Over 30mm

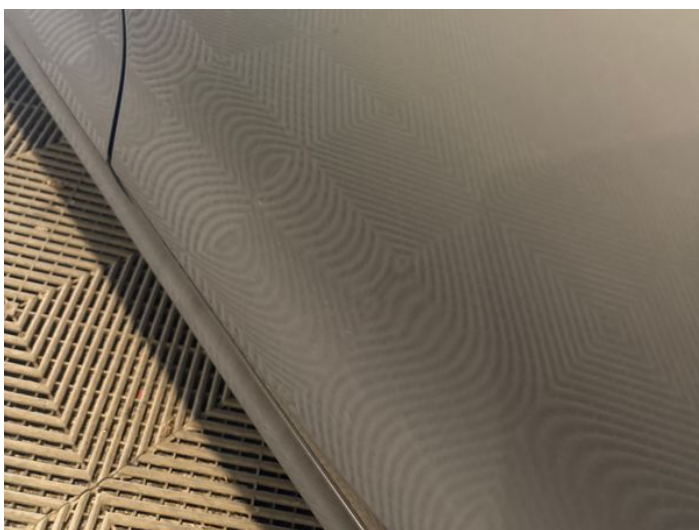
7: Door nsr  
Scratched  
UpTo 25mm Thru Paint

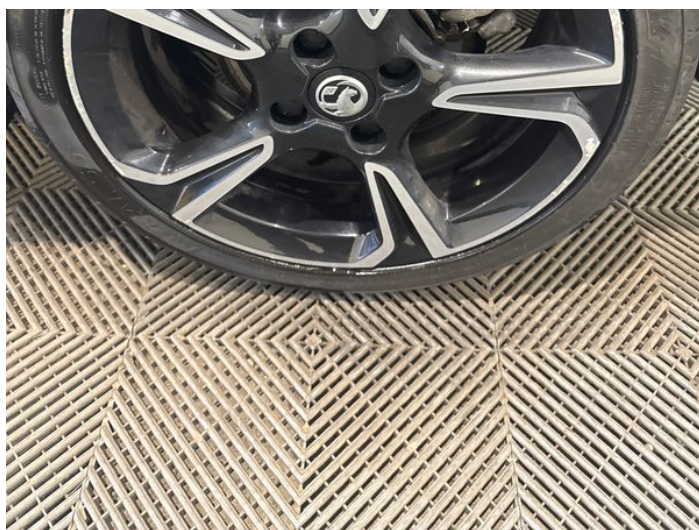
8: Wheel nsr  
Scratched  
Over 50mm

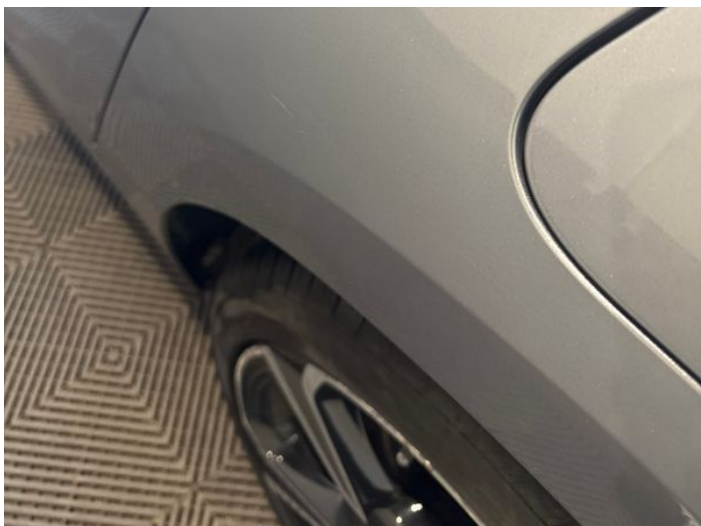
9: Qtr Panel nsr  
Scratched  
UpTo 25mm Thru Paint

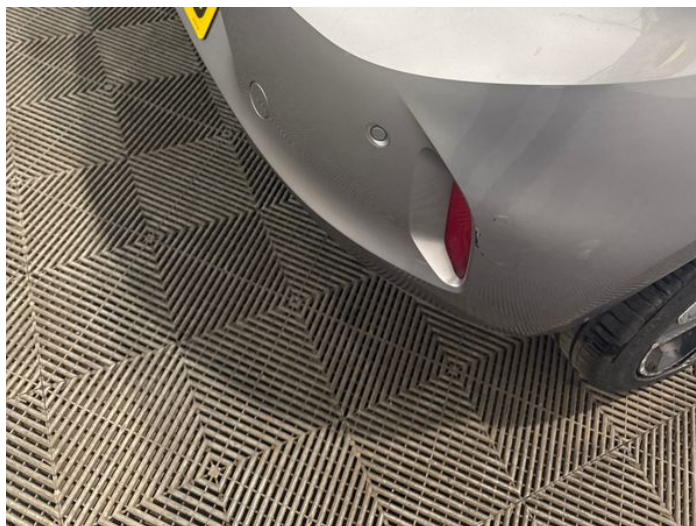
10: Bumper Rear  
Scratched  
Over 100mm Thru Paint

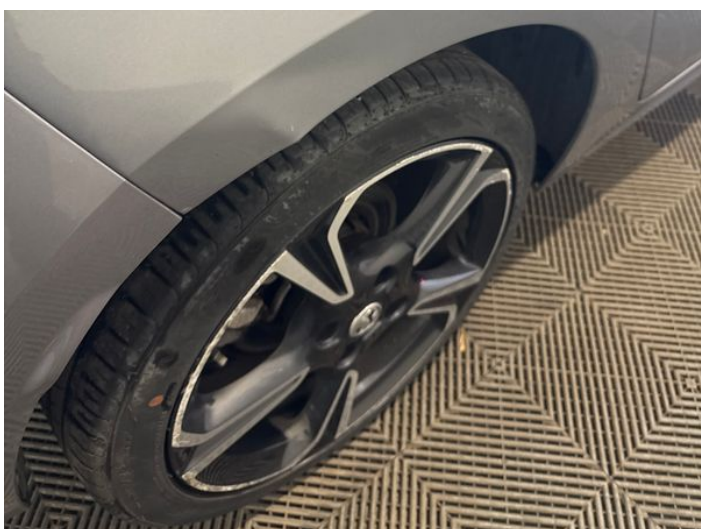
11: Qtr Panel osr  
Dented  
Over 30mm

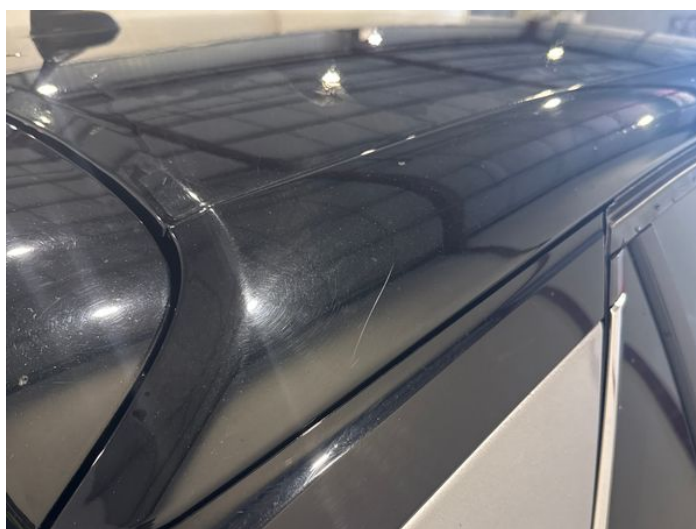
12: C Post os  
Scratched  
Over 25mm Thru Paint

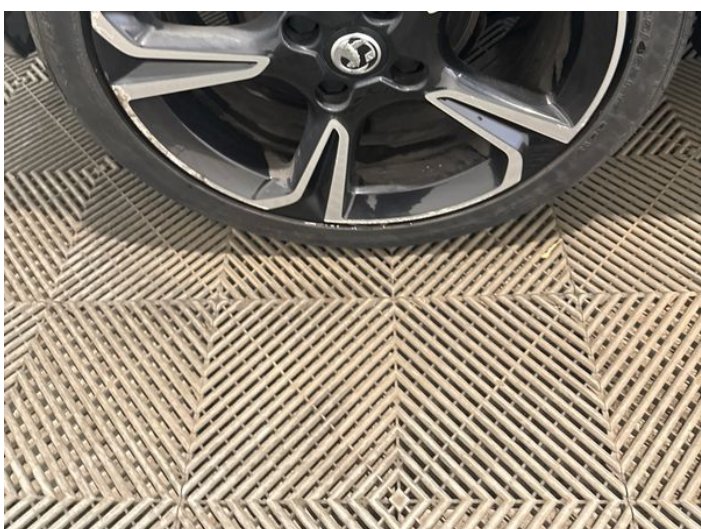
13: Wheel osr  
Scratched  
Over 50mm

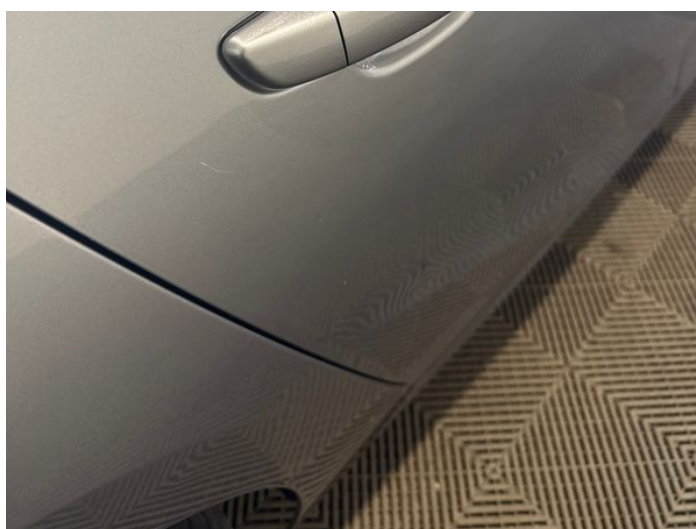
14: Door osr  
Scratched  
Over 25mm Thru Paint

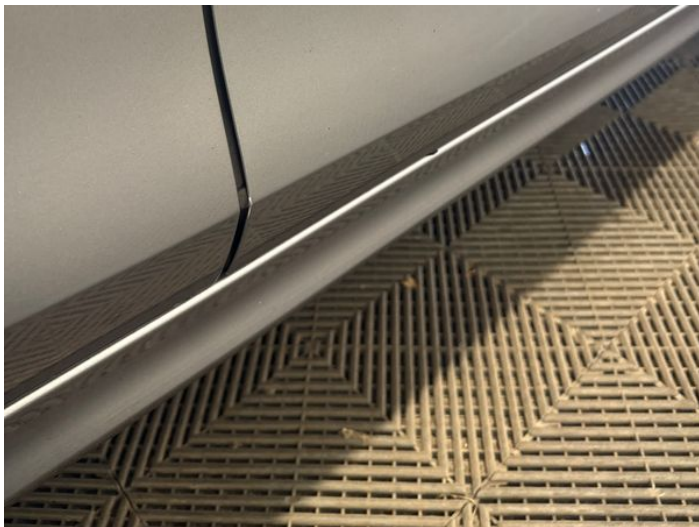
15: Door osf  
Chipped  
Edge Chip

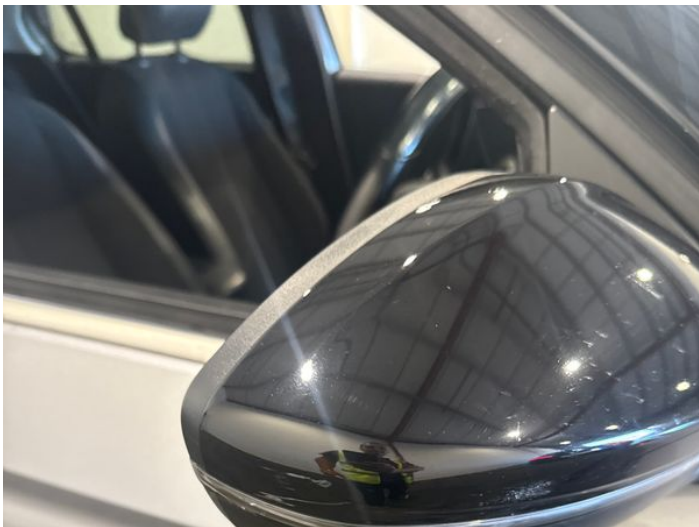
16: Door Mirror Assy osf  
Scratched (Painted)  
Over 25mm Thru Paint

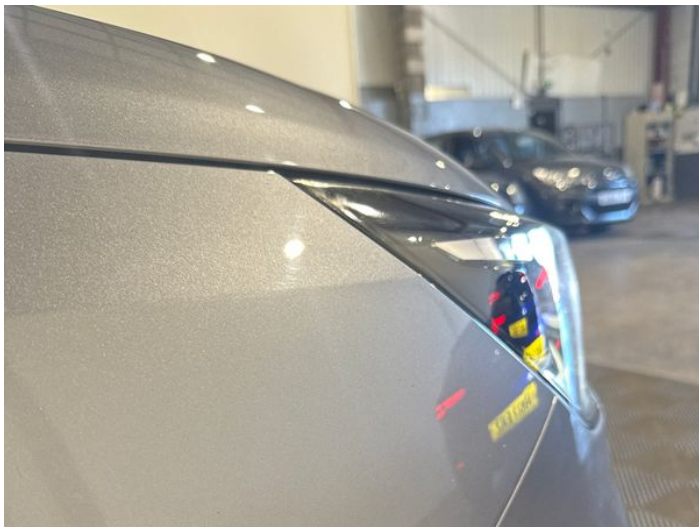
17: Wing osf  
Chipped  
1 To 5

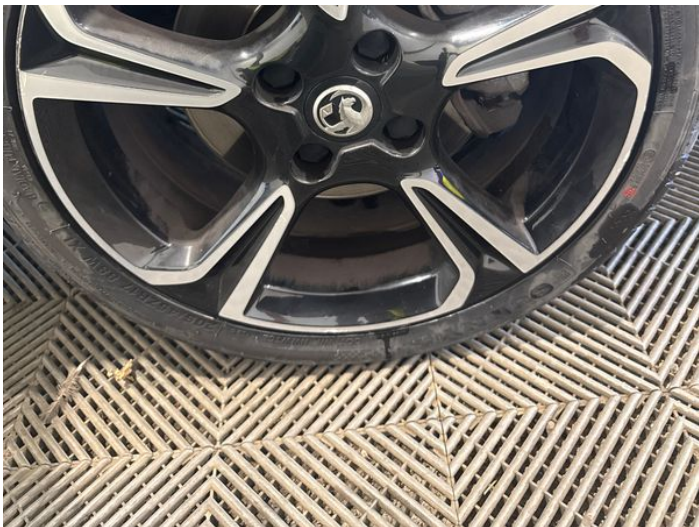
18: Wheel osf  
Scratched  
Over 50mm
