## VEHICLE INSPECTION REPORT

**AO69VYA**

### Toyota RAV4 2.5 VVT-i Hybrid Design 5dr CVT 2WD

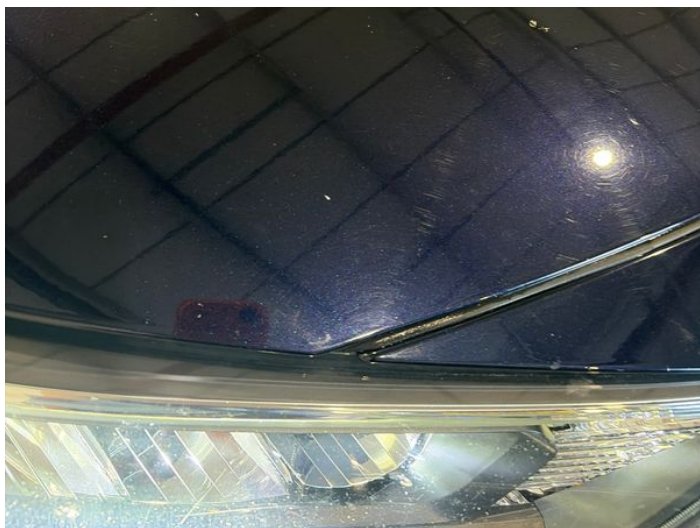
1: Bonnet  
Chipped  
1 To 5

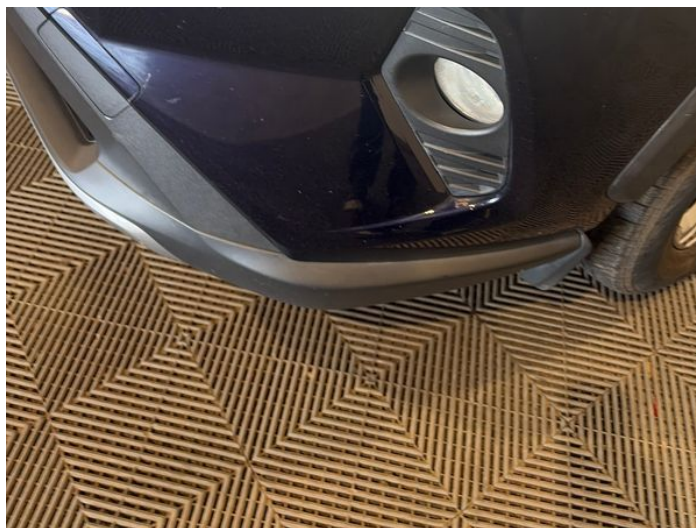
2: Bumper Front  
Scratched  
25 to 100mm Thru Paint

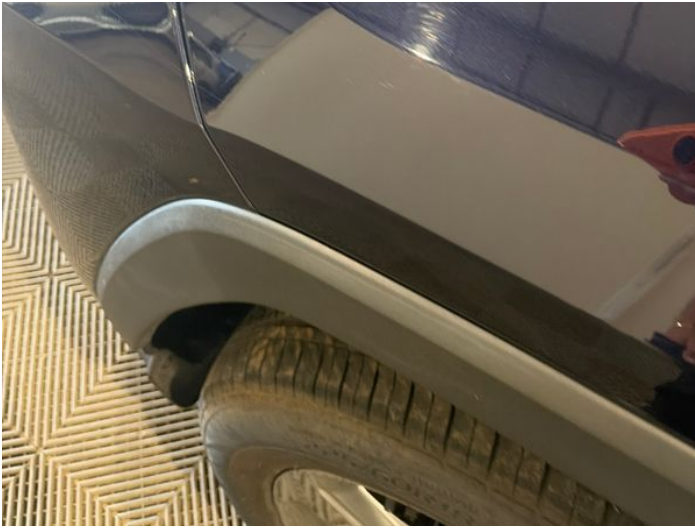
3: Wing nsf  
Chipped  
1 To 5

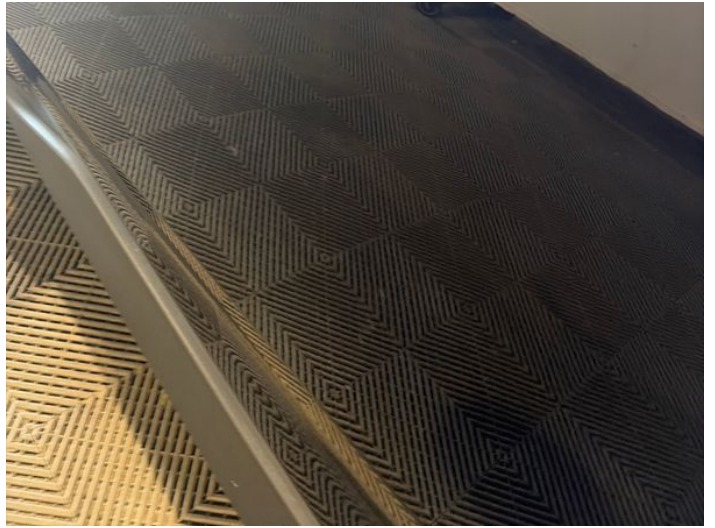
4: Door nsf  
Chipped  
Multiple Chips

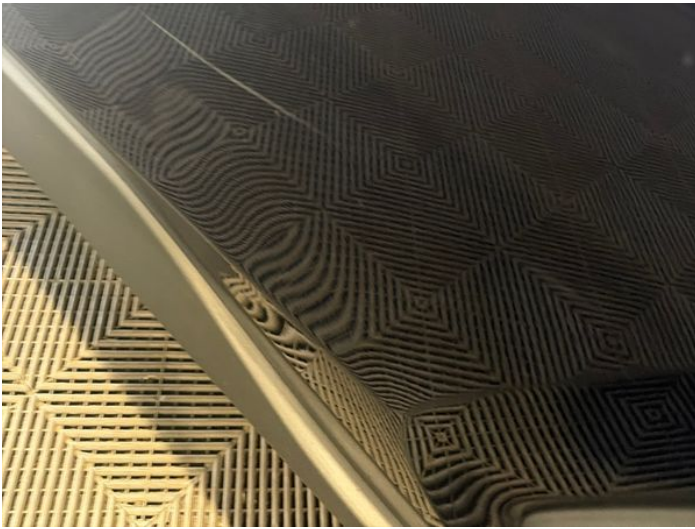
5: Door nsr  
Scratched  
Over 25mm Thru Paint

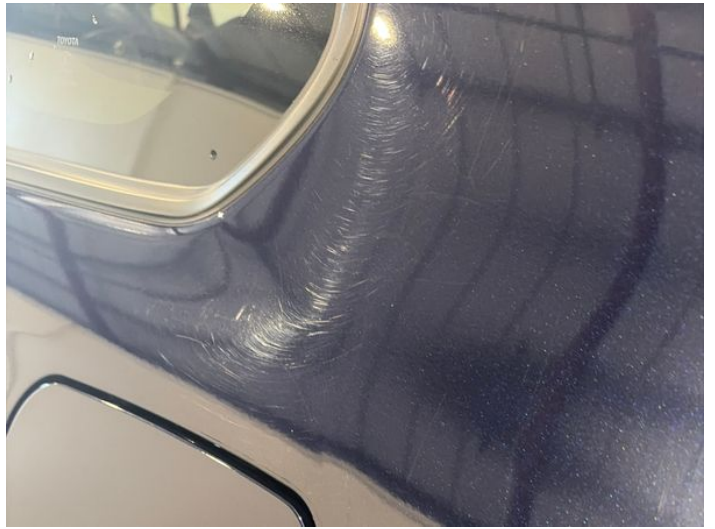
6: Qtr Panel nsr  
Dented  
With Paint Damage

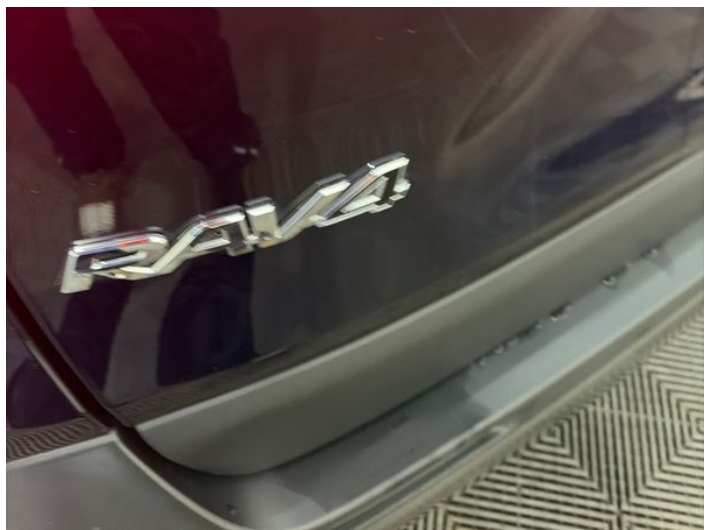
8: Tailgate  
Scratched  
Over 25mm Thru Paint

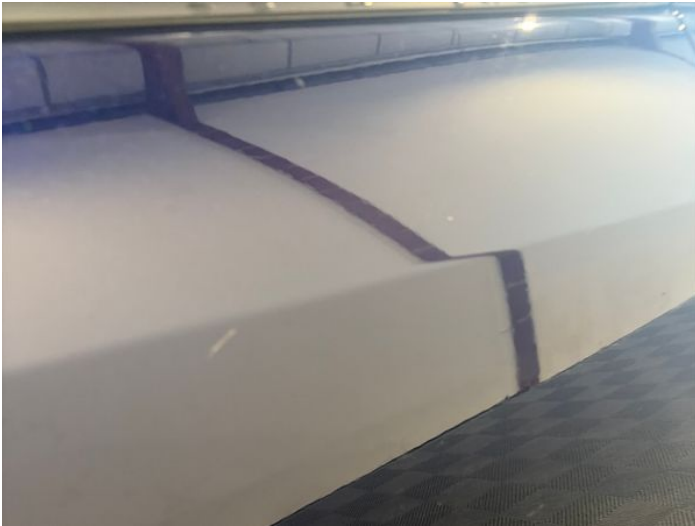
9: Door osr  
Scratched  
Over 25mm Thru Paint

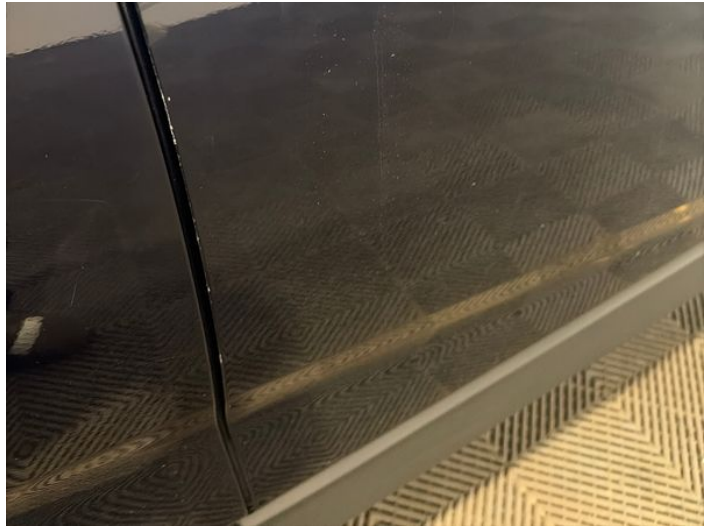
10: Door osf  
Chipped  
Edge Chip

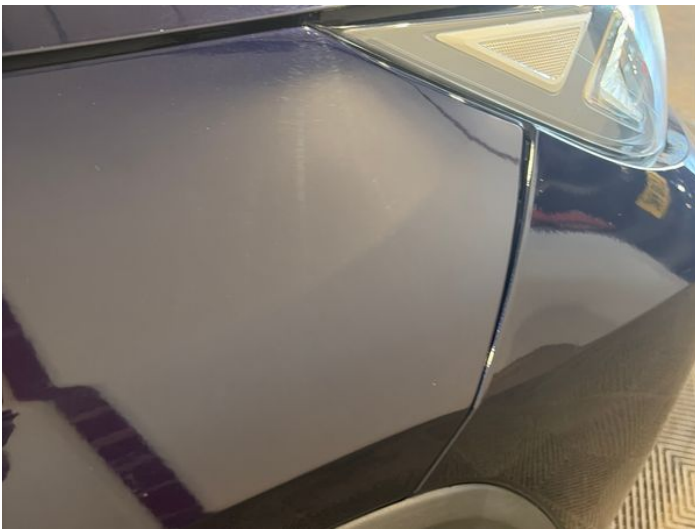
11: Wing osf  
Chipped  
1 To 5

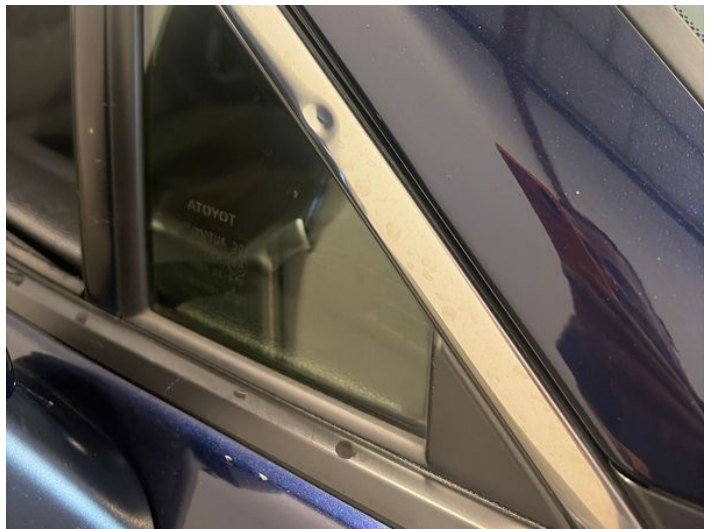
12: Door osf  
Dented  
Between 10mm + 30mm

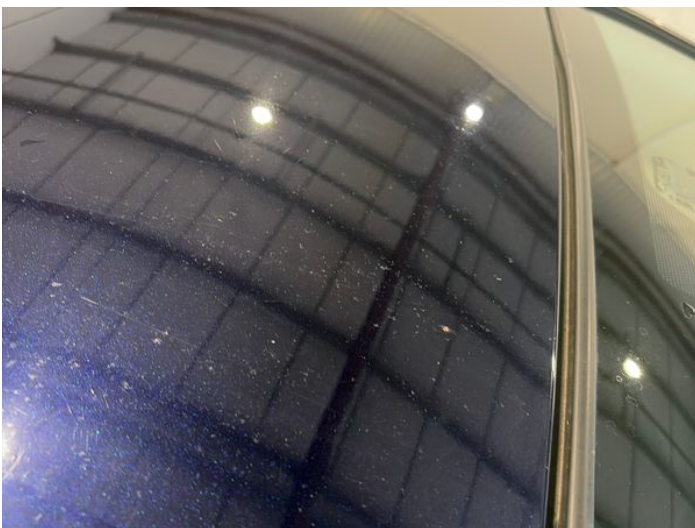
13: Roof  
Chipped  
1 To 5

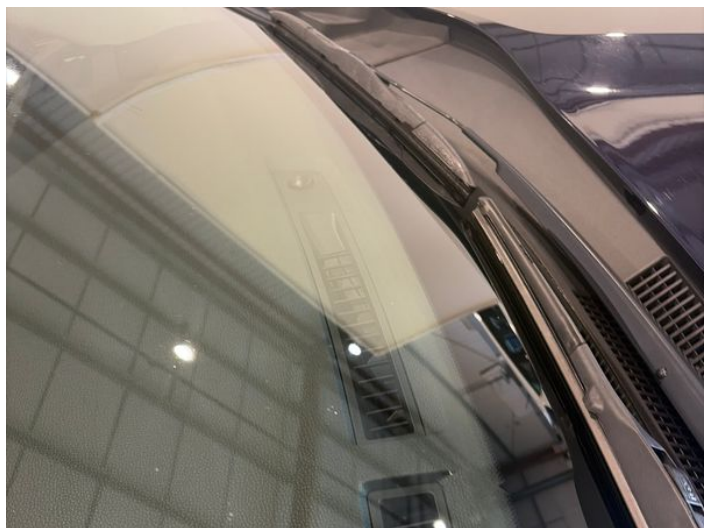
14: Screen Front  
Chipped  
UpTo 10mm

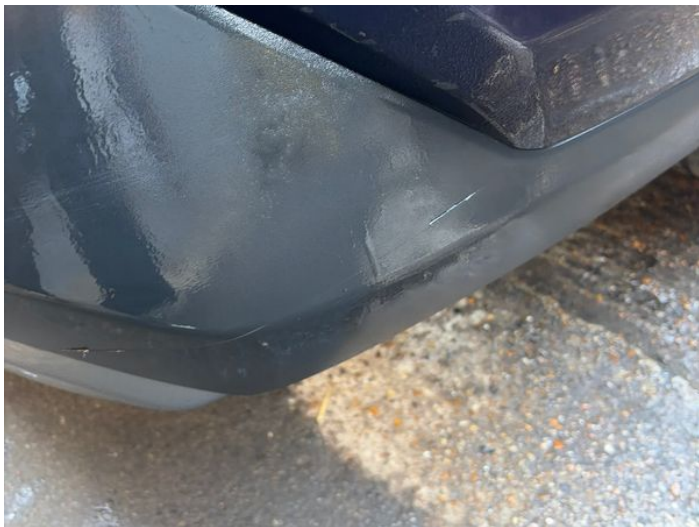
15: Bumper Rear Moulding  
Scuffed (Unpainted)  
UpTo 100mm
