VEHICLE INSPECTION REPORT

FP74KSX

Dacia Jogger 1.0 TCe Extreme 5dr

Cat: S Incident History

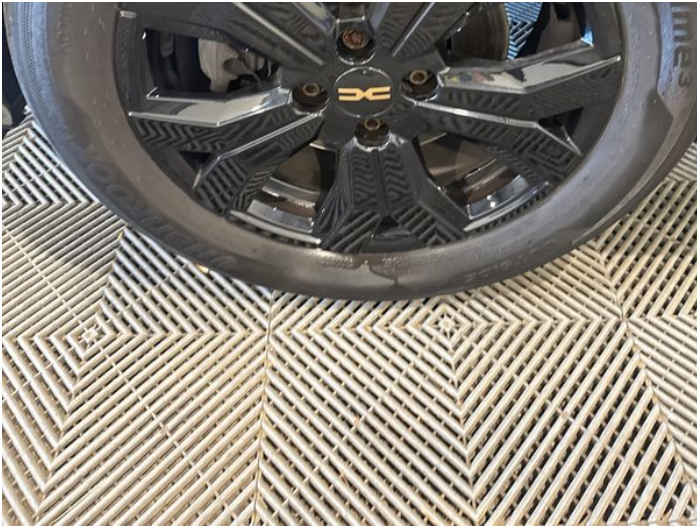
3: Wheel nsf  
Scratched  
Over 50mm

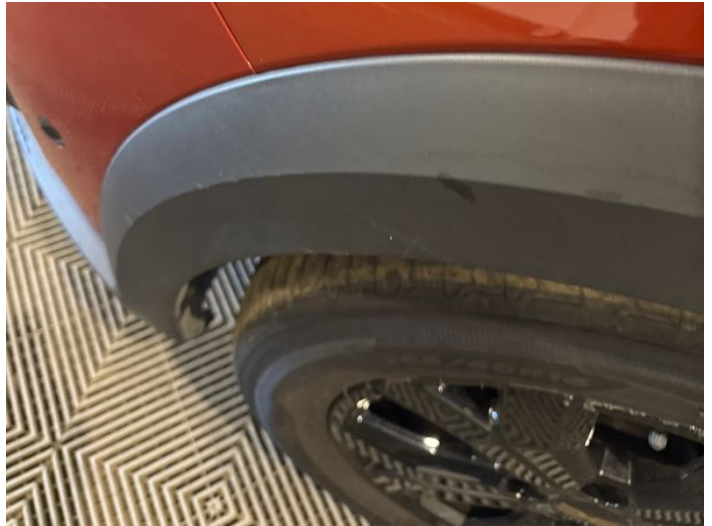
4: Wing nsf  
Scratched  
Over 25mm Thru Paint

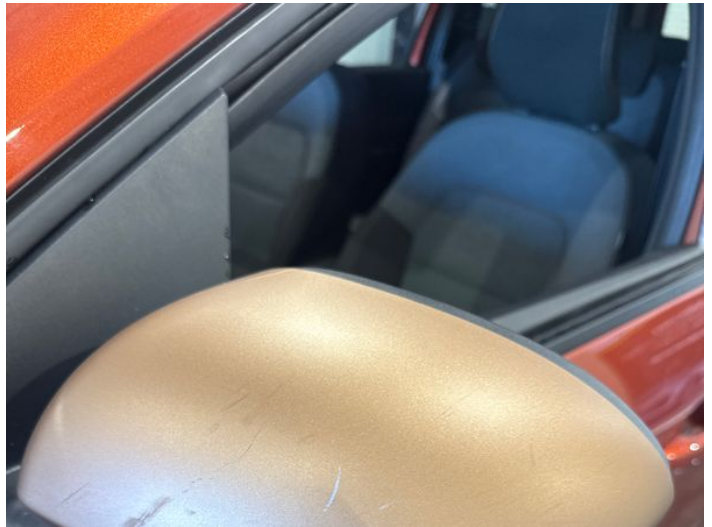
6: Door Mirror Assy nsf  
Scratched (Painted)  
UpTo 25mm Thru Paint

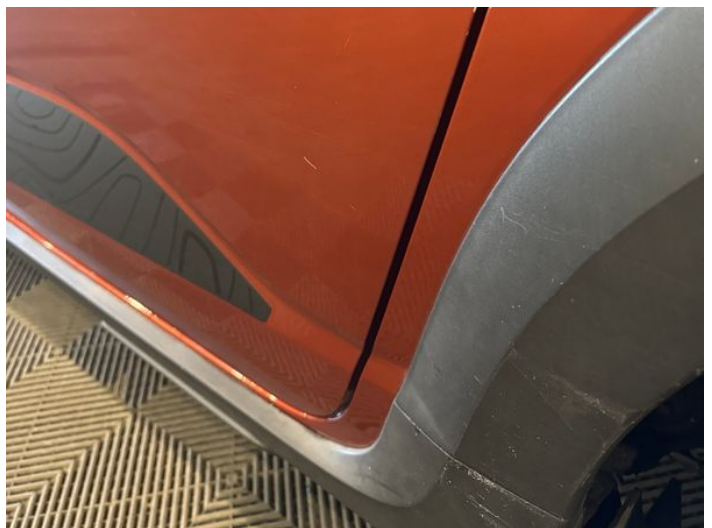
8: Door nsr  
Scratched  
UpTo 25mm Thru Paint

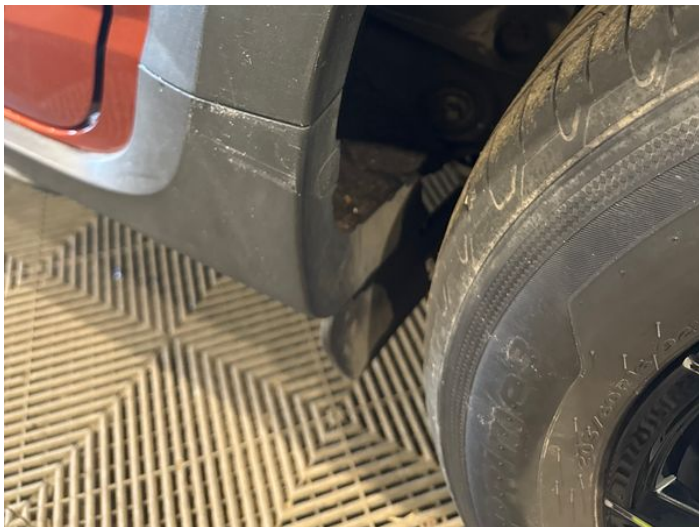
9: Qtr Panel Arch Extension ns  
Scuffed (Unpainted)  
UpTo 100mm

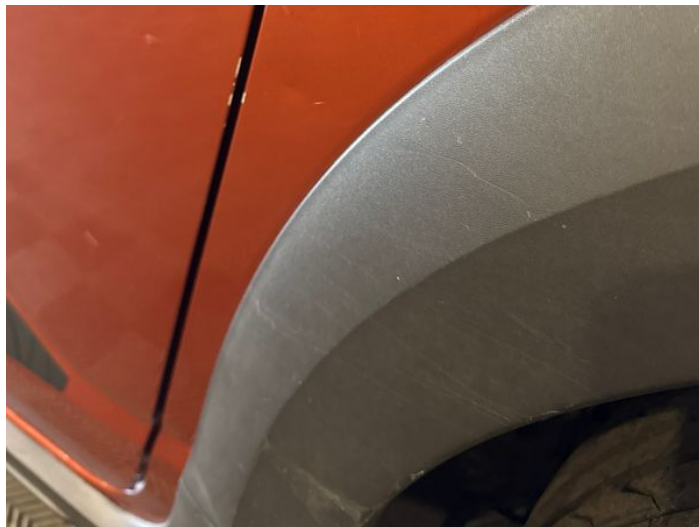
10: Qtr Panel nsr  
Dented  
Between 10mm + 30mm

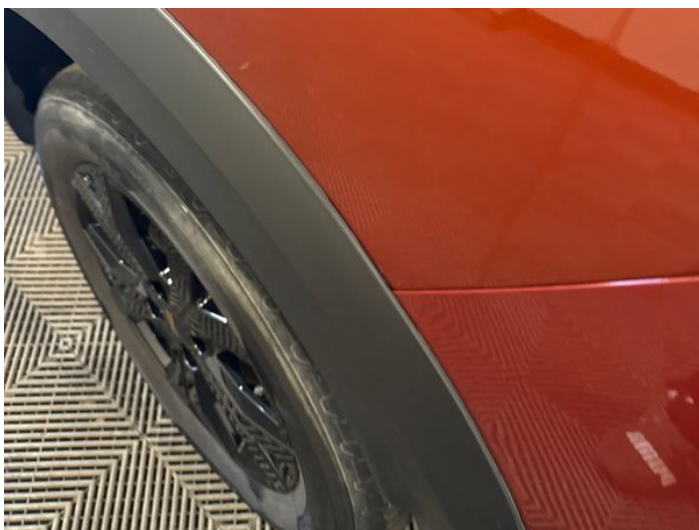
11: Qtr Panel nsr  
Scratched  
UpTo 25mm Thru Paint

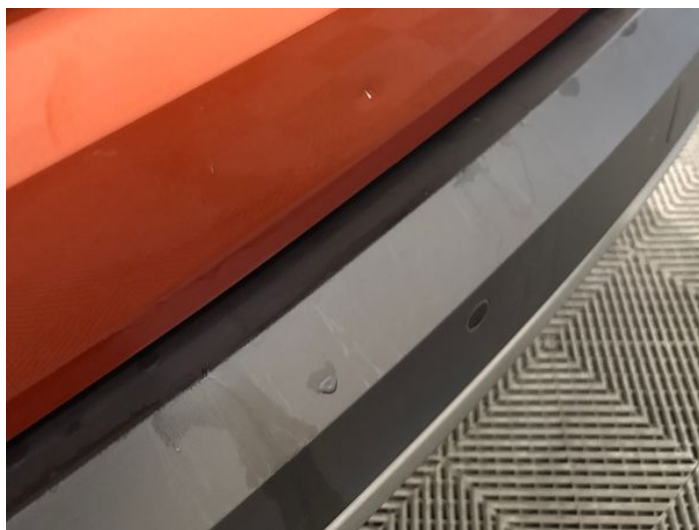
12: Tailgate  
Dented  
2 Or Less UpTo 10mm

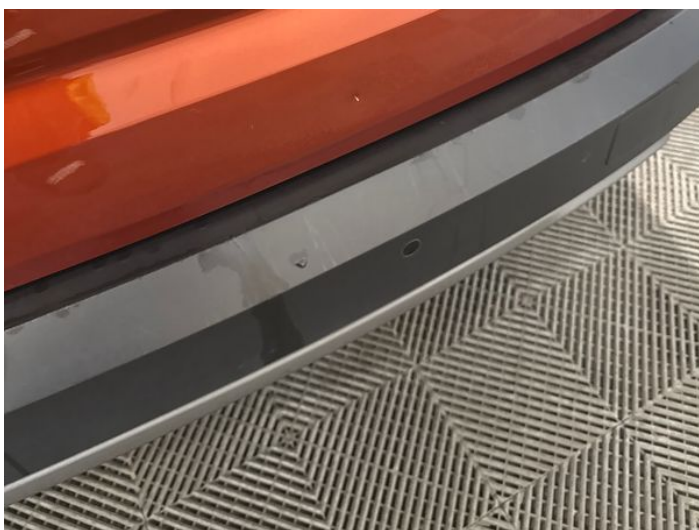
13: Tailgate  
Chipped  
1 To 5

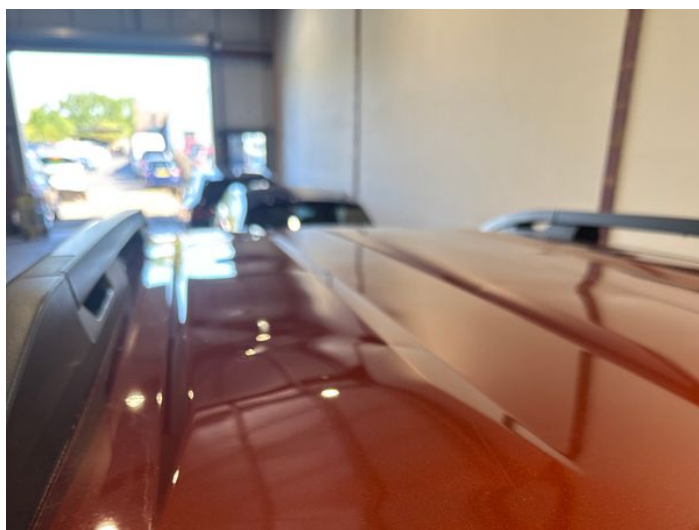
14: Roof  
Dented  
Over 30mm

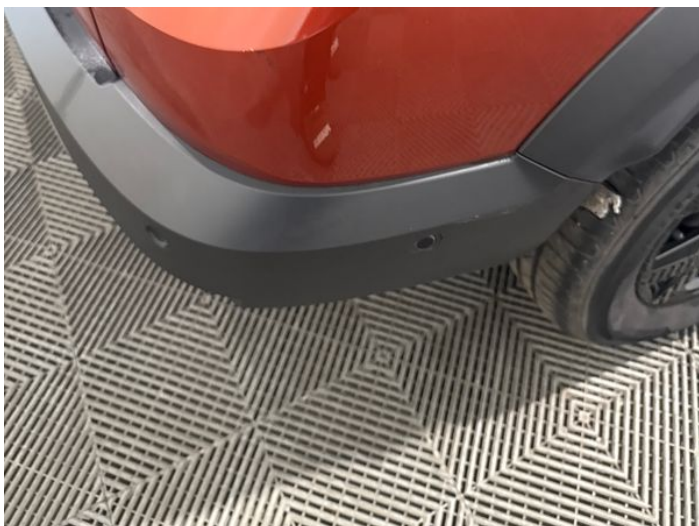
15: Bumper Rear  
Scratched  
25 to 100mm Thru Paint

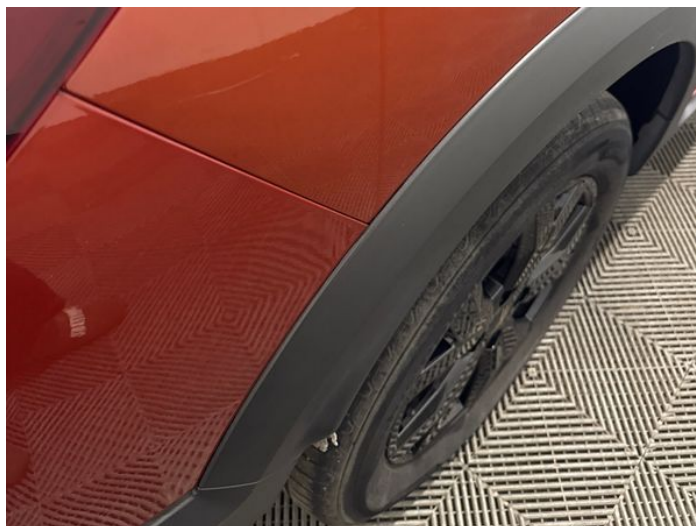
16: Qtr Panel osr  
Scratched  
Over 25mm Thru Paint

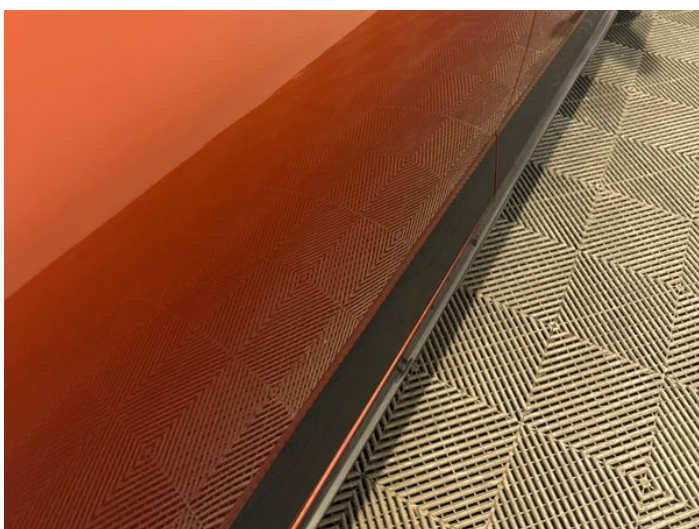
17: Door osr  
Dented  
Over 30mm

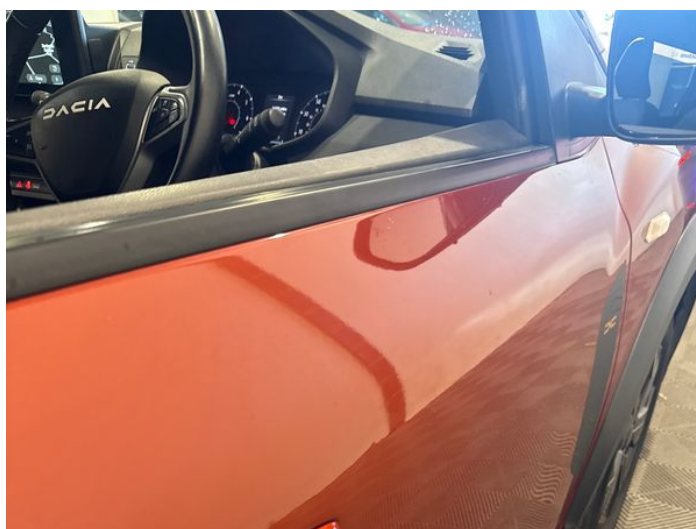
18: Door osf  
Dented  
Between 10mm + 30mm
