# VEHICLE INSPECTION REPORT

DE05BUO

## Honda Jazz 1.4 i-DSi SE 5dr CVT-7

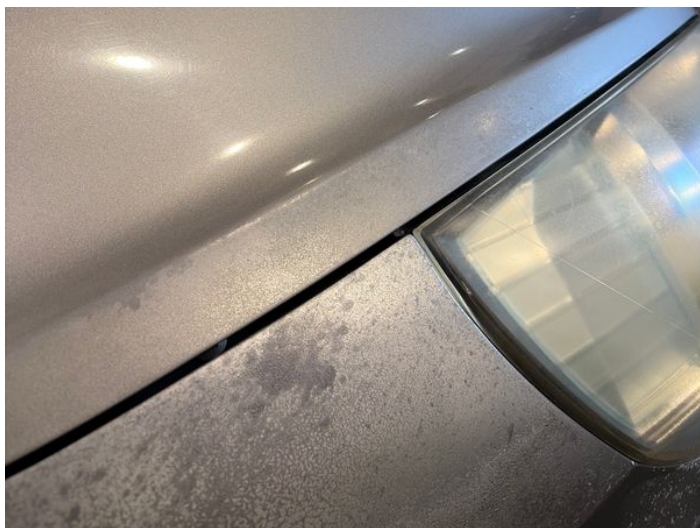
1: Bonnet  
Poor Previous Repair  
Poor Paint

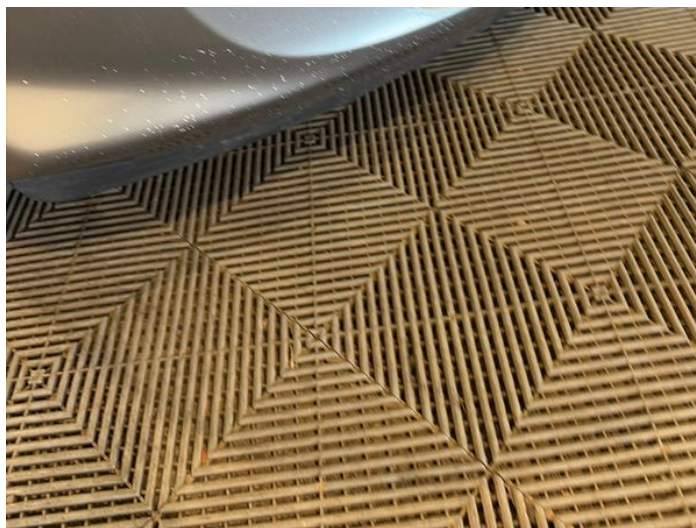
2: Bumper Front  
Dented  
With Paint Damage

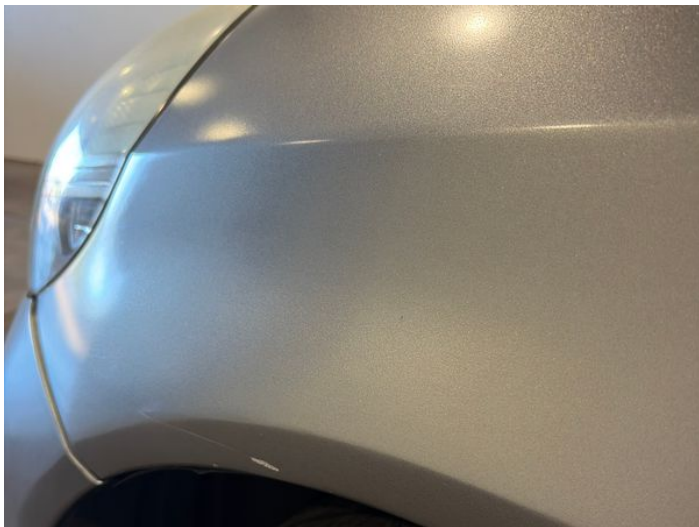
3: Wing nsf  
Poor Previous Repair  
Poor Paint

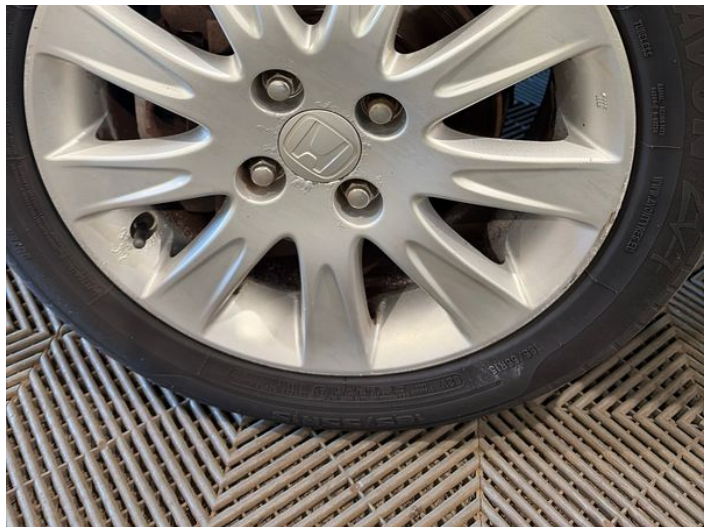
4: Wheel nsf  
Scratched  
Over 50mm

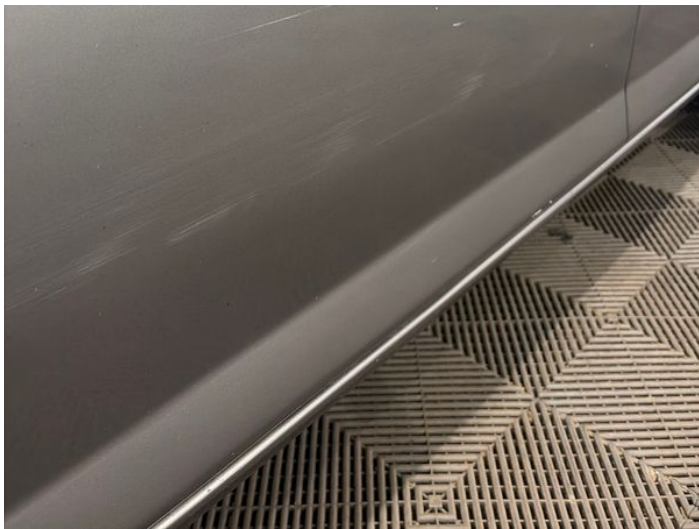
5: Door nsf  
Scratched  
Over 25mm Thru Paint

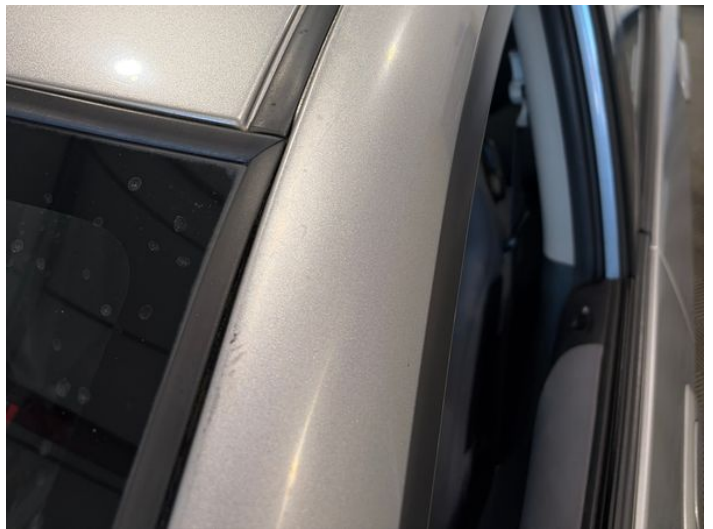
6: A Post ns  
Poor Previous Repair  
Poor Paint

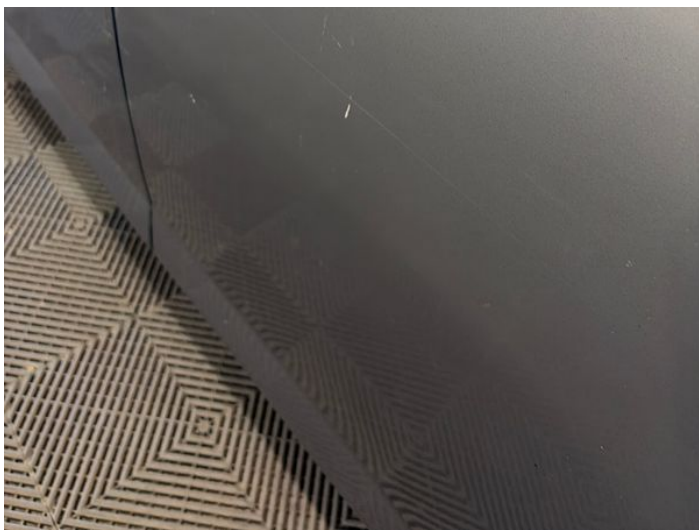
7: Door nsr  
Scratched  
Over 25mm Thru Paint

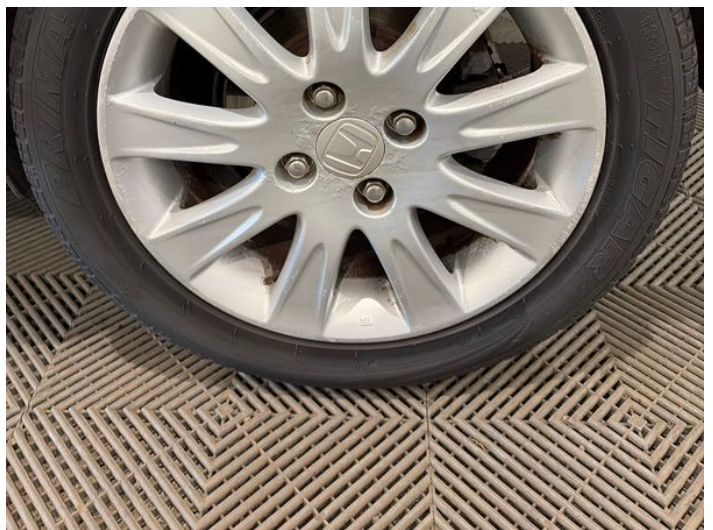
8: Wheel nsr  
Scratched  
Over 50mm

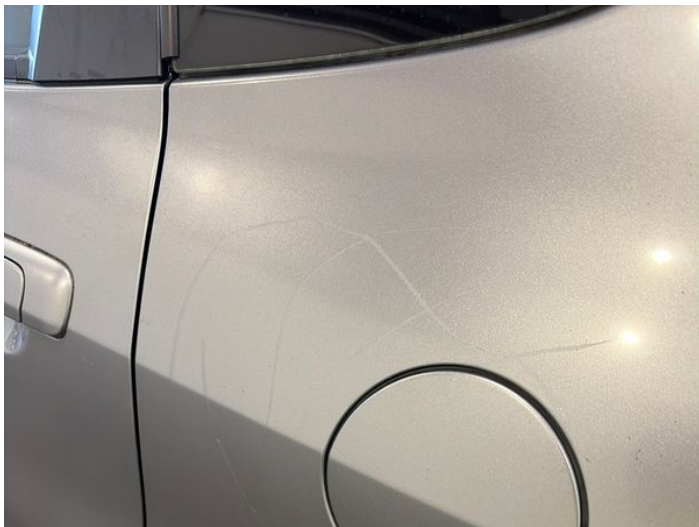
9: Qtr Panel nsr  
Scratched  
Over 25mm Thru Paint

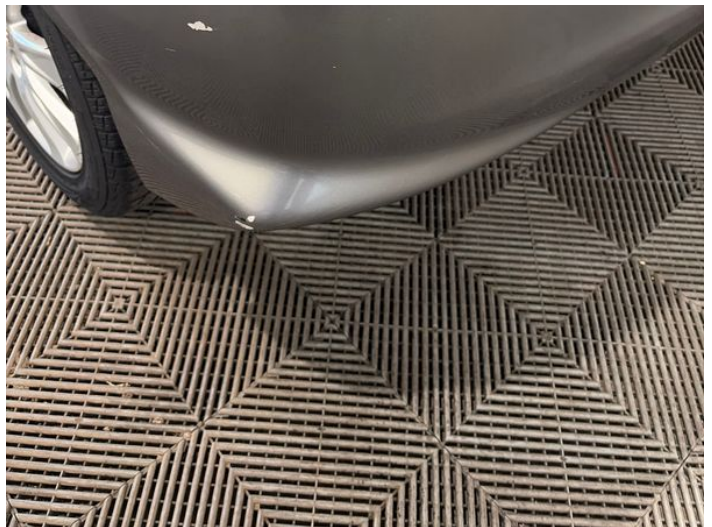
10: Bumper Rear  
Dented  
With Paint Damage

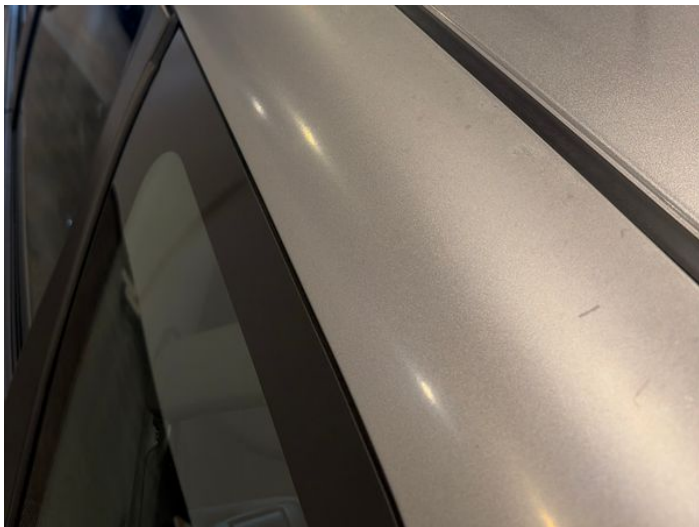
11: B Post ns  
Poor Previous Repair  
Poor Paint

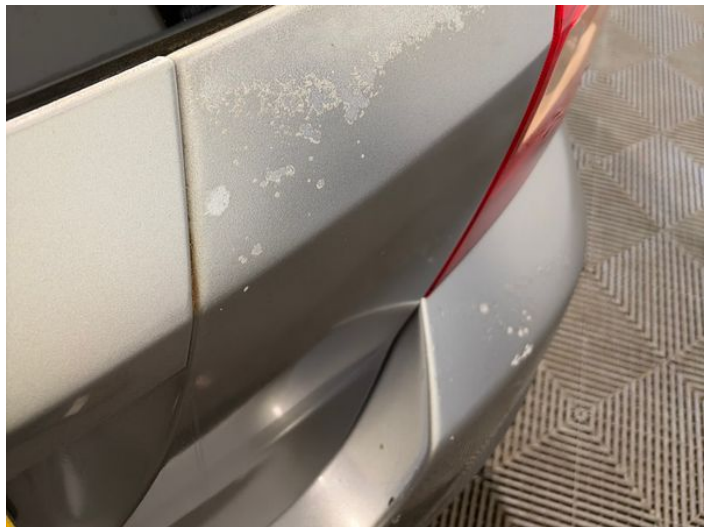
12: Tailgate  
Poor Previous Repair  
Poor Paint

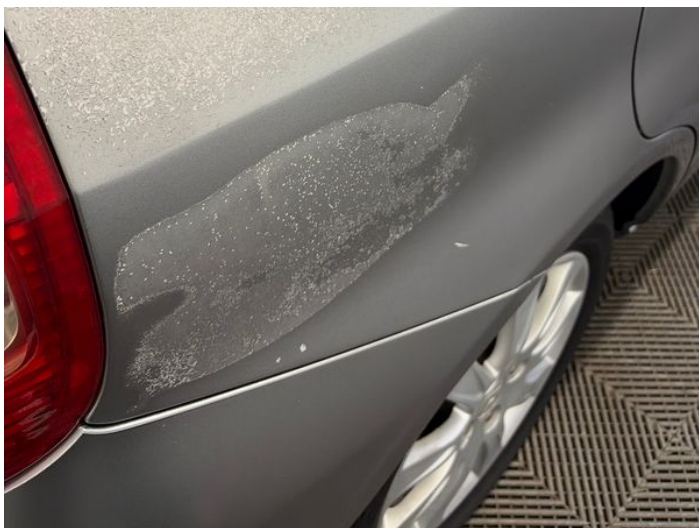
13: Qtr Panel osr  
Poor Previous Repair  
Poor Paint

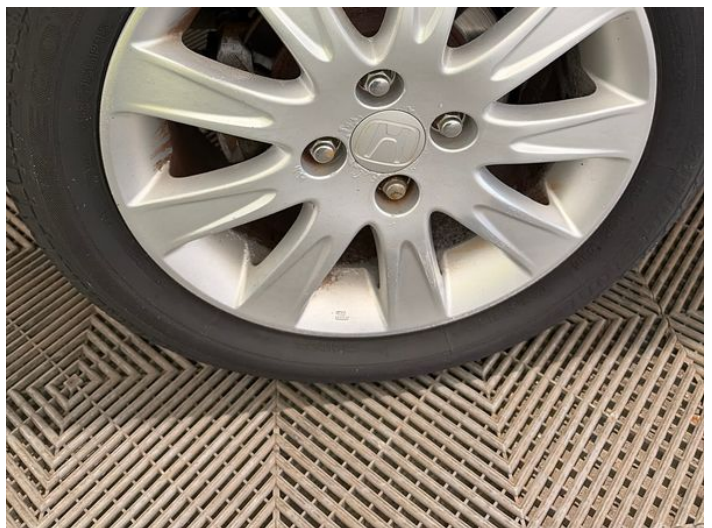
14: Wheel osr  
Scratched  
Over 50mm

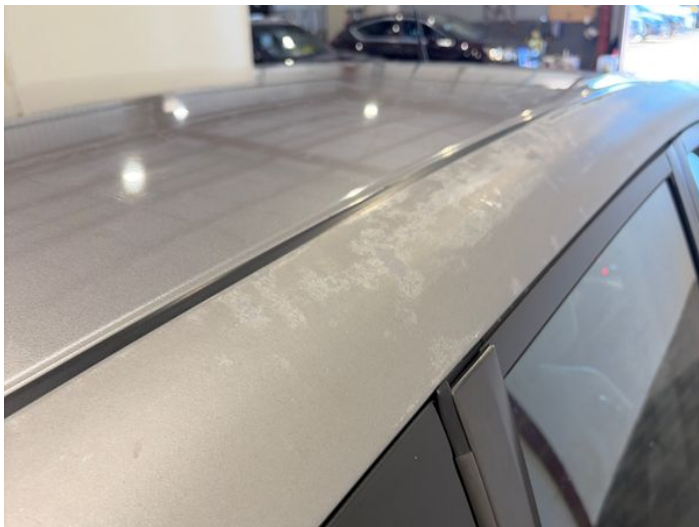
15: B Post os  
Poor Previous Repair  
Paint Flake

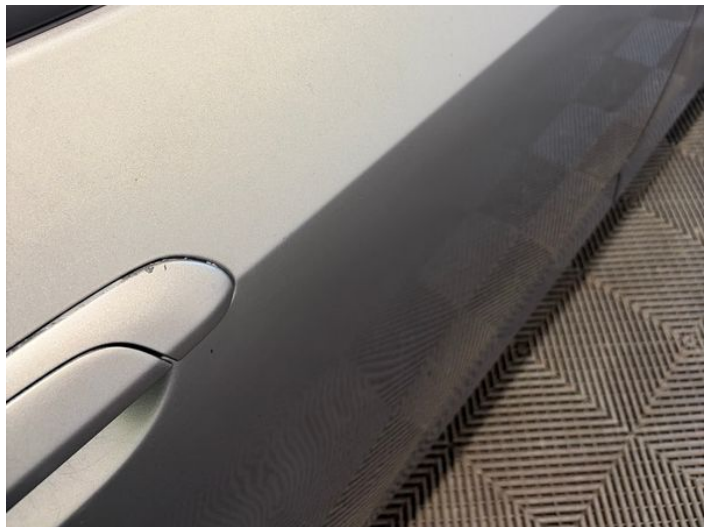
16: Door osr  
Poor Previous Repair  
Poor Paint

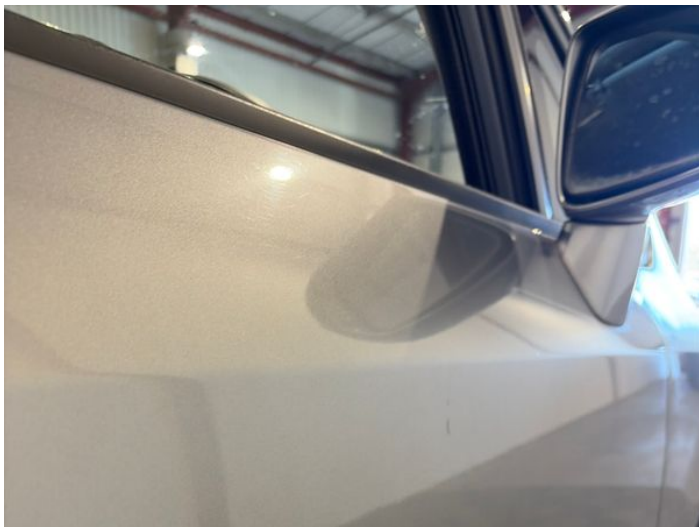
17: Door osf  
Dented  
Over 30mm

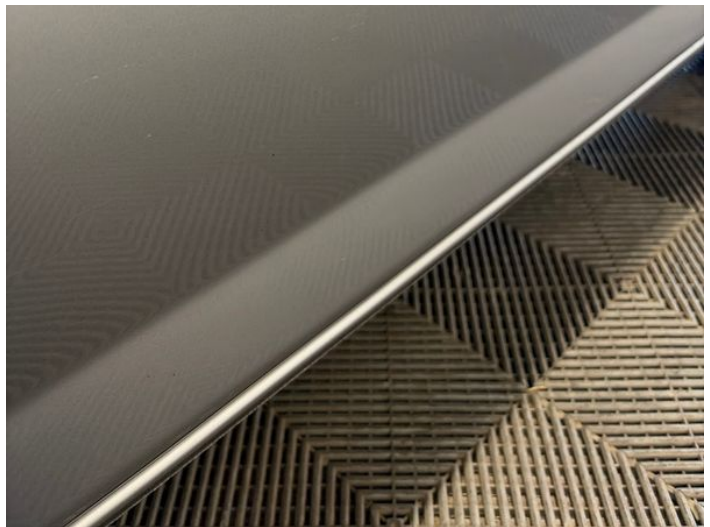
18: Door osf  
Scratched  
Over 25mm Thru Paint

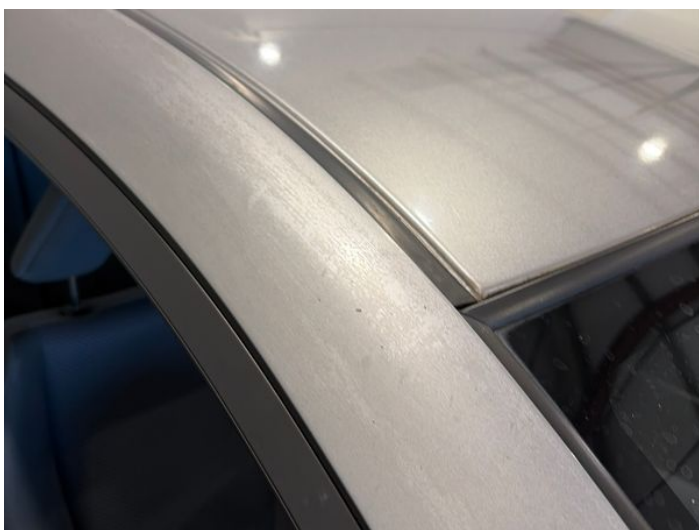
19: A Post os  
Poor Previous Repair  
Paint Flake

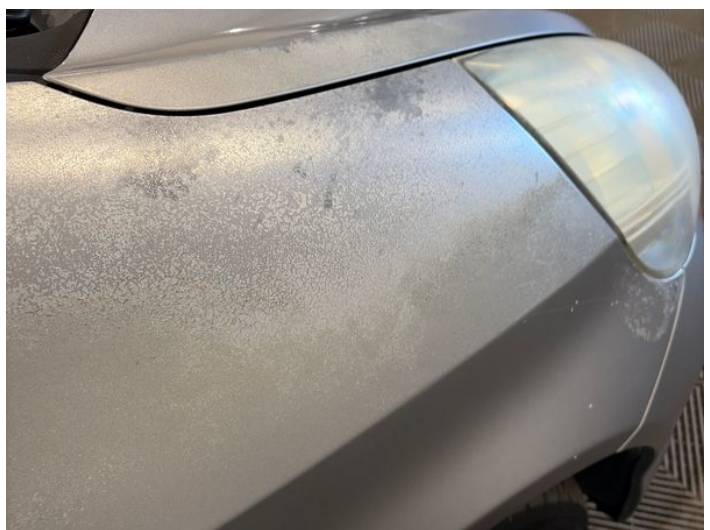
20: Wing osf  
Poor Previous Repair  
Paint Flake

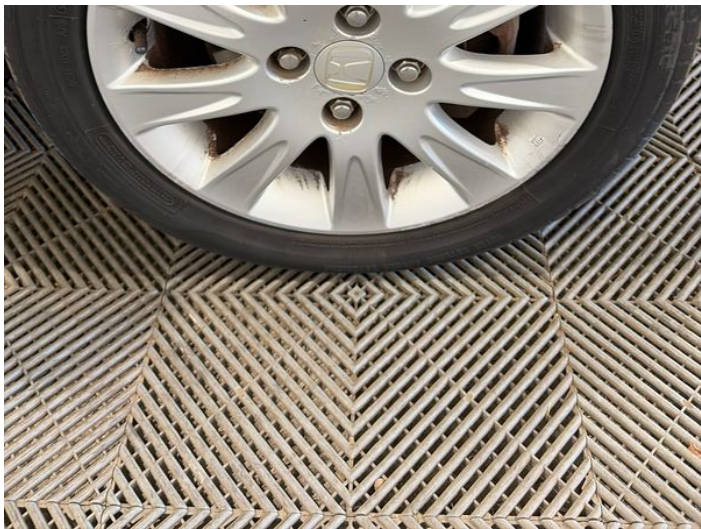
21: Wheel of  
Corroded  
Light
