## VEHICLE INSPECTION REPORT

**KN14GKP**

### Peugeot 3008 1.6 HDi Allure 5dr

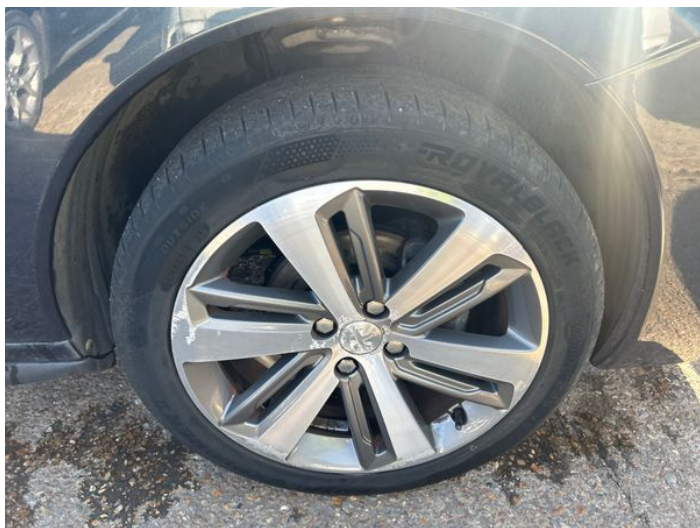
1: Wheel osf  
Scratched  
Over 50mm

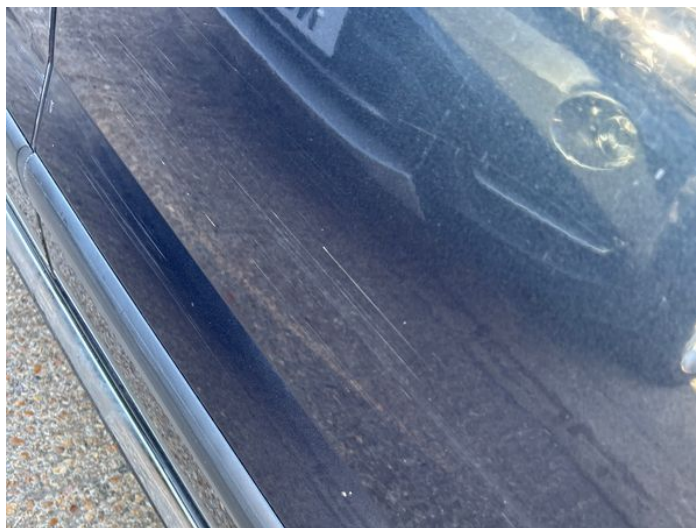
2: Door osf  
Scratched  
Over 25mm Thru Paint

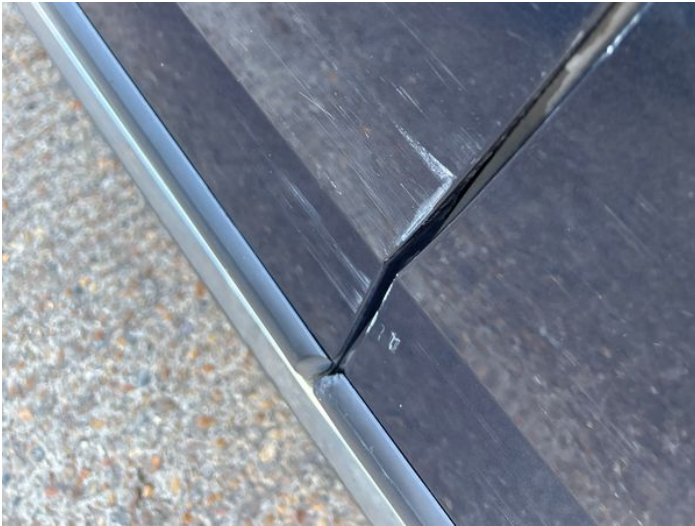
3: Door osr  
Scratched  
Over 25mm Thru Paint

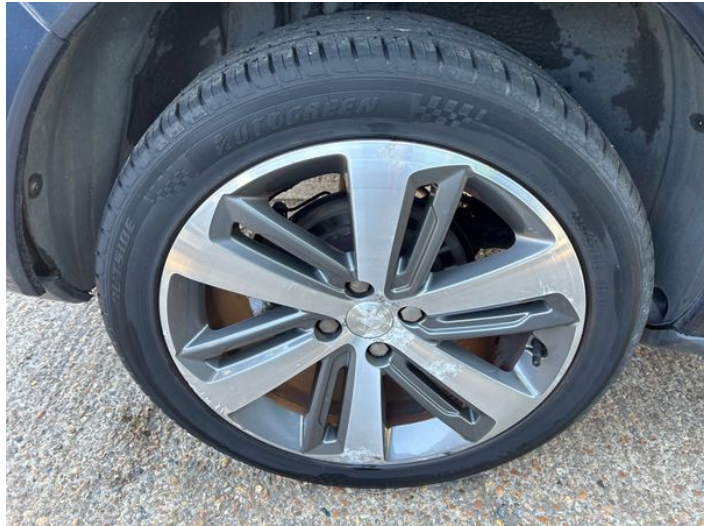
4: Wheel osr  
Corroded  
Light

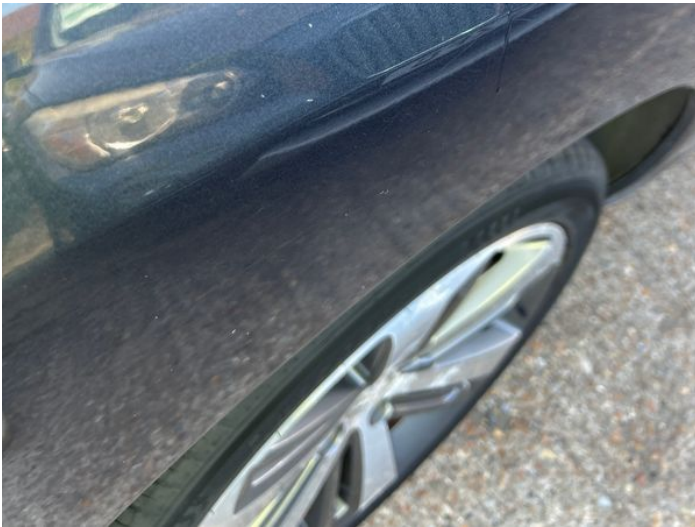
5: Qtr Panel osr  
Chipped  
1 To 5

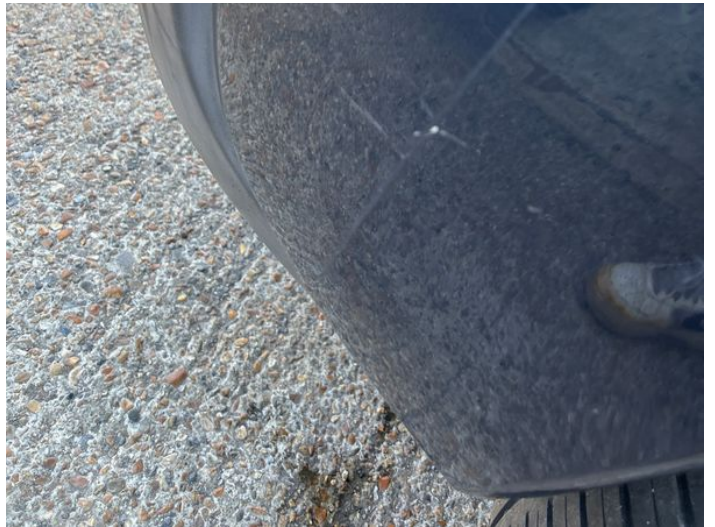
6: Bumper Rear  
Scratched  
Over 100mm Thru Paint

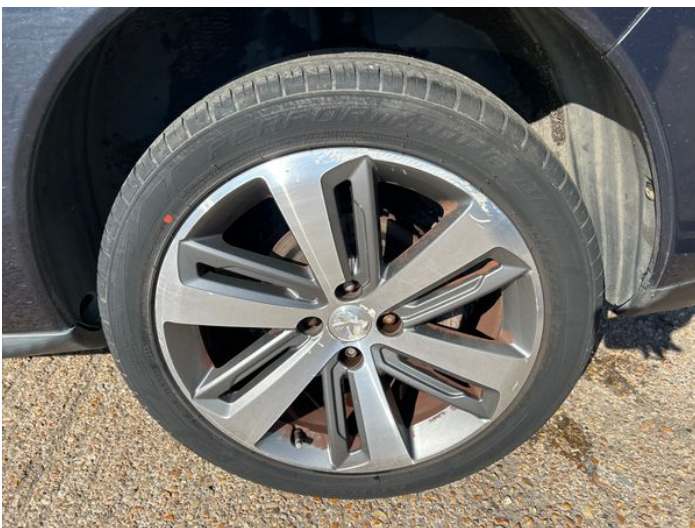
7: Wheel nsr  
Scratched  
Over 50mm

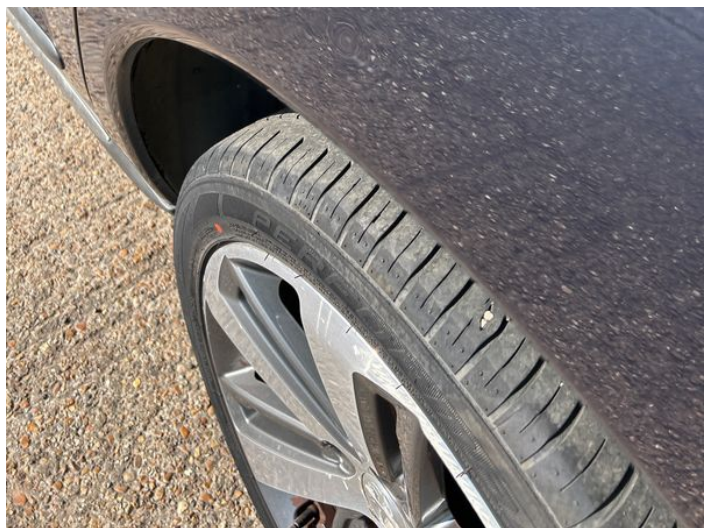
8: Qtr Panel nsr  
Dented  
Between 10mm + 30mm

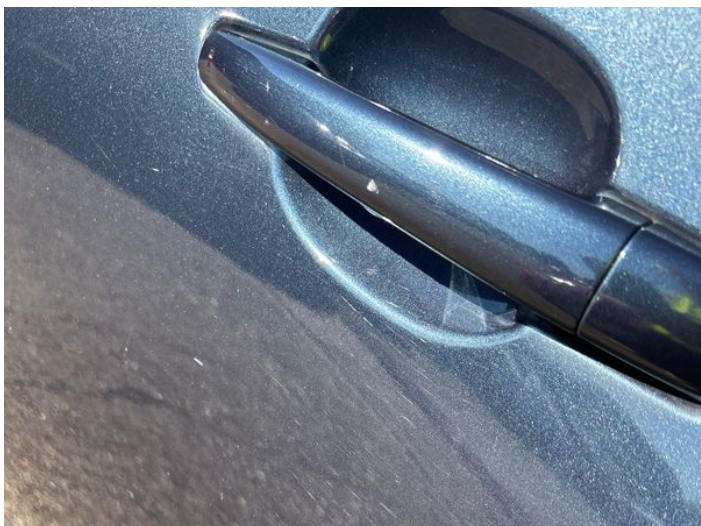
9: Door nsr  
Chipped  
1 To 5

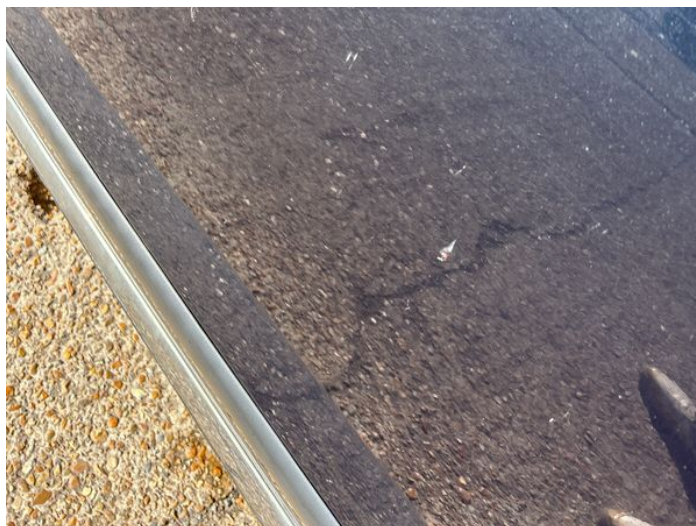
10: Door nsf  
Chipped  
1 To 5

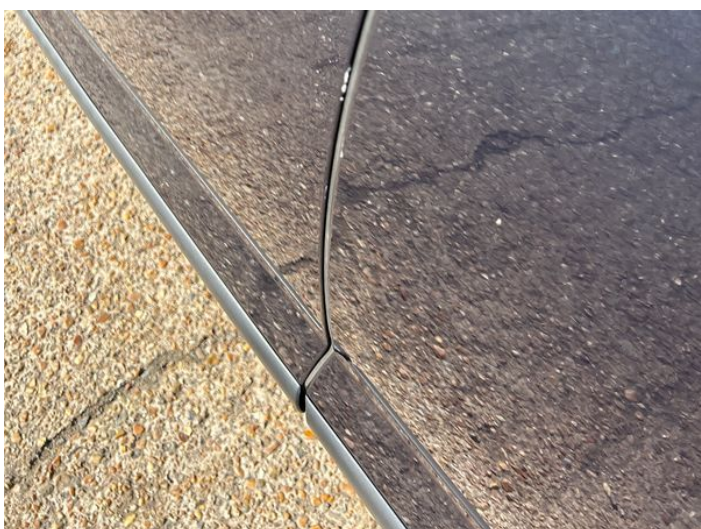
11: Door nsf  
Chipped  
Edge Chip

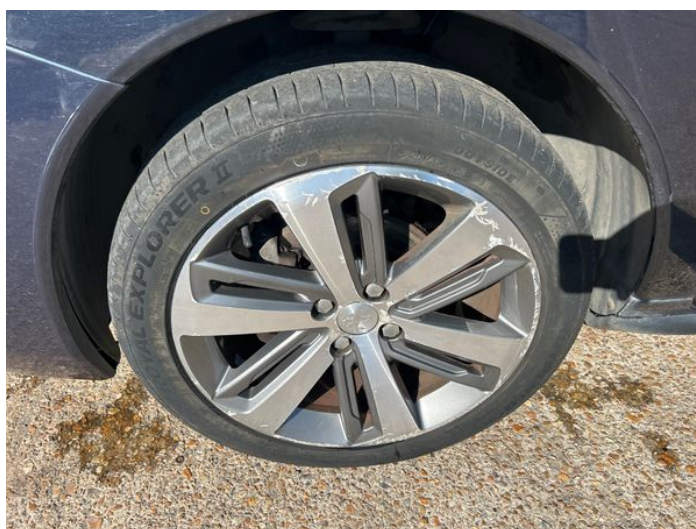
12: Wheel nsf  
Scratched  
Over 50mm

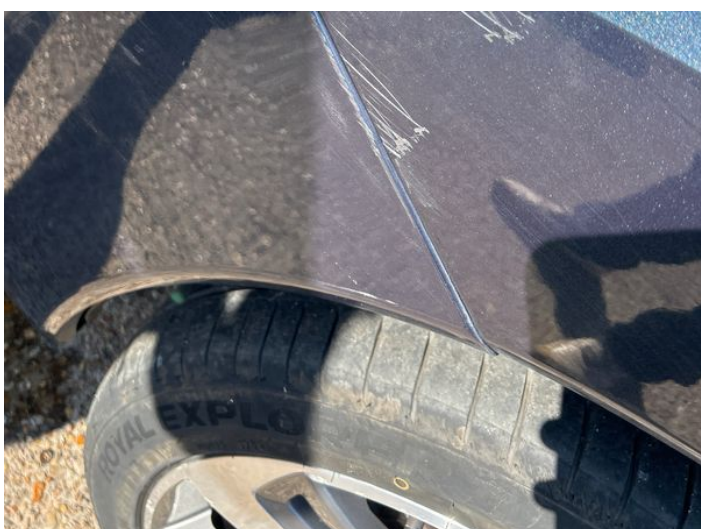
13: Wing nsf  
Scratched  
Over 25mm Thru Paint

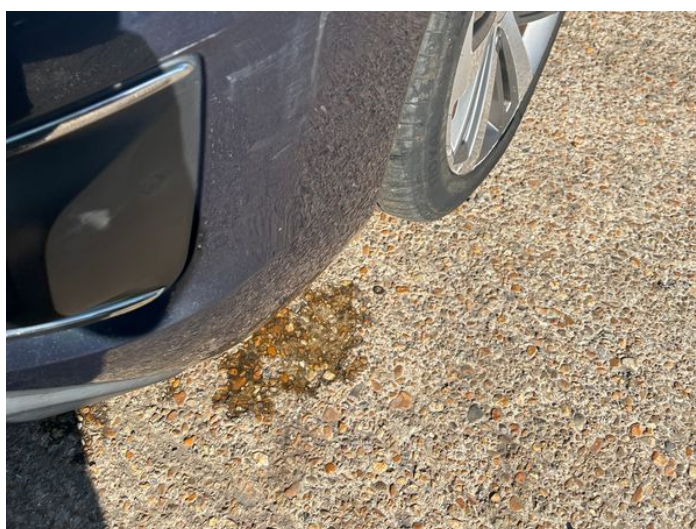
14: Bumper Front  
Scratched  
Over 100mm Thru Paint

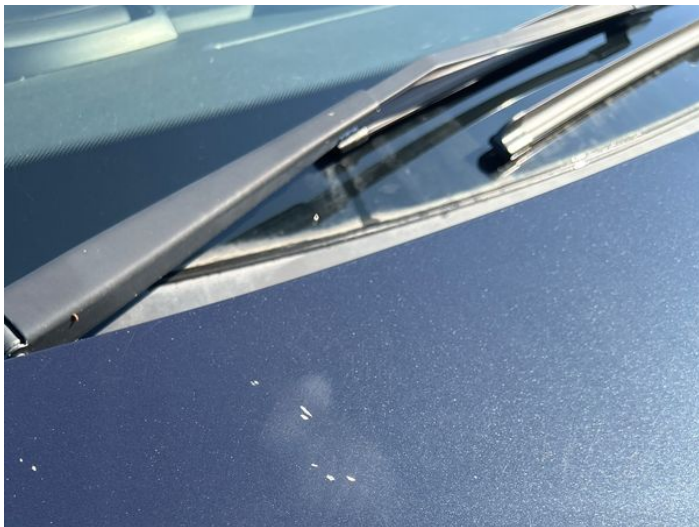
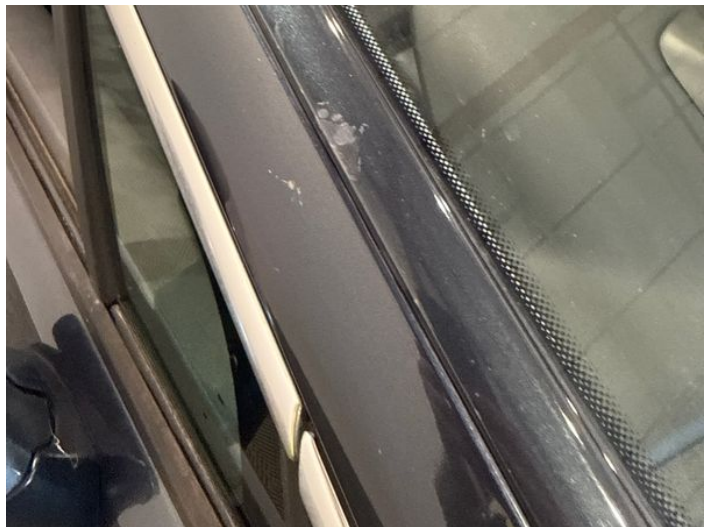
15: Bonnet  
Chipped  
1 To 5
