## VEHICLE INSPECTION REPORT

**DS20WFN**

### Ford S-Max 2.0 EcoBlue 190 ST-Line 5dr Auto

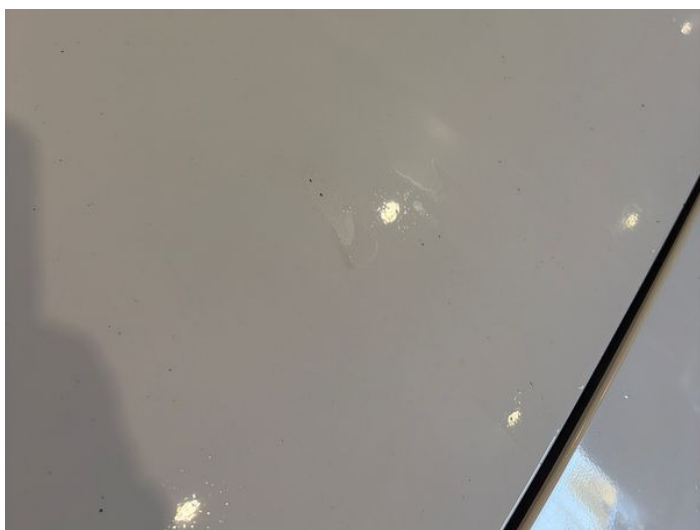
1: Bonnet  
Poor Previous Repair  
Poor Paint

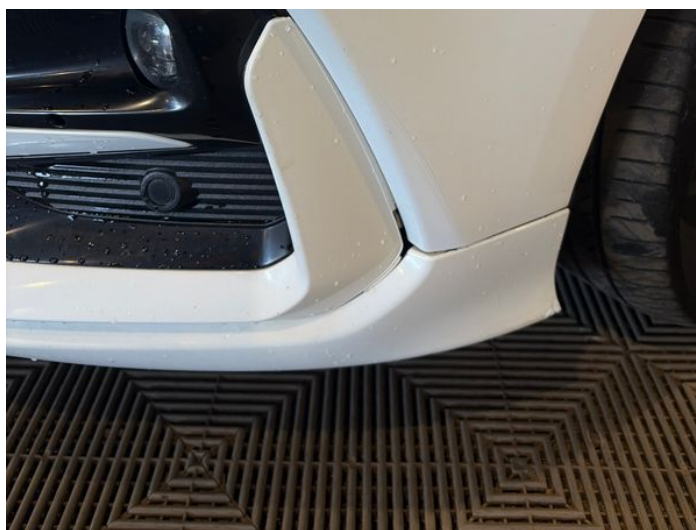
2: Bumper Front  
Dented  
With Paint Damage

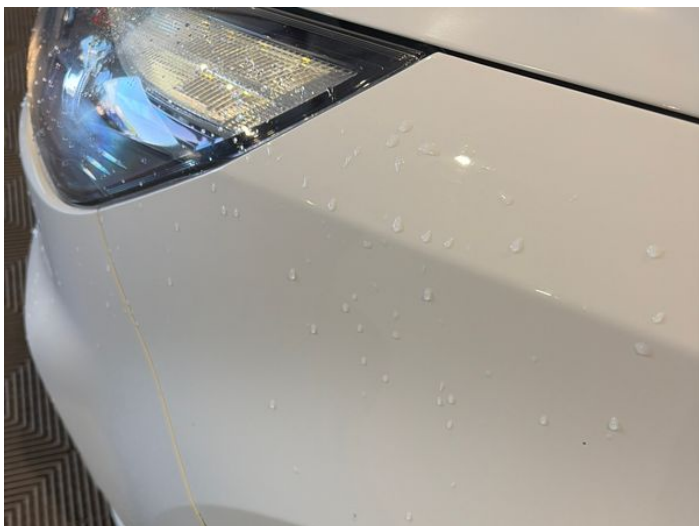
3: Wing nsf  
Chipped  
1 To 5

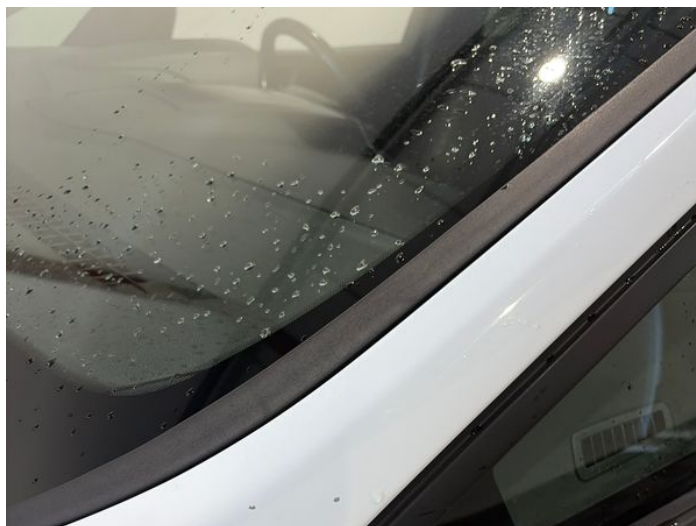
4: A Post ns  
Chipped  
1 To 5

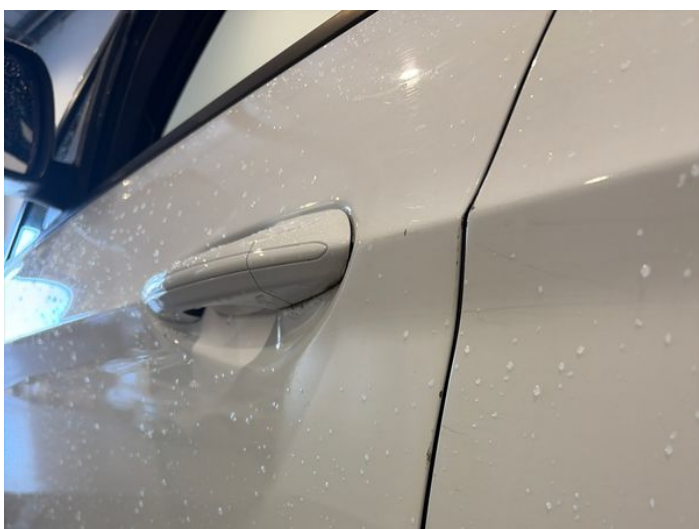
5: Door nsf  
Chipped  
Edge Chip

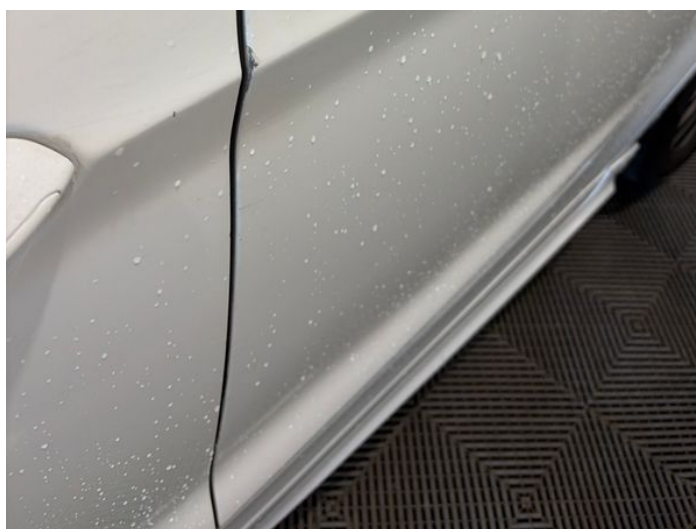
6: Door nsr  
Dented  
With Paint Damage

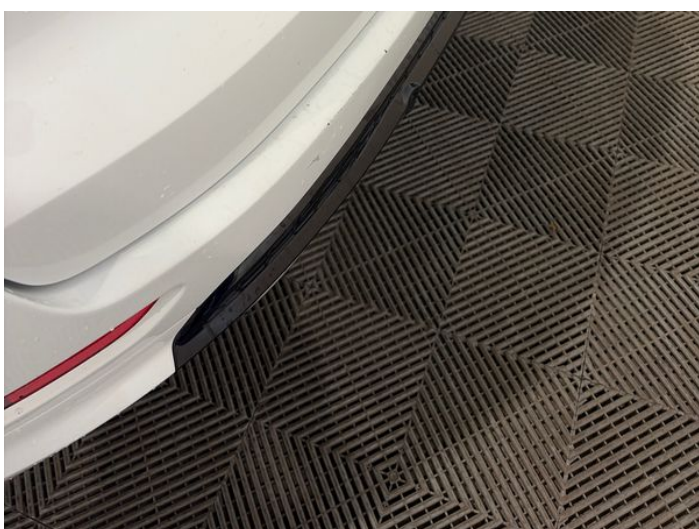
7: Bumper Rear  
Scratched  
25 to 100mm Thru Paint

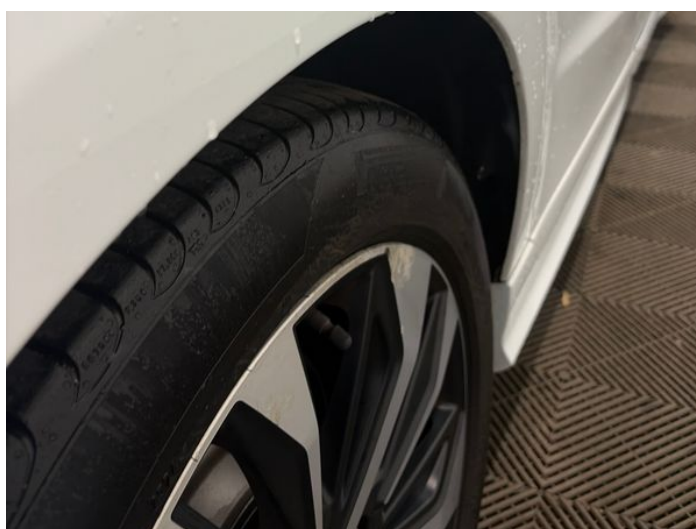
8: Qtr Panel osr  
Dented  
Between 10mm + 30mm

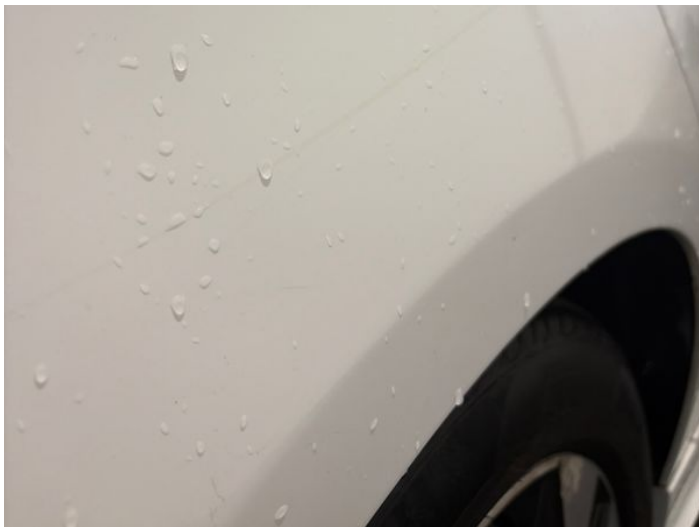
9: Qtr Panel osr  
Scratched  
Over 25mm Thru Paint

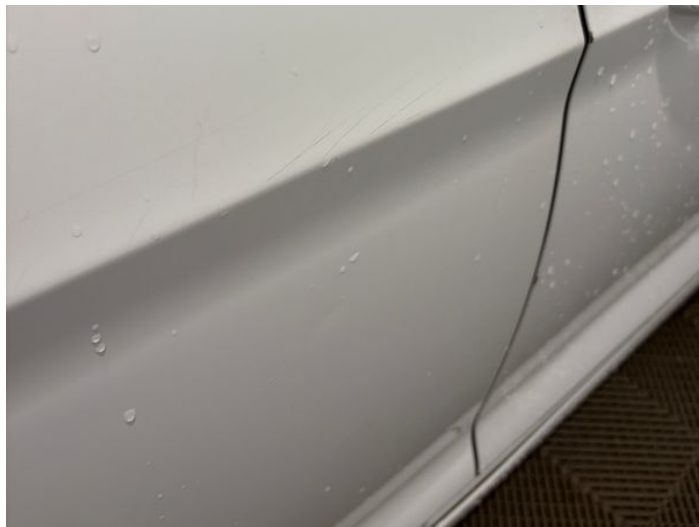
10: Door osr  
Scratched  
Over 25mm Thru Paint

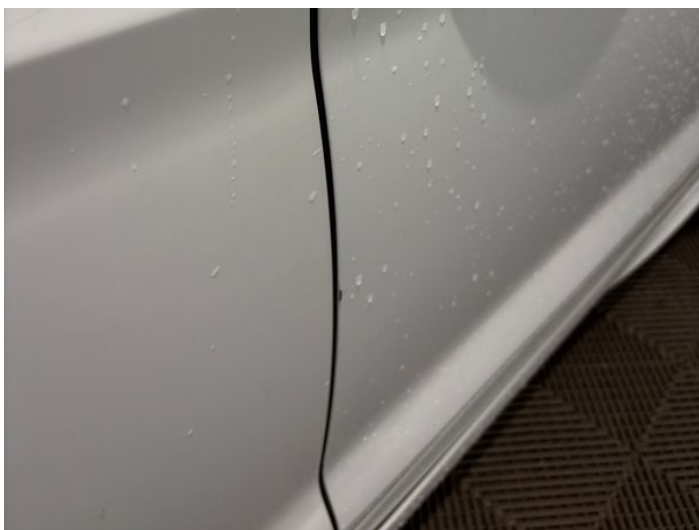
11: Door osf  
Scratched  
Over 25mm Thru Paint

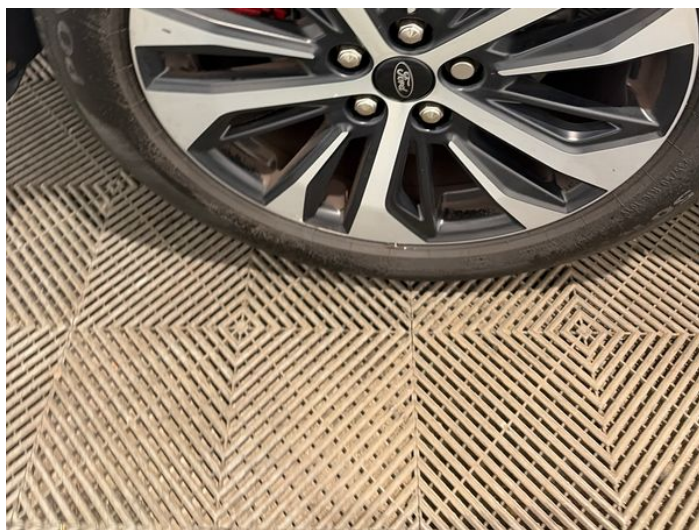
12: Wheel osr  
Corroded  
Light

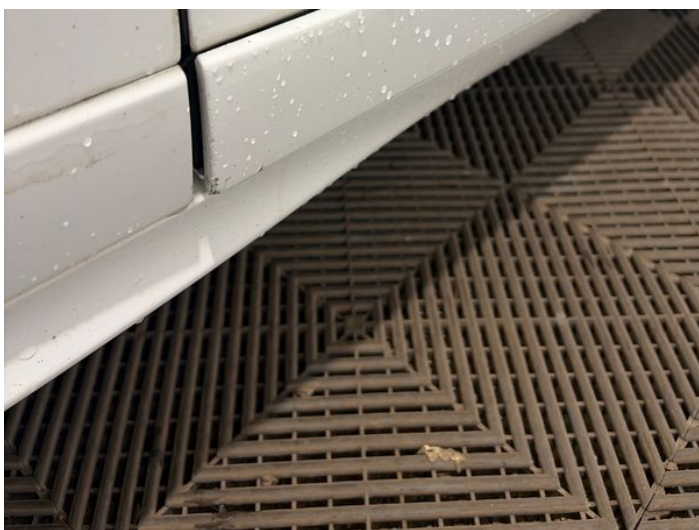
13: Door Moulding osf  
Scratched (Painted)  
Over 25mm Thru Paint

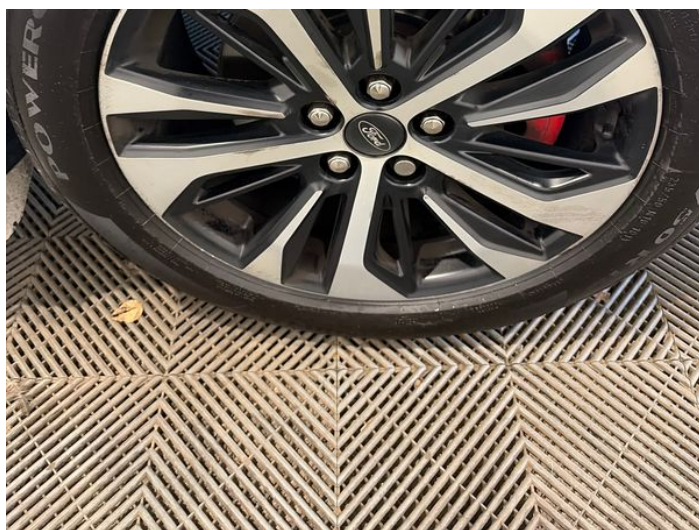
14: Wheel osf  
Scratched  
Over 50mm

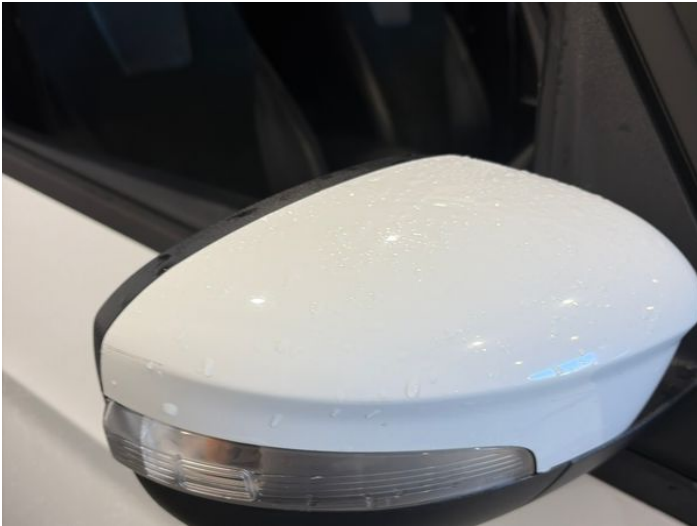
15: Door Mirror Assy osf  
Scratched (Painted)  
UpTo 25mm Thru Paint

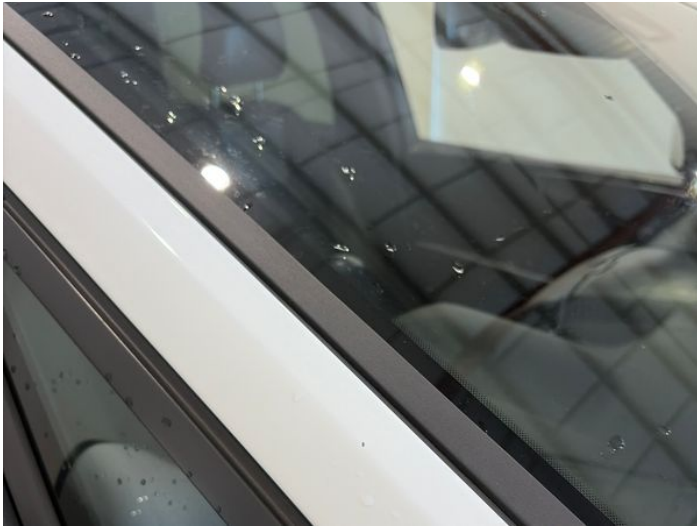
16: A Post os  
Chipped  
1 To 5

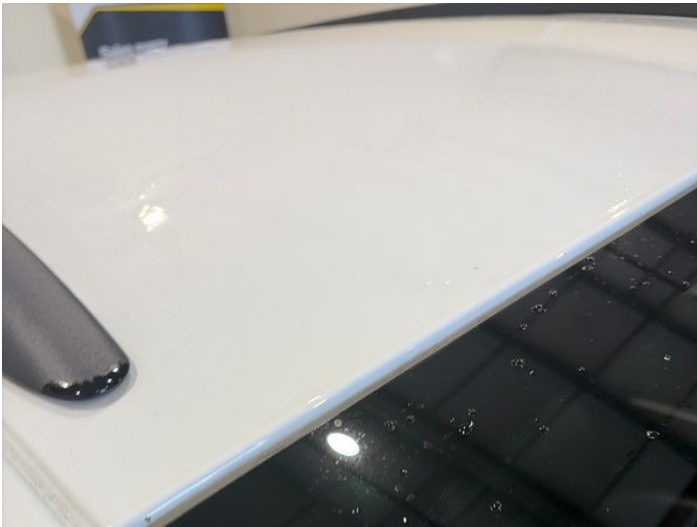
17: Roof  
Chipped  
Edge Chip

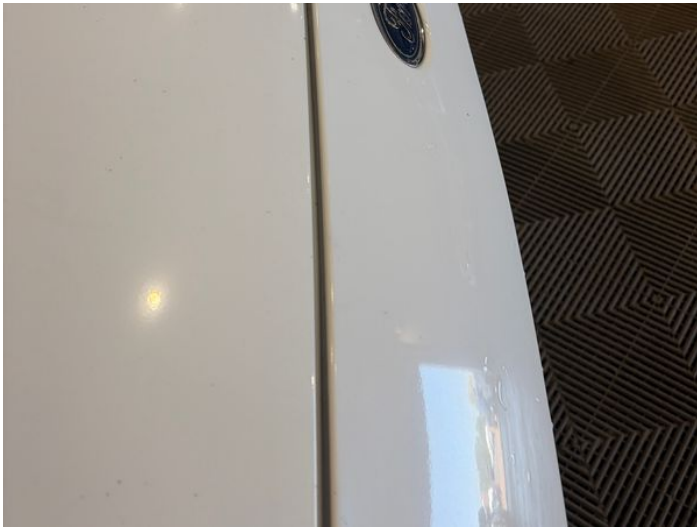
18: Bumper Front  
Poor Previous Repair  
Poor Paint
