# VEHICLE INSPECTION REPORT

**GP21AUV**

## Kia Rio 1.0 T GDi 48V 118 3 5dr DCT

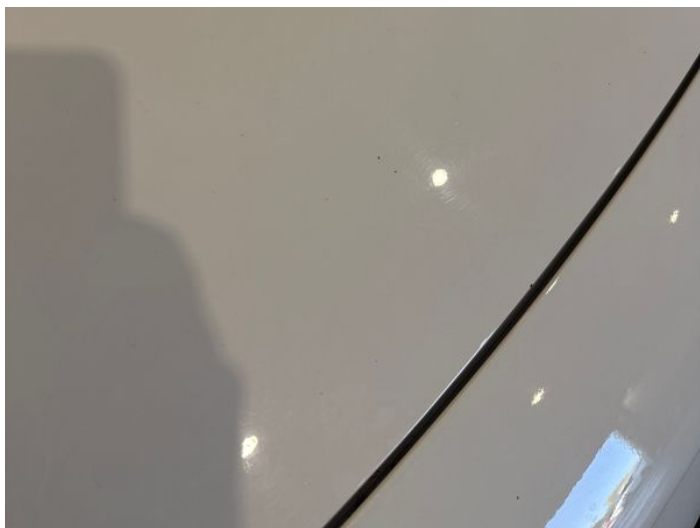
1: Bonnet  
Chipped  
1 To 5

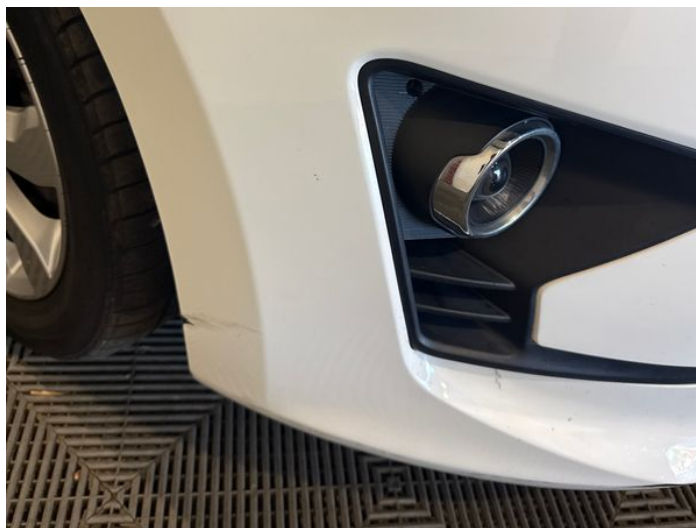
2: Bumper Front  
Scratched  
25 to 100mm Thru Paint

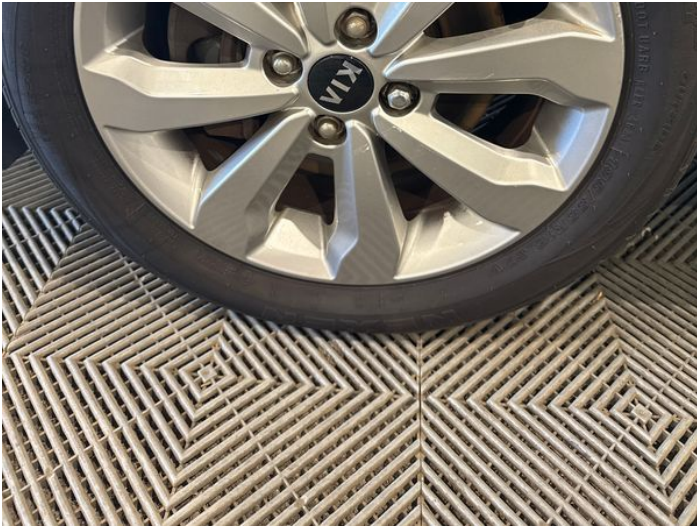
3: Wheel nsf  
Scratched  
Over 50mm

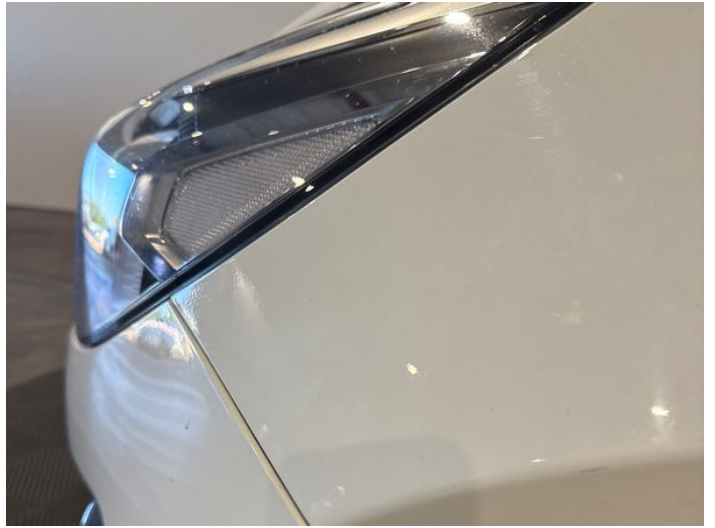
4: Wing nsf  
Chipped  
1 To 5

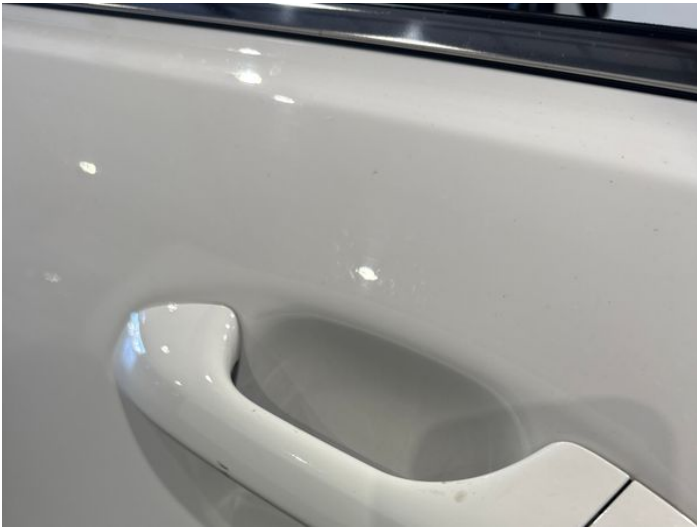
5: Handle Outer nsf  
Scratched (Painted)  
UpTo 25mm Thru Paint

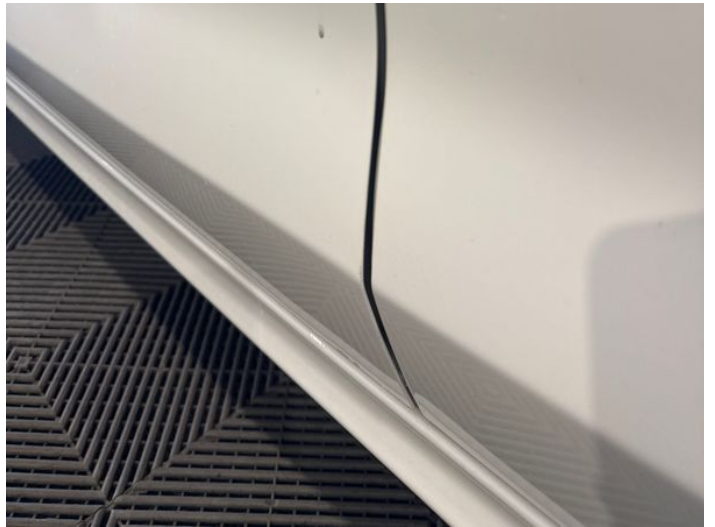
6: Door nsf  
Chipped  
Edge Chip

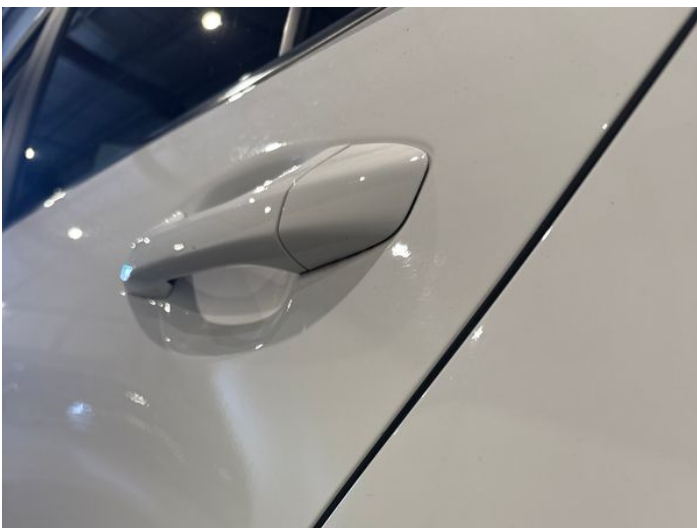
7: Door nsr  
Chipped  
Edge Chip

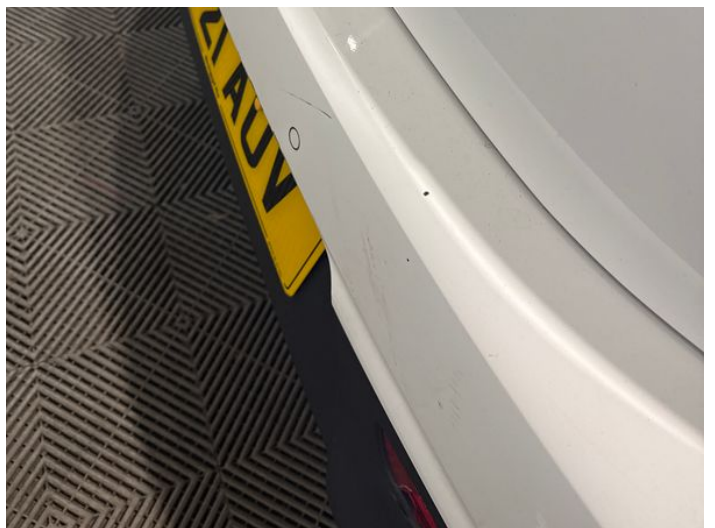
8: Bumper Rear  
Scratched  
Over 100mm Thru Paint

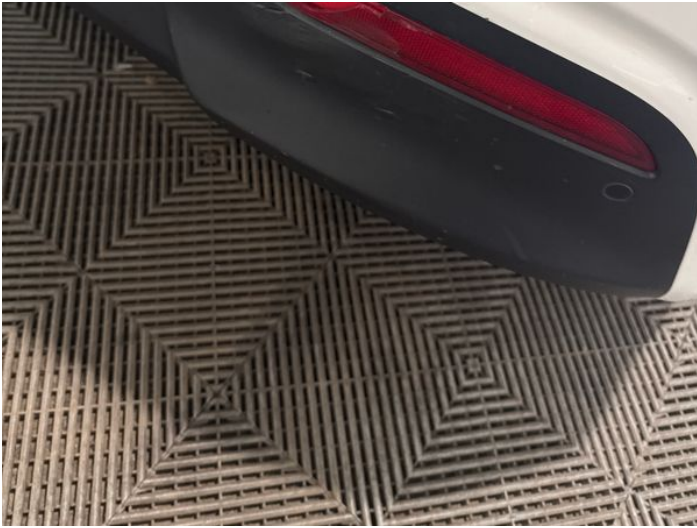
9: Bumper Reflector osr  
Broken  
Replace

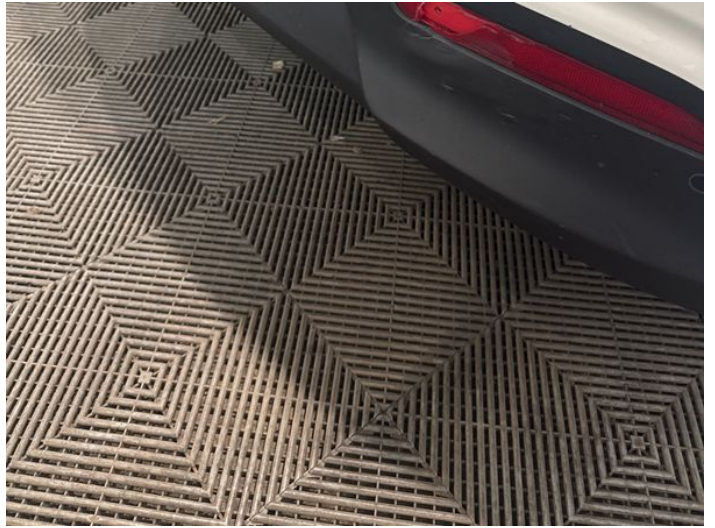
10: Bumper Rear Moulding  
Scuffed (Unpainted)  
Over 100mm

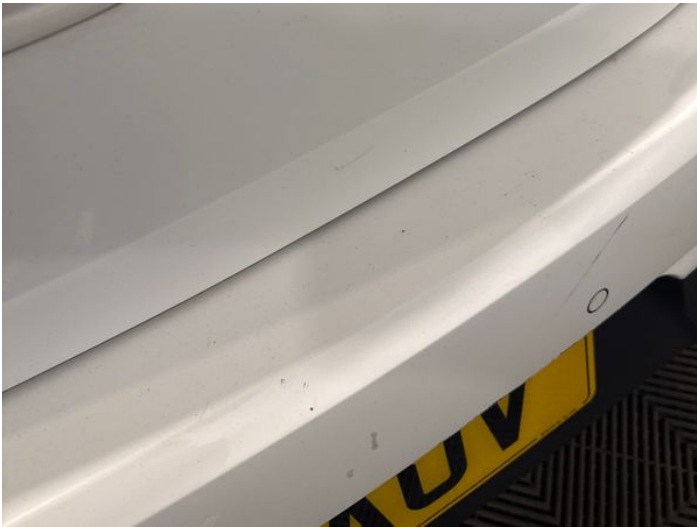
11: Tailgate  
Scratched  
UpTo 25mm Thru Paint

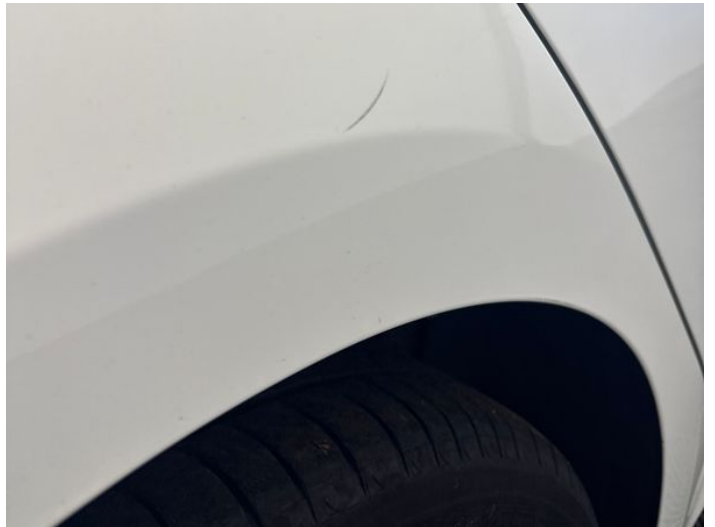
12: Qtr Panel osr  
Scratched  
Over 25mm Thru Paint

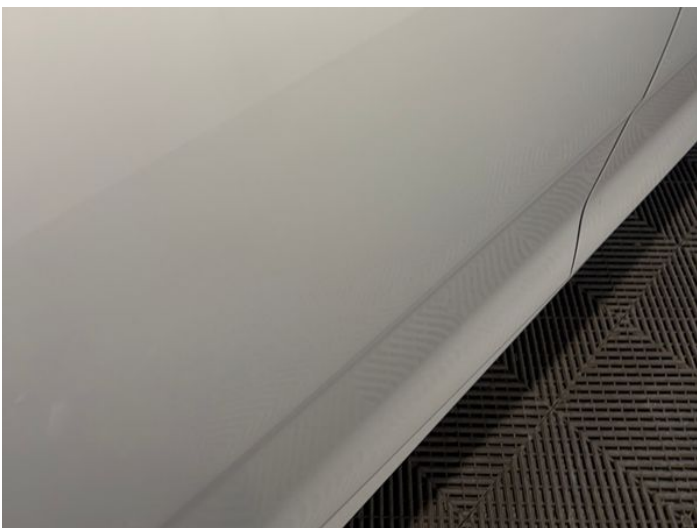
13: Door osr  
Scratched  
Over 25mm Thru Paint

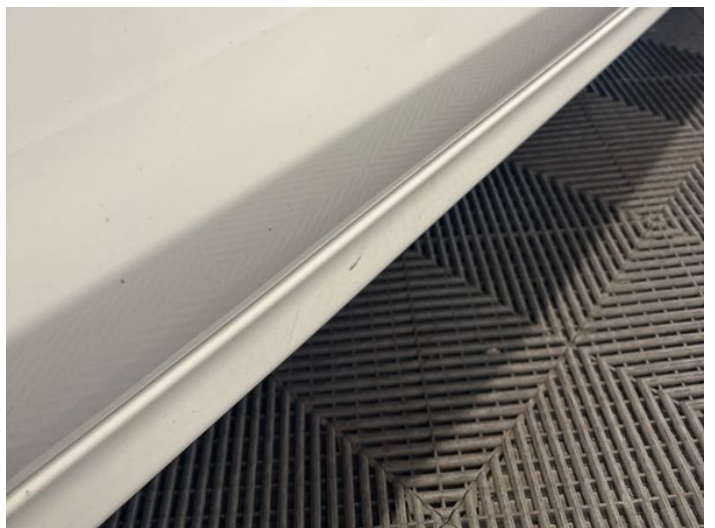
14: Door osf  
Dented  
Between 10mm + 30mm

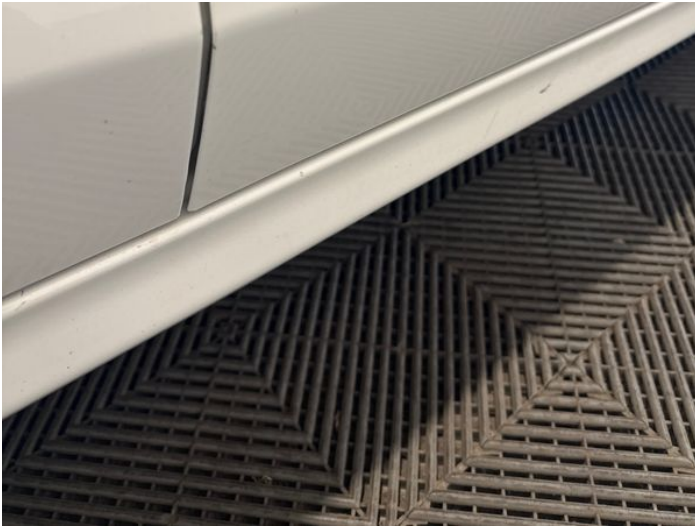
15: Door osf  
Chipped  
Edge Chip

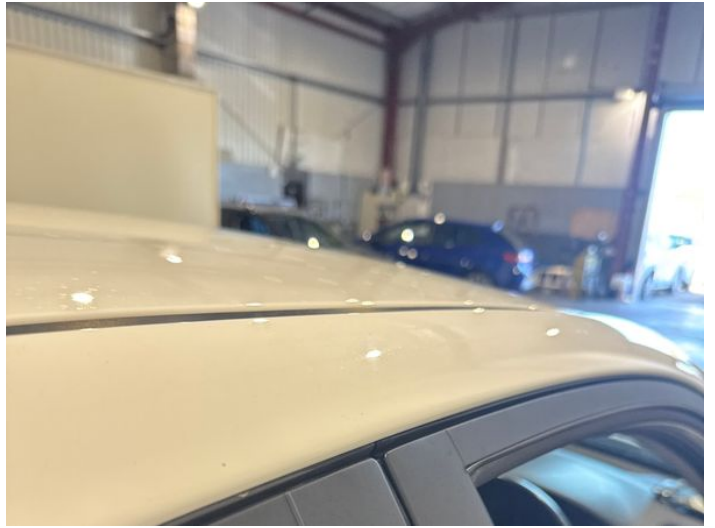
16: B Post os  
Dented  
Over 2 UpTo 10mm

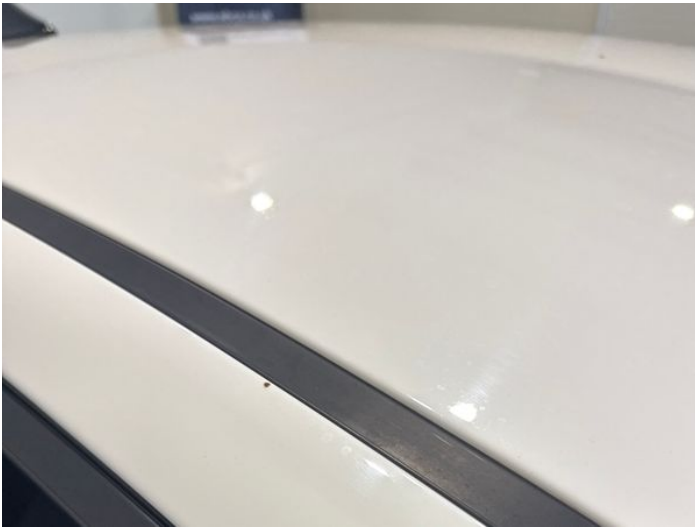
17: A Post os  
Chipped  
1 To 5

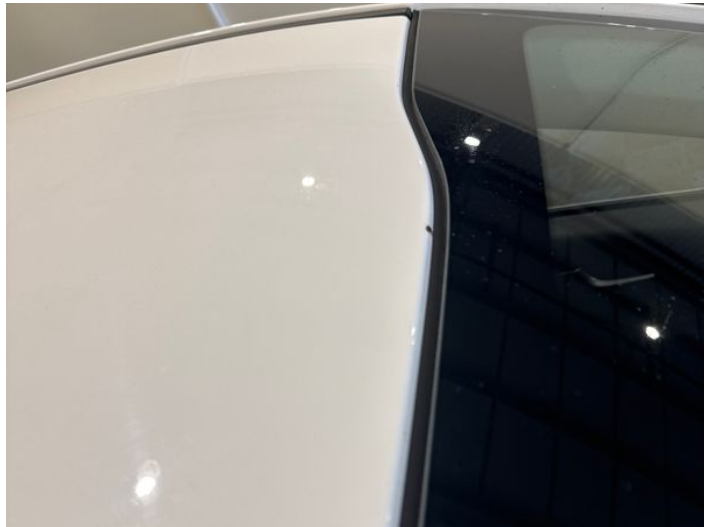
18: Roof  
Chipped  
Edge Chip

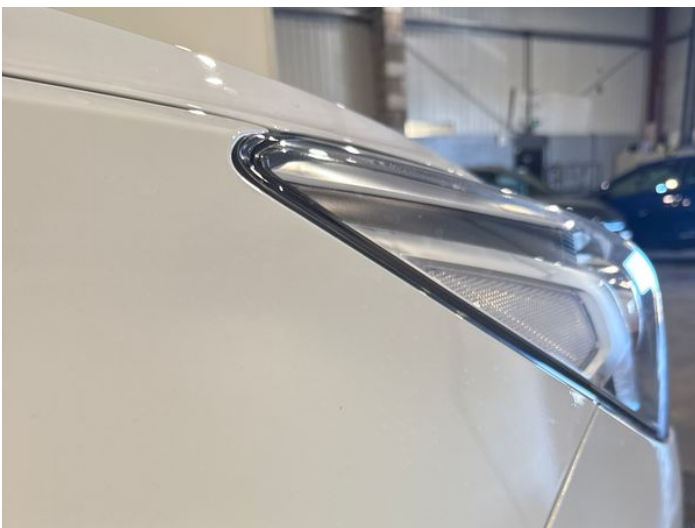
19: Wing osf  
Chipped  
1 To 5

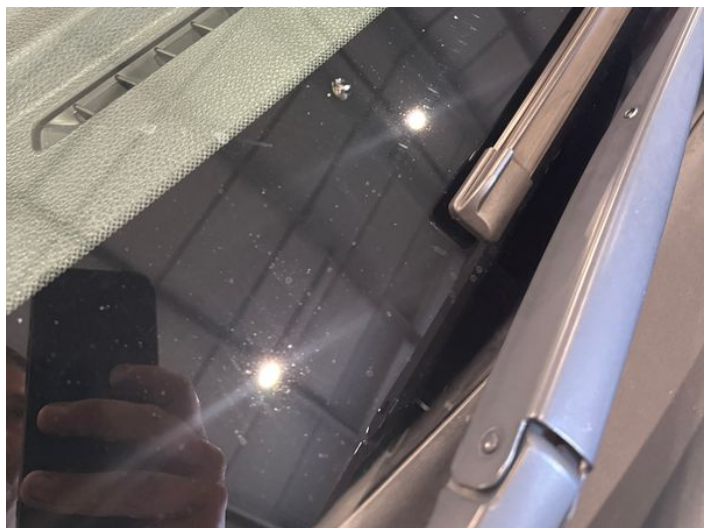
20: Screen Front  
Chipped  
Over 10mm
