# VEHICLE INSPECTION REPORT

RE69PVD

## Nissan Qashqai 1.3 DiG-T Tekna 5dr

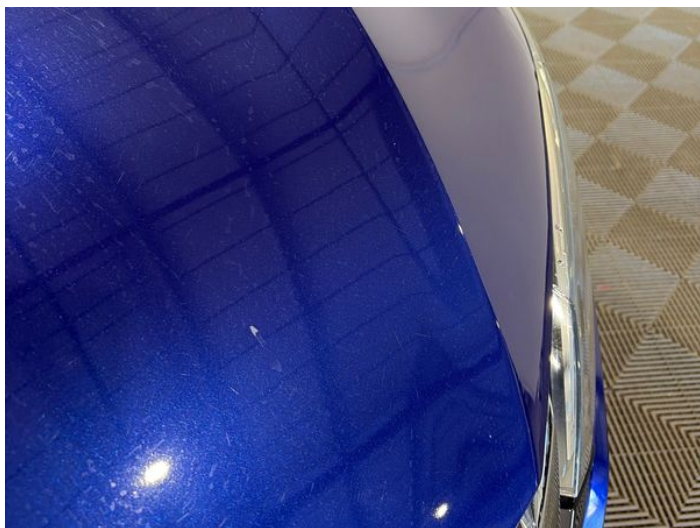
1: Bonnet  
Chipped  
1 To 5

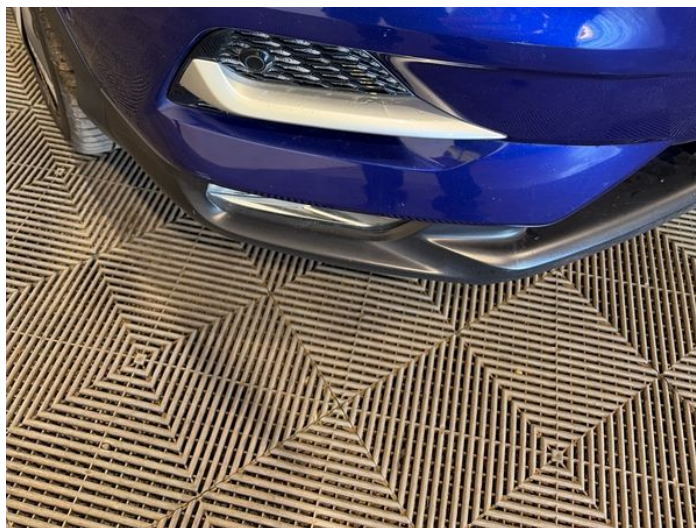
2: Bumper Front  
Scratched  
Over 100mm Thru Paint

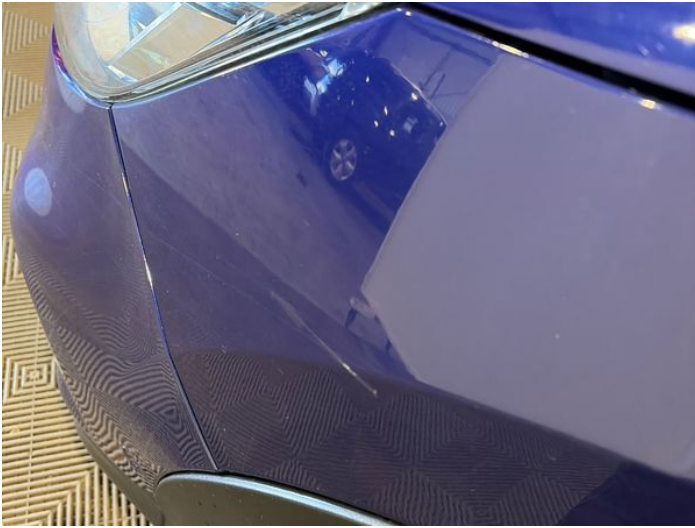
3: Wing nsf  
Scratched  
Over 25mm Thru Paint

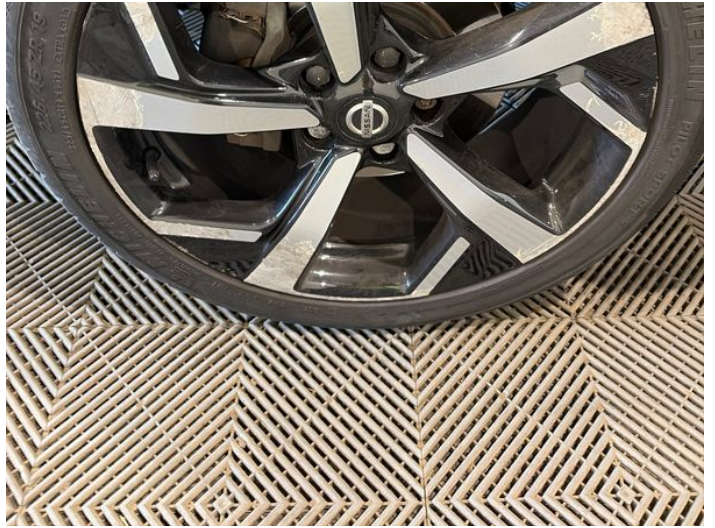
4: Wheel nsf  
Scratched  
Over 50mm

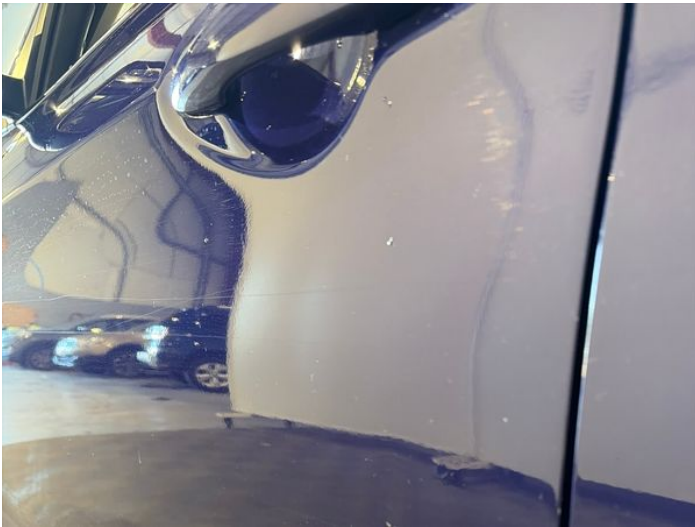
5: Door nsf  
Dented  
Over 30mm

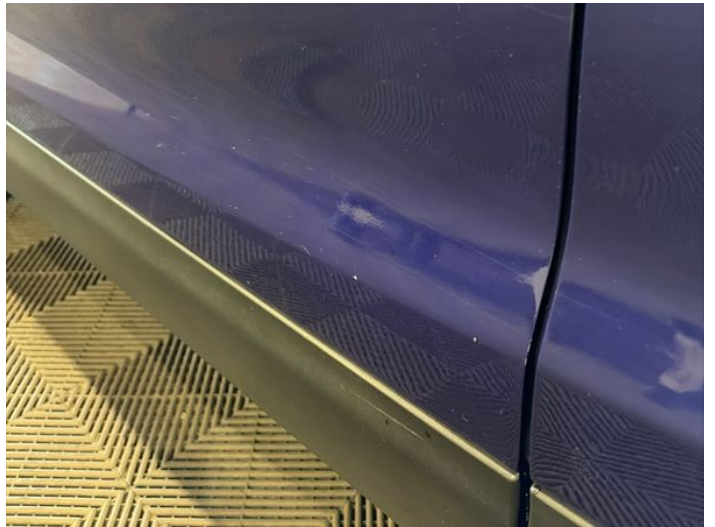
6: Door nsf  
Chipped  
Multiple Chips

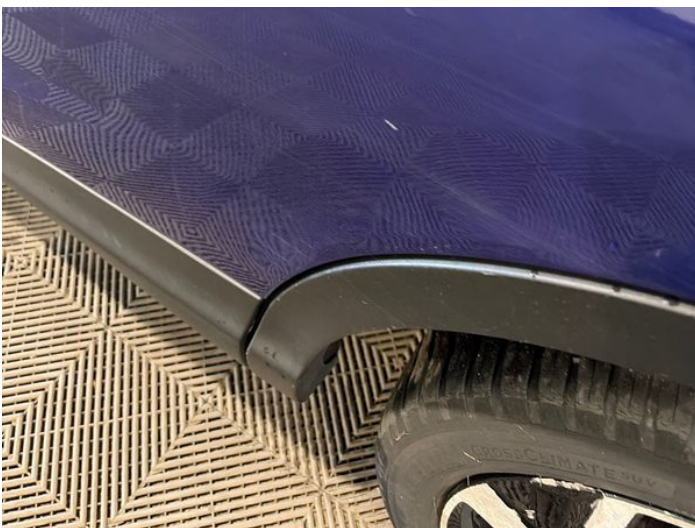
7: Door nsr  
Scratched  
Over 25mm Thru Paint

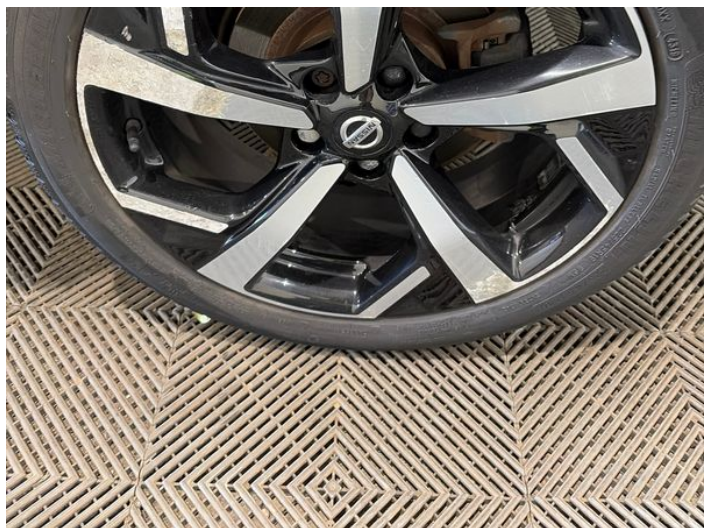
8: Wheel nsr  
Scratched  
Over 50mm

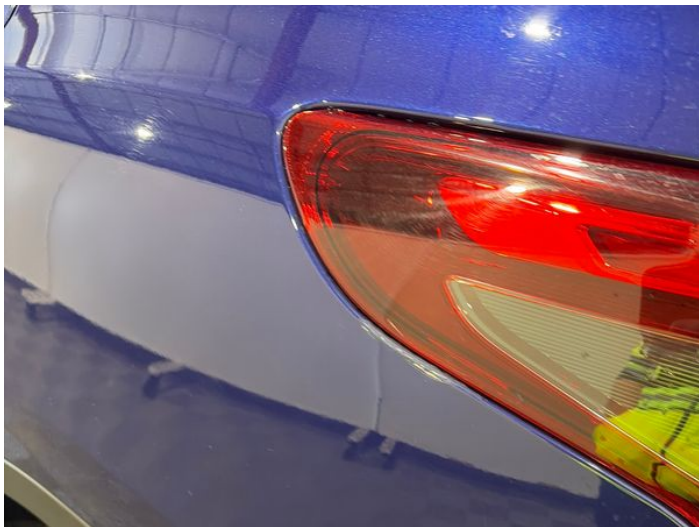
9: Qtr Panel nsr  
Scratched  
Over 25mm Thru Paint

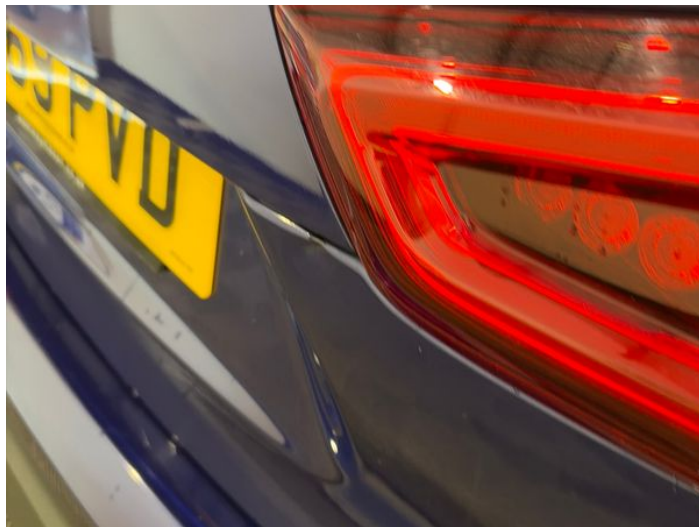
10: Tailgate  
Dented  
Between 10mm + 30mm

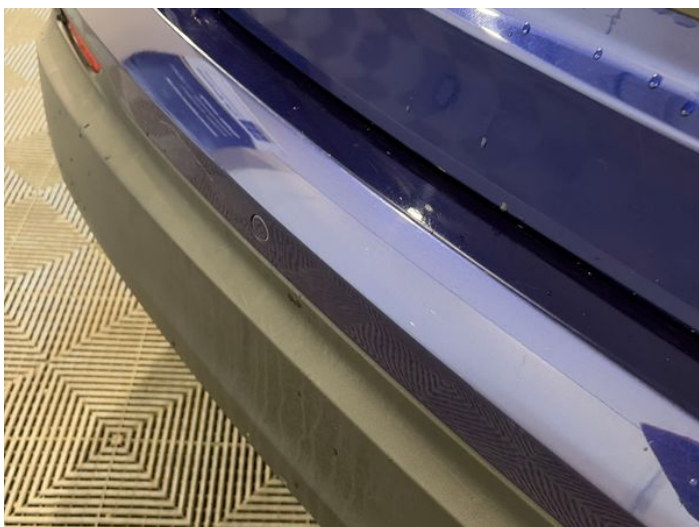
11: Bumper Rear  
Scratched  
25 to 100mm Thru Paint

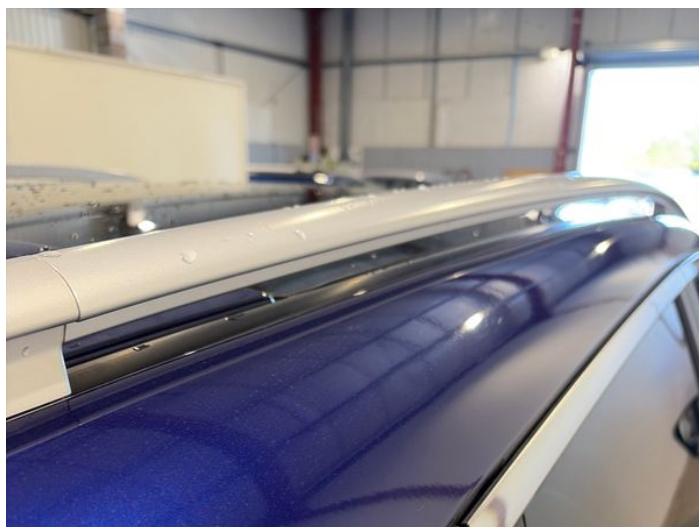
12: C Post os  
Dented  
Between 10mm + 30mm

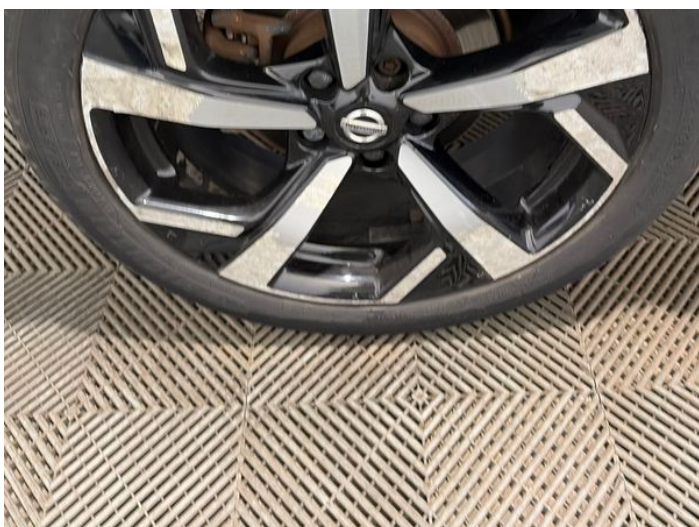
13: Wheel osr  
Scratched  
Over 50mm

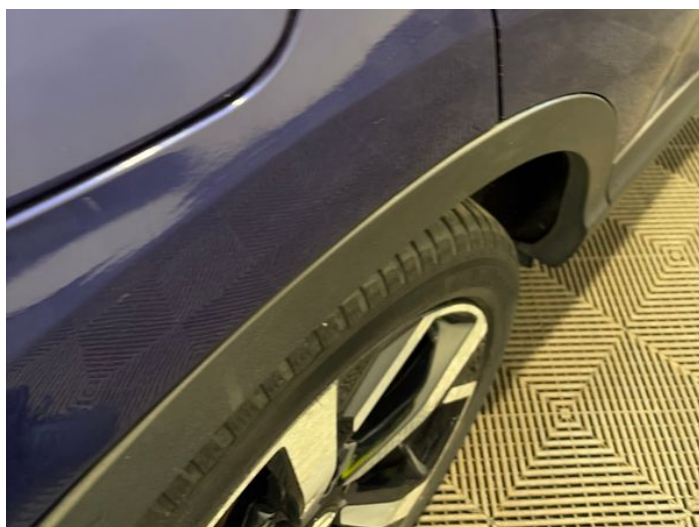
14: Qtr Panel osr  
Scratched  
UpTo 25mm Thru Paint

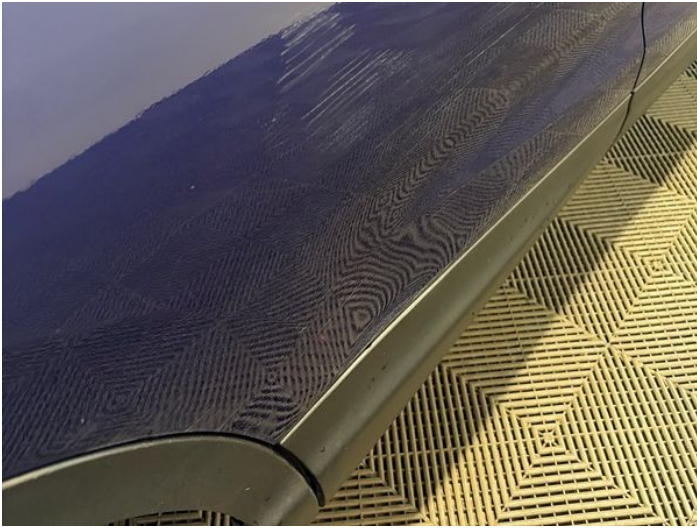
15: Door osr  
Scratched  
Over 25mm Thru Paint

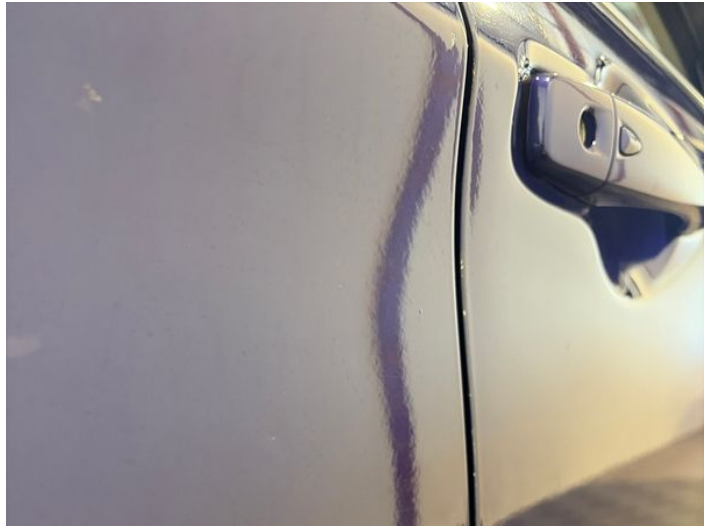
16: Door osr  
Dented  
Between 10mm + 30mm

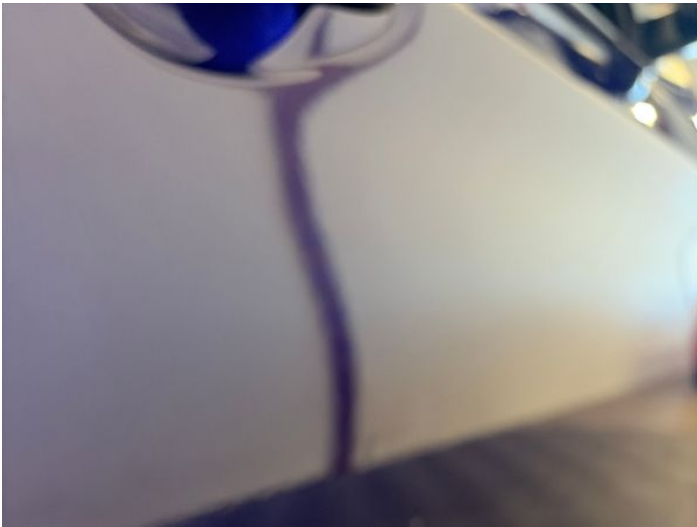
17: Door osf  
Dented  
Between 10mm + 30mm

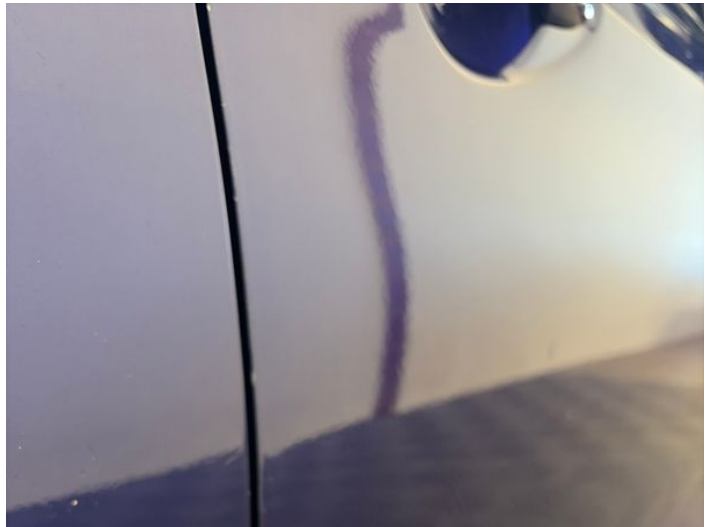
18: Door osf  
Chipped  
Edge Chip

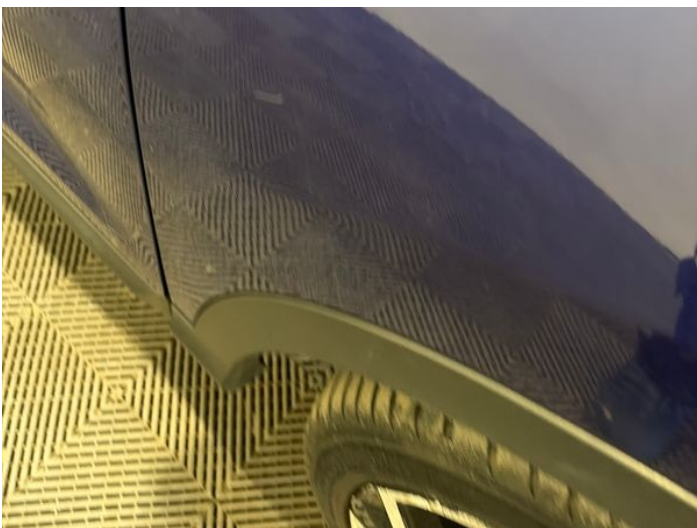
19: Wing osf  
Scratched  
UpTo 25mm Thru Paint

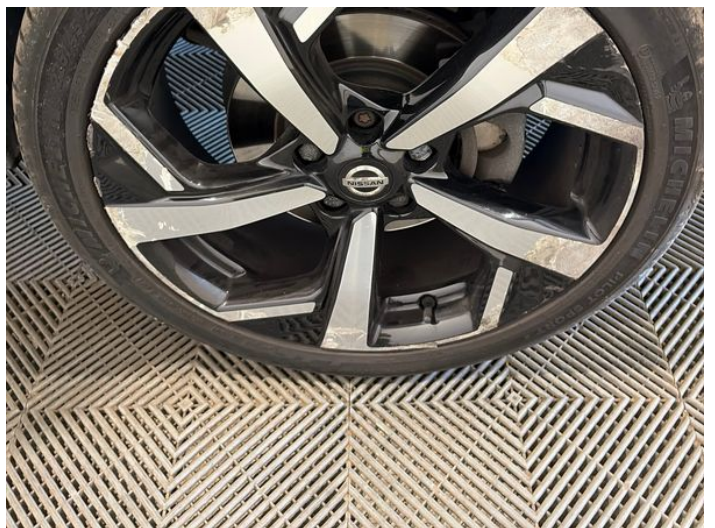
20: Wheel osf  
Scratched  
Over 50mm

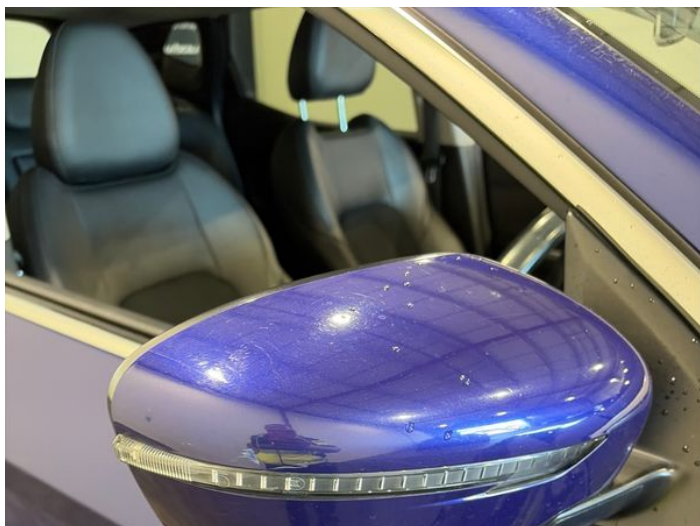
21: Door Mirror Assy osf  
 Scratched (Painted)  
 UpTo 25mm Thru Paint
