## VEHICLE INSPECTION REPORT

**RO69VTG**

### Nissan Qashqai 1.5 dCi 115 N-Connecta 5dr

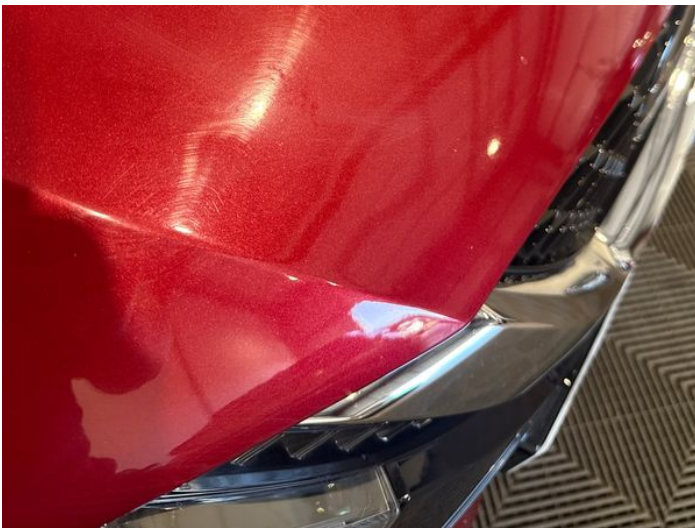
1: Bonnet  
Scratched  
Over 25mm Thru Paint

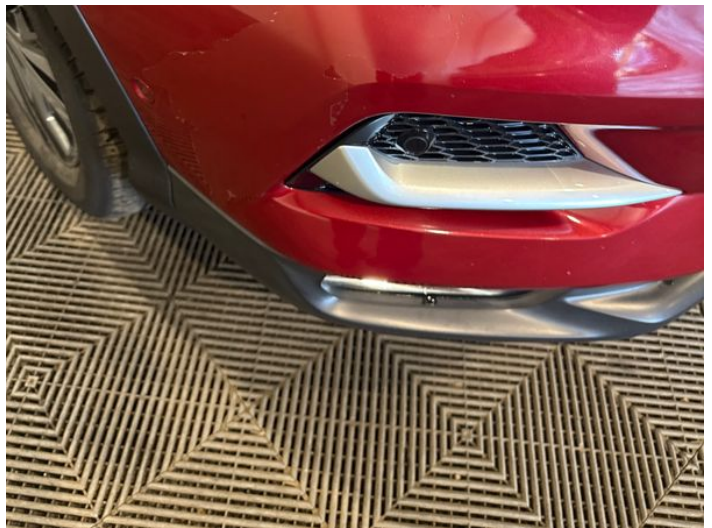
2: Bumper Front  
Poor Previous Repair  
Paint Flake

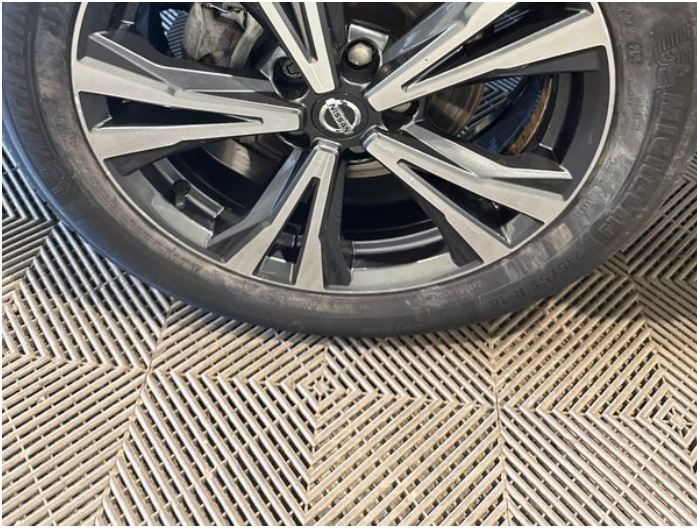
3: Wheel nsf  
Scratched  
Over 50mm

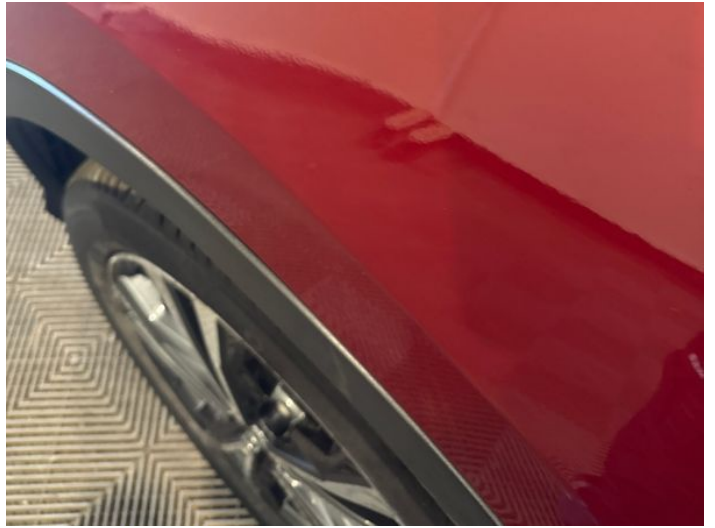
4: Wing nsf  
Chipped  
1 To 5

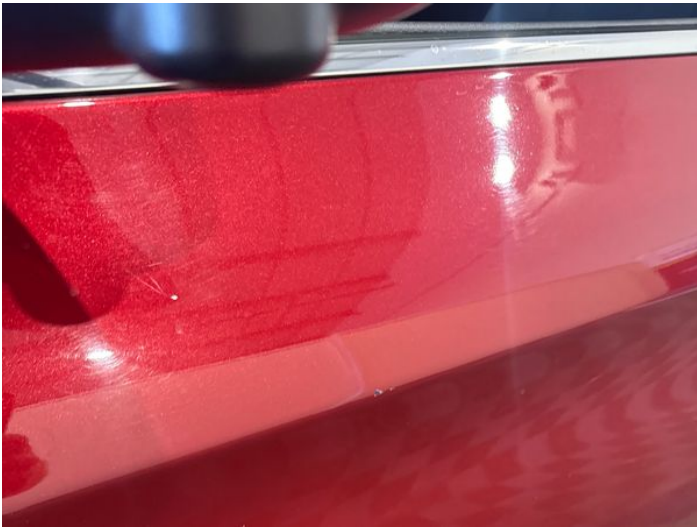
5: Door nsf  
Chipped  
1 To 5

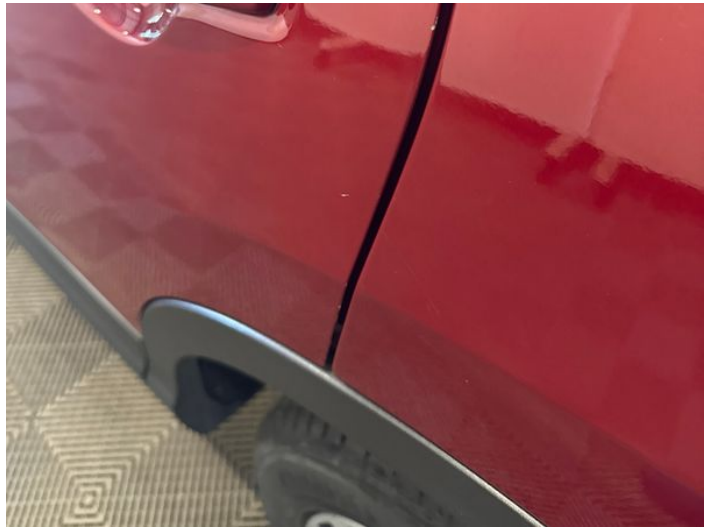
6: Door nsr  
Chipped  
Edge Chip

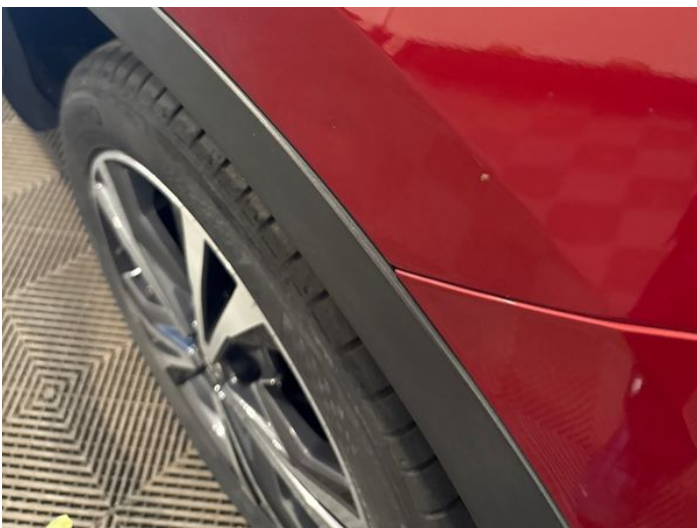
7: Qtr Panel nsr  
Dented  
Between 10mm + 30mm

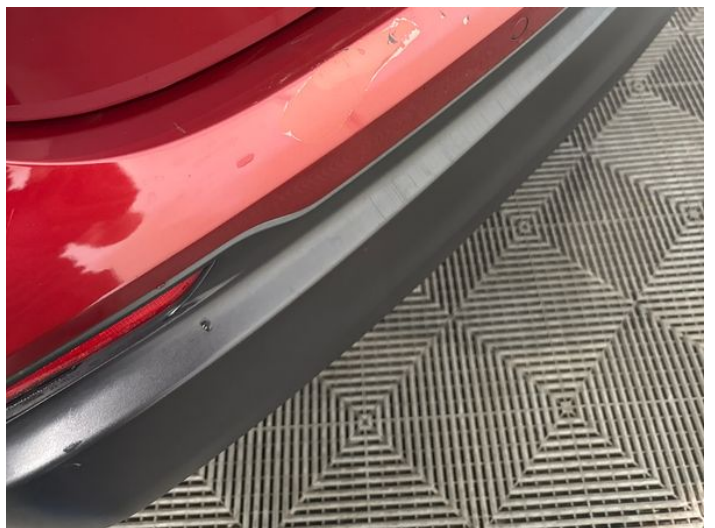
8: Bumper Rear  
Poor Previous Repair  
Paint Flake

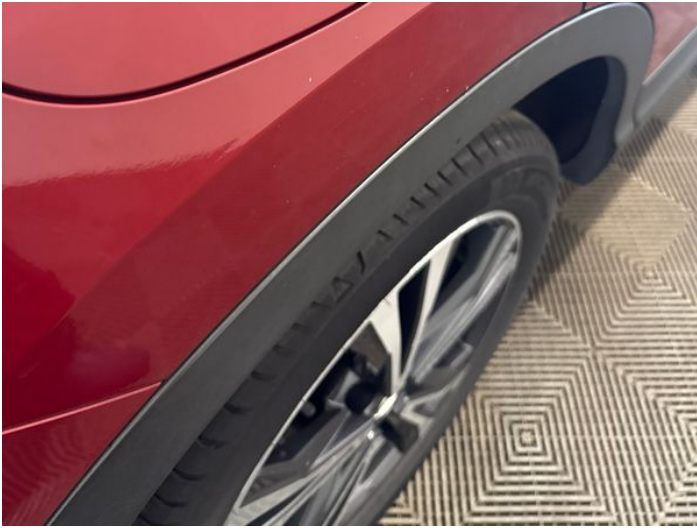
9: Qtr Panel osr  
Chipped  
1 To 5

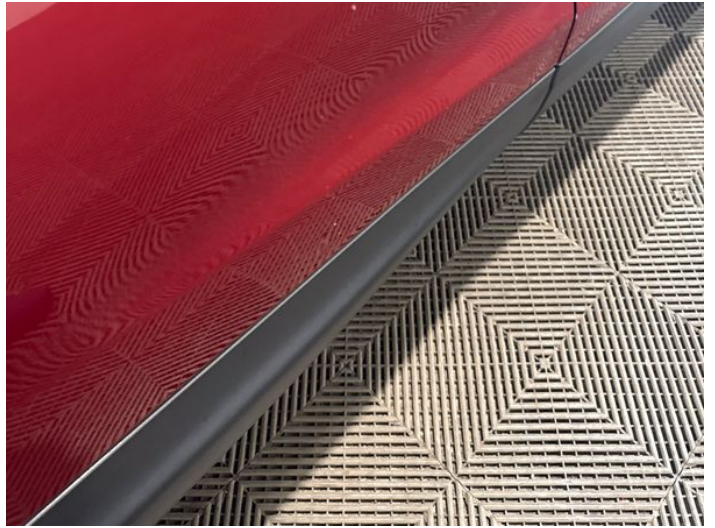
10: Door osr  
Chipped  
Multiple Chips

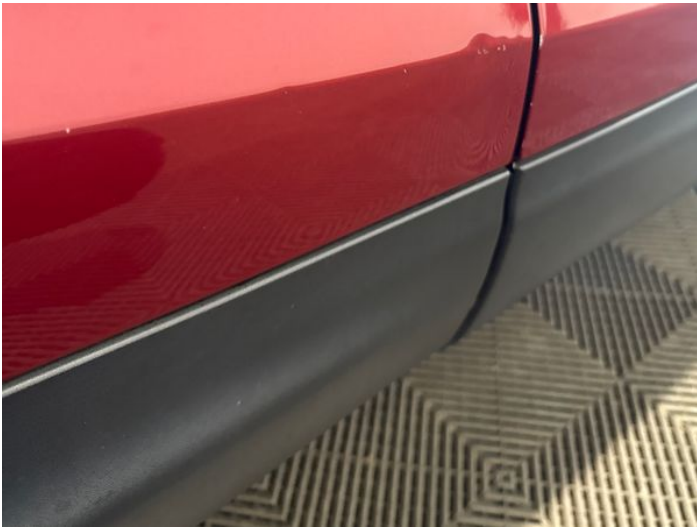
11: Door osr  
Dented  
Between 10mm + 30mm

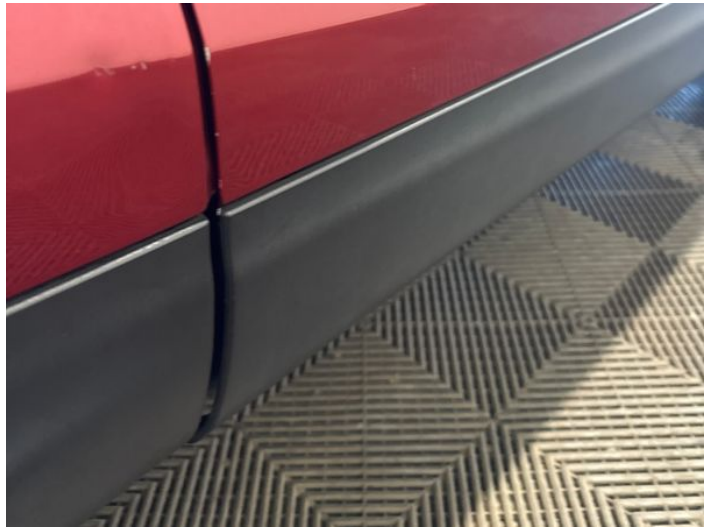
12: Door osf  
Chipped  
Edge Chip

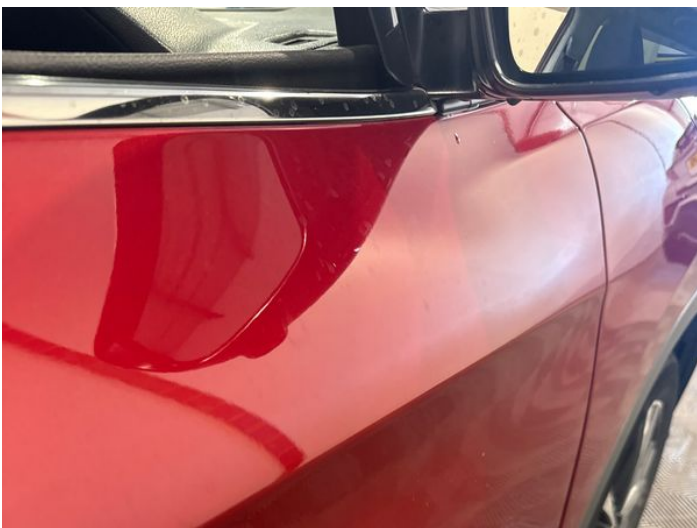
13: Door osf  
Dented  
2 Or Less UpTo 10mm

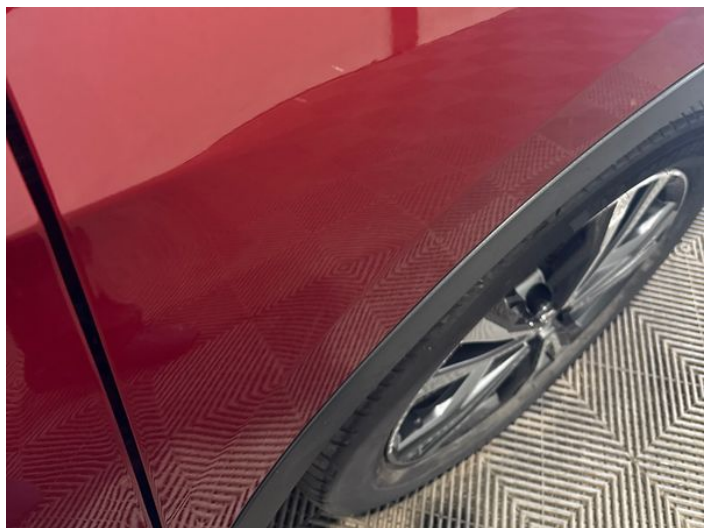
14: Wing osf  
Scratched  
UpTo 25mm Thru Paint
