VEHICLE INSPECTION REPORT

Skoda Citigo 1.0 MPI SE 5dr

Eastbourne Car Auctions

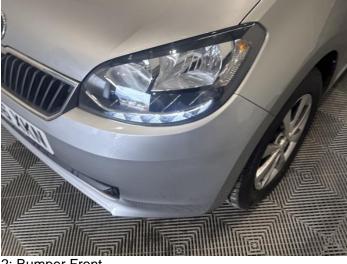
2: Bumper Front Chipped Multiple Chips

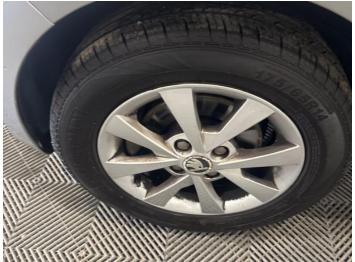
4: Wheel nsf Scratched Over 50mm

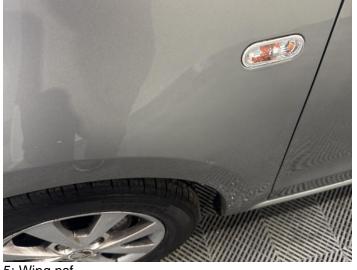
5: Wing nsf Dented Over 2 UpTo 10mm

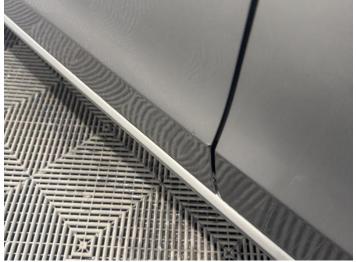
6: Door nsf Dented Over 2 UpTo 10mm

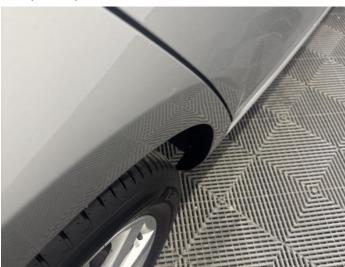
11: Bumper Rear Chipped Multiple Chips

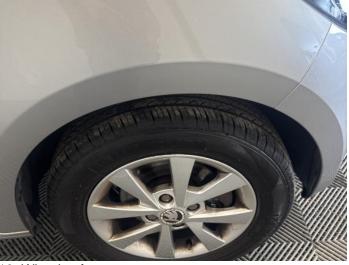
15: Door osf Scratched Over 25mm Not Thru Paint
