# VEHICLE INSPECTION REPORT

**RJ08WGV**

## Honda Accord Ex+ I-Vtec

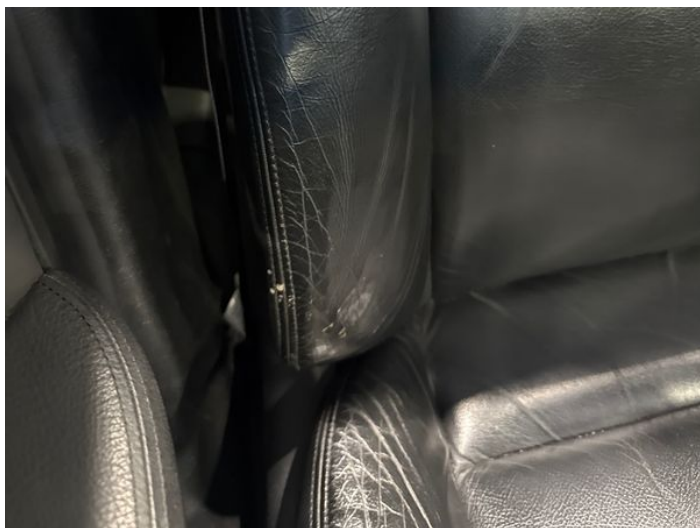
1: Seat Back Cover osf  
Scuffed  
Over 25mm

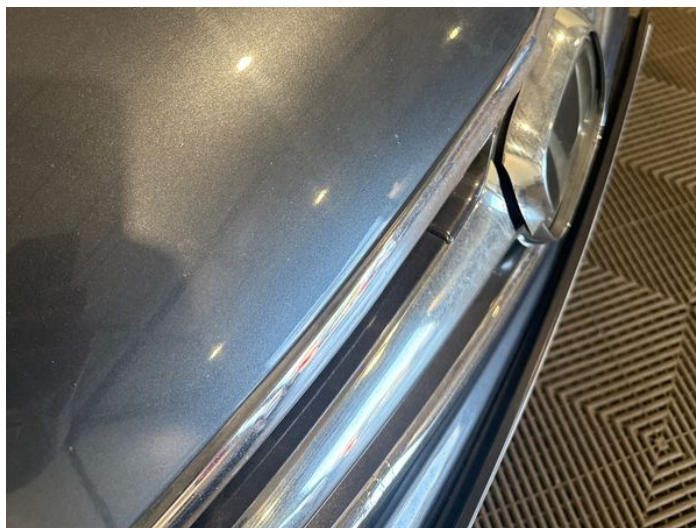
2: Bonnet  
Chipped  
Multiple Chips

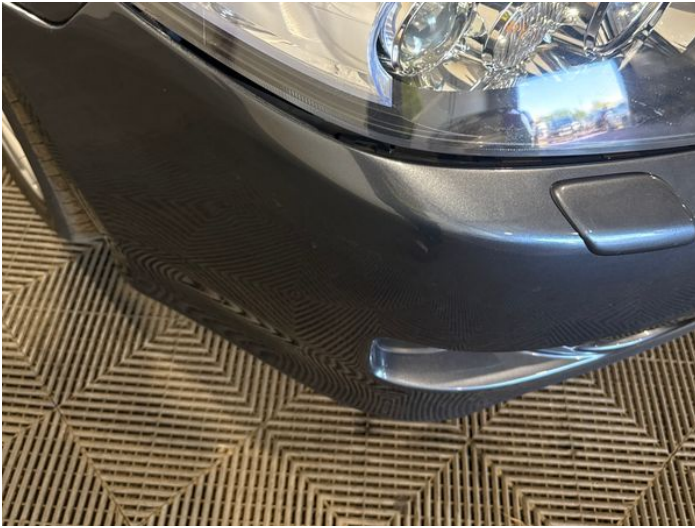
3: Bumper Front  
Insecure  
Action Required

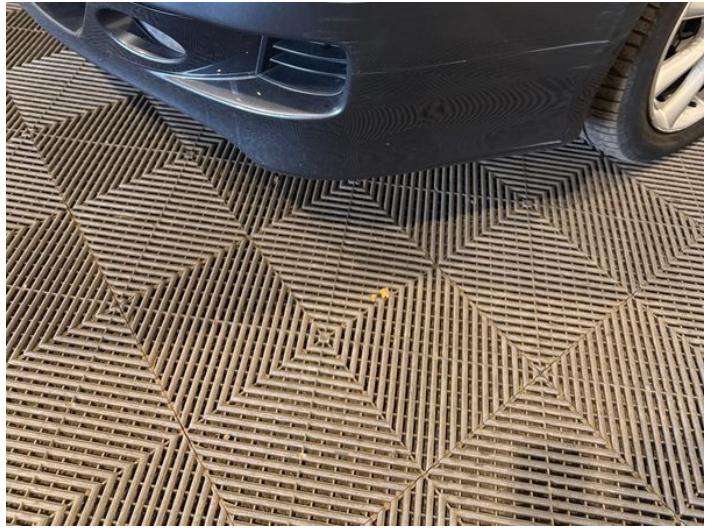
4: Bumper Front  
Scratched  
25 to 100mm Thru Paint

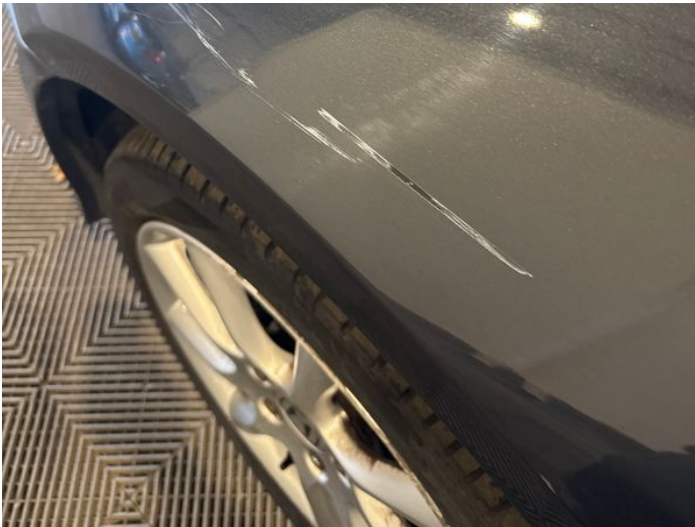
5: Wing nsf  
Scratched  
Over 25mm Thru Paint

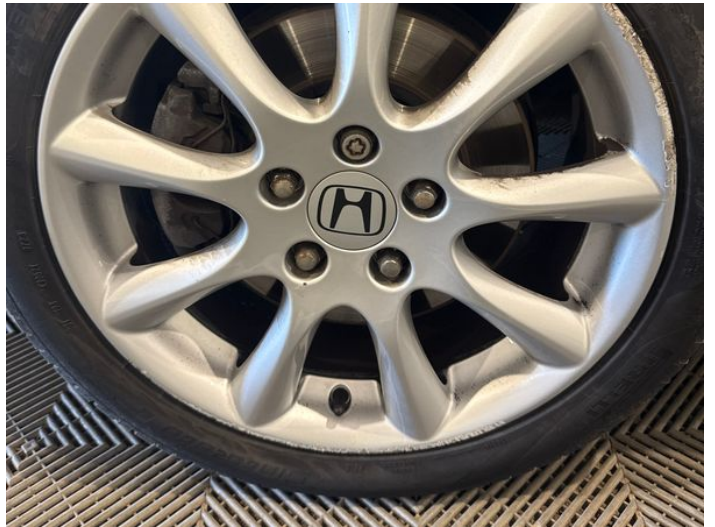
6: Wheel nsf  
Scratched  
Over 50mm

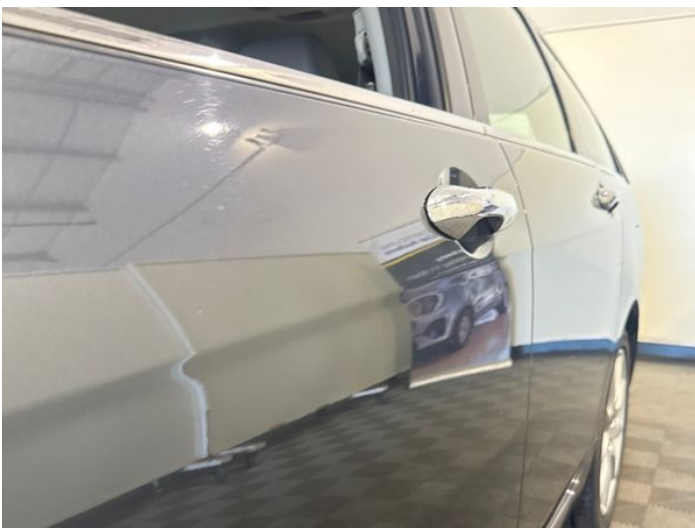
7: Door nsf  
Dented  
2 Or Less UpTo 10mm

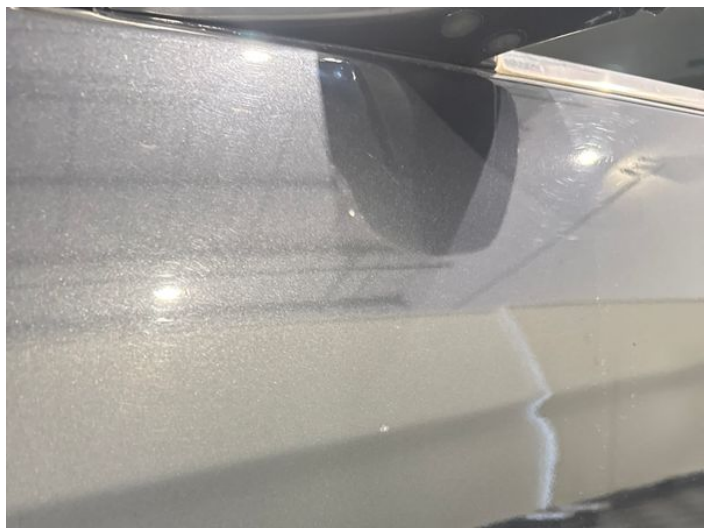
8: Door nsf  
Chipped  
1 To 5

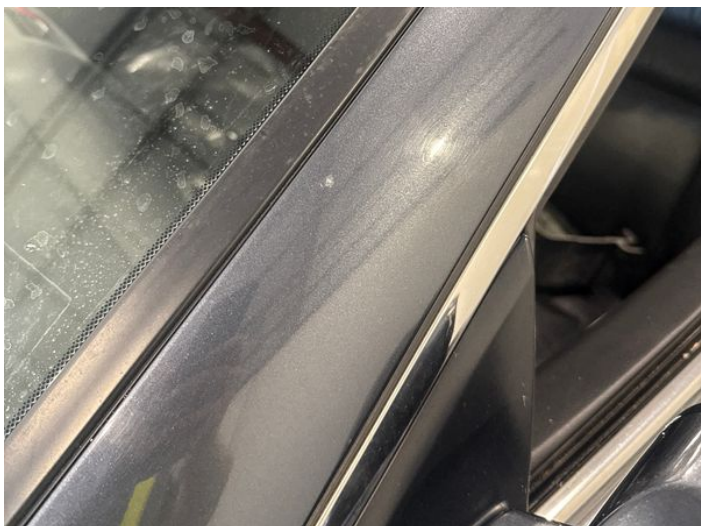
9: A Post ns  
Chipped  
1 To 5

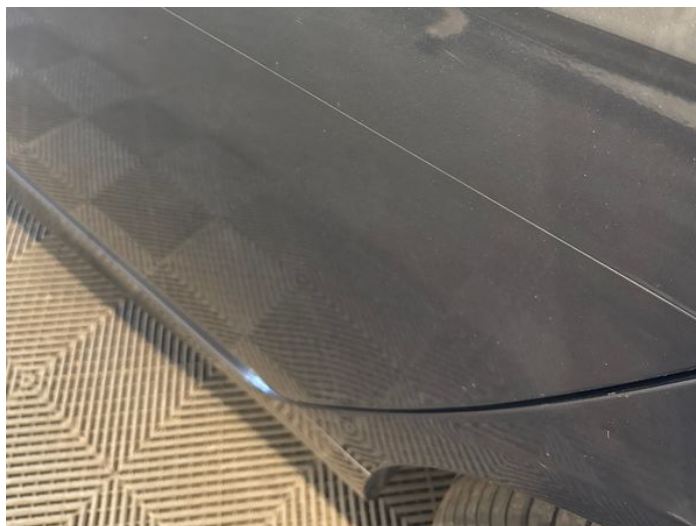
10: Door nsr  
Scratched  
Over 25mm Thru Paint

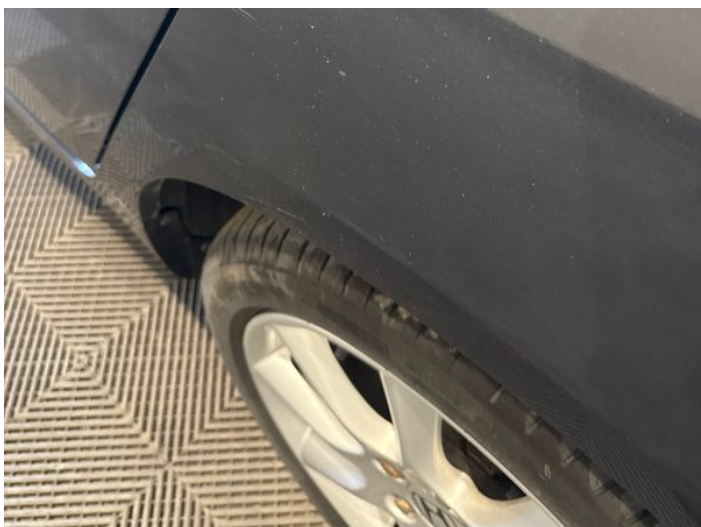
11: Qtr Panel nsr  
Scratched  
Over 25mm Thru Paint

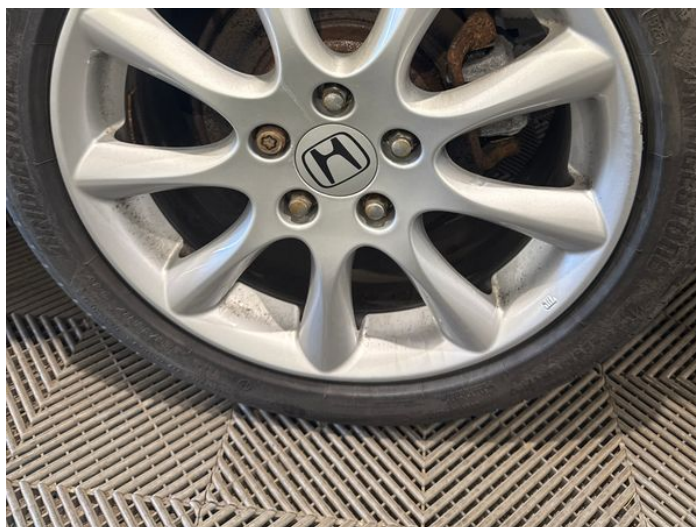
12: Wheel nsr  
Scratched  
Up To 50mm

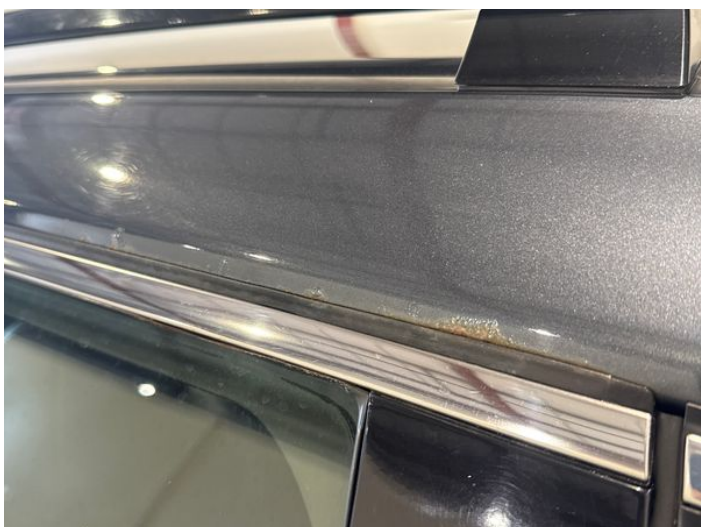
13: B Post ns  
Rusted  
Over 5mm

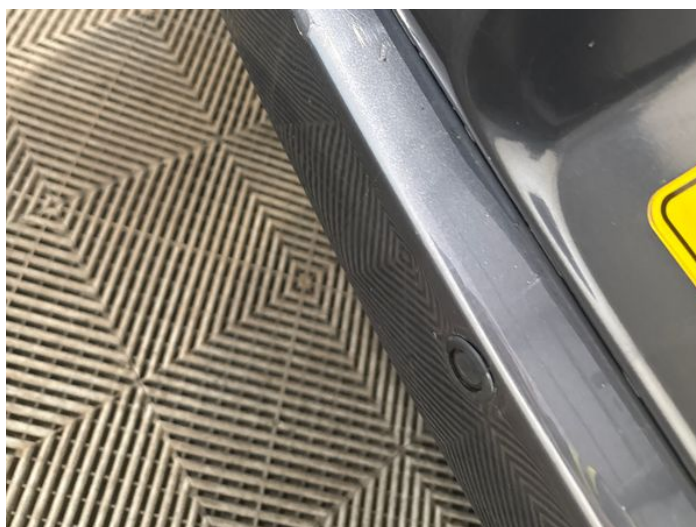
14: Bumper Rear  
Scratched  
25 to 100mm Thru Paint

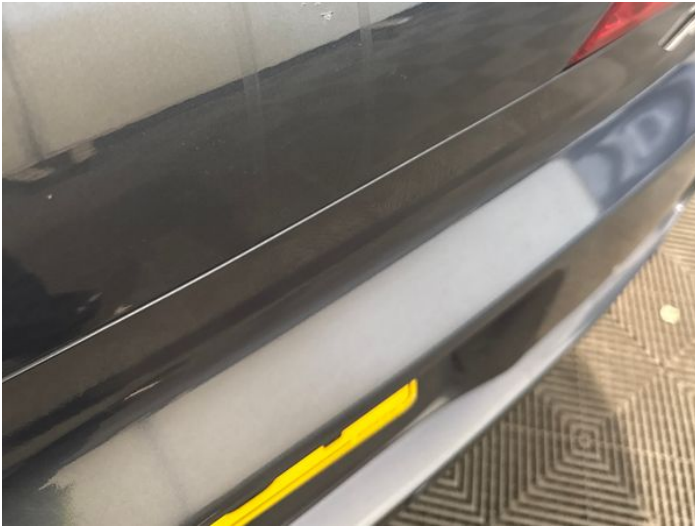
15: Tailgate  
Rusted  
Over 5mm

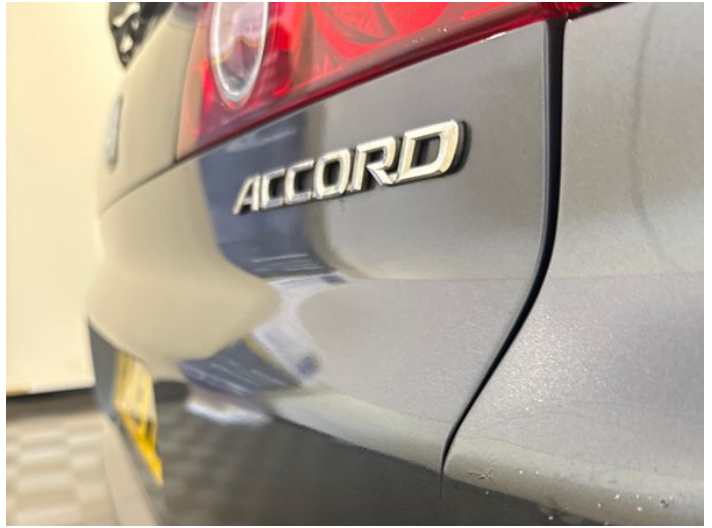
16: Tailgate  
Poor Previous Repair  
Rippled UpTo 30%

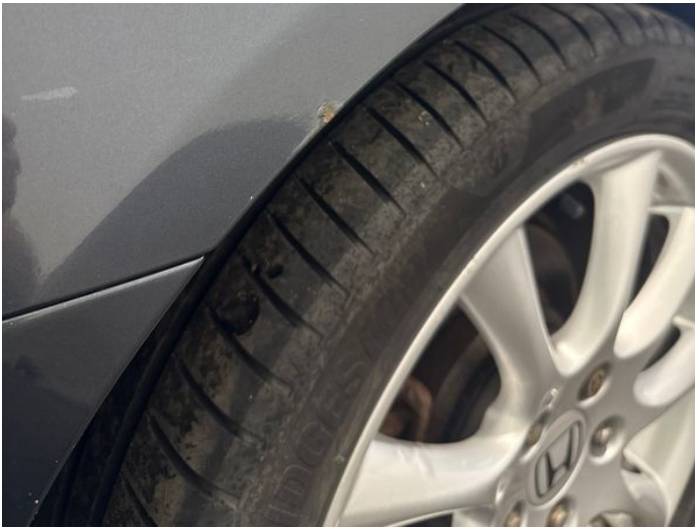
17: Qtr Panel osr  
Rusted  
Over 5mm

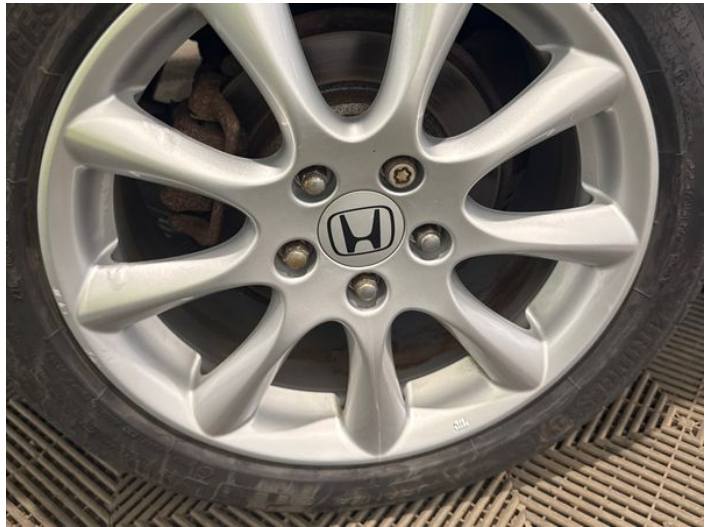
18: Wheel osr  
Scratched  
Over 50mm

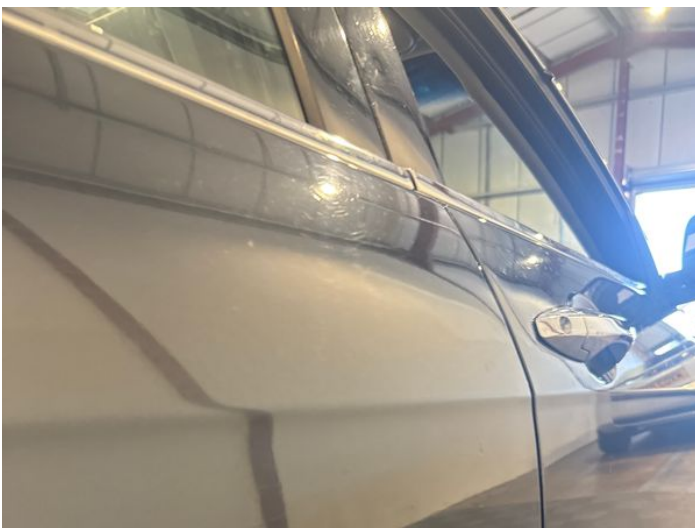
19: Door osr  
Dented  
Over 2 UpTo 10mm

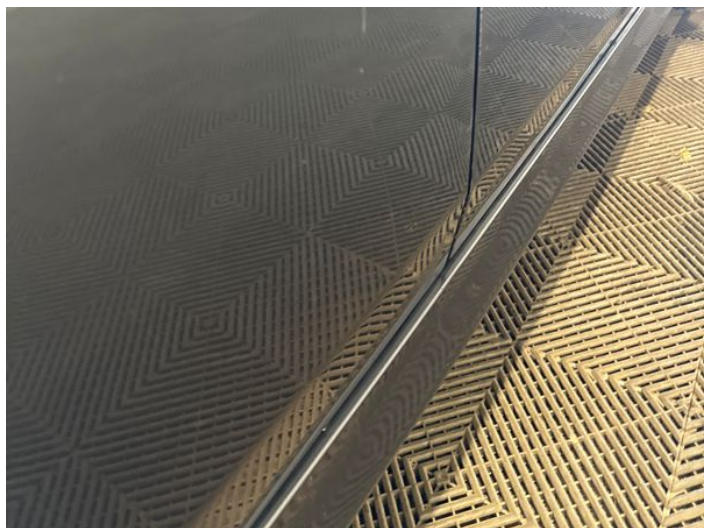
20: Door osr  
Scratched  
UpTo 25mm Thru Paint

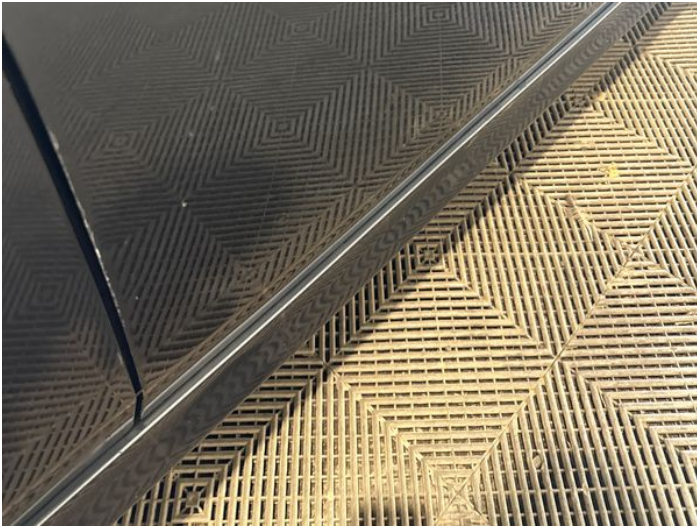
21: Door osf  
Scratched  
Over 25mm Thru Paint

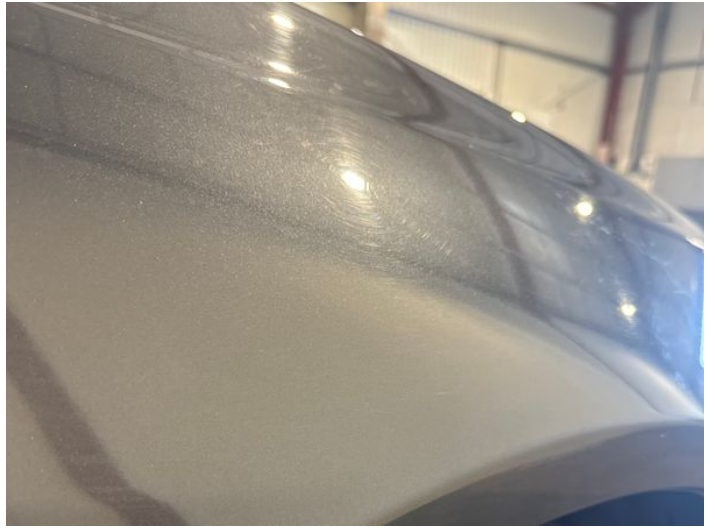
22: Wing osf  
Chipped  
1 To 5

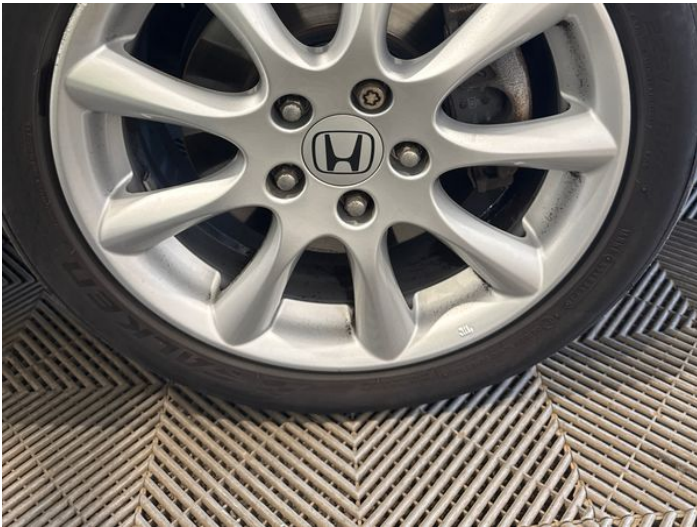
23: Wheel osf  
Scratched  
Over 50mm

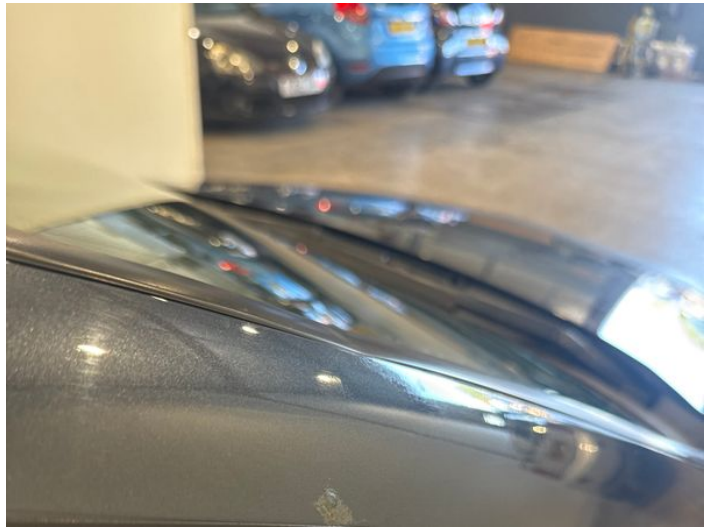
24: A Post os  
Rusted  
Over 5mm

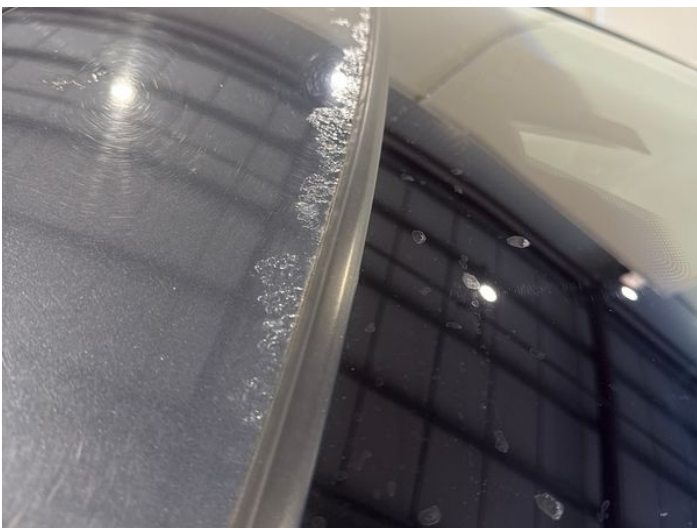
25: Roof  
Rusted  
Over 5mm
