## VEHICLE INSPECTION REPORT

**MJ65NDF**

### Volkswagen Tiguan 2.0 TDi BlueMotion Tech Match 4MOTION 5dr 150 DSG

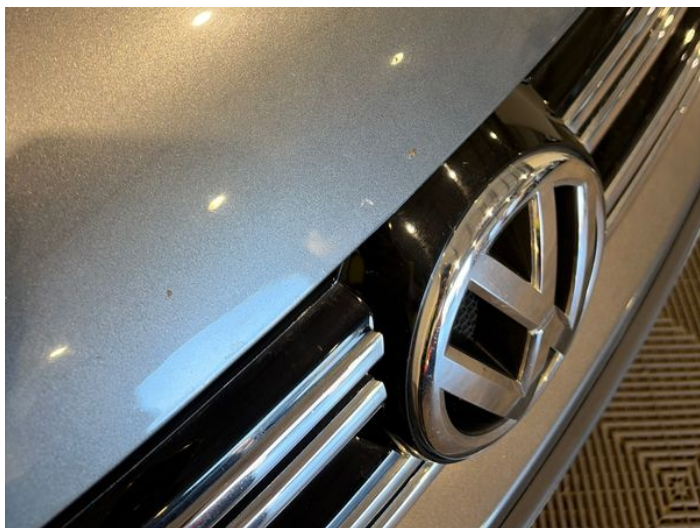
1: Bonnet  
Rusted  
Over 5mm

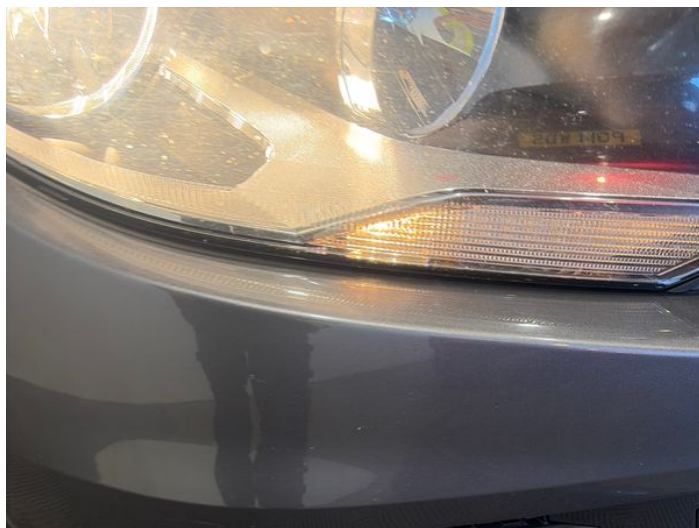
2: Bumper Front  
Chipped  
1 To 5

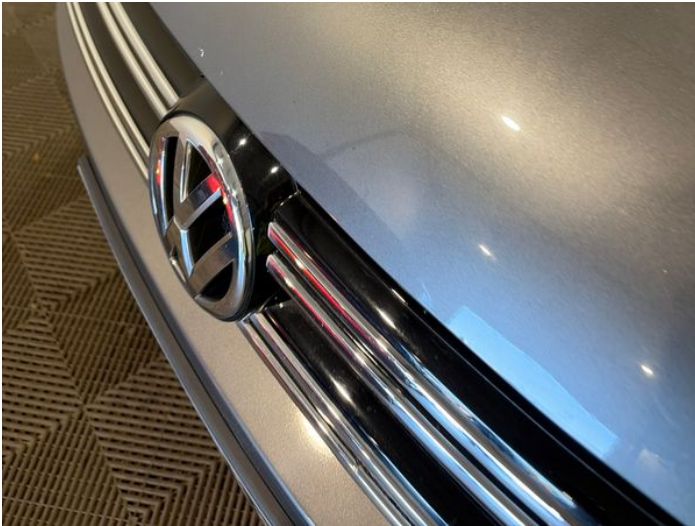
3: Bonnet  
Dented  
Between 10mm + 30mm

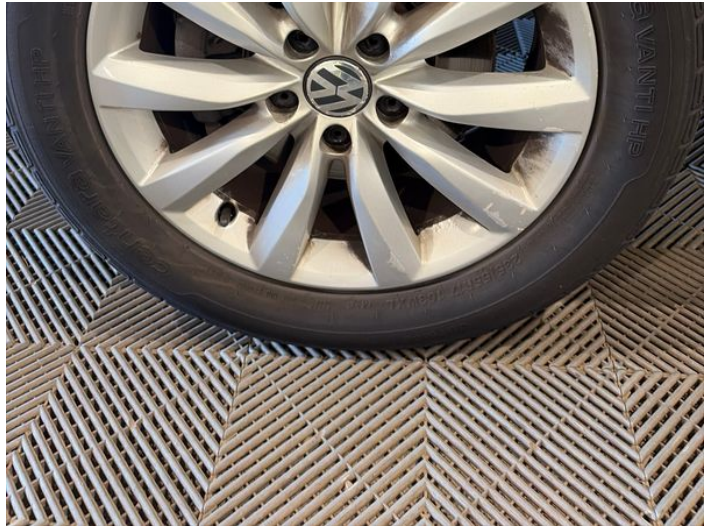
4: Wheel nsf  
Scratched  
Over 50mm

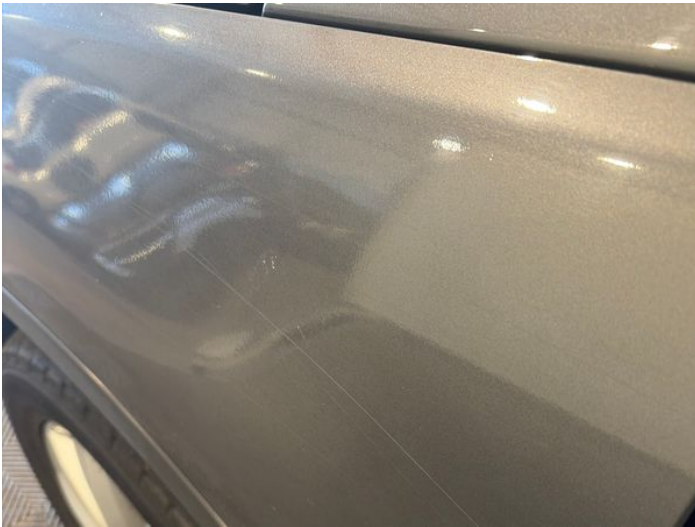
5: Wing nsf  
Scratched  
Over 25mm Thru Paint

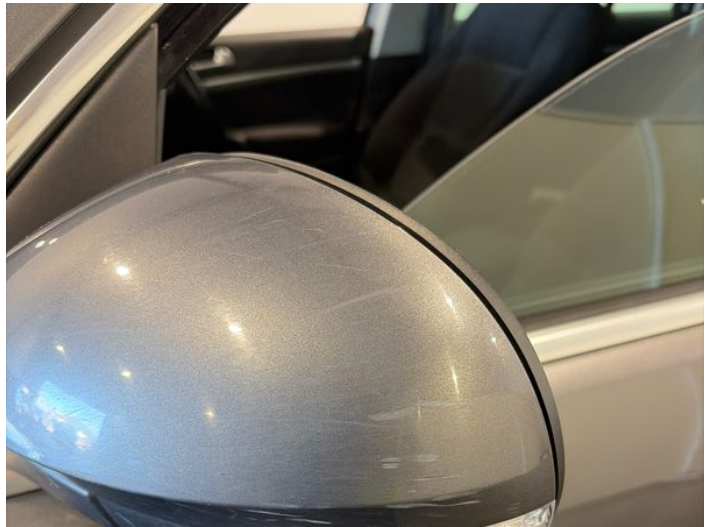
6: Door Mirror Assy osf  
Scratched (Painted)  
Over 25mm Thru Paint

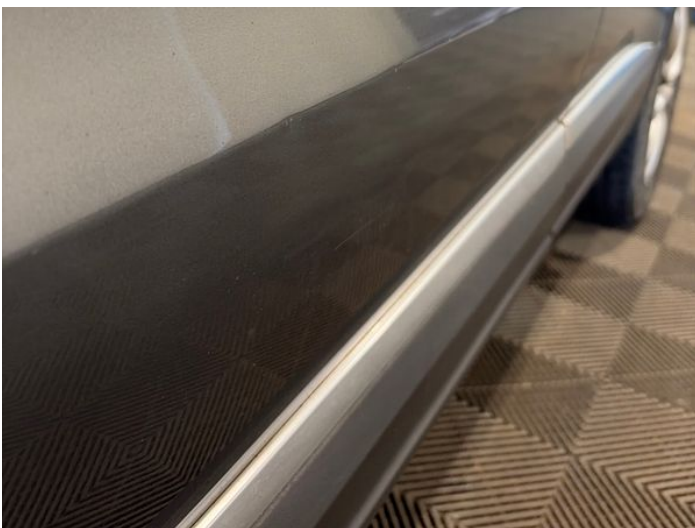
7: Door nsf  
Dented  
Over 2 UpTo 10mm

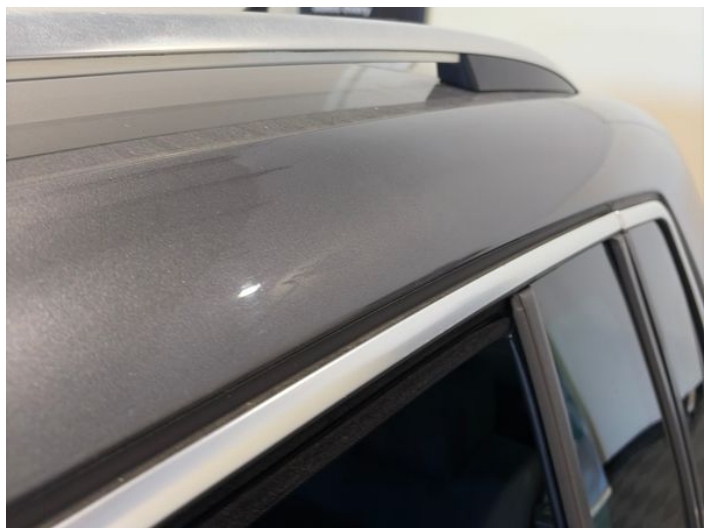
8: B Post ns  
Dented  
Between 10mm + 30mm

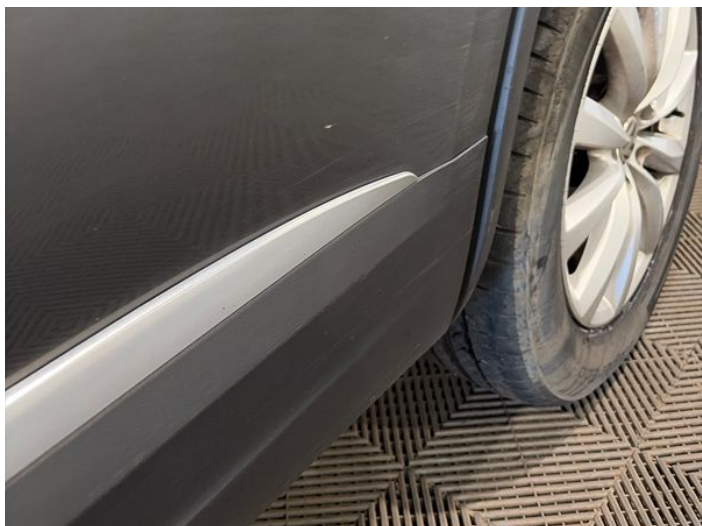
9: Door nsr  
Scratched  
Over 25mm Thru Paint

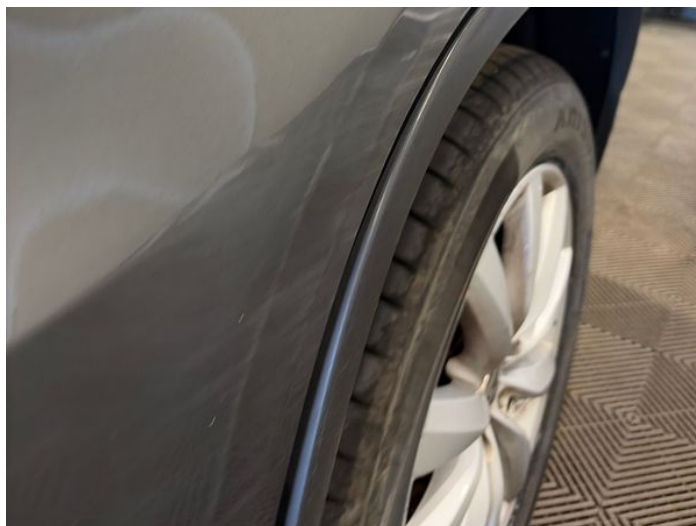
10: Door nsr  
Dented  
Between 10mm + 30mm

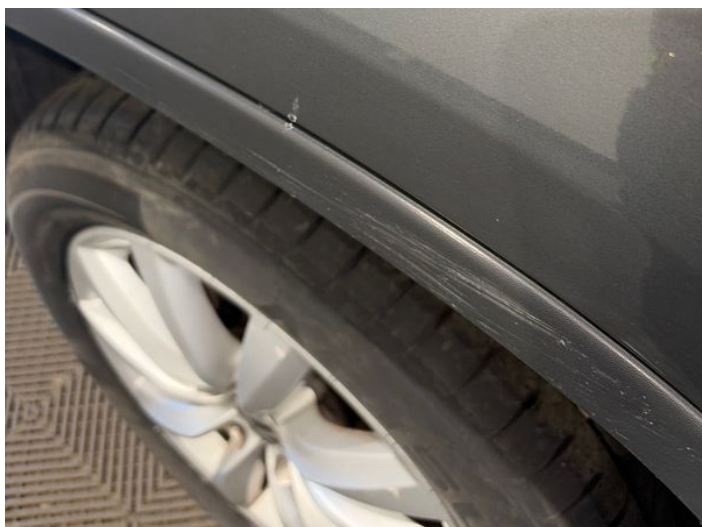
11: Qtr Panel nsr  
Scratched  
UpTo 25mm Thru Paint

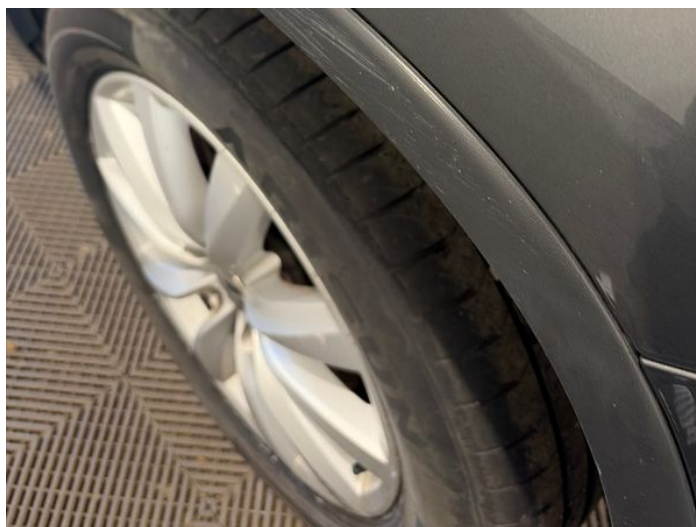
12: Qtr Panel Moulding ns  
Scuffed (Unpainted)  
Over 100mm

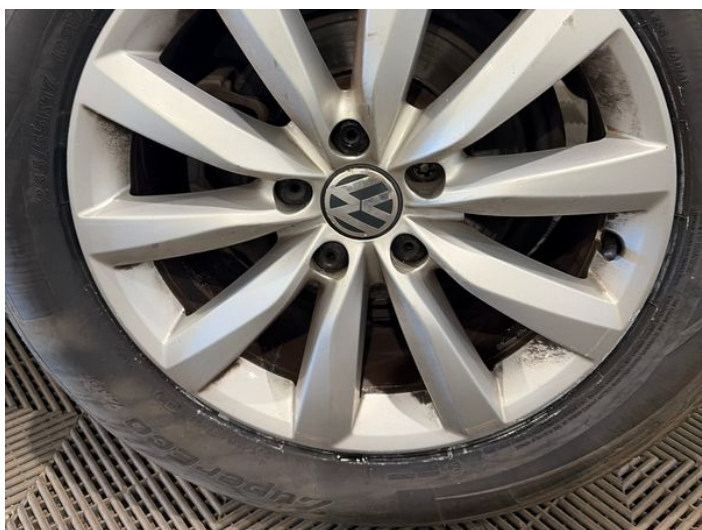
13: Wheel nsr  
Scratched  
Over 50mm

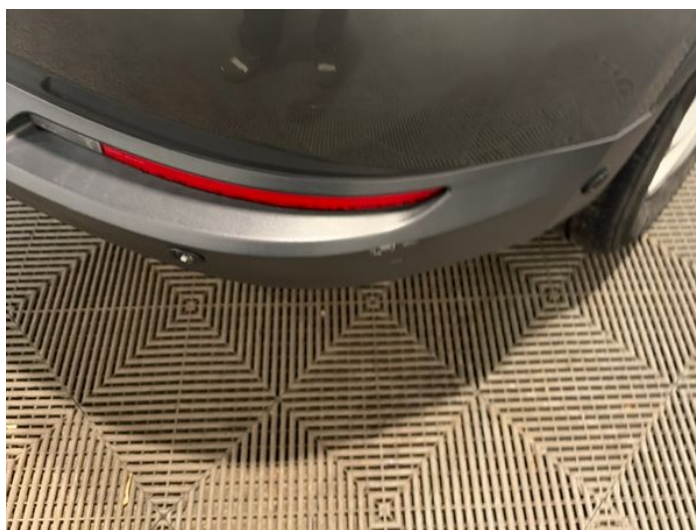
14: Bumper Rear  
Chipped  
1 To 5

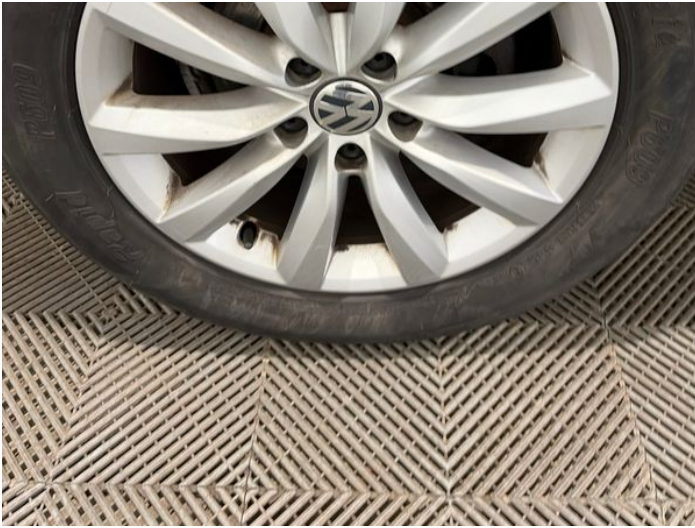
15: Wheel osr  
Scratched  
Up To 50mm

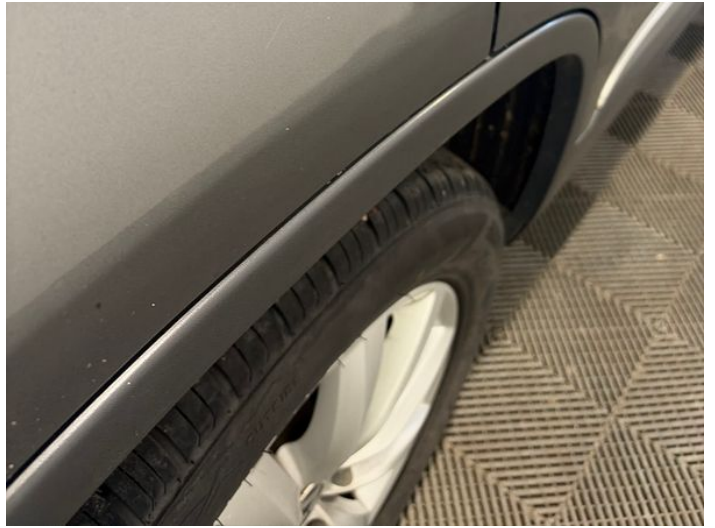
16: Qtr Panel osr  
Dented  
Between 10mm + 30mm

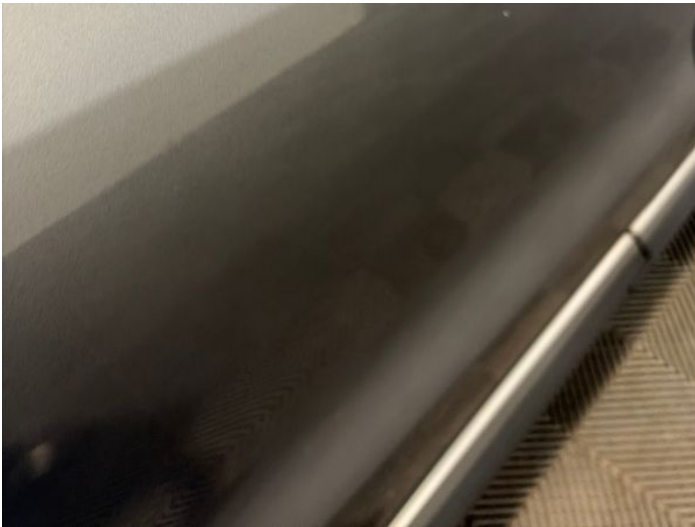
17: Door osr  
Dented  
Between 10mm + 30mm

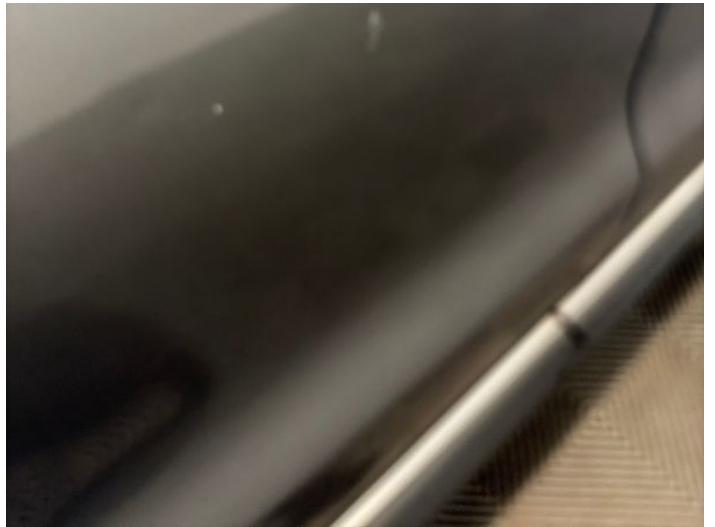
18: Door osr  
Scratched  
UpTo 25mm Thru Paint

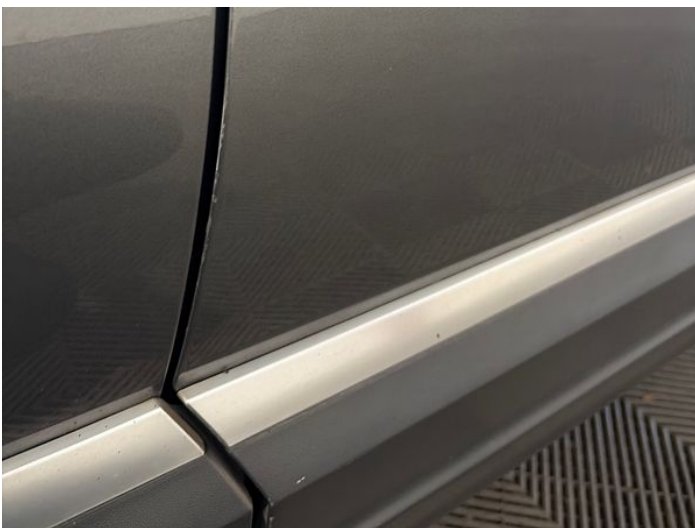
19: Door osf  
Chipped  
Edge Chip

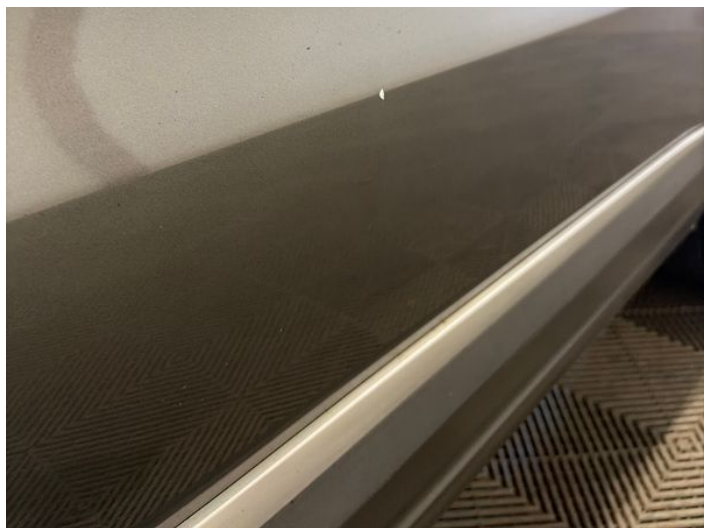
20: Door osf  
Chipped  
Edge Chip

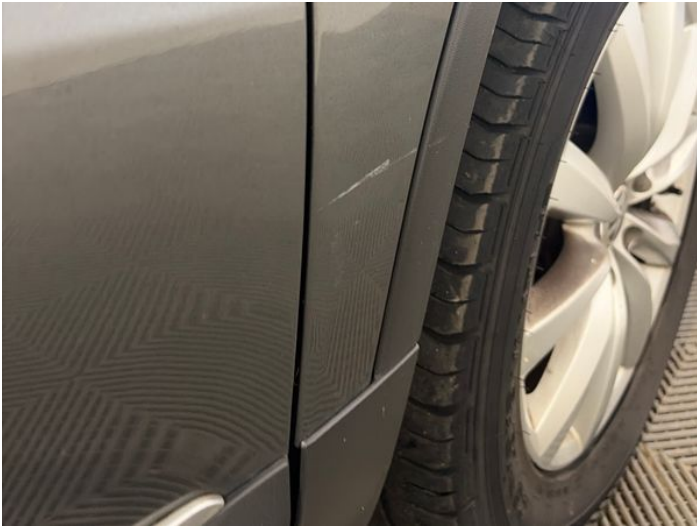
21: Wing osf  
Dented  
Between 10mm + 30mm

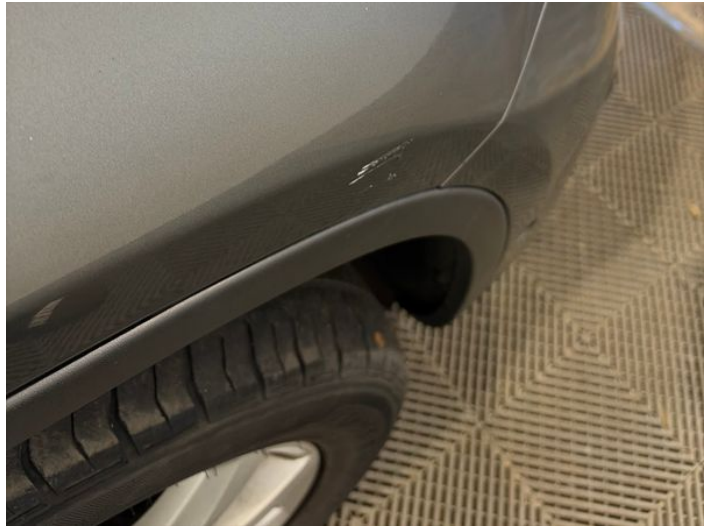
22: Wing osf  
Scratched  
Over 25mm Thru Paint

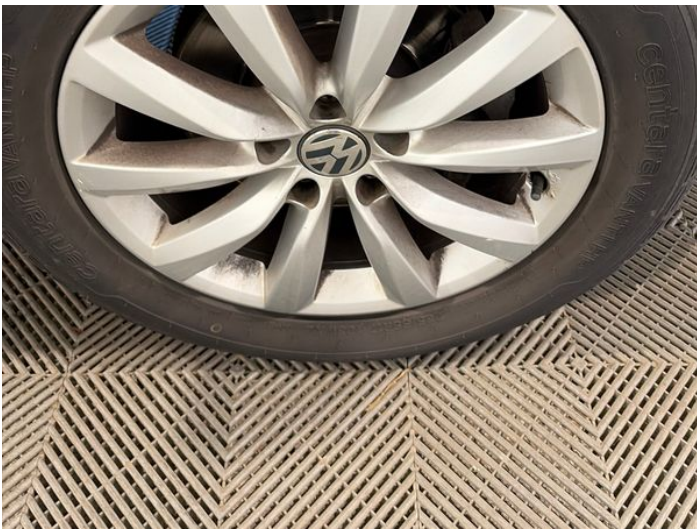
23: Wheel osf  
Scratched  
Up To 50mm

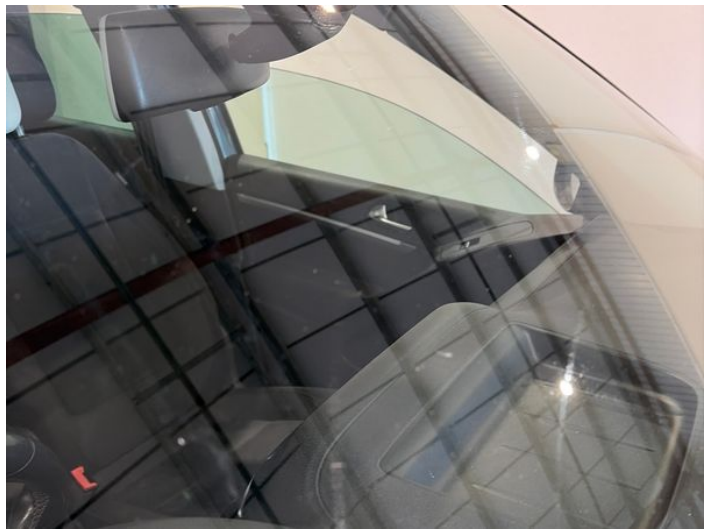
24: Screen Front  
Cracked  
Replace

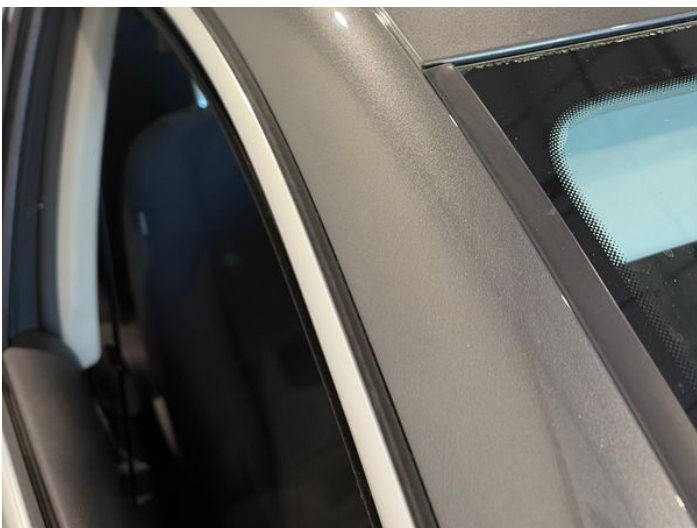
25: A Post os  
Dented  
2 Or Less UpTo 10mm

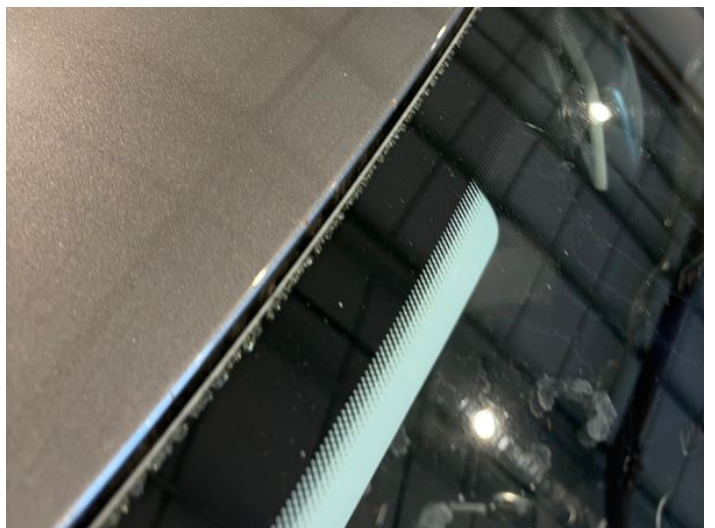
26: Roof  
Chipped  
Edge Chip

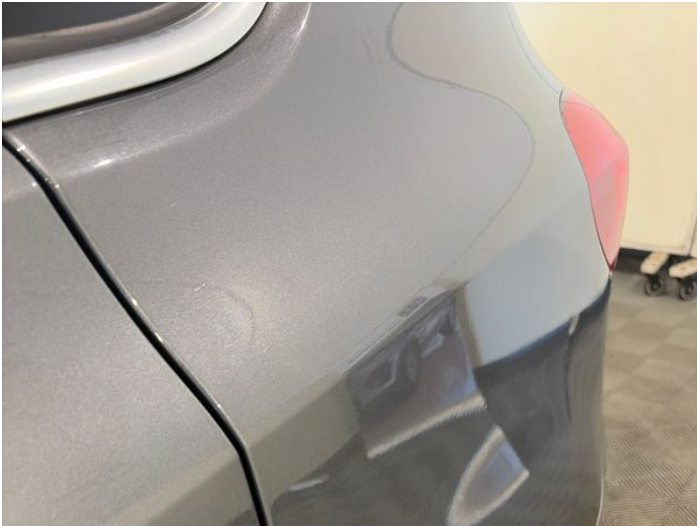
27: Qtr Panel nsr  
Dented  
2 Or Less UpTo 10mm

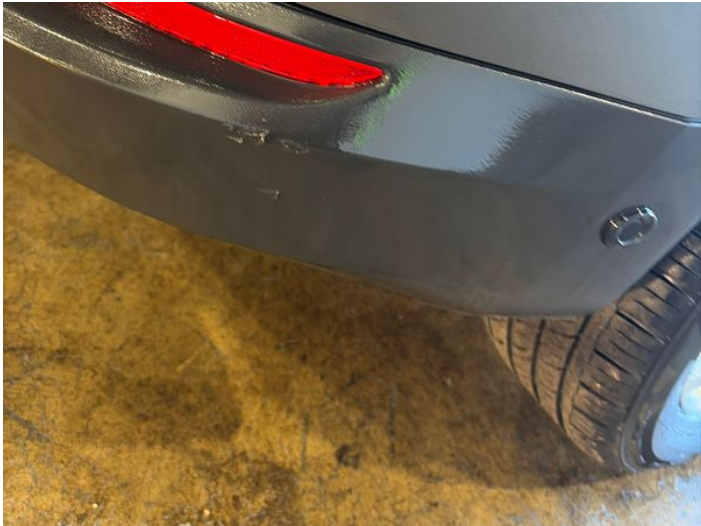
28: Bumper Rear Moulding  
Scuffed (Unpainted)  
UpTo 100mm

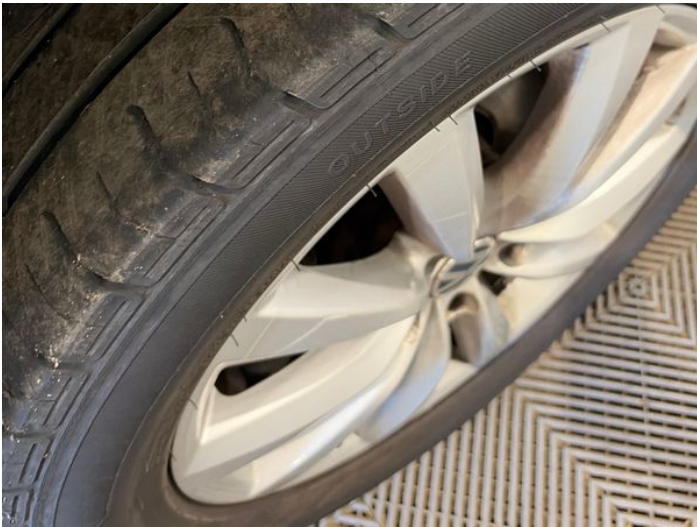
| NSF | BUDGET | Damaged |

29: Tyre nsf  
Damaged  
Replace
