# VEHICLE INSPECTION REPORT

**ST67LMK**

## Hyundai Tucson 1.6 GDi Blue Drive SE Nav 5dr 2WD

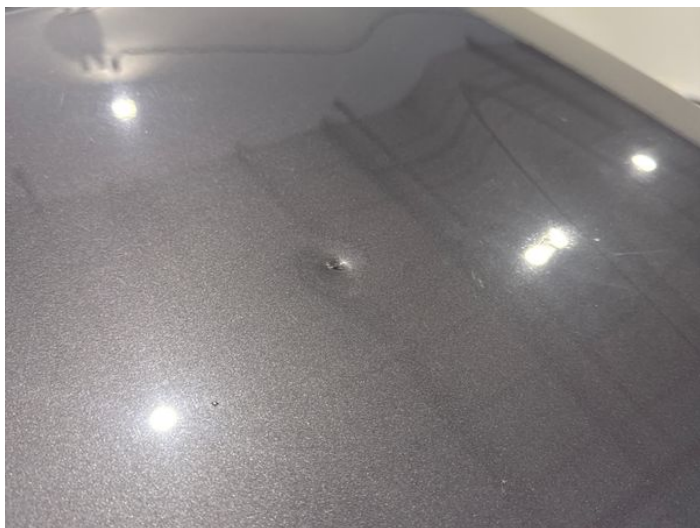
1: Bonnet  
Dented  
With Paint Damage

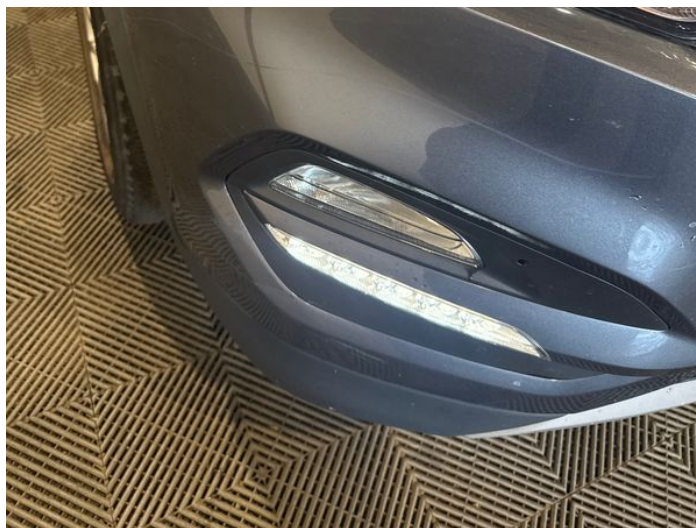
2: Bumper Front  
Scratched  
Over 100mm Thru Paint

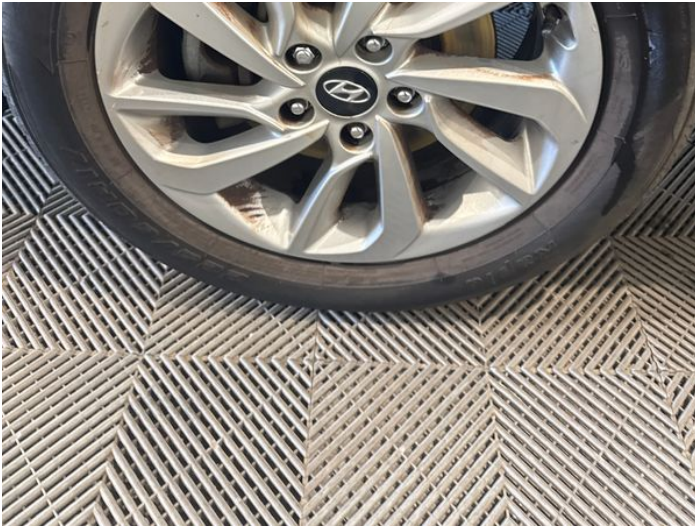
3: Wheel nsf  
Scratched  
Over 50mm

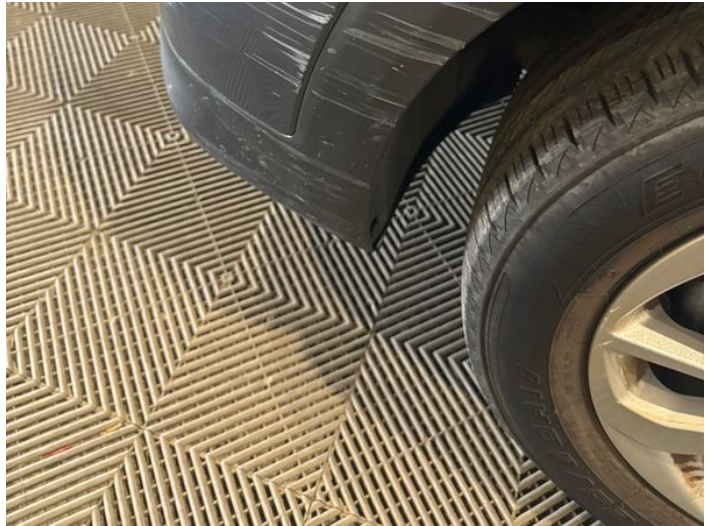
4: Bumper Front Moulding  
Scuffed (Unpainted)  
Over 100mm

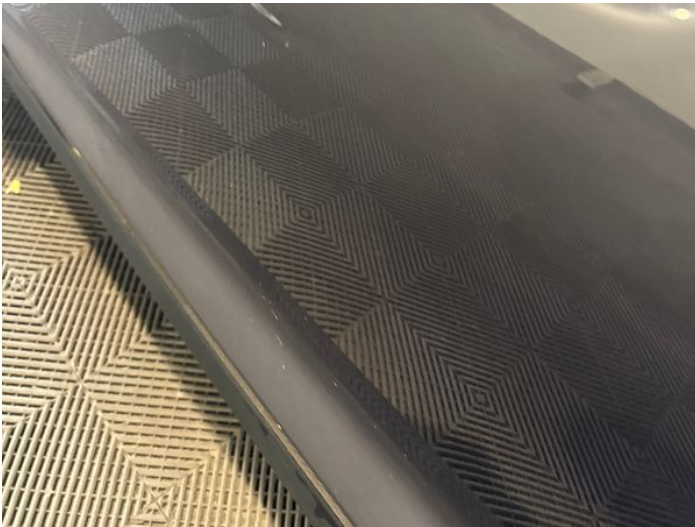
5: Door nsf  
Dented  
With Paint Damage

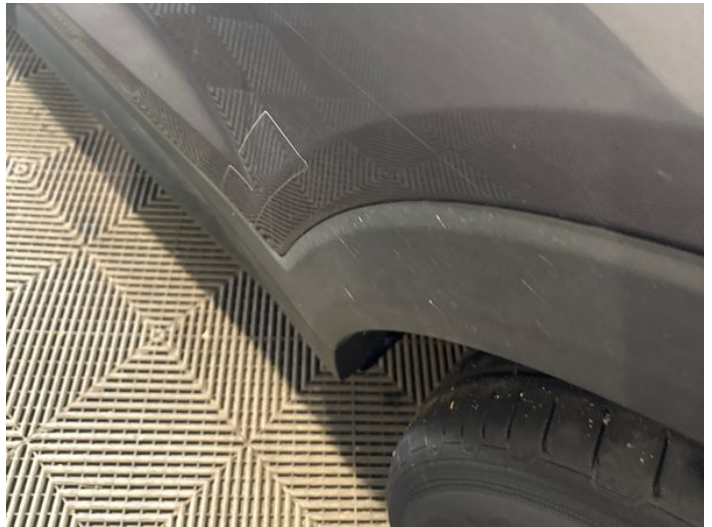
6: Door nsr  
Scratched  
Over 25mm Thru Paint

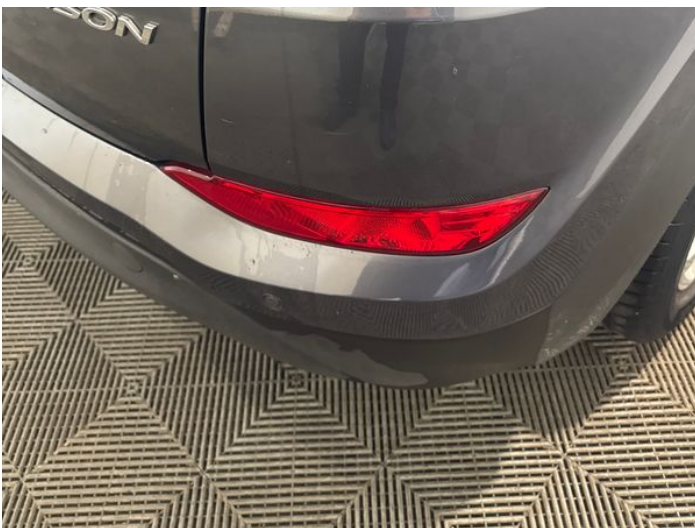
7: Bumper Rear  
Scratched  
25 to 100mm Thru Paint

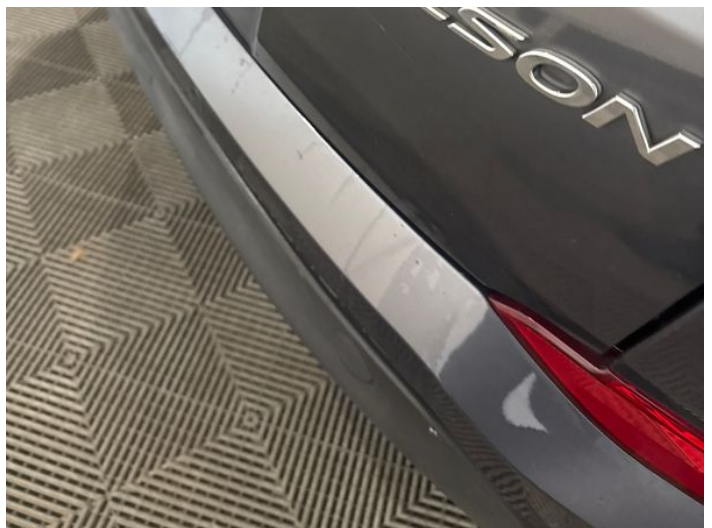
8: Tailgate  
Scratched  
Over 25mm Thru Paint

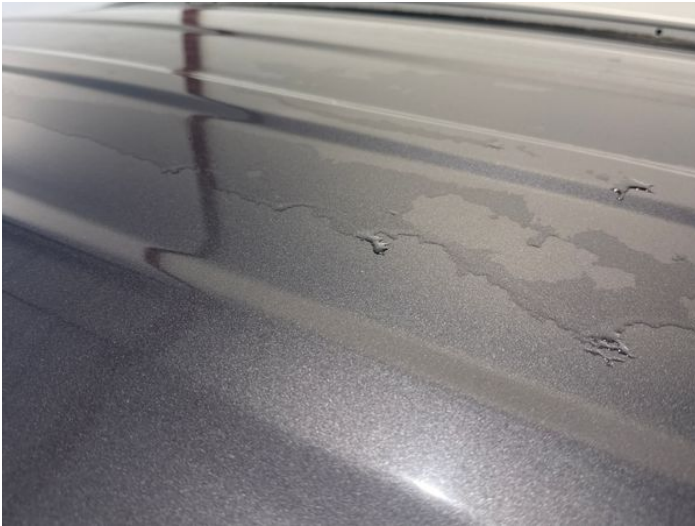
9: Roof  
Dented  
Over 30mm

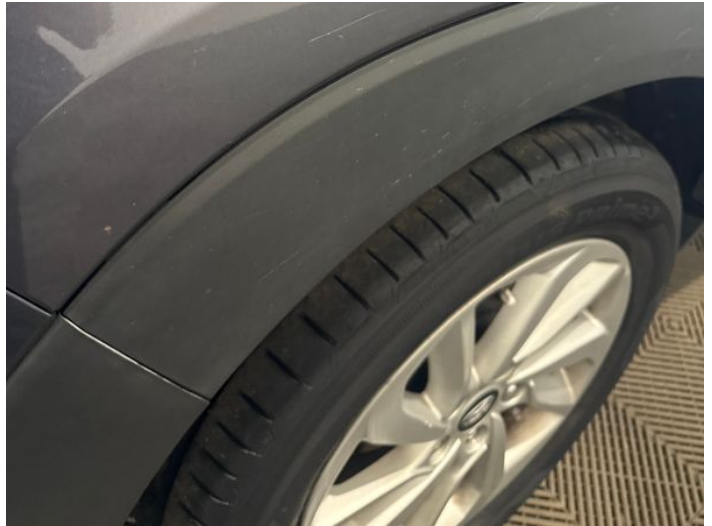
10: Qtr Panel osr  
Scratched  
Over 25mm Thru Paint

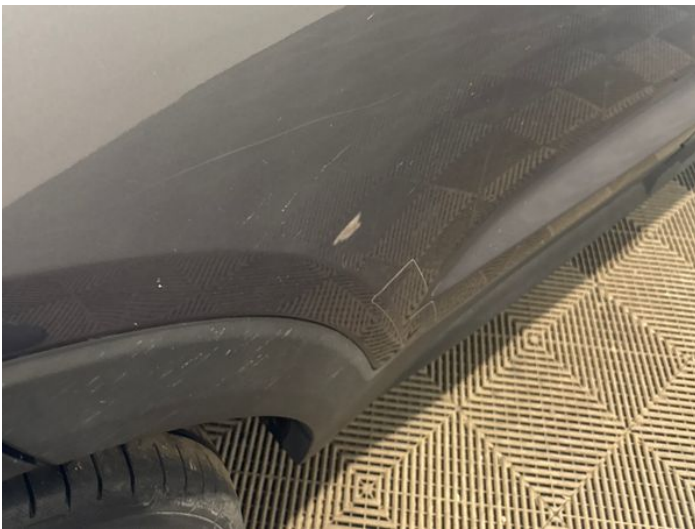
11: Door osr  
Scratched  
Over 25mm Thru Paint

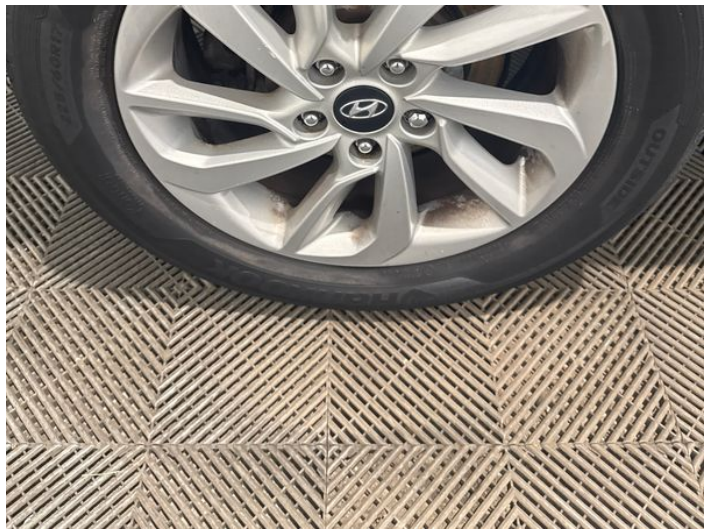
12: Wheel osr  
Scratched  
Over 50mm

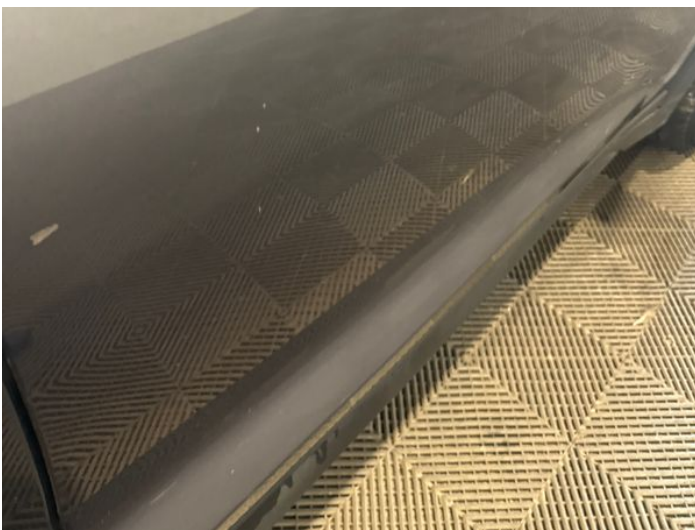
13: Door osf  
Scratched  
Over 25mm Thru Paint

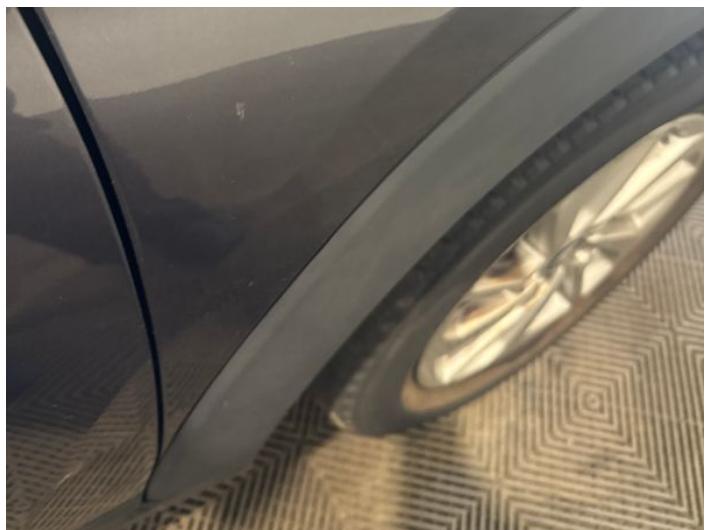
14: Wing osf  
Scratched  
UpTo 25mm Thru Paint

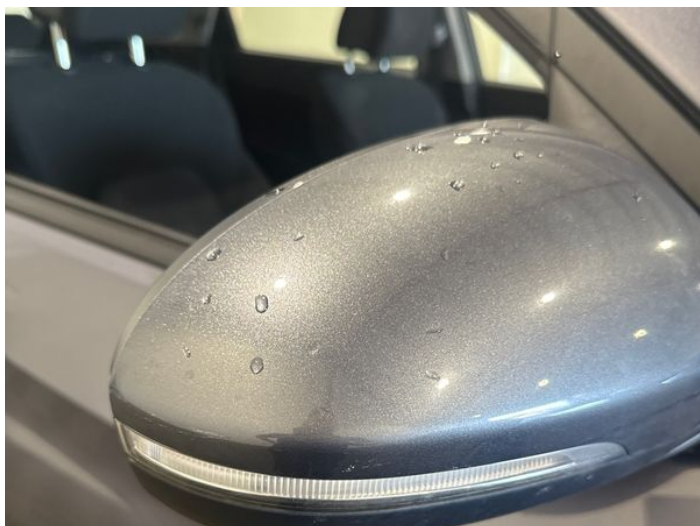
15: Door Mirror Assy osf  
Scratched (Painted)  
Over 25mm Thru Paint
