## VEHICLE INSPECTION REPORT

**GU11JFG**

### Toyota Aygo 1.0 VVT-i Go 5dr

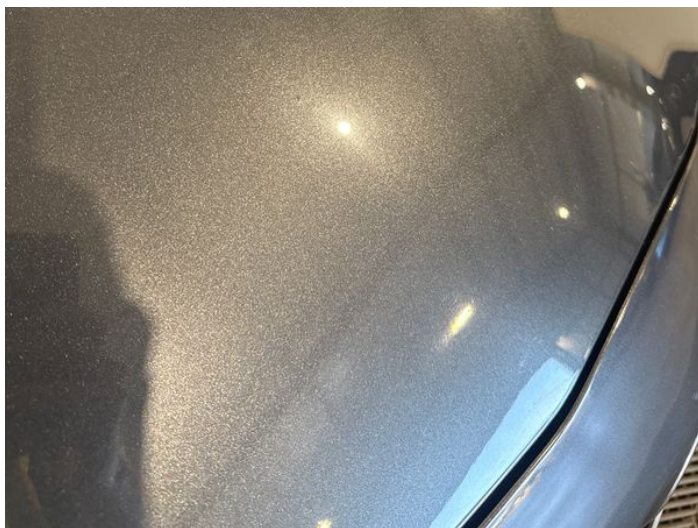
1: Bonnet  
Chipped  
1 To 5

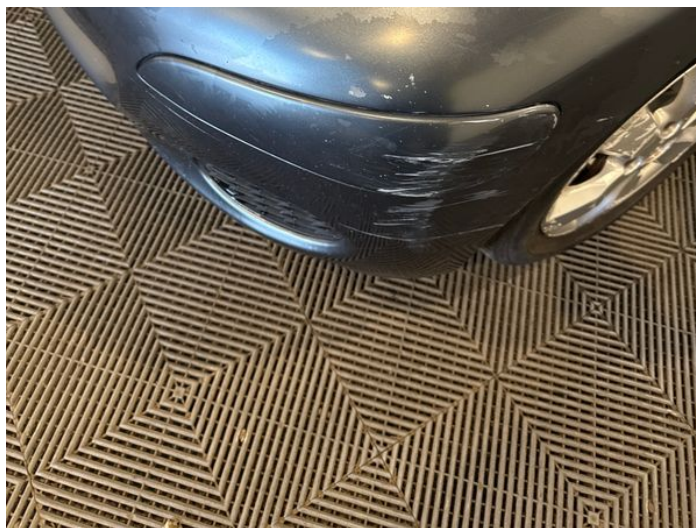
2: Bumper Front  
Poor Previous Repair  
Paint Flake

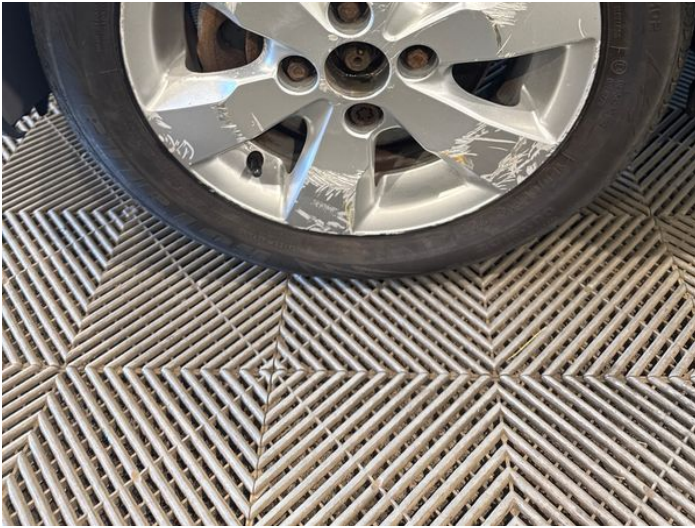
3: Wheel nsf  
Scratched  
Over 50mm

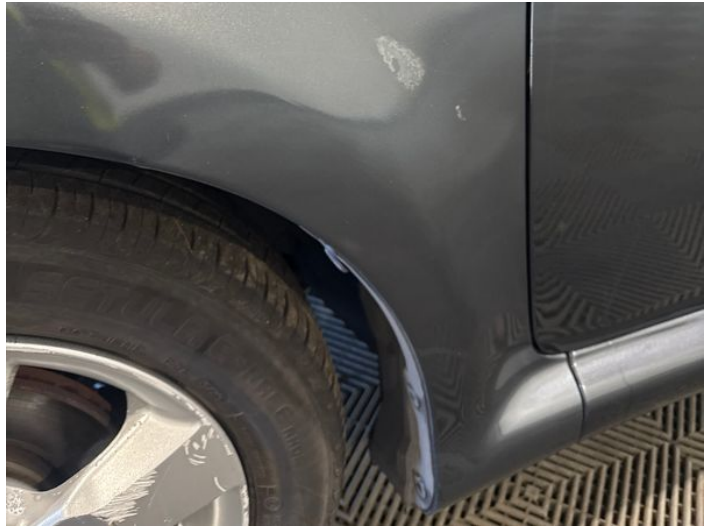
4: Wing nsf  
Poor Previous Repair  
Poor Paint

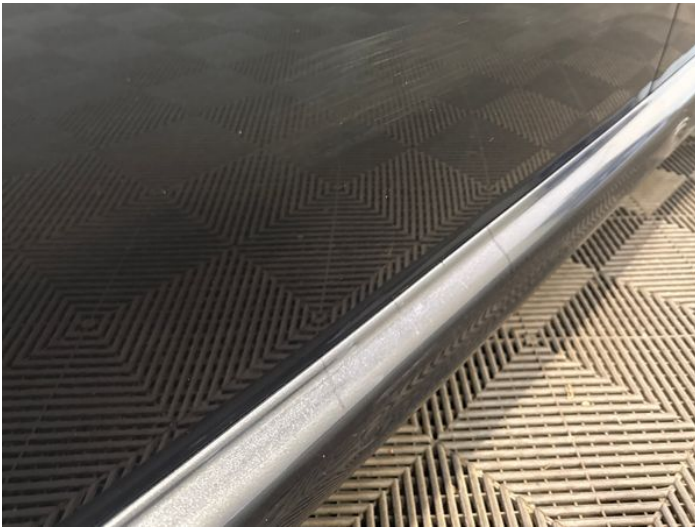
5: Door nsf  
Scratched  
Over 25mm Thru Paint

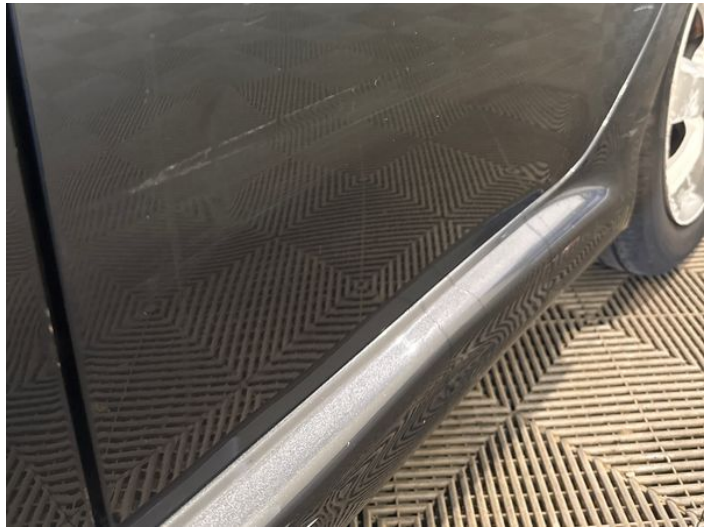
6: Door nsr  
Dented  
With Paint Damage

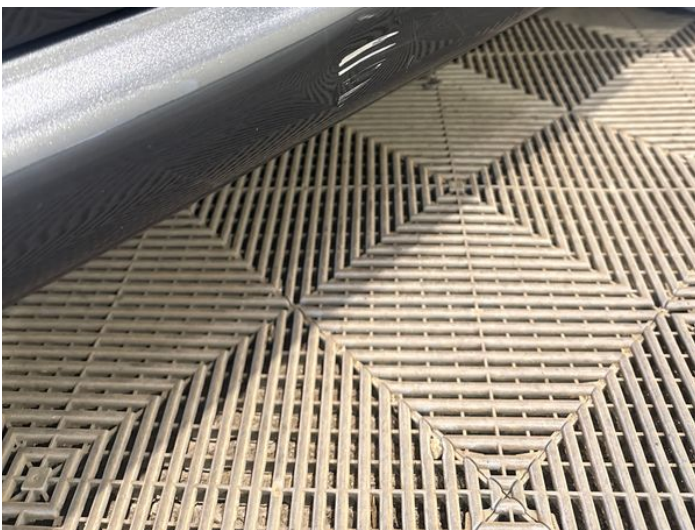
7: Sill ns  
Dented  
With Paint Damage

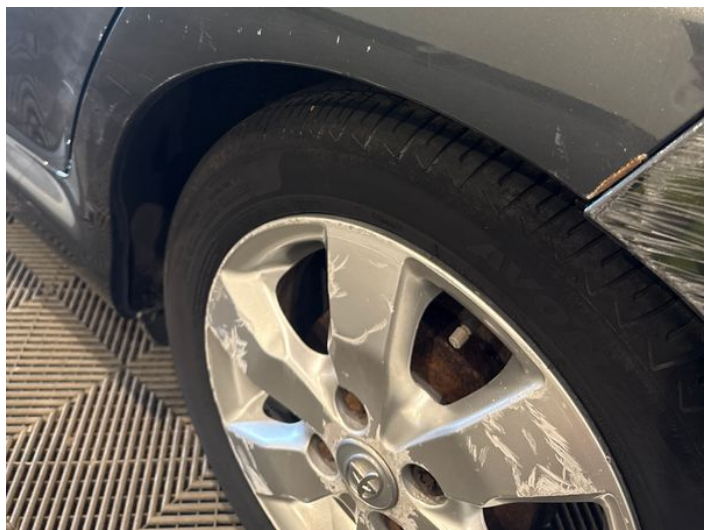
8: Qtr Panel nsr  
Dented  
With Paint Damage

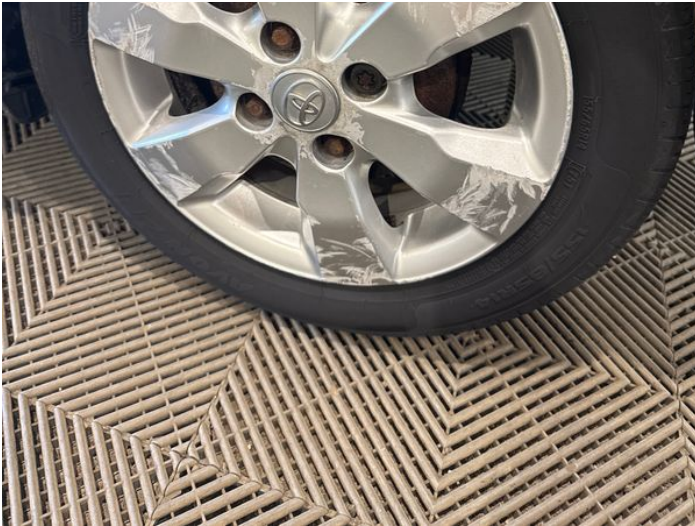
9: Wheel nsr  
Scratched  
Over 50mm

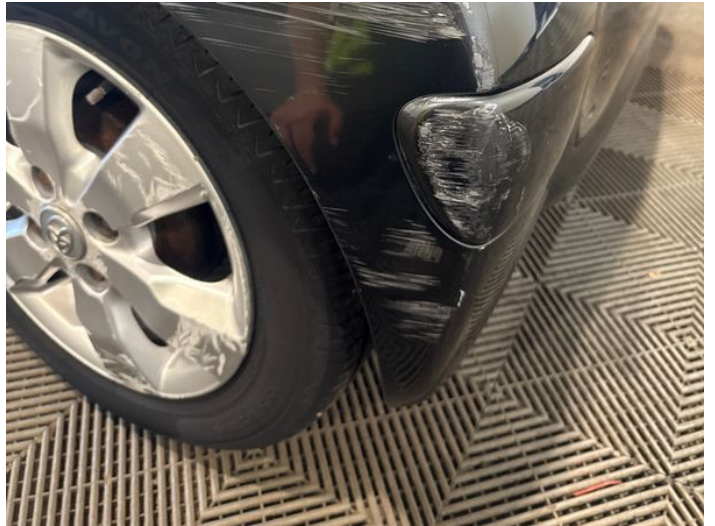
10: Bumper Rear  
Scratched  
Over 100mm Thru Paint

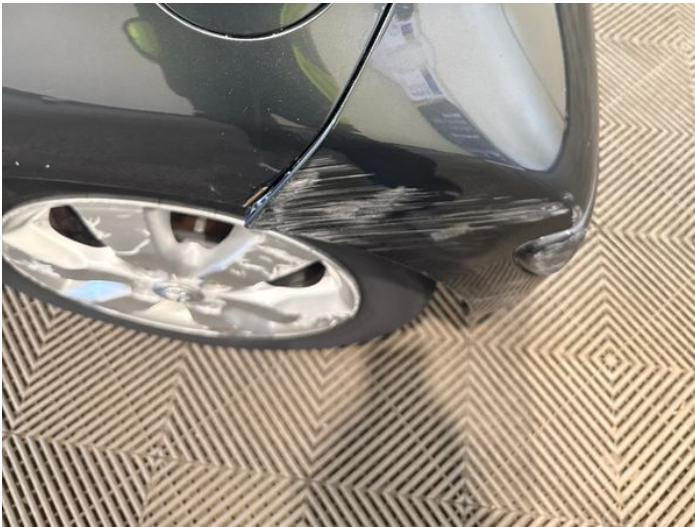
11: Bumper Rear  
Insecure  
Action Required

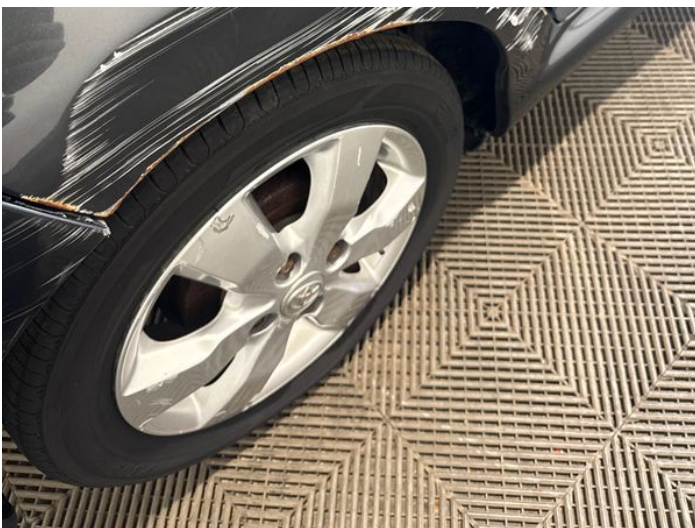
13: Qtr Panel osr  
Dented  
With Paint Damage

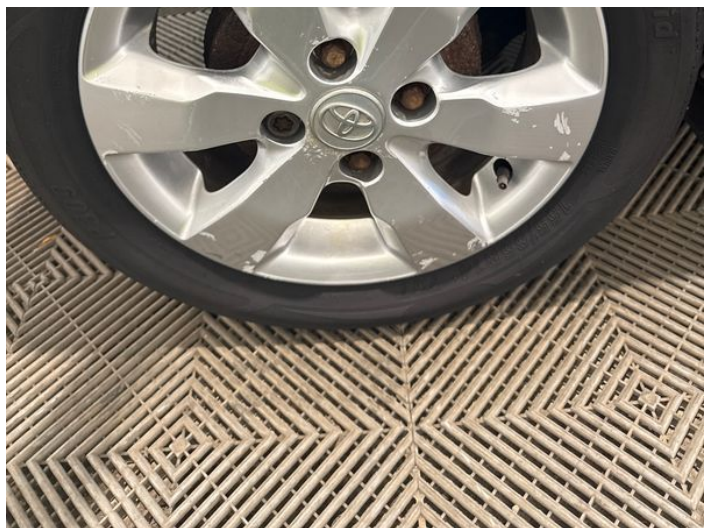
14: Wheel osr  
Scratched  
Over 50mm

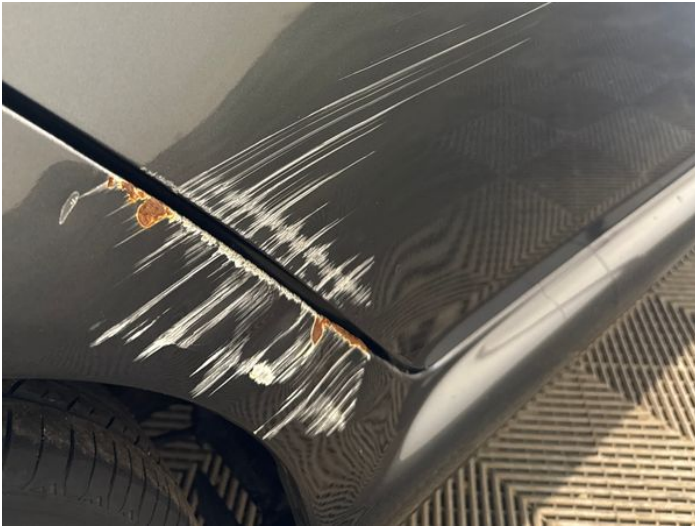
15: Door osr  
Dented  
With Paint Damage

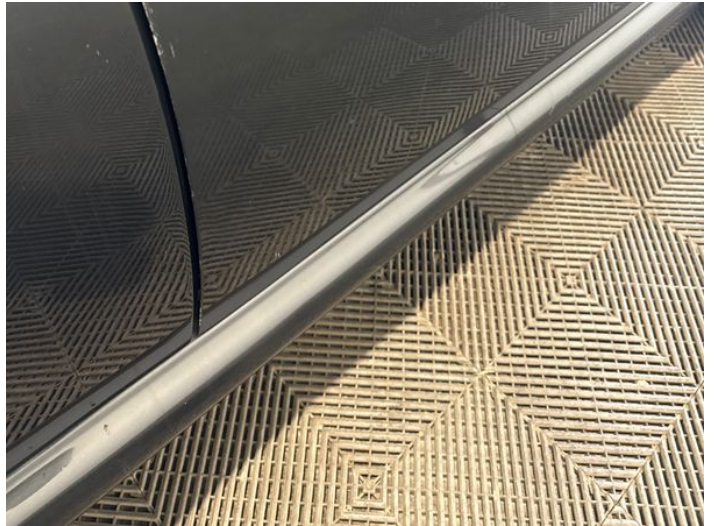
16: Door osf  
Scratched  
Over 25mm Thru Paint

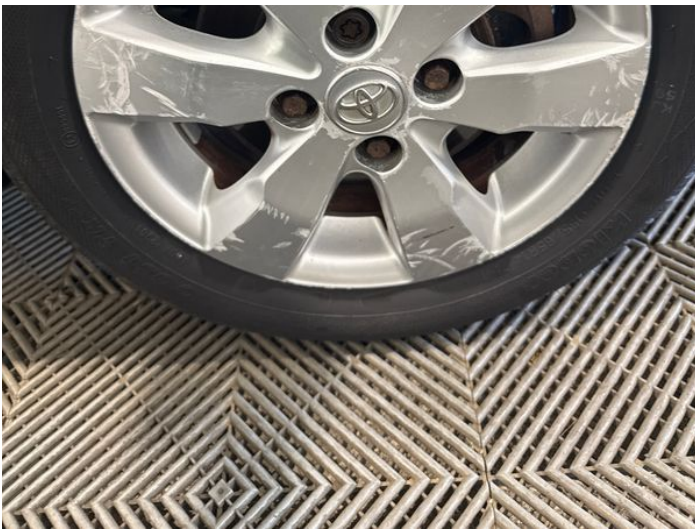
17: Wheel osf  
Scratched  
Over 50mm

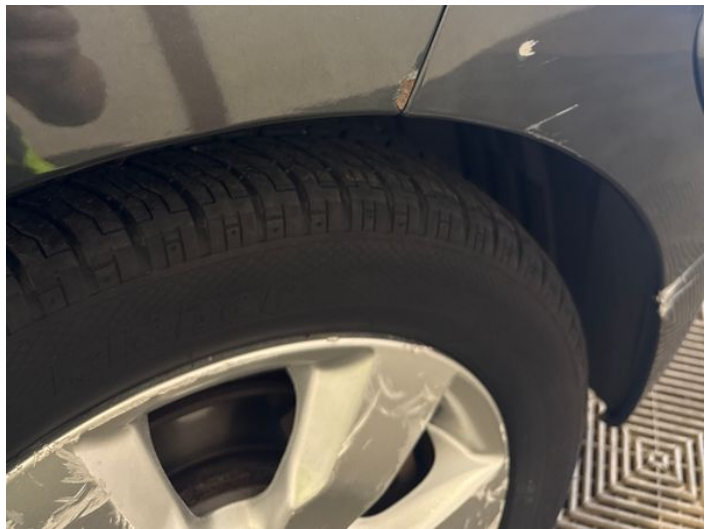
18: Wing osf  
Rusted  
Over 5mm

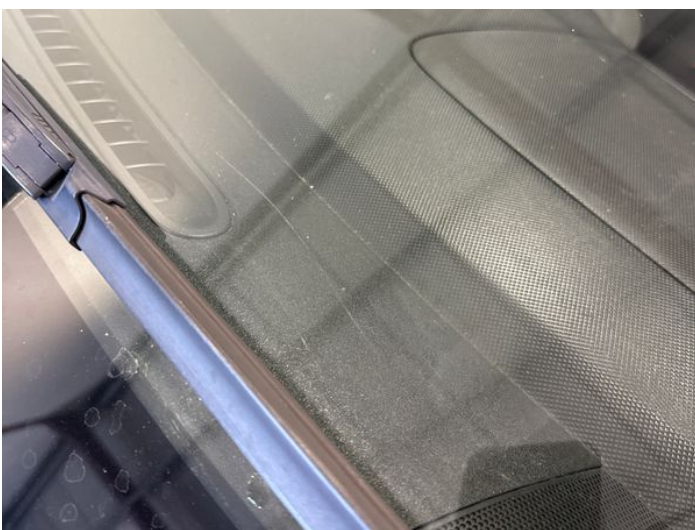
19: Screen Front  
Cracked  
Replace

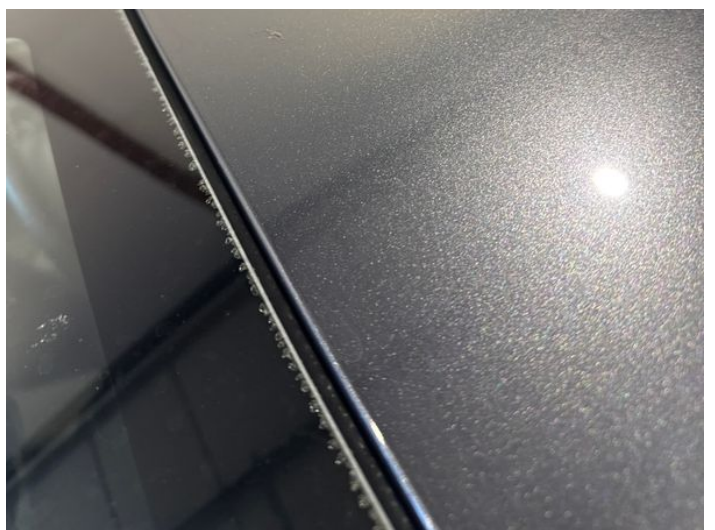
20: Roof  
Rusted  
UpTo 5mm
