# VEHICLE INSPECTION REPORT

**PK64KXJ**

nama  
GRADE  
4

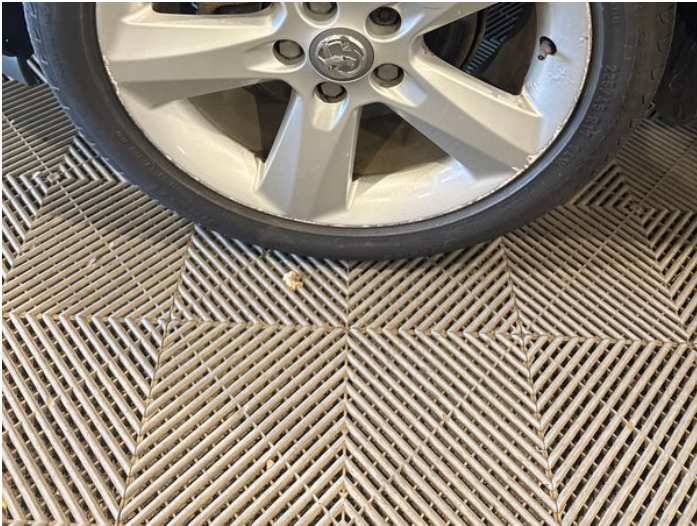
3: Wheel nsf  
Scratched  
Over 50mm

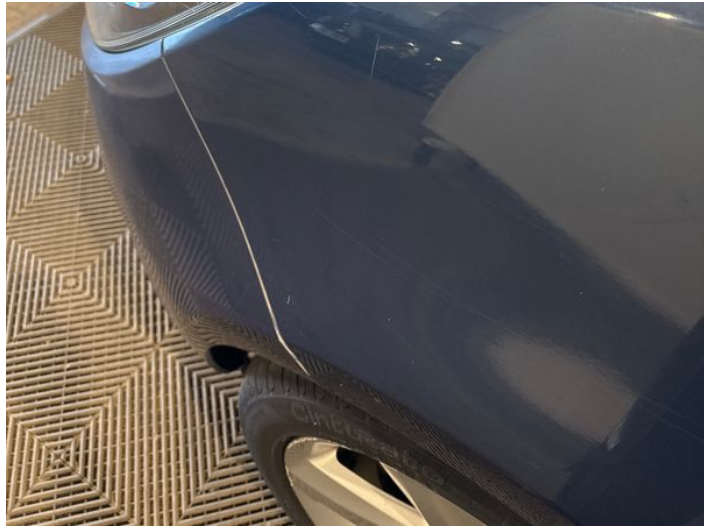
4: Wing nsf  
Scratched  
UpTo 25mm Thru Paint

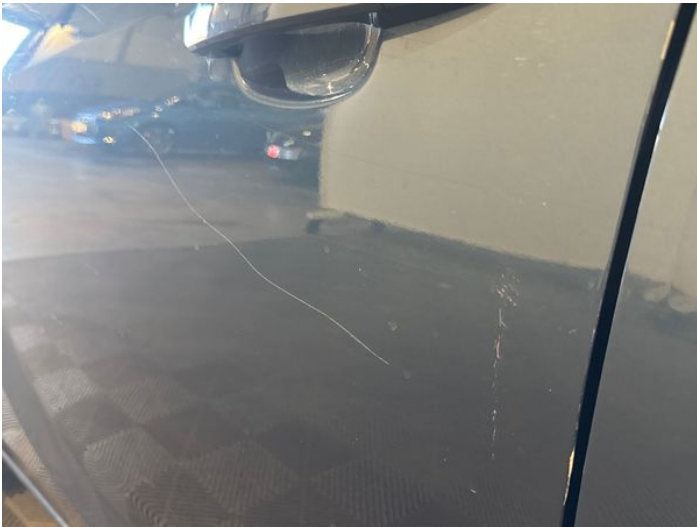
5: Door nsf  
Scratched  
Over 25mm Thru Paint

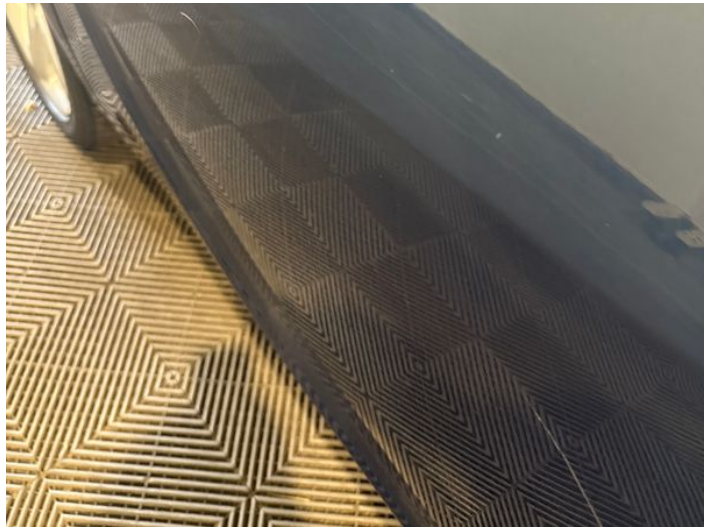
6: Door nsf  
Dented  
2 Or Less UpTo 10mm

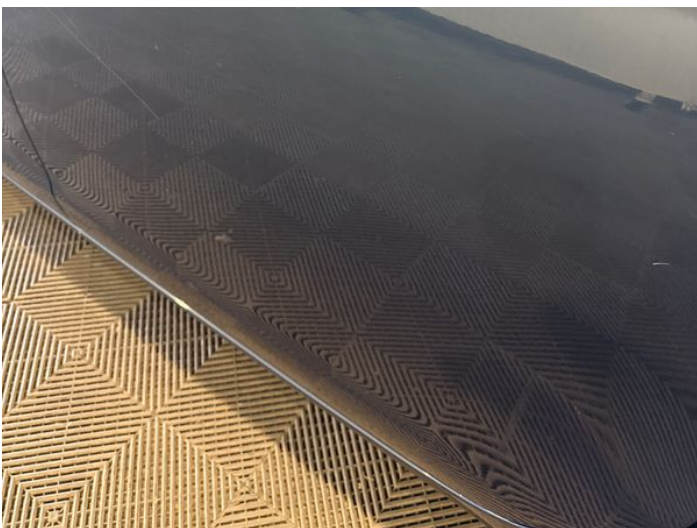
7: Door nsr  
Dented  
With Paint Damage

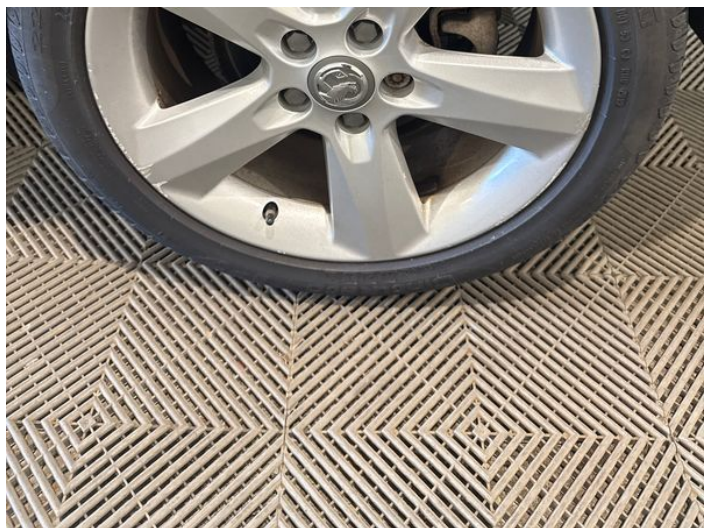
8: Wheel nsr  
Scratched  
Over 50mm

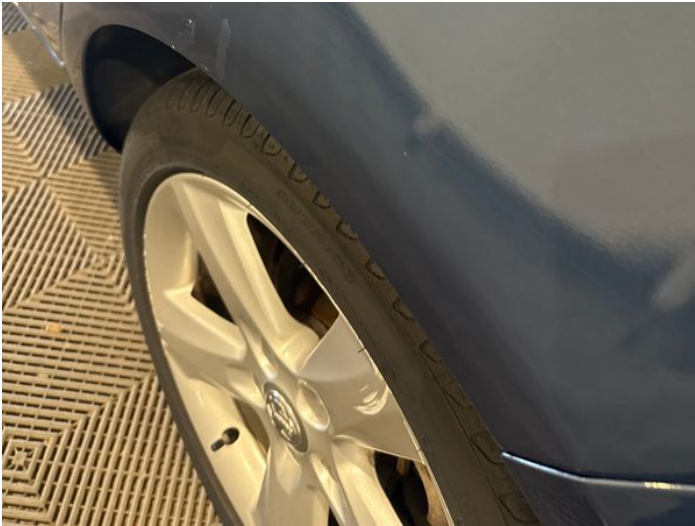
9: Qtr Panel nsr  
Poor Previous Repair  
Paint Flake

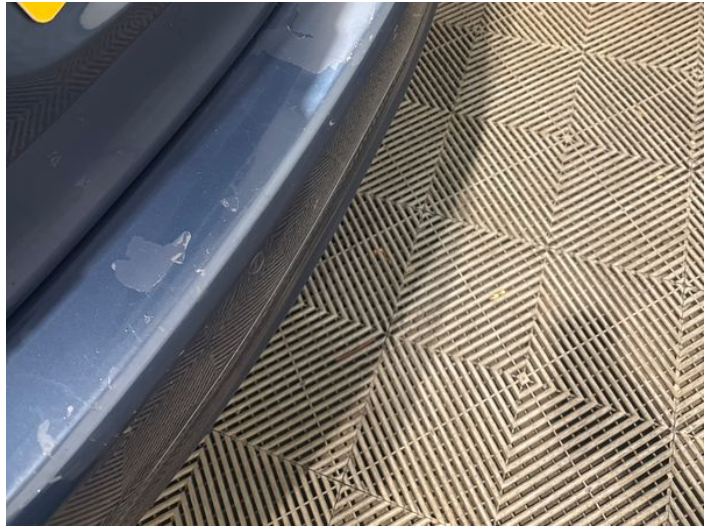
10: Bumper Rear  
Poor Previous Repair  
Paint Flake

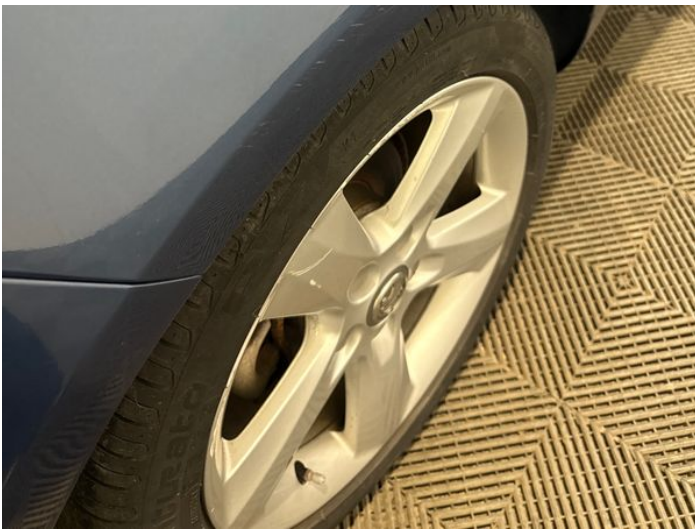
11: Qtr Panel osr  
Chipped  
Multiple Chips

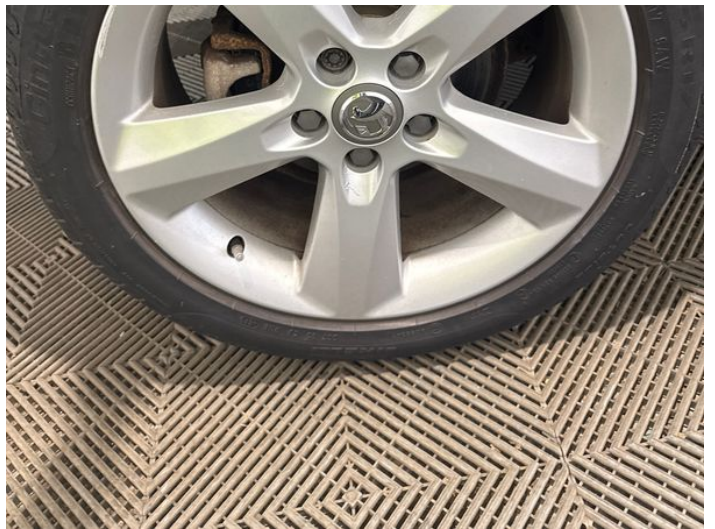
12: Wheel osr  
Scratched  
Over 50mm

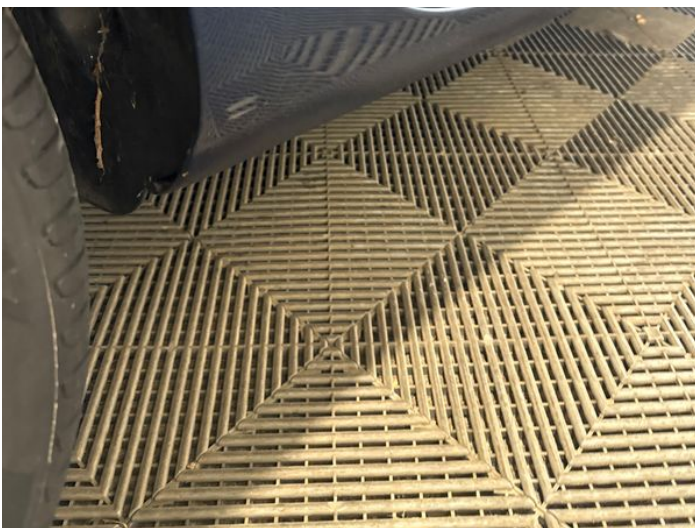
13: Sill os  
Scratched  
UpTo 25mm Thru Paint

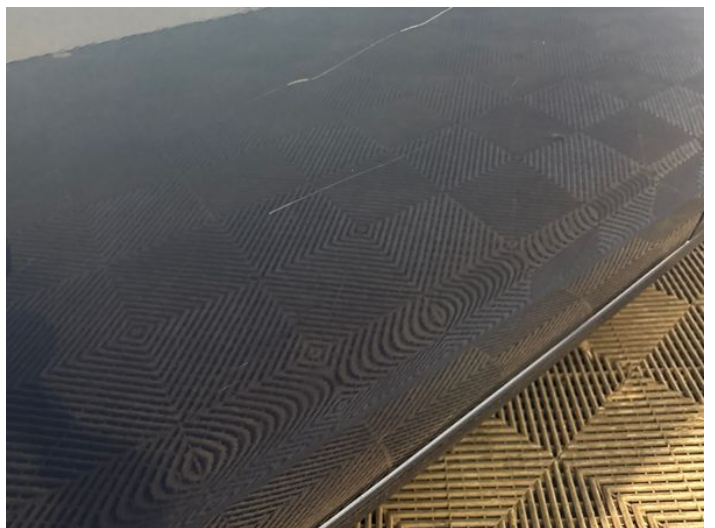
14: Door osr  
Scratched  
Over 25mm Thru Paint

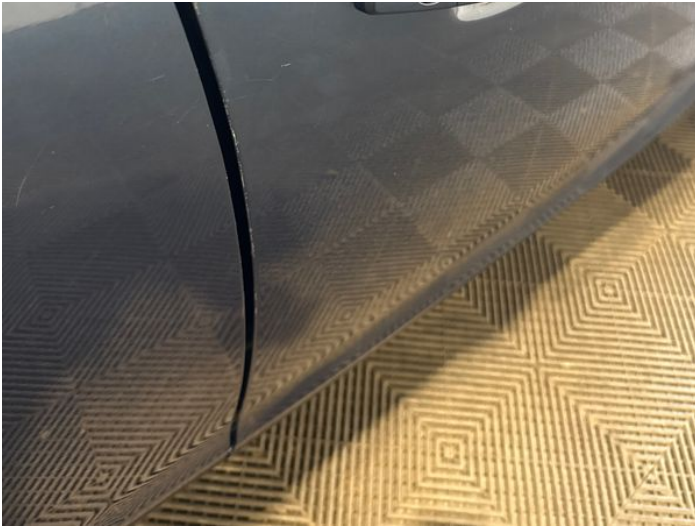
15: Door osf  
Chipped  
Edge Chip

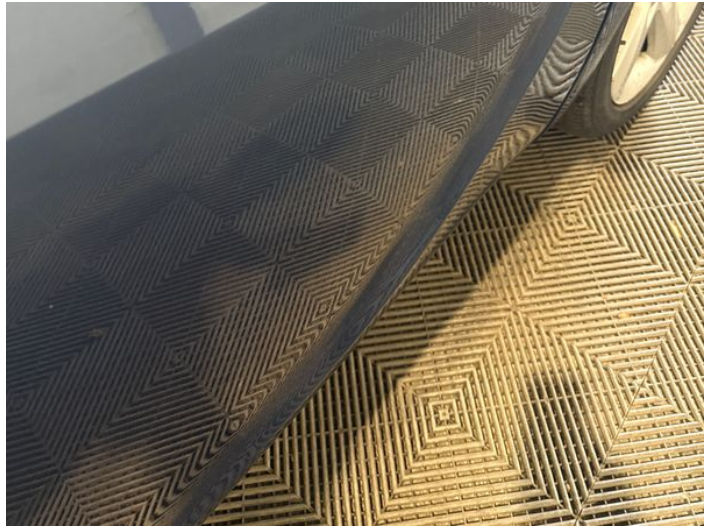
16: Door osf  
Dented  
Between 10mm + 30mm

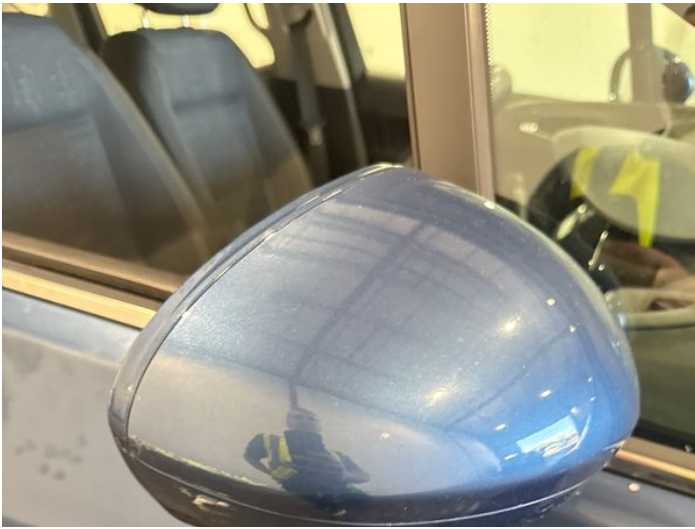
17: Door Mirror Assy osf  
Scratched (Painted)  
UpTo 25mm Thru Paint

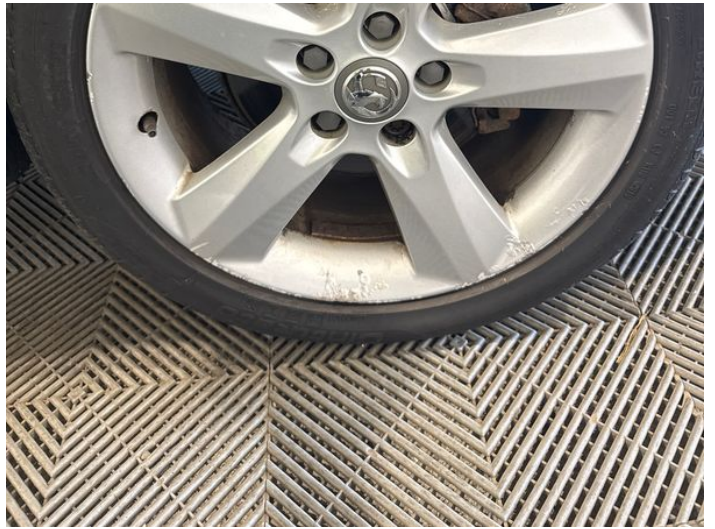
18: Wheel osf  
Scratched  
Over 50mm

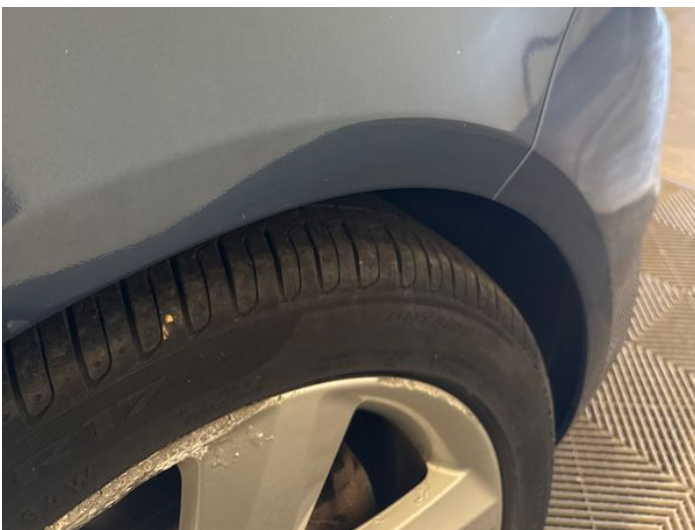
19: Wing osf  
Poor Previous Repair  
Poor Paint

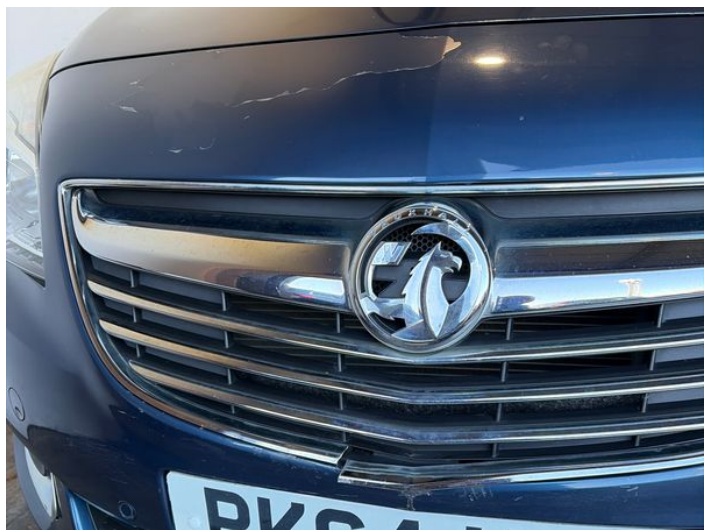
20: Bumper Front Grill  
Broken  
Replace
