# VEHICLE INSPECTION REPORT

**YD59UTZ**

## BMW X1 xDrive 23d SE 5dr Step Auto

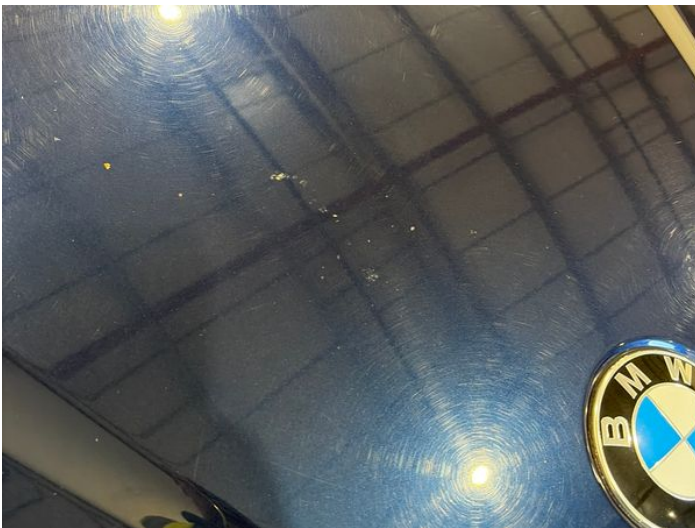
1: Bonnet  
Chipped  
Multiple Chips

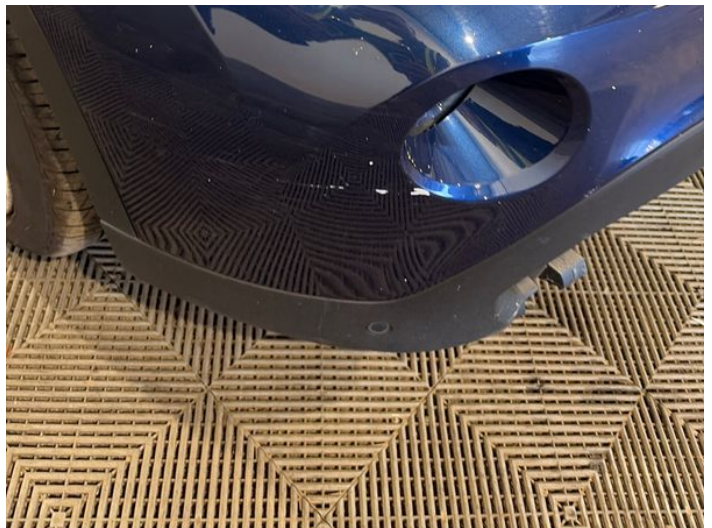
2: Bumper Front  
Scratched  
25 to 100mm Thru Paint

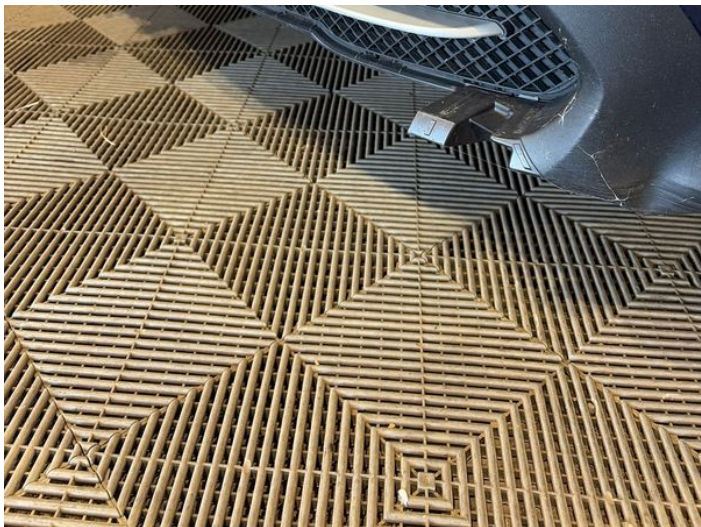
3: Bumper Front Moulding  
Missing  
Replace

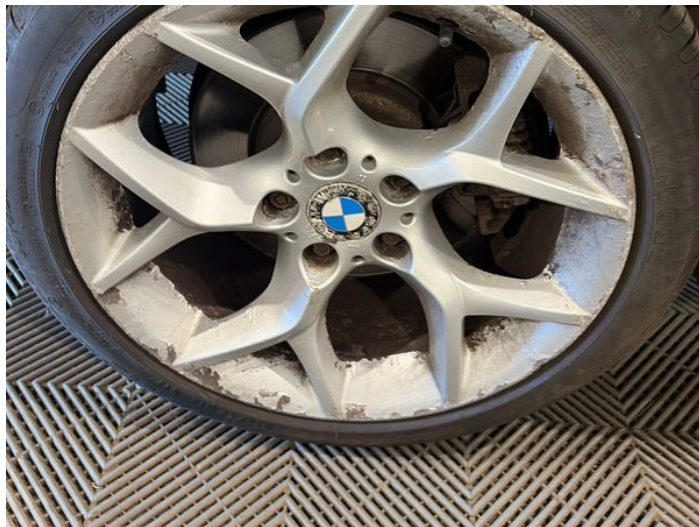
4: Wheel nsf  
Scratched  
Over 50mm

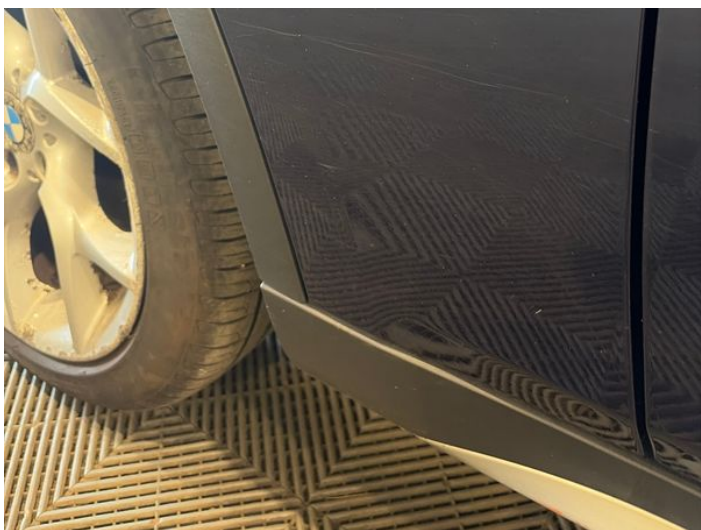
5: Wing nsf  
Scratched  
UpTo 25mm Thru Paint

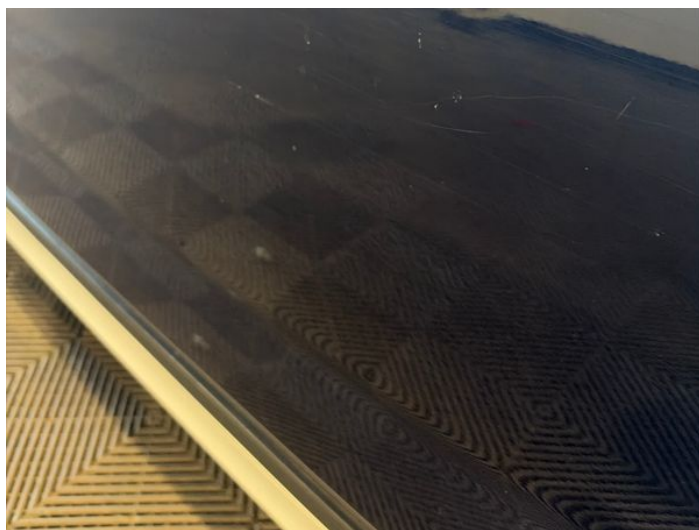
6: Door nsf  
Scratched  
Over 25mm Thru Paint

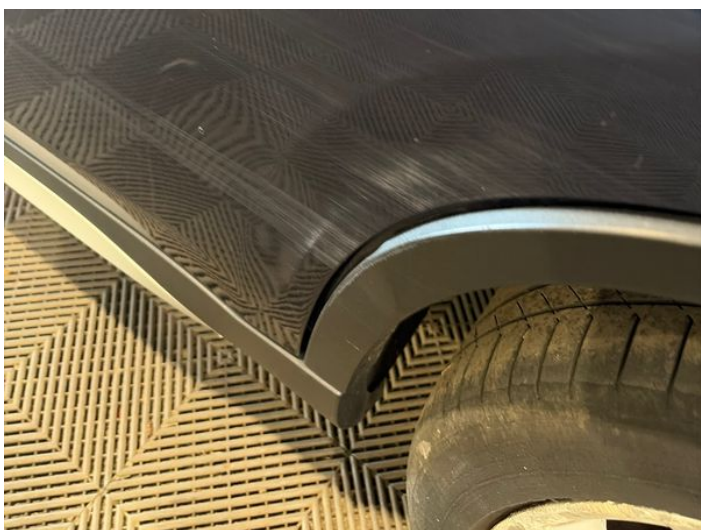
7: Door nsr  
Scratched  
Over 25mm Thru Paint

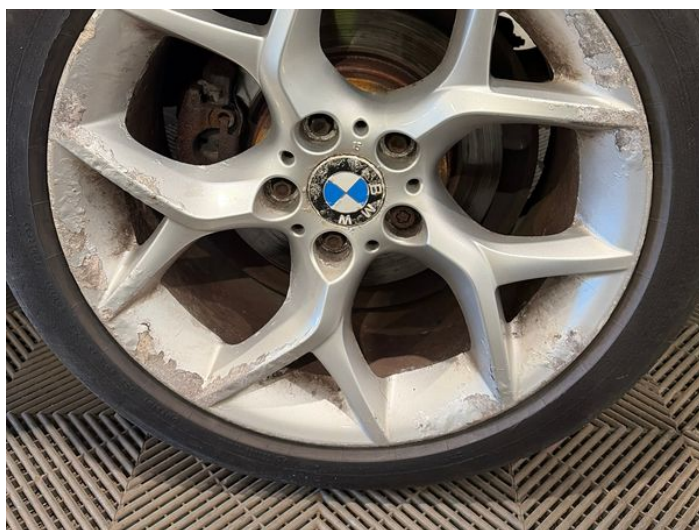
8: Wheel nsr  
Scratched  
Over 50mm

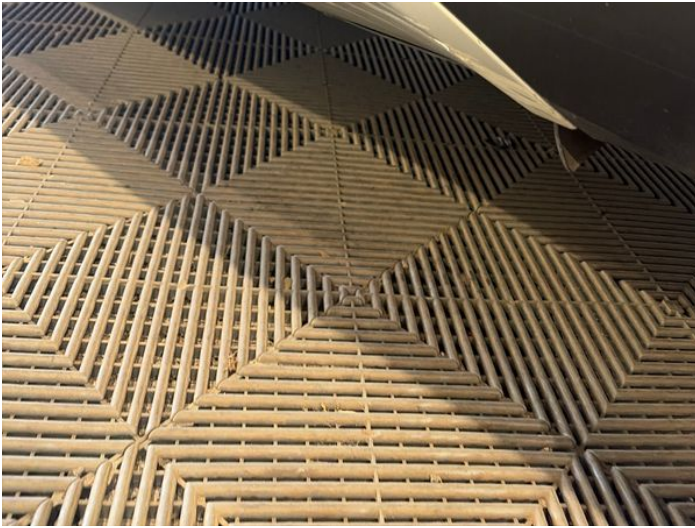
9: Sill Panel Trim ns  
Scratched (Painted)  
Over 25mm Thru Paint

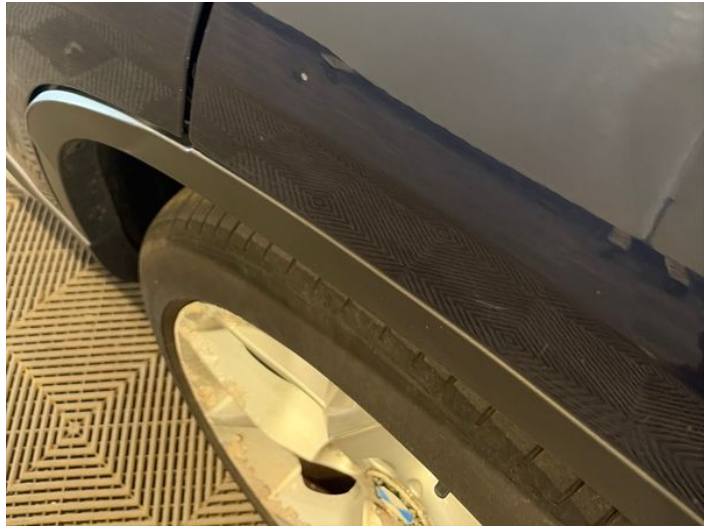
10: Qtr Panel nsr  
Dented  
Between 10mm + 30mm

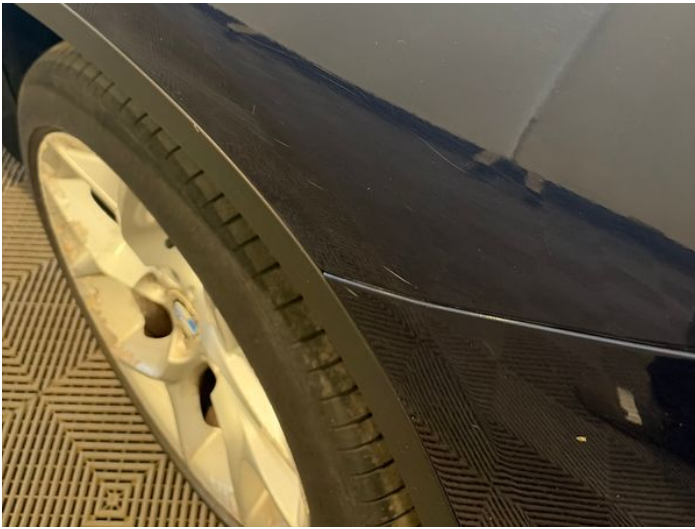
11: Qtr Panel nsr  
Scratched  
Over 25mm Thru Paint

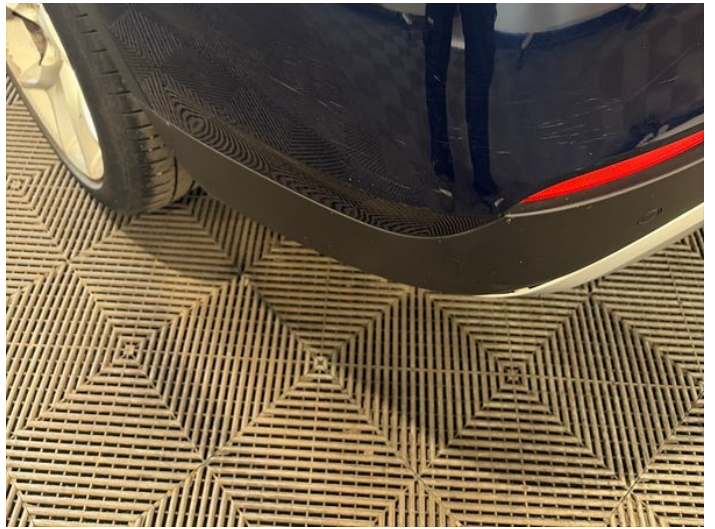
12: Bumper Rear  
Scratched  
Over 100mm Thru Paint

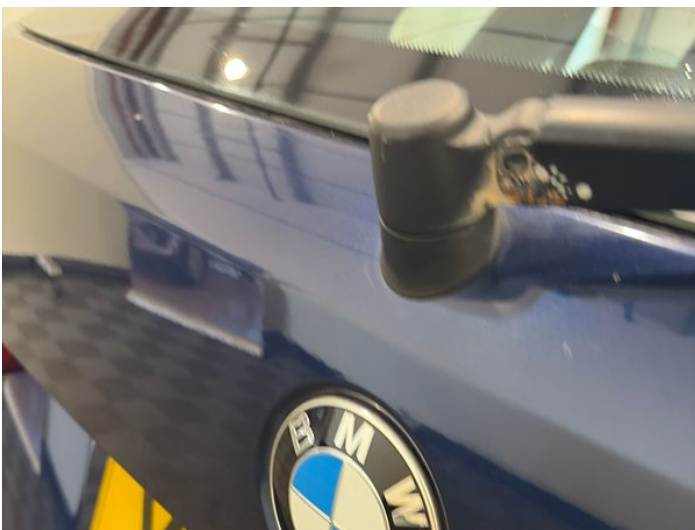
13: Tailgate  
Scratched  
UpTo 25mm Thru Paint

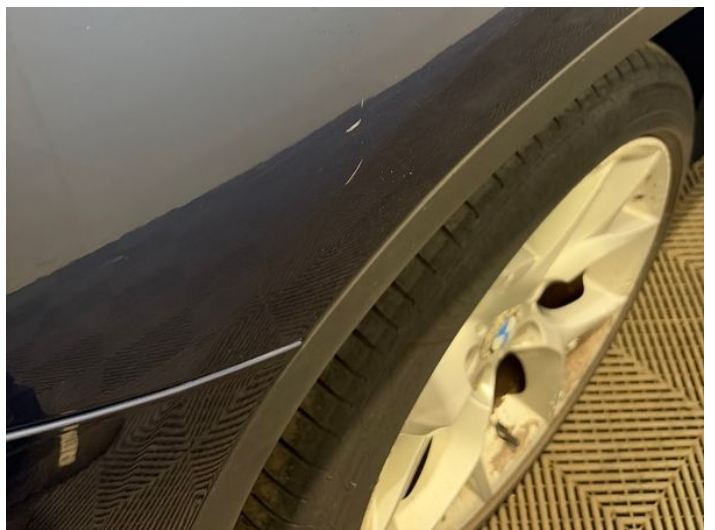
14: Qtr Panel osr  
Scratched  
UpTo 25mm Thru Paint

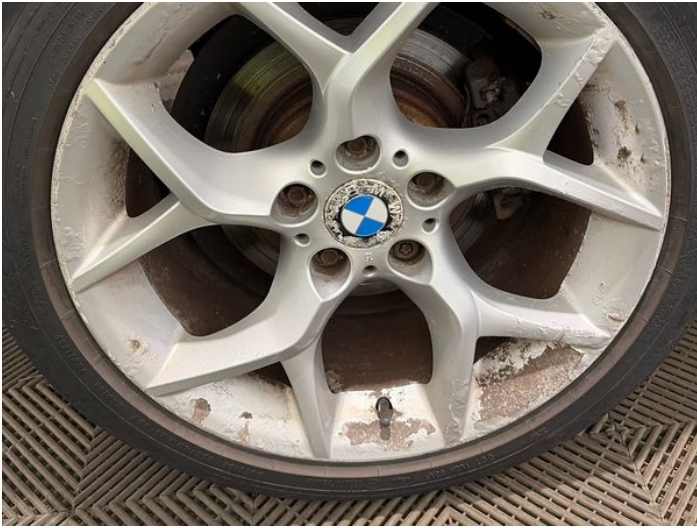
15: Wheel osr  
Scratched  
Over 50mm

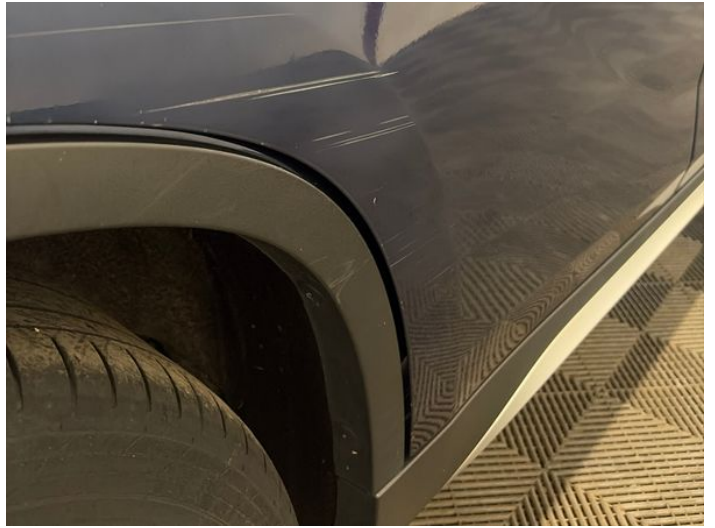
16: Door osr  
Scratched  
Over 25mm Thru Paint

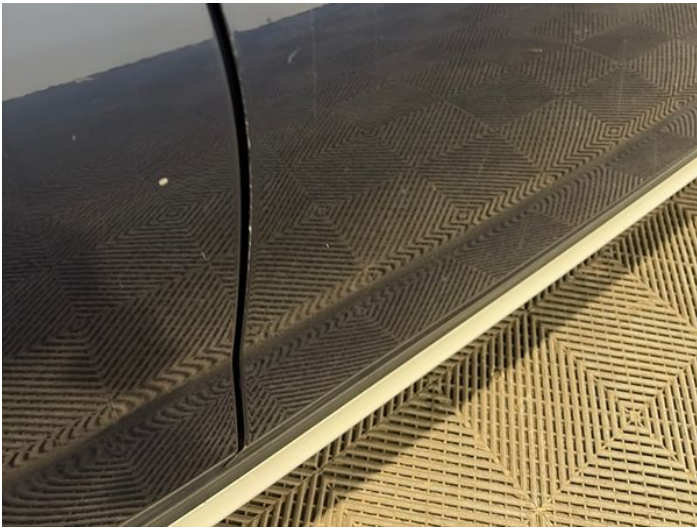
17: Door osf  
Chipped  
Edge Chip

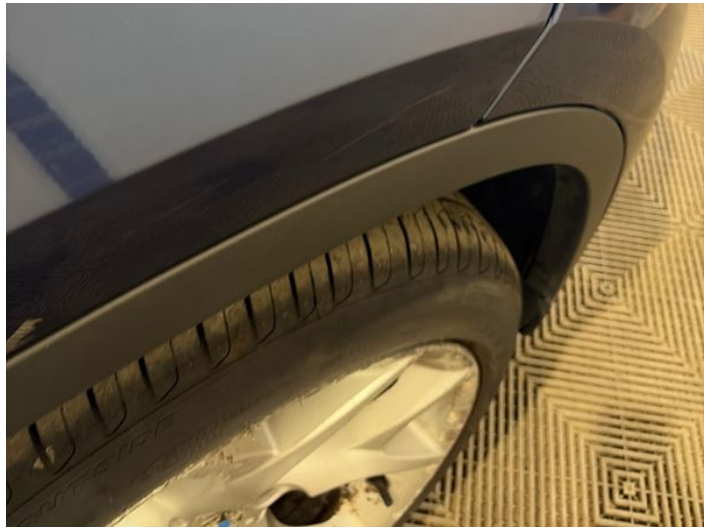
18: Wing osf  
Scratched  
Over 25mm Thru Paint

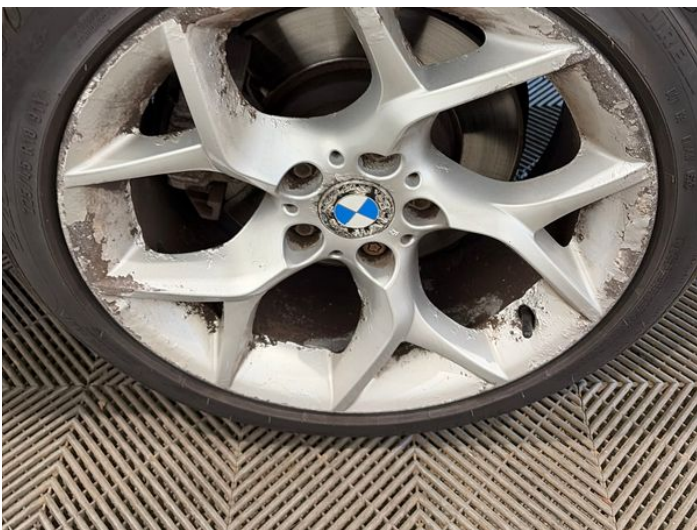
19: Wheel osf  
Corroded  
Light

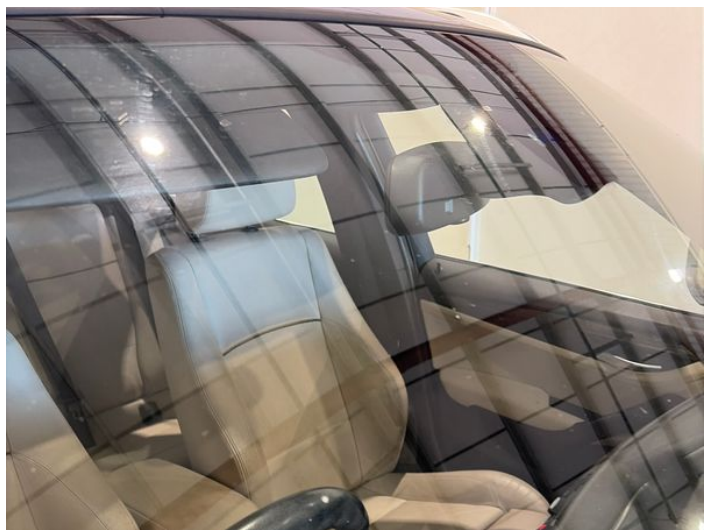
20: Screen Front  
Chipped  
UpTo 10mm

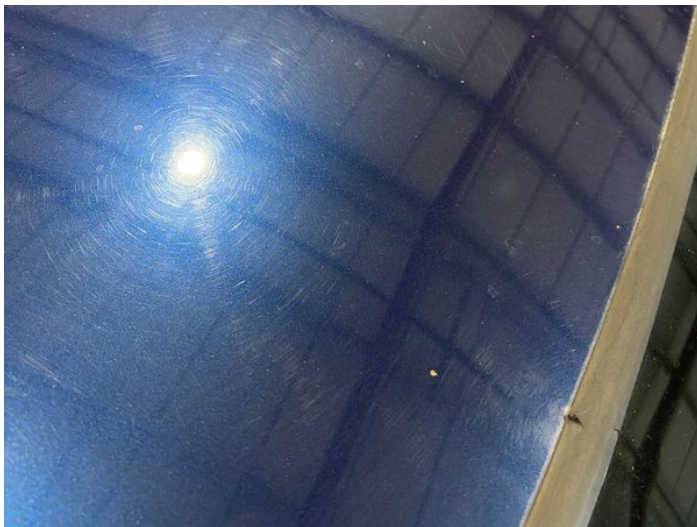
21: Roof  
 Scratched  
 Over 25mm Thru Paint

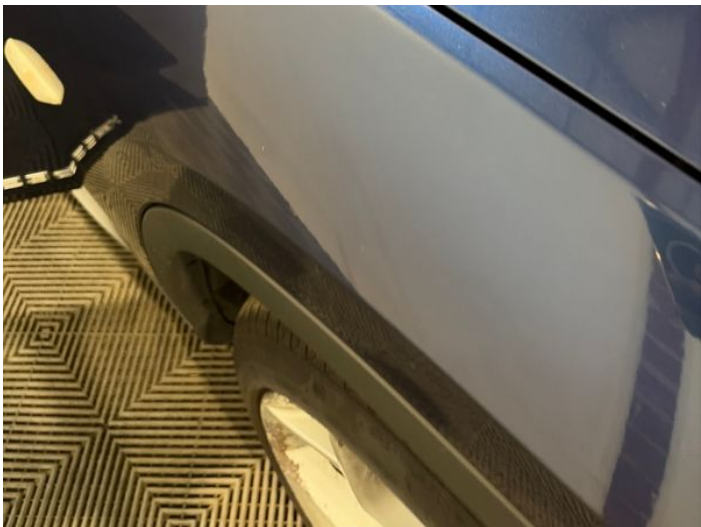
22: Wing of  
 Dented  
 Between 10mm + 30mm
