# VEHICLE INSPECTION REPORT

**EA59VHV**

## Ford Fiesta 1.4 Zetec 5dr

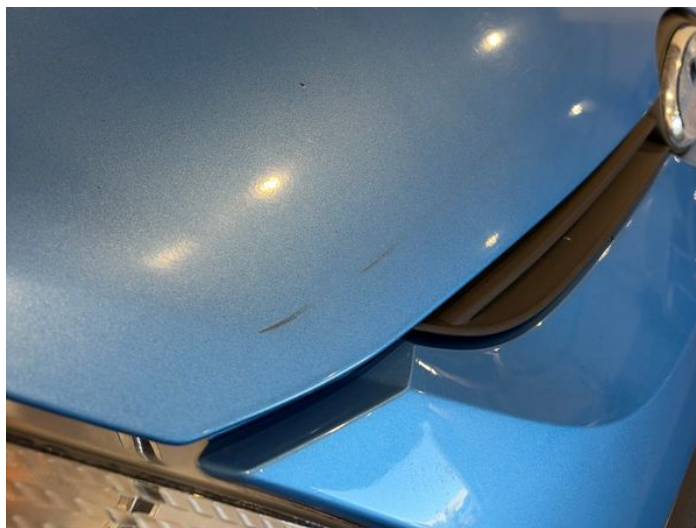
2: Bonnet  
Scratched  
Over 25mm Thru Paint

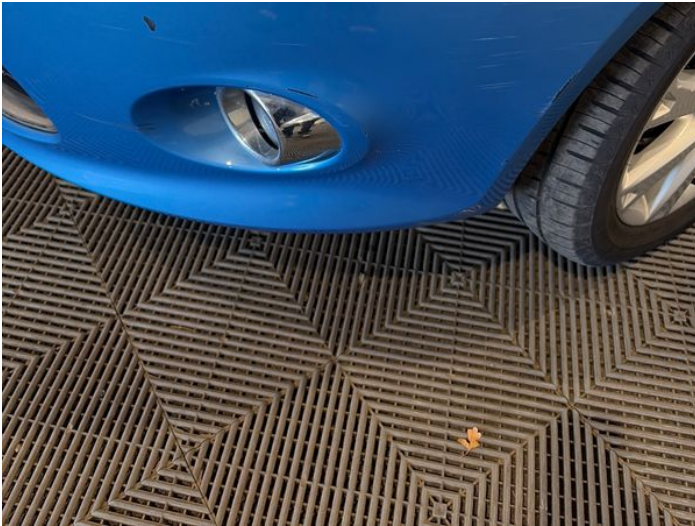
3: Bumper Front  
Scratched  
Over 100mm Thru Paint

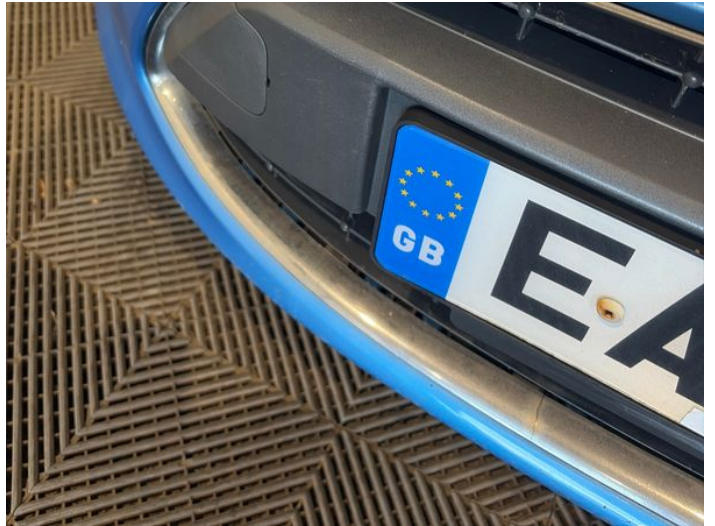
4: Bumper Front Grill  
Broken  
Replace

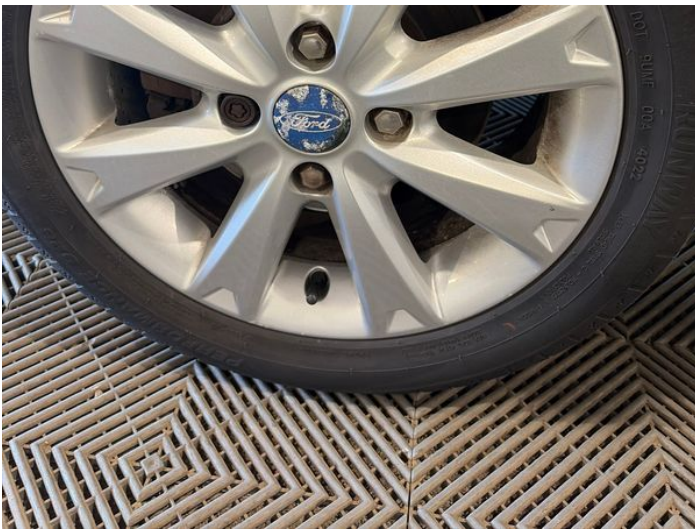
5: Wheel nsf  
Scratched  
Up To 50mm

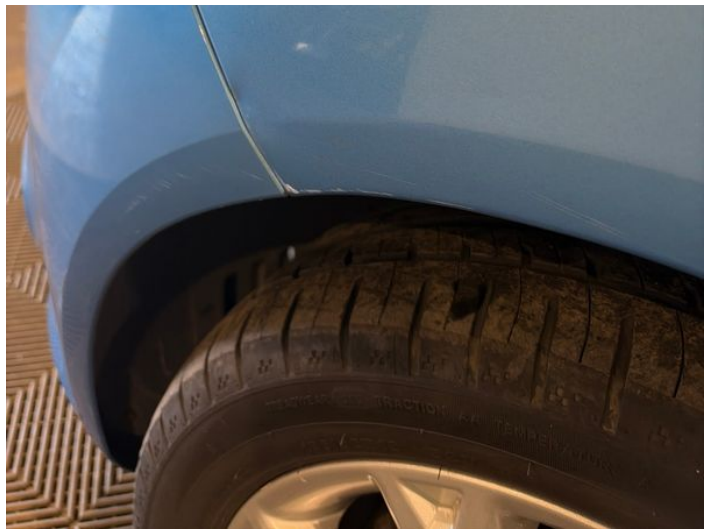
6: Wing nsf  
Dented  
Between 10mm + 30mm

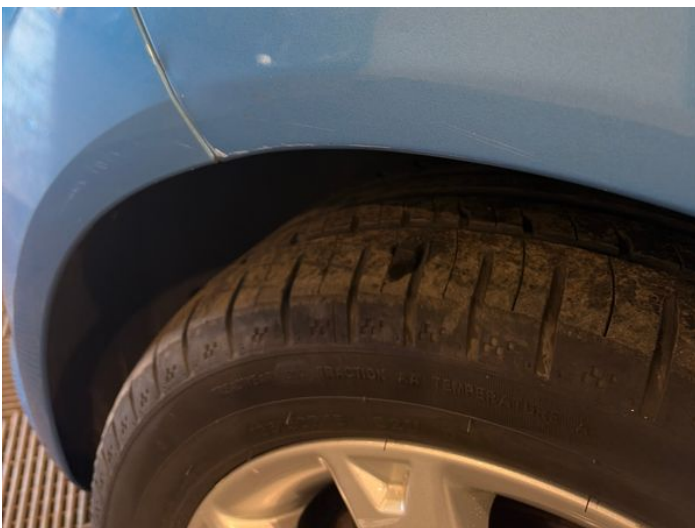
7: Wing nsf  
Scratched  
Up To 25mm Thru Paint

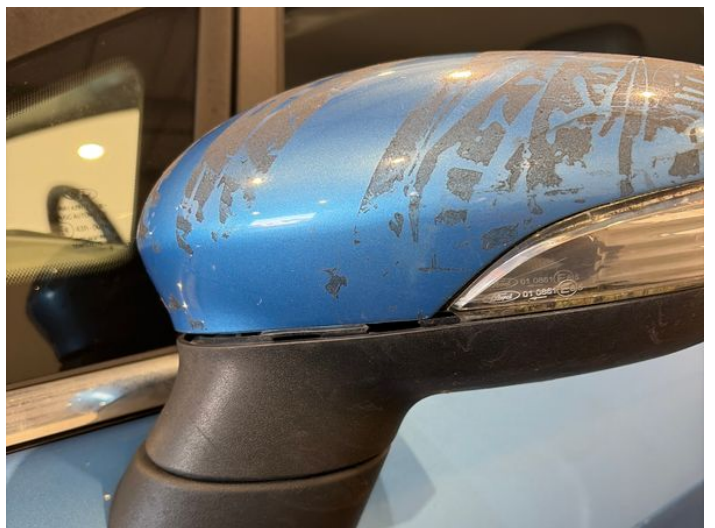
8: Door Mirror Assy nsf  
Broken  
Replace

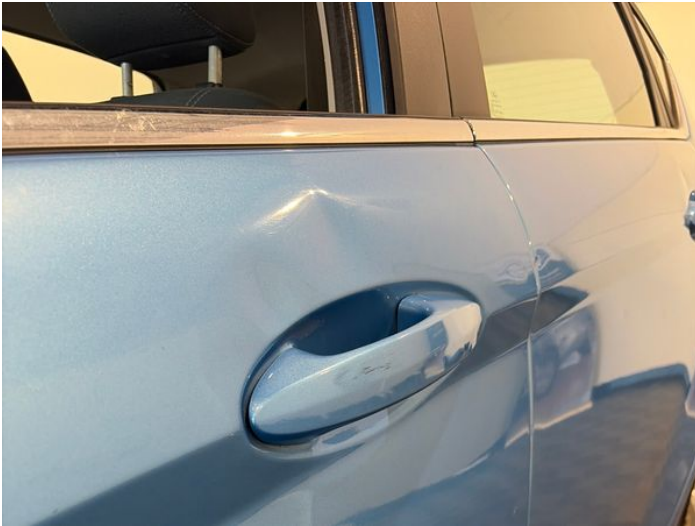
9: Door nsf  
Dented  
With Paint Damage

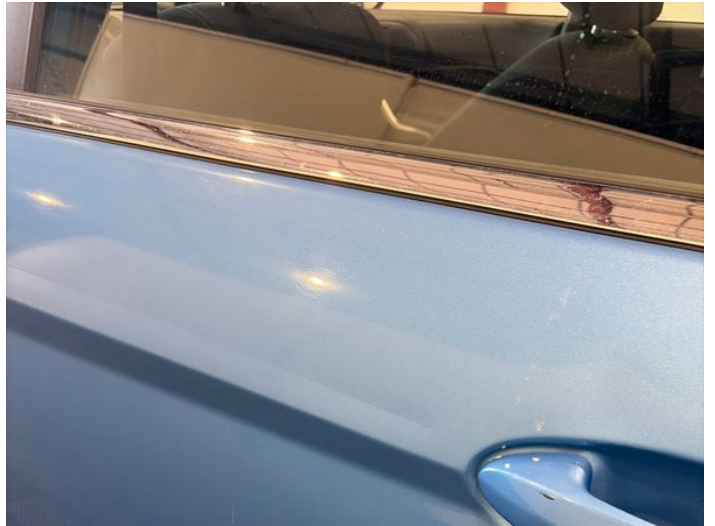
10: Door nsr  
Dented  
With Paint Damage

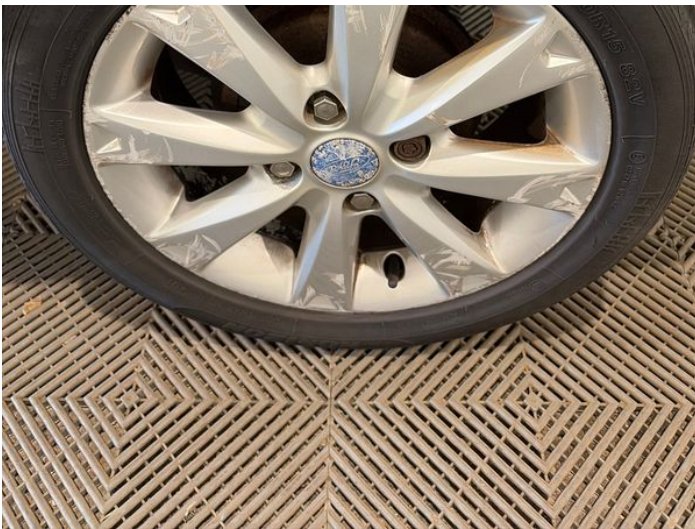
11: Wheel nsr  
Scratched  
Over 50mm

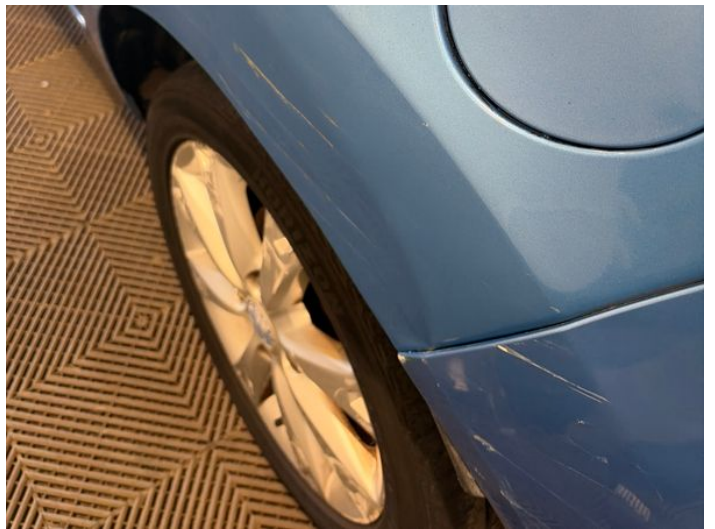
12: Qtr Panel nsr  
Dented  
With Paint Damage

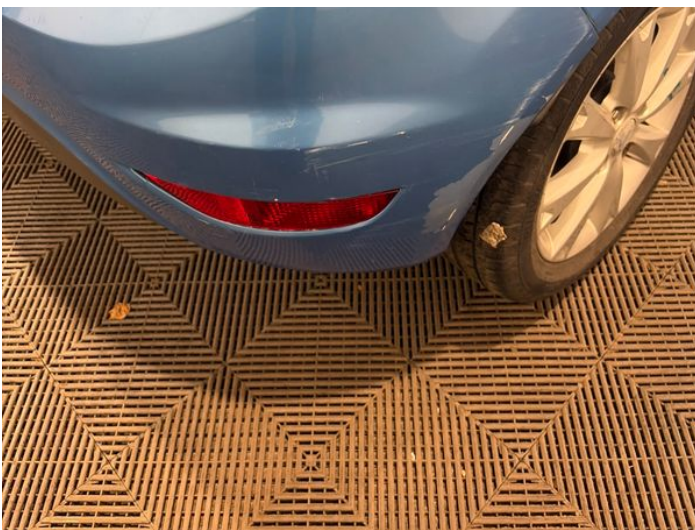
13: Bumper Rear  
Scratched  
Over 100mm Thru Paint

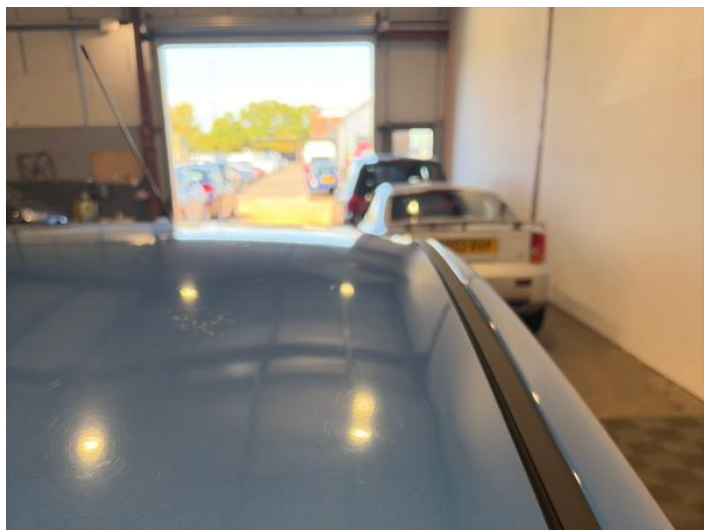
14: Roof  
Dented  
Over 30mm

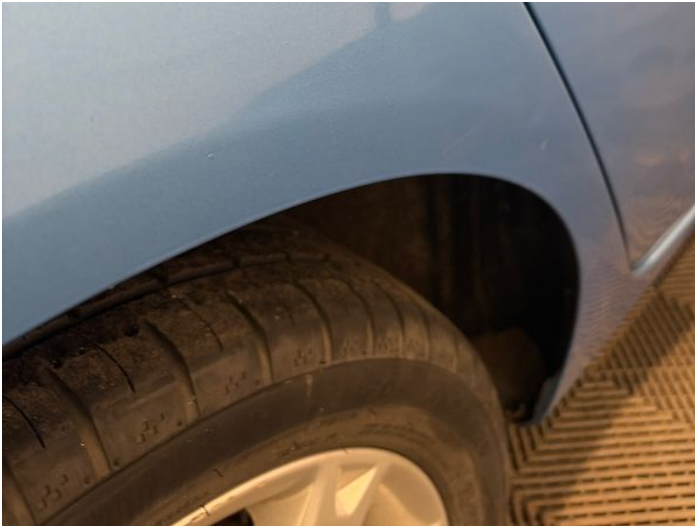
15: Qtr Panel osr  
Dented  
Between 10mm + 30mm

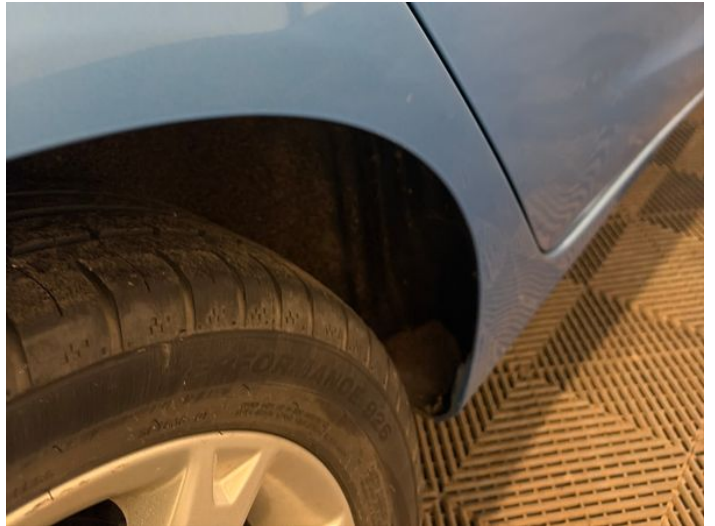
16: Qtr Panel osr  
Scratched  
UpTo 25mm Thru Paint

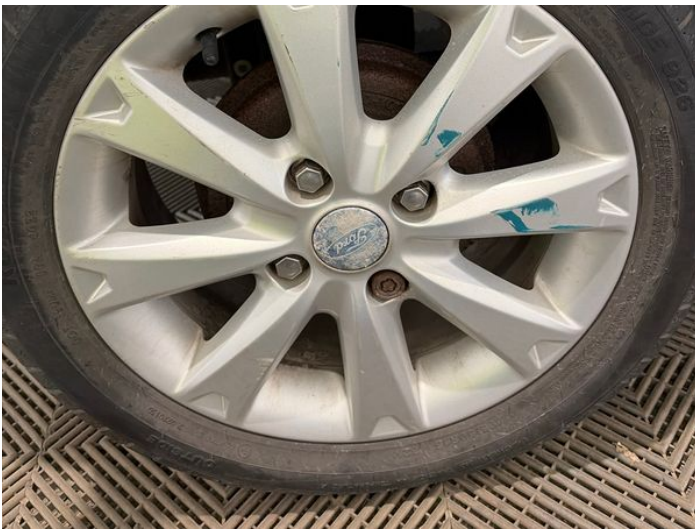
17: Wheel osr  
Scratched  
Over 50mm

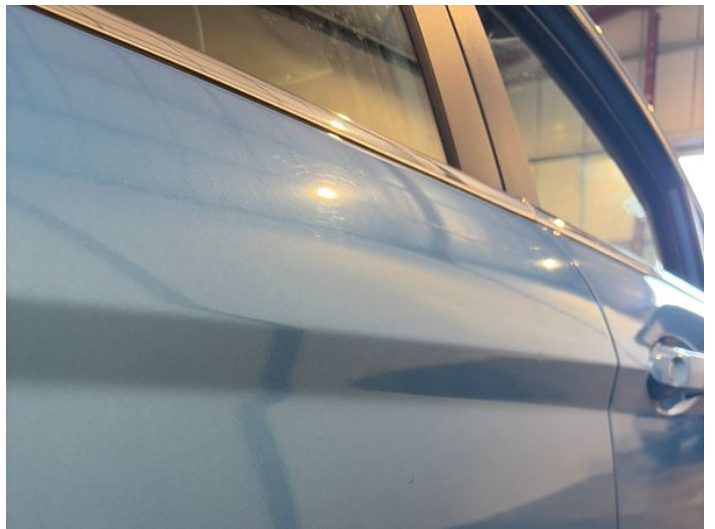
18: Door osr  
Dented  
Over 30mm

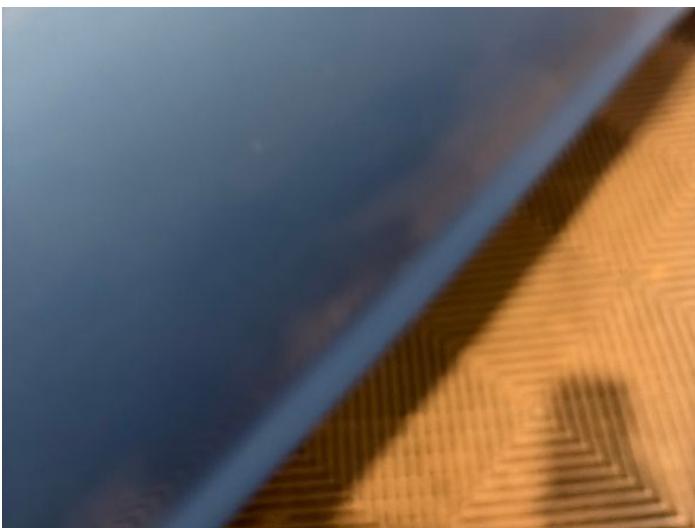
19: Door osf  
Chipped  
1 To 5

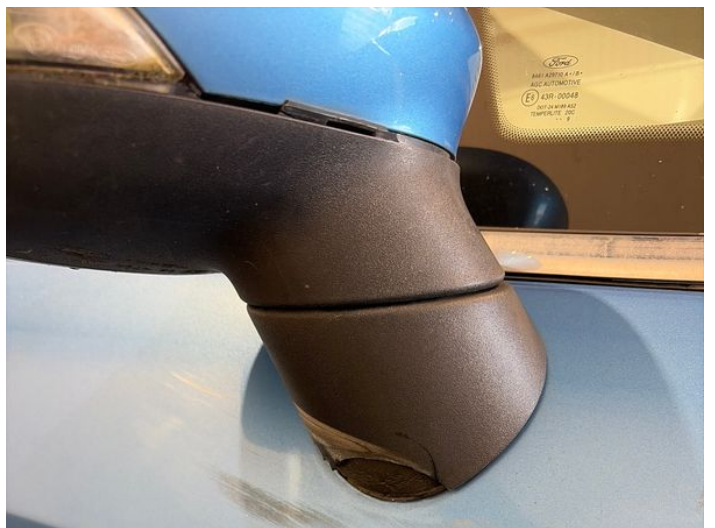
20: Door Mirror Assy osf  
Broken  
Replace

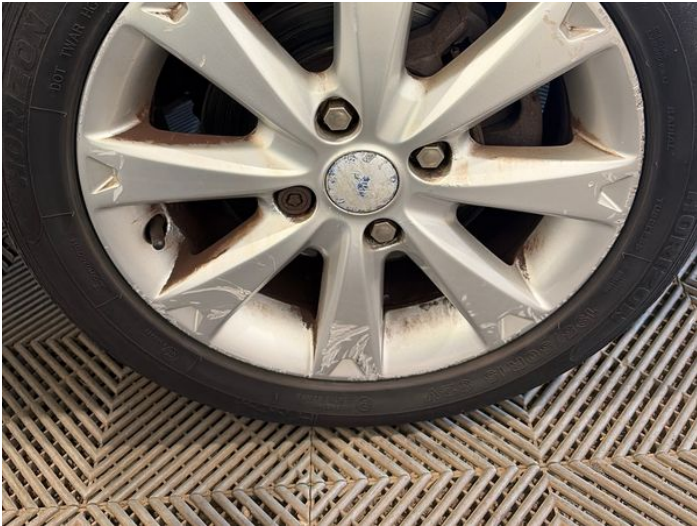
21: Wheel osf  
Scratched  
Over 50mm

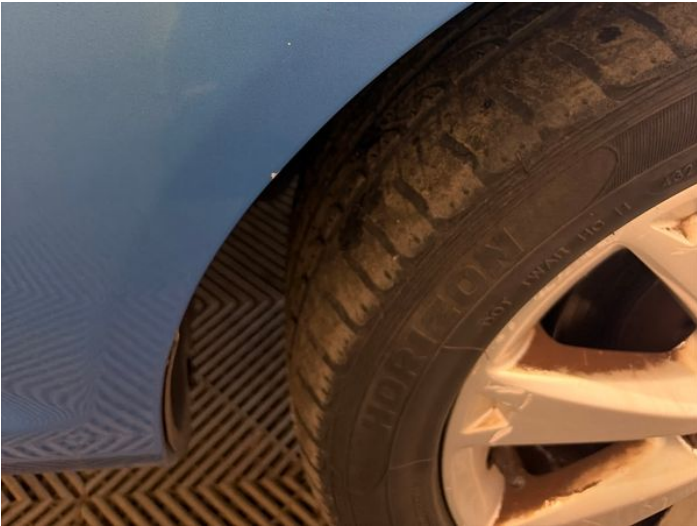
22: Wing osf  
Chipped  
1 To 5
