# VEHICLE INSPECTION REPORT

**MX02RVP**

## Toyota Celica 1.8 VVTi 3dr

**Cat: C**  
**Inspection**

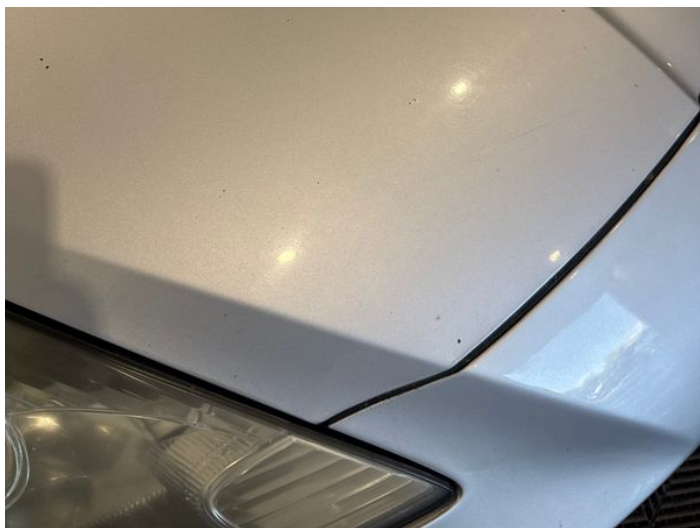
1: Bonnet  
Chipped  
Multiple Chips

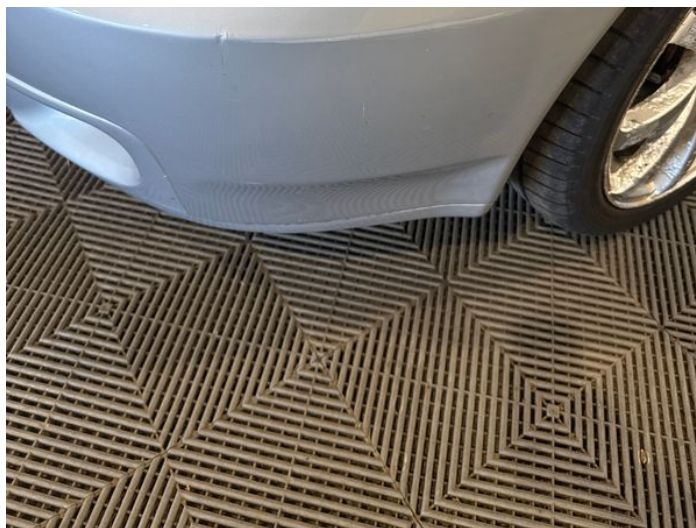
2: Bumper Front  
Dented  
With Paint Damage

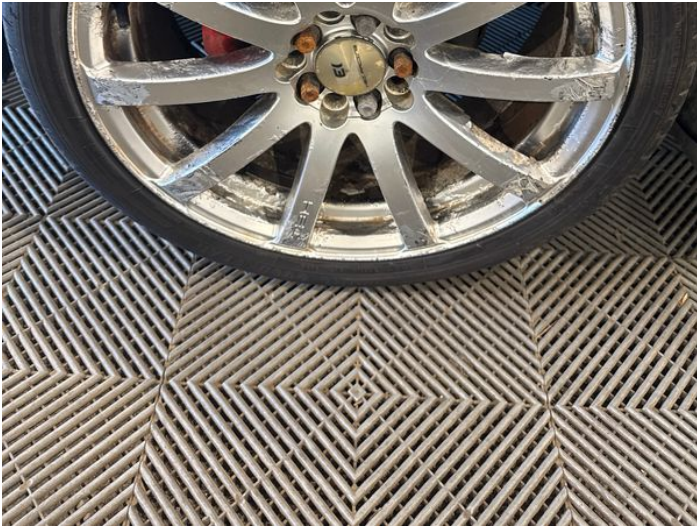
3: Wheel nsf  
Corroded  
Light

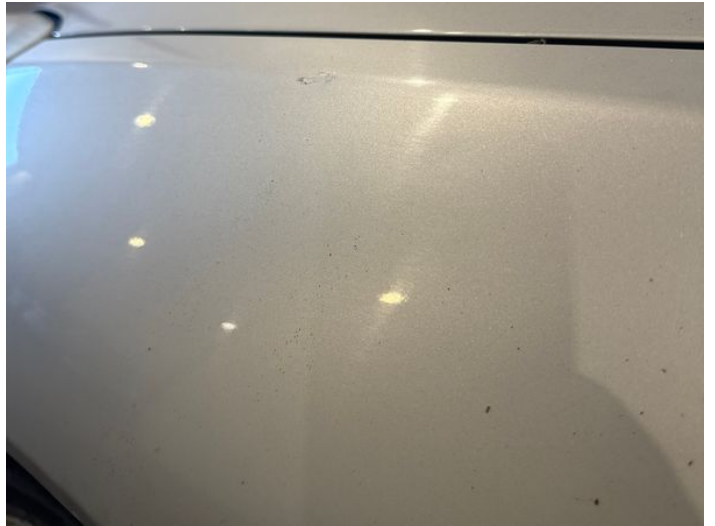
4: Wing nsf  
Scratched  
UpTo 25mm Thru Paint

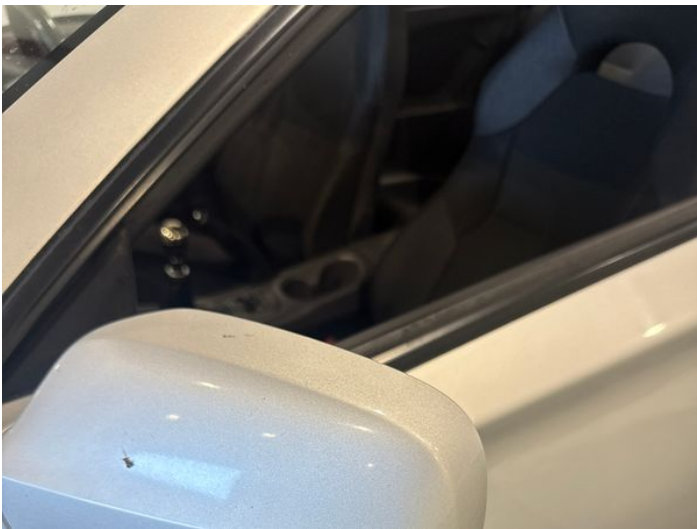
5: Door Mirror Assy nsf  
Scratched (Painted)  
UpTo 25mm Thru Paint

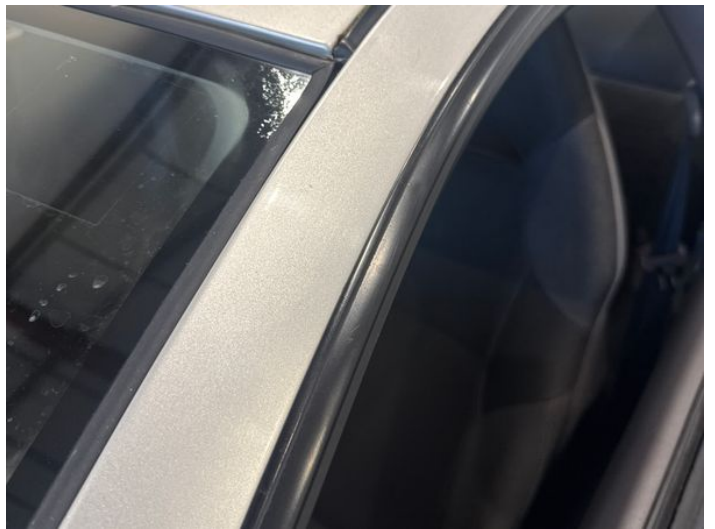
6: A Post nsf  
Scratched  
UpTo 25mm Thru Paint

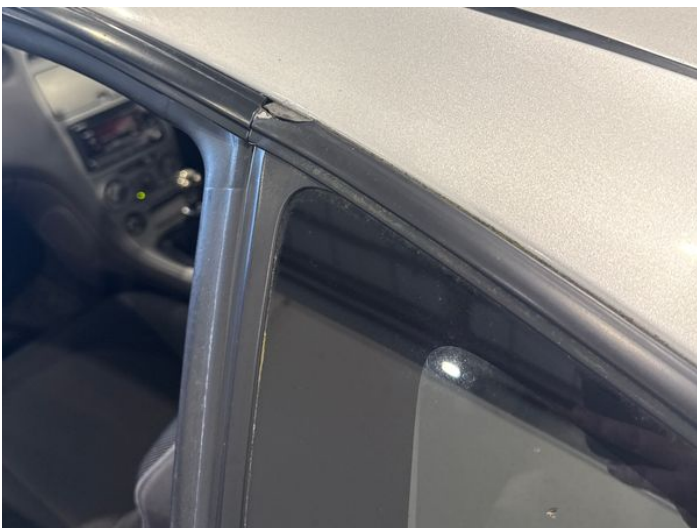
7: Aperture Seal nsr  
Broken  
Replace

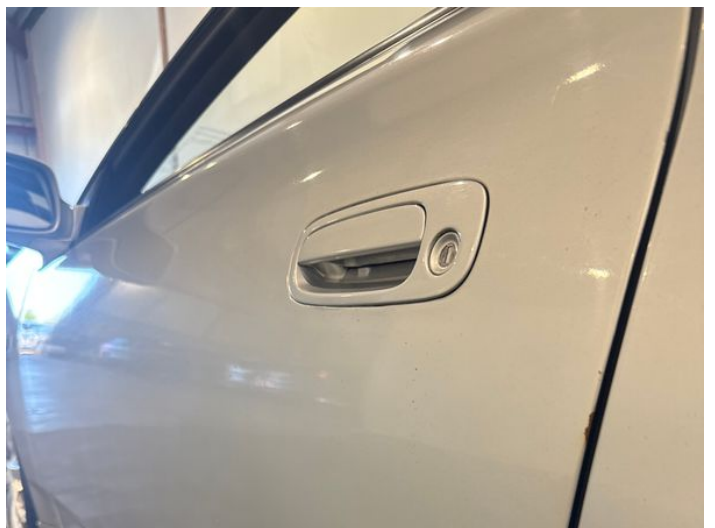
8: Door nsf  
Poor Previous Repair  
Rippled UpTo 30%

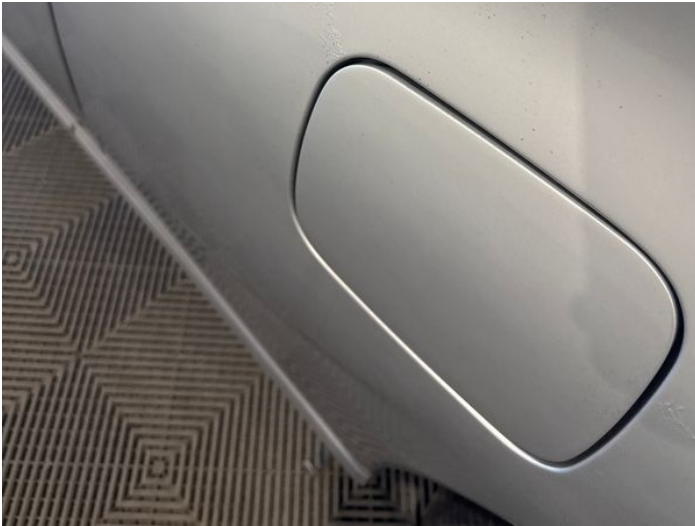
9: Qtr Panel nsr  
Rusted  
Over 5mm

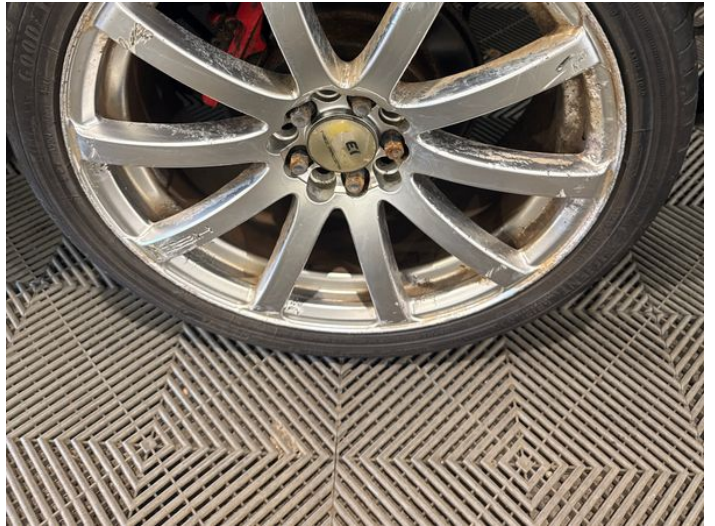
10: Wheel nsr  
Corroded  
Light

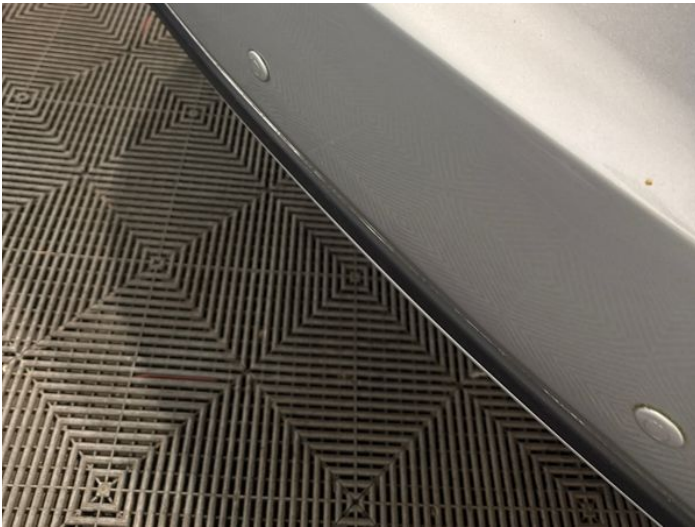
11: Bumper Rear  
Scratched  
25 to 100mm Thru Paint

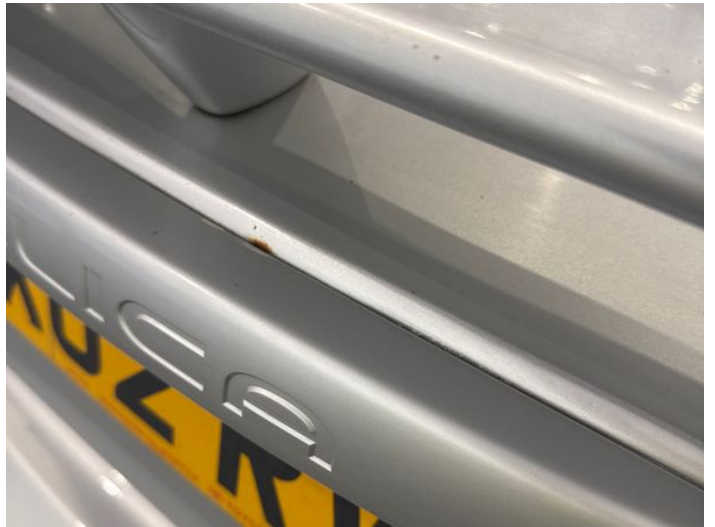
12: Tailgate  
Rusted  
Over 5mm

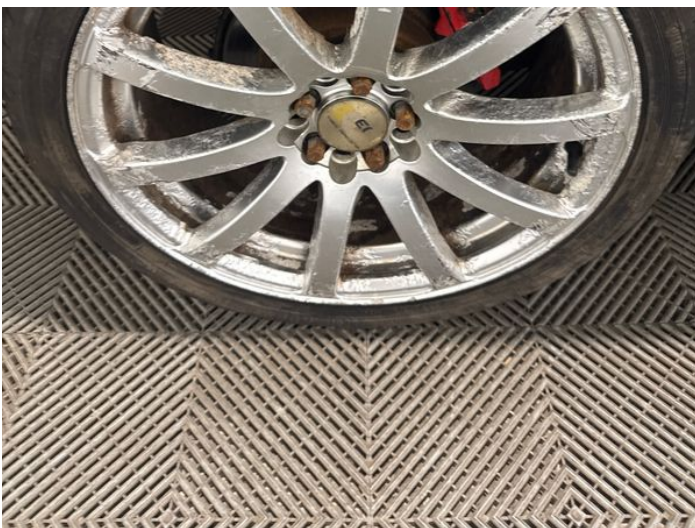
13: Wheel osr  
Corroded  
Light

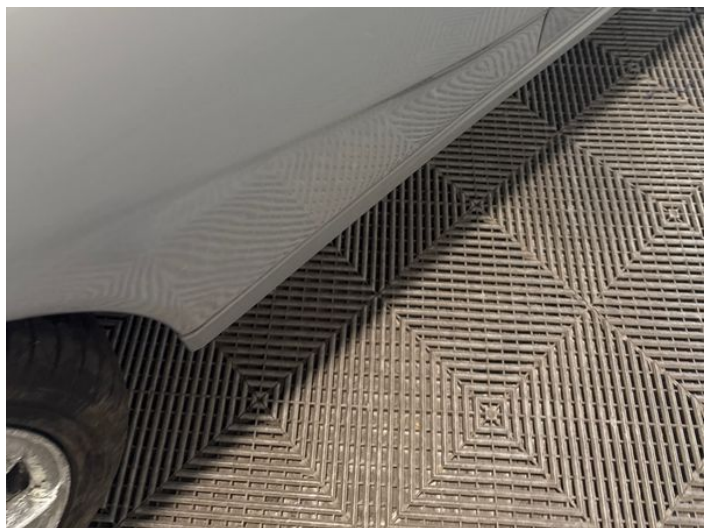
14: Qtr Panel osr  
Scratched  
Over 25mm Thru Paint

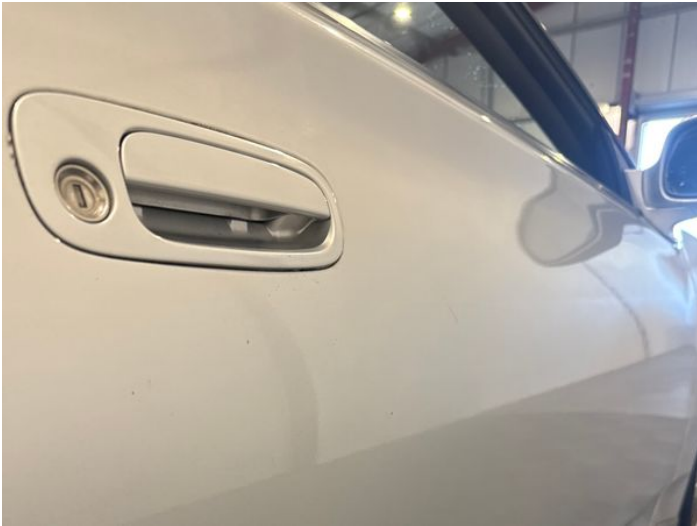
15: Door osf  
Poor Previous Repair  
Rippled UpTo 30%

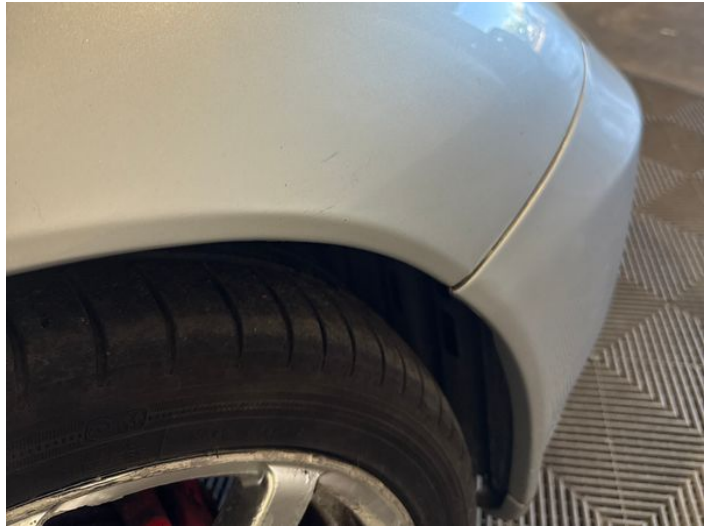
16: Wing osf  
Poor Previous Repair  
Poor Paint

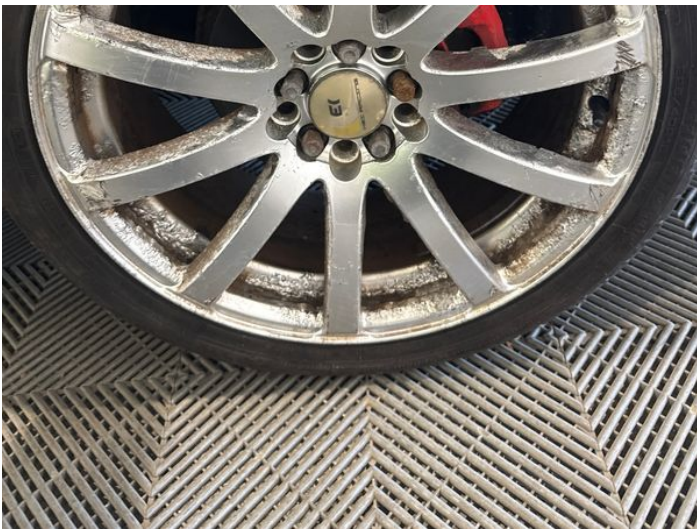
17: Wheel osf  
Scratched  
Over 50mm

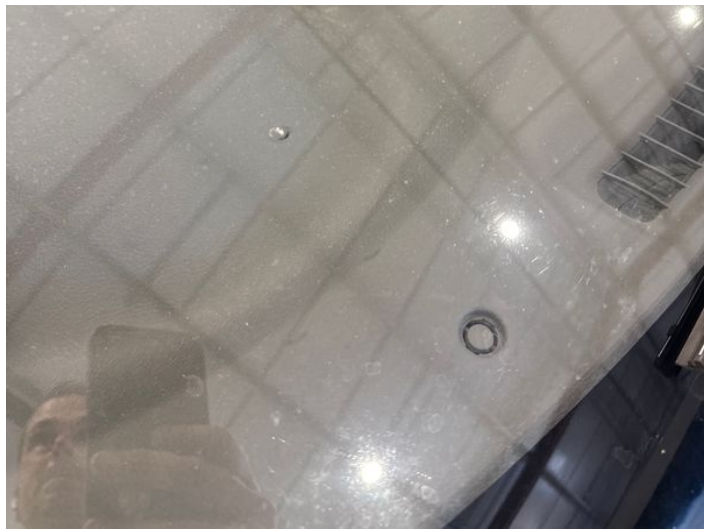
18: Screen Front  
Chipped  
Over 10mm
