# VEHICLE INSPECTION REPORT

**AJ10ZKW**

## Ford S-Max 2.0 EcoBoost Titanium 5dr Powershift

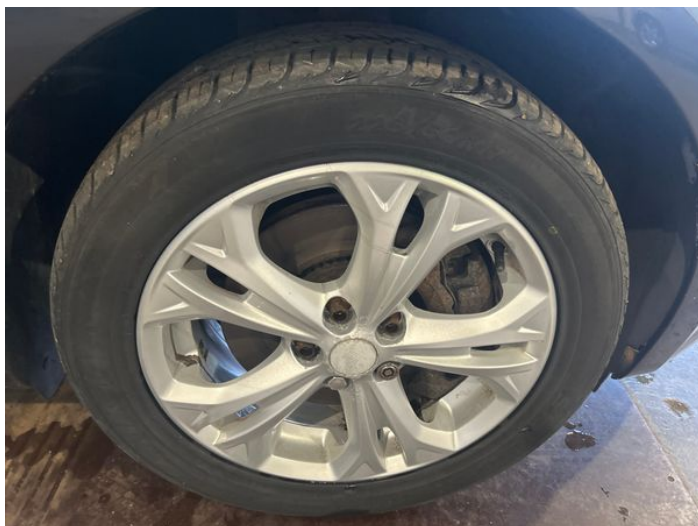
1: Wheel osf  
Corroded  
Light

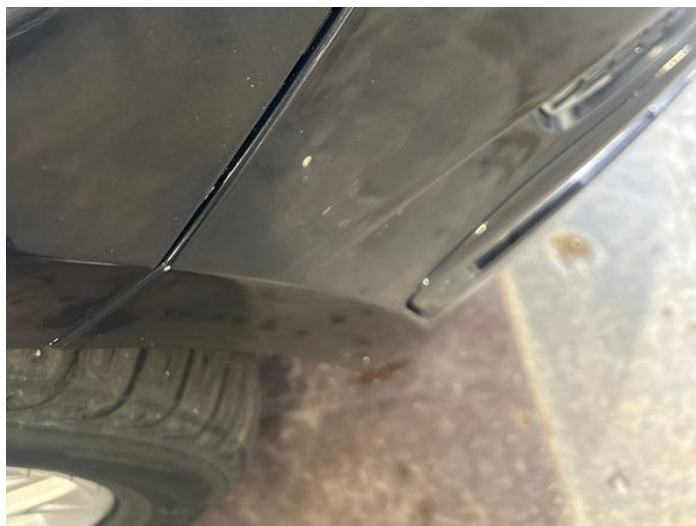
2: Wing osf  
Chipped  
1 To 5

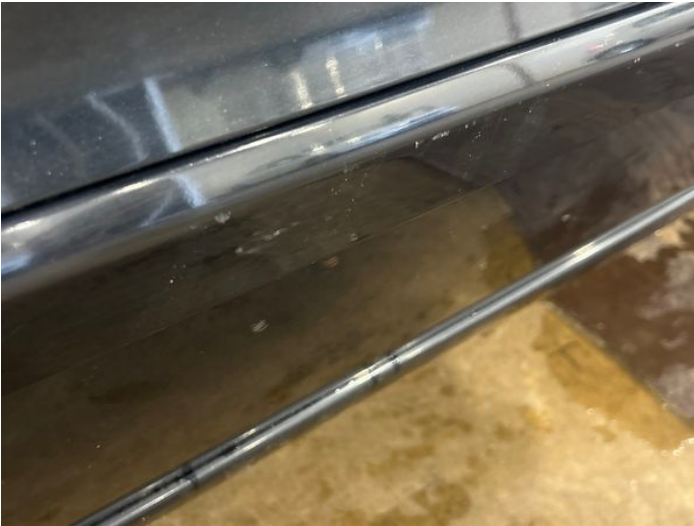
3: Door Moulding osf  
Scratched (Painted)  
UpTo 25mm Thru Paint

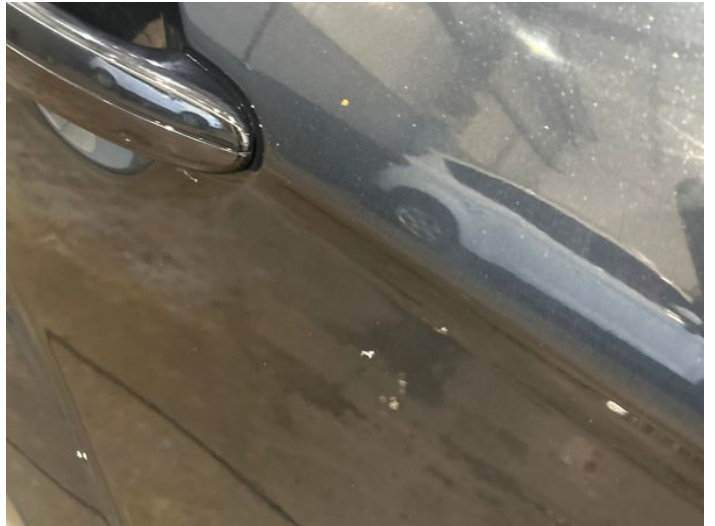
4: Door osr  
Chipped  
1 To 5

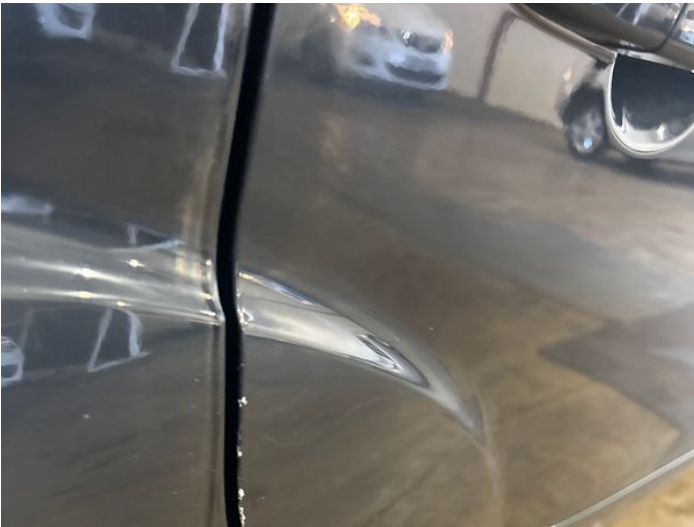
5: Door osr  
Chipped  
Edge Chip

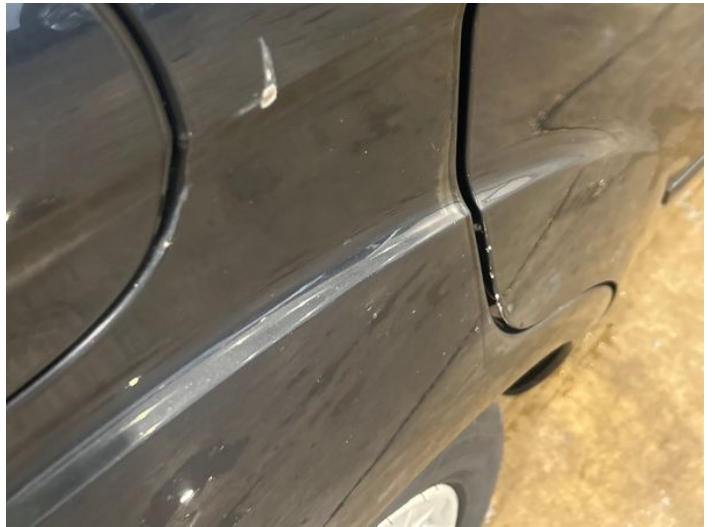
6: Qtr Panel osr  
Scratched  
UpTo 25mm Thru Paint

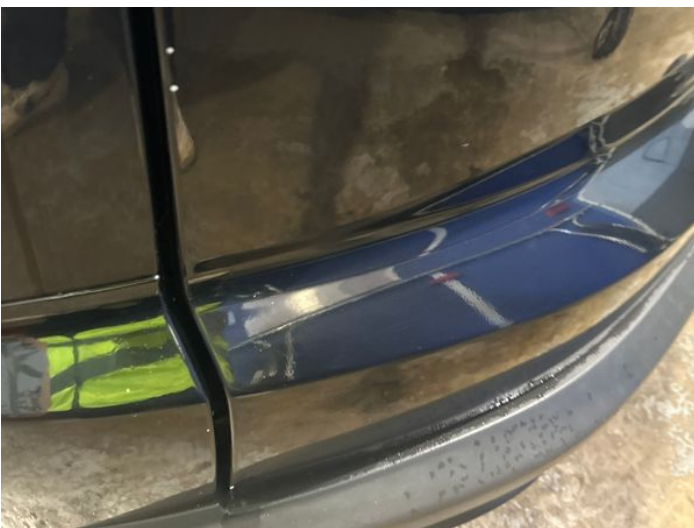
7: Tailgate  
Chipped  
1 To 5

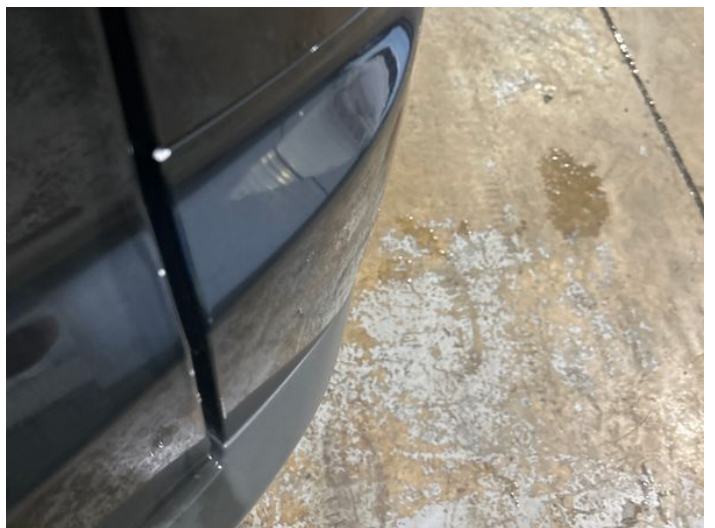
8: Bumper Rear  
Chipped  
1 To 5

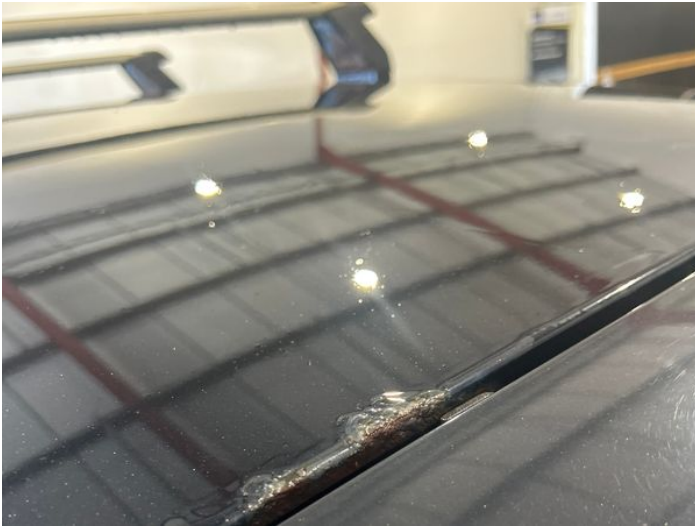
9: Roof  
Rusted  
Over 5mm

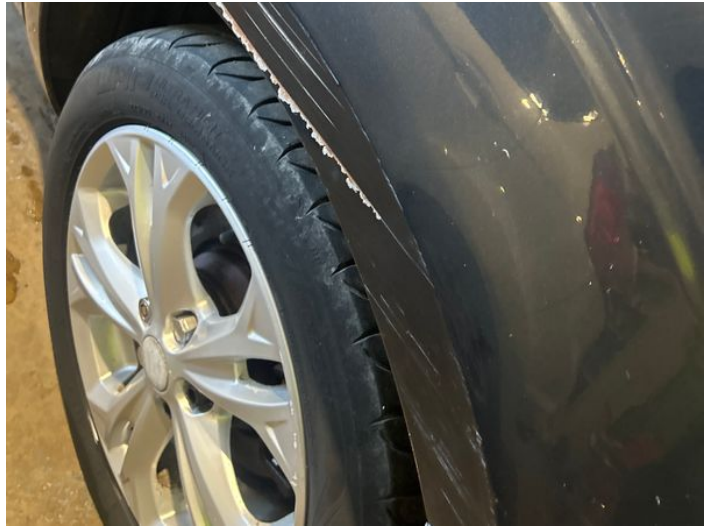
10: Qtr Panel nsr  
Dented  
With Paint Damage

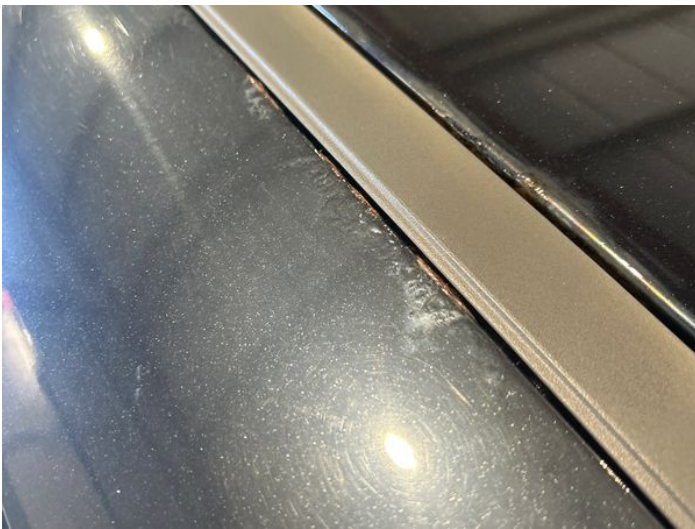
11: D Post ns  
Rusted  
Over 5mm

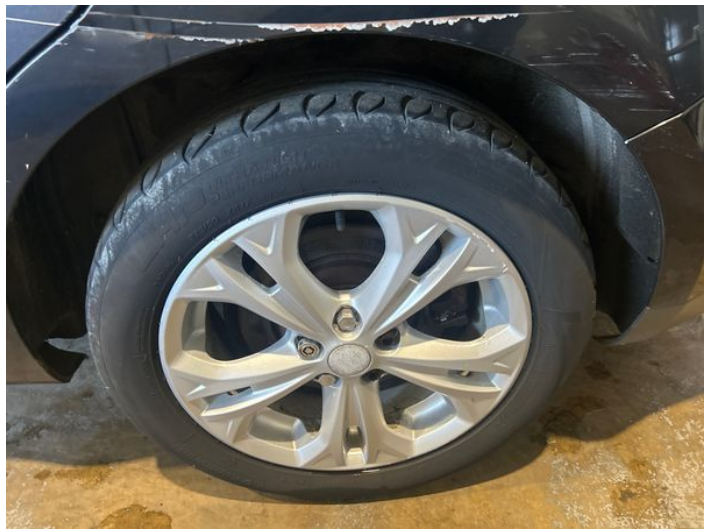
12: Wheel nsr  
Scratched  
Up To 50mm

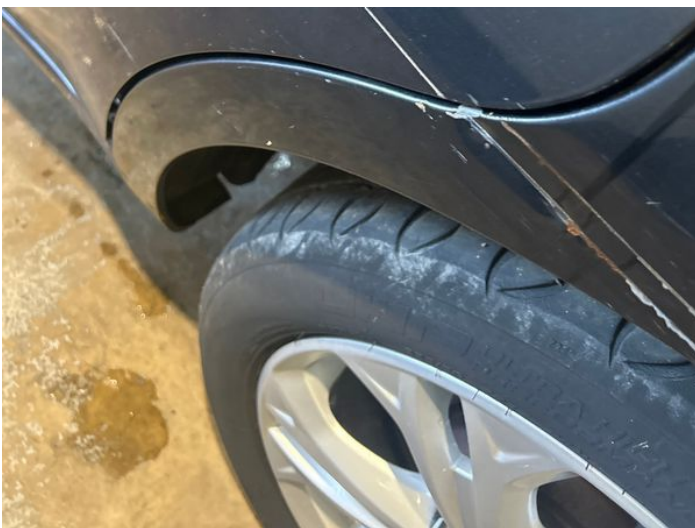
13: Door nsr  
Scratched  
Over 25mm Thru Paint

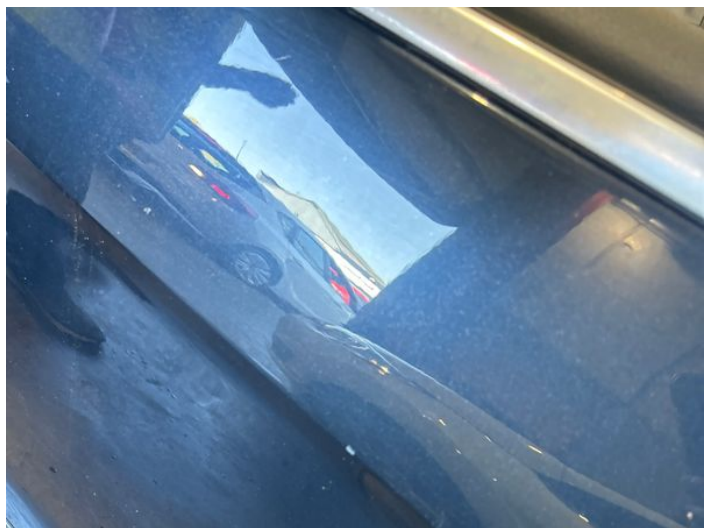
14: Door nsf  
Chipped  
1 To 5

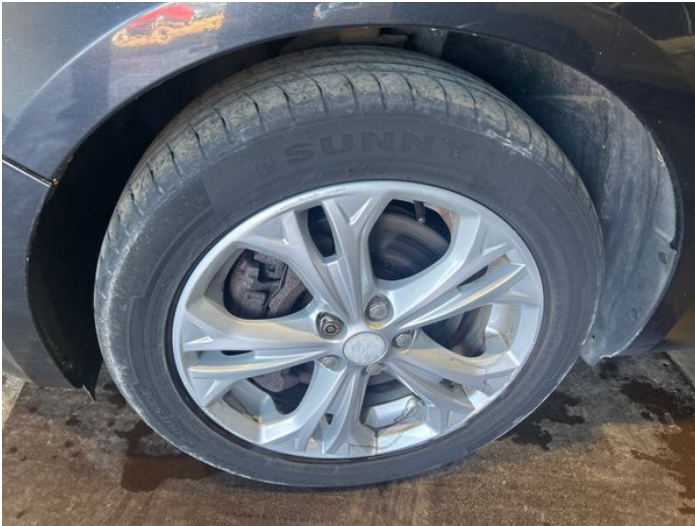
15: Wheel nsf  
Scratched  
Over 50mm

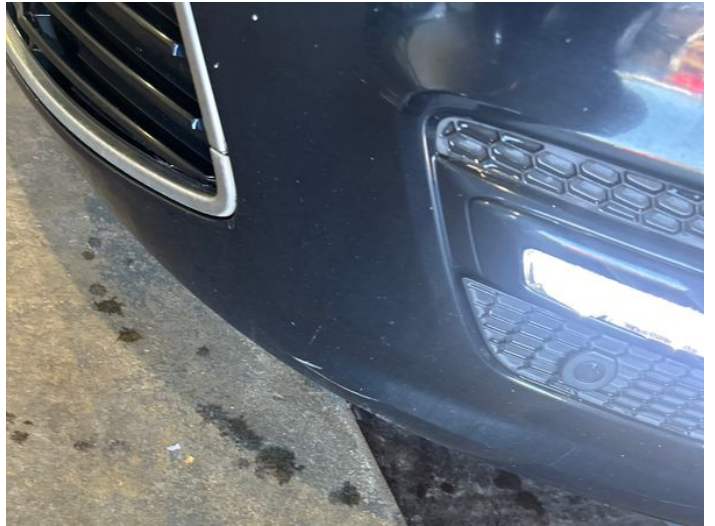
16: Bumper Front  
Scratched  
Over 100mm Thru Paint

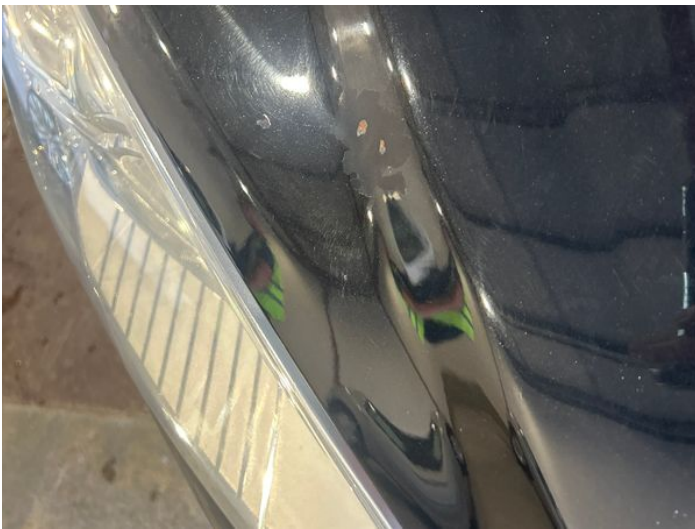
17: Bonnet  
Poor Previous Repair  
Paint Flake

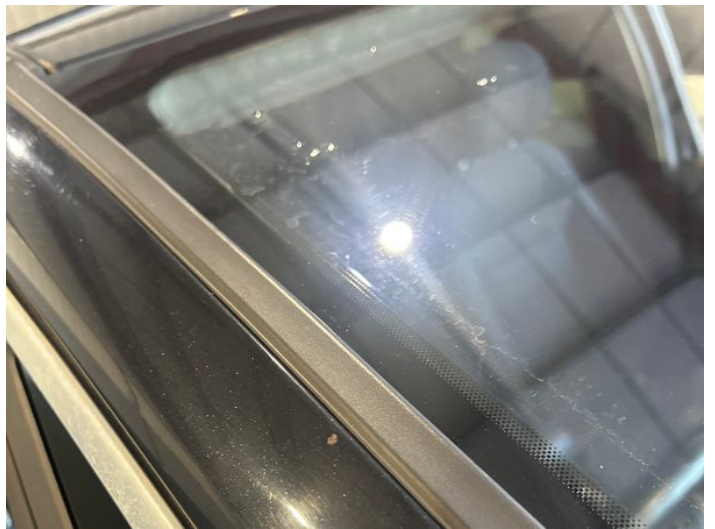
18: A Post os  
Chipped  
1 To 5

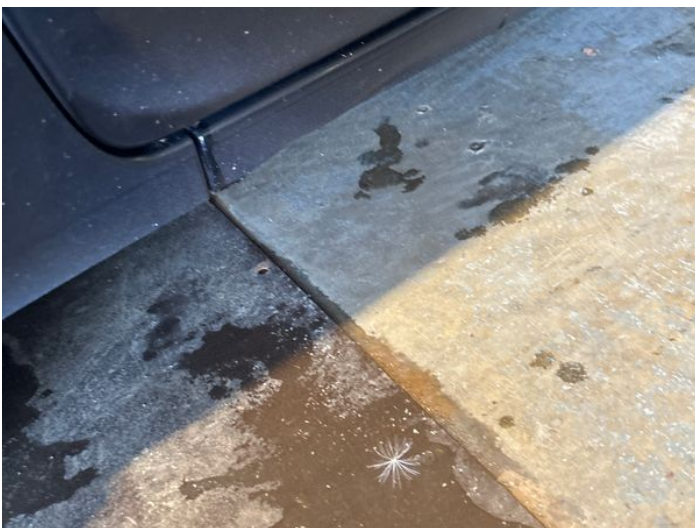
19: Sill ns  
Dented  
Over 30mm
