# VEHICLE INSPECTION REPORT

**AU63NFH**

## Citroen Berlingo Multispace 1.6 e-HDi 90 Airdream VTR 5dr EGS6

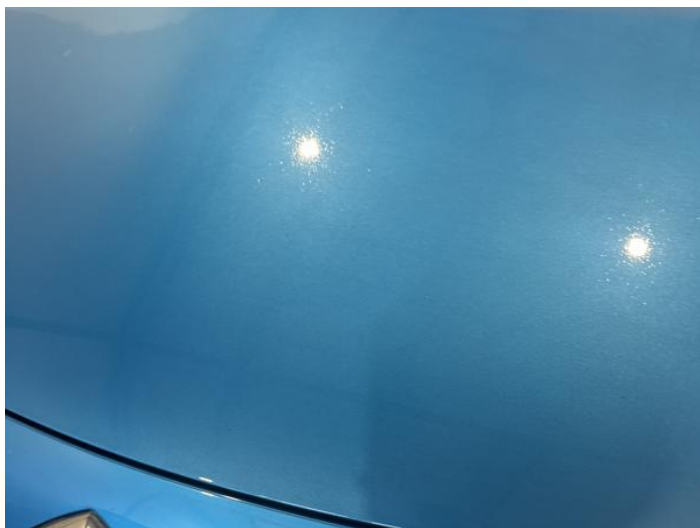
1: Bonnet  
Chipped  
1 To 5

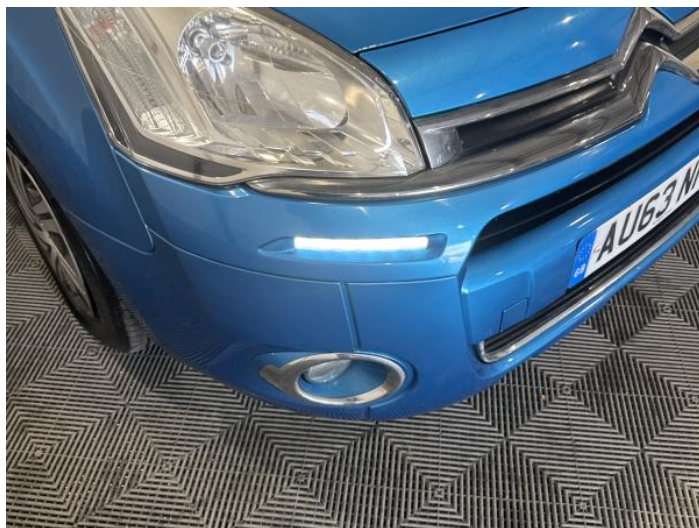
2: Bumper Front  
Chipped  
Multiple Chips

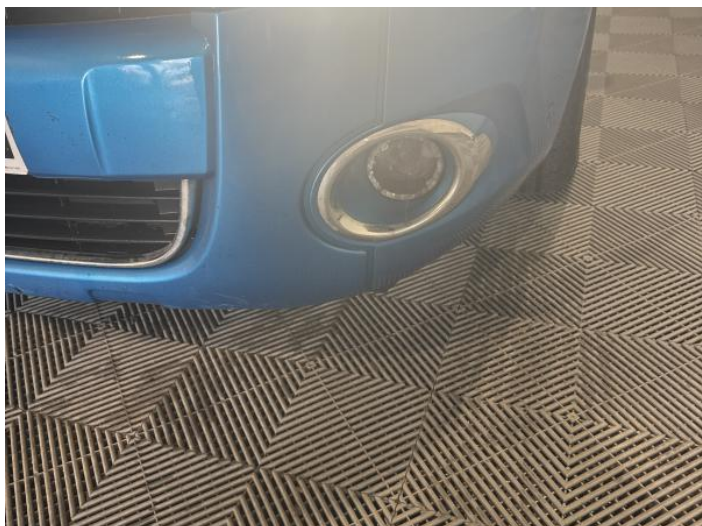
3: Fogdriving Lamp nsf  
Broken  
Replace

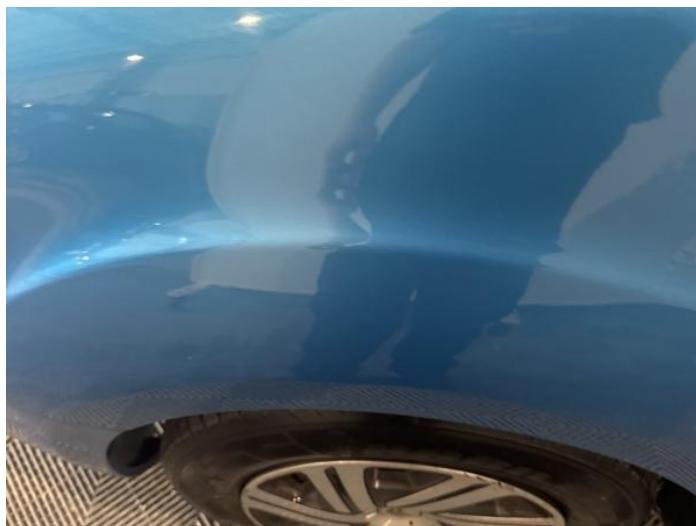
4: Wing nsf  
Scratched  
Over 25mm Not Thru Paint

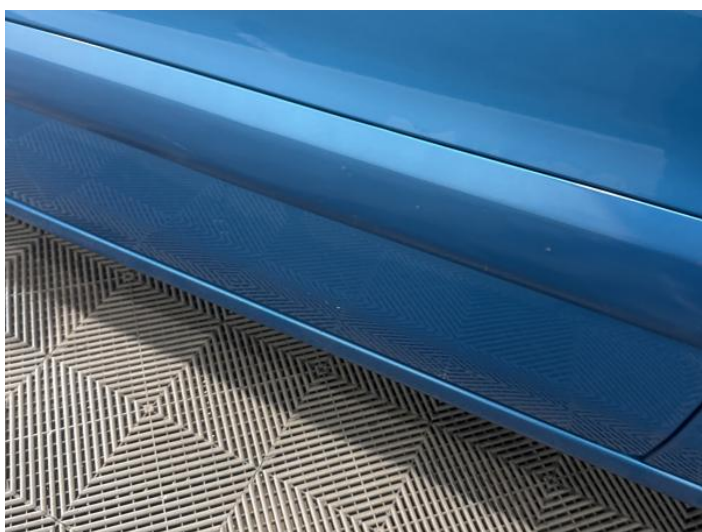
5: Door nsf  
Chipped  
1 To 5

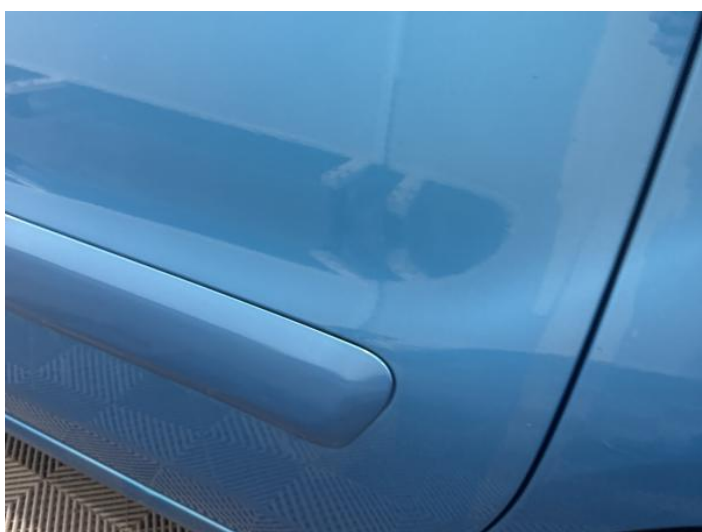
7: Door nsr  
Dented  
2 Or Less UpTo 10mm

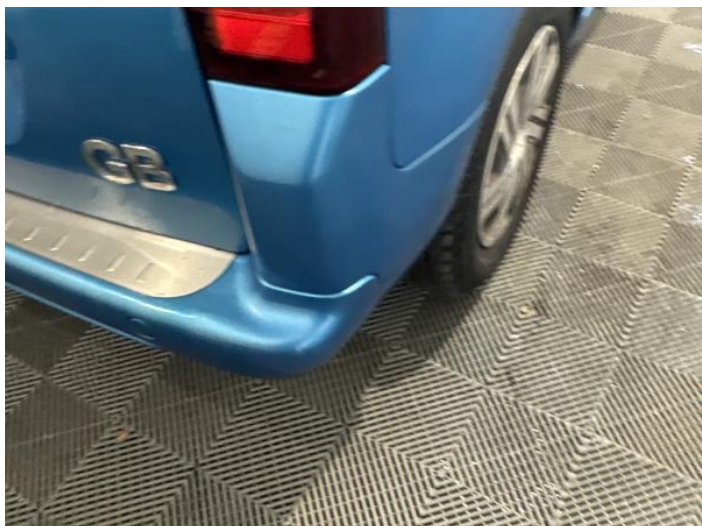
9: Bumper Rear  
Poor Previous Repair  
Poor Paint

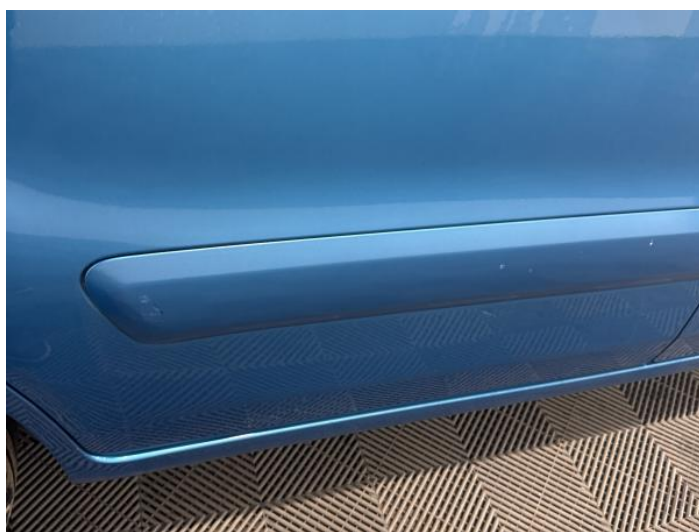
12: Door Moulding osr  
Scratched (Painted)  
Over 25mm Thru Paint

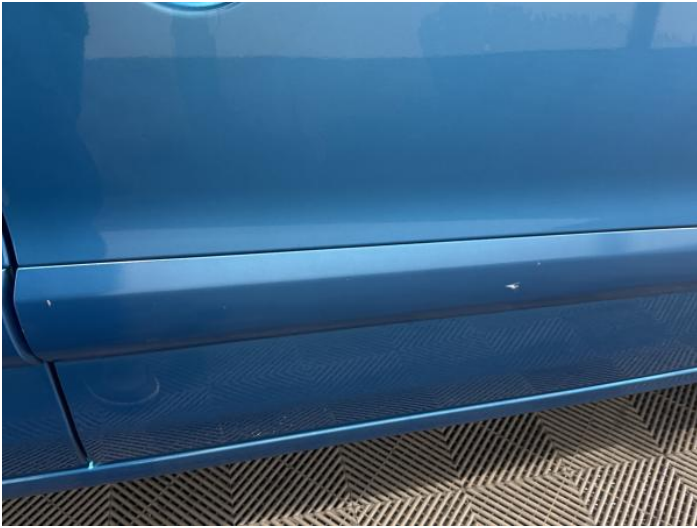
15: Door Moulding osf  
Scratched (Painted)  
Over 25mm Thru Paint
