# VEHICLE INSPECTION REPORT

**EO64ULW**

## Vauxhall Mokka 1.7 CDTi Exclusiv 5dr

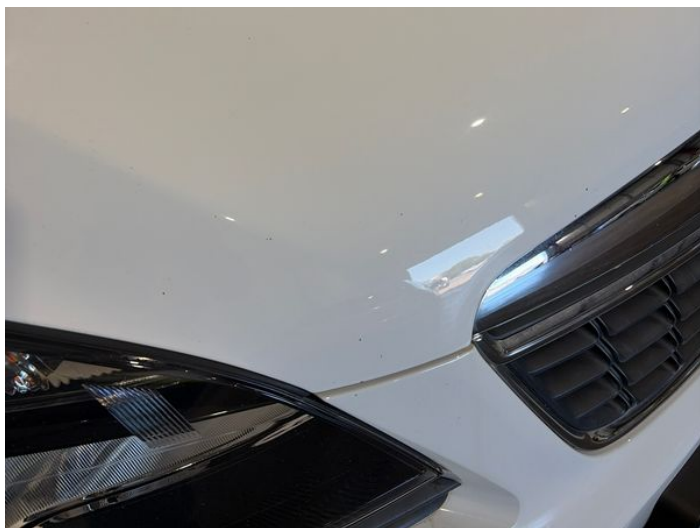
1: Bonnet  
Chipped  
Multiple Chips

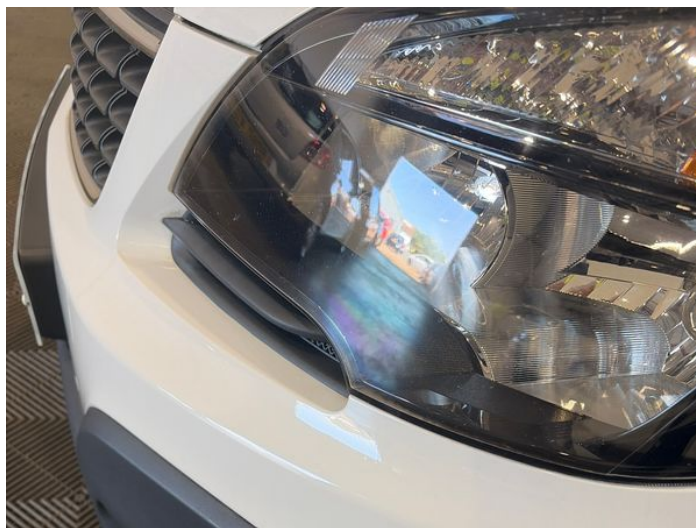
2: Bumper Front  
Chipped  
1 To 5

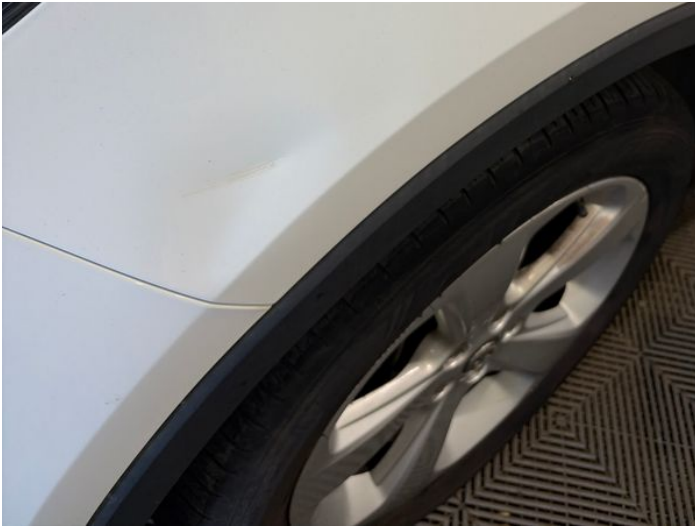
3: Wing nsf  
Dented  
With Paint Damage

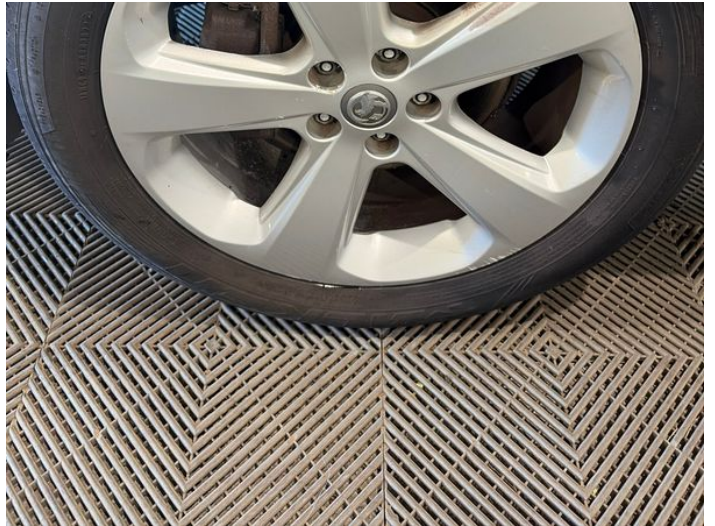
4: Wheel nsf  
Scratched  
Over 50mm

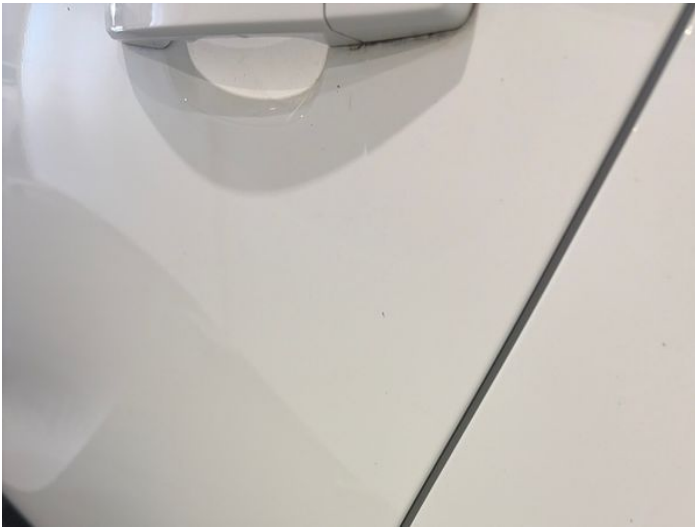
5: Door nsr  
Chipped  
Edge Chip

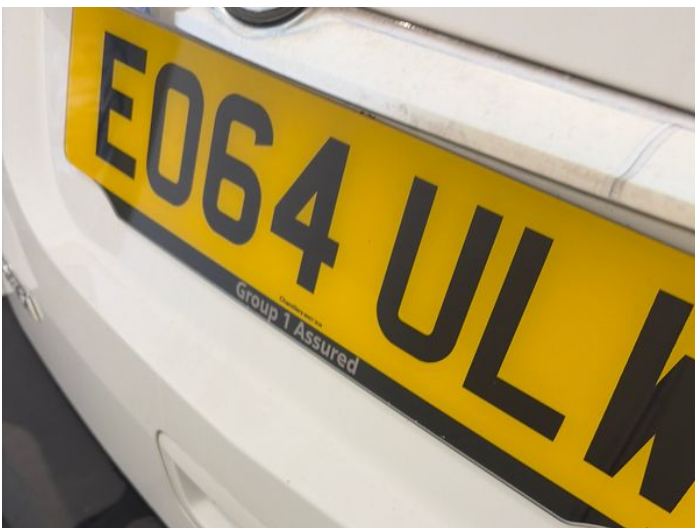
7: Tailgate  
Chipped  
1 To 5

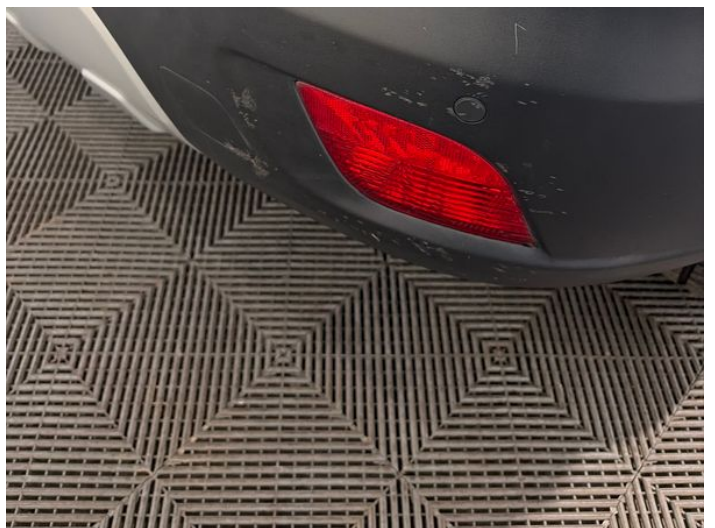
8: Bumper Rear Moulding  
Scuffed (Unpainted)  
UpTo 100mm

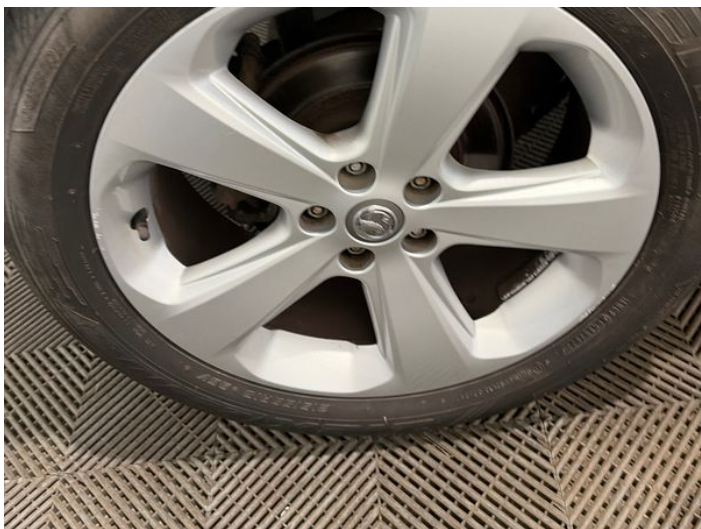
9: Wheel osr  
Scratched  
Over 50mm

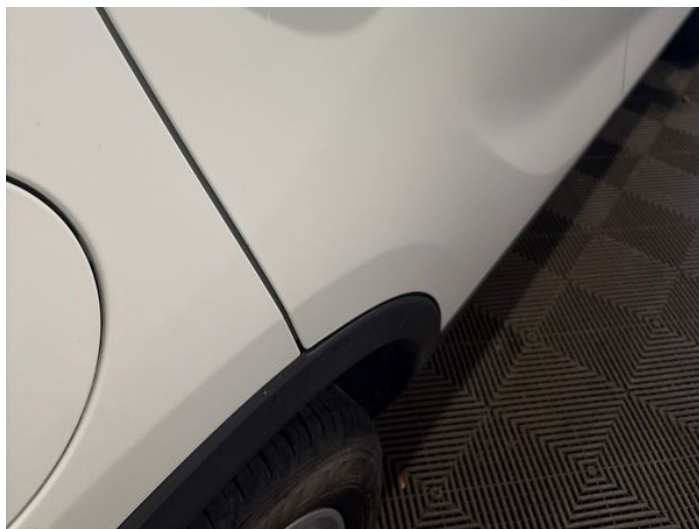
10: Door osr  
Poor Previous Repair  
Poor Paint

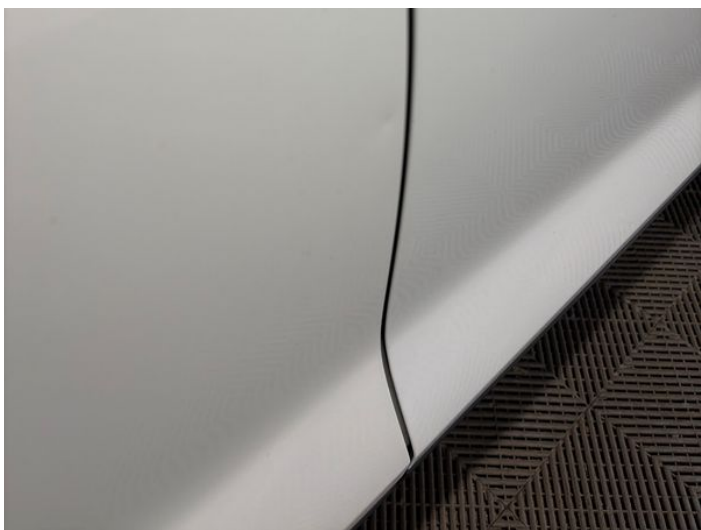
11: Door osr  
Dented  
Between 10mm + 30mm

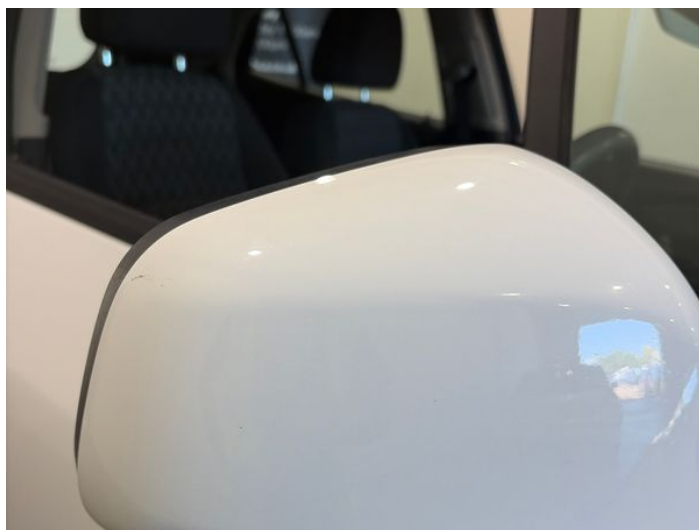
12: Door Mirror Assy osf  
Scratched (Painted)  
UpTo 25mm Thru Paint

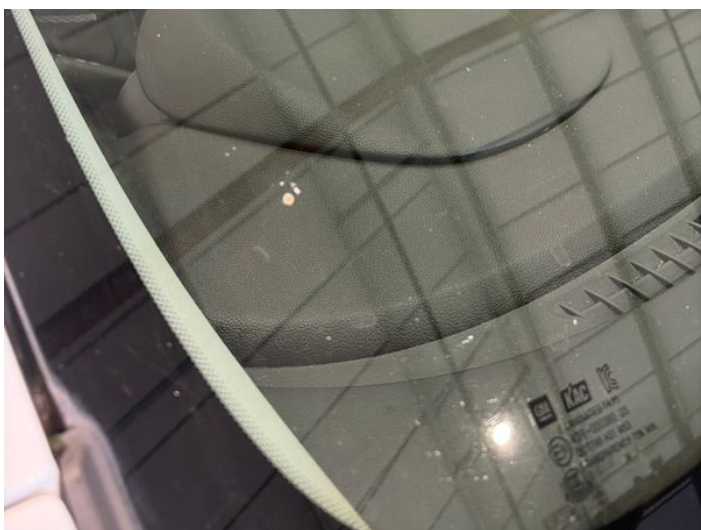
13: Screen Front  
Chipped  
UpTo 10mm

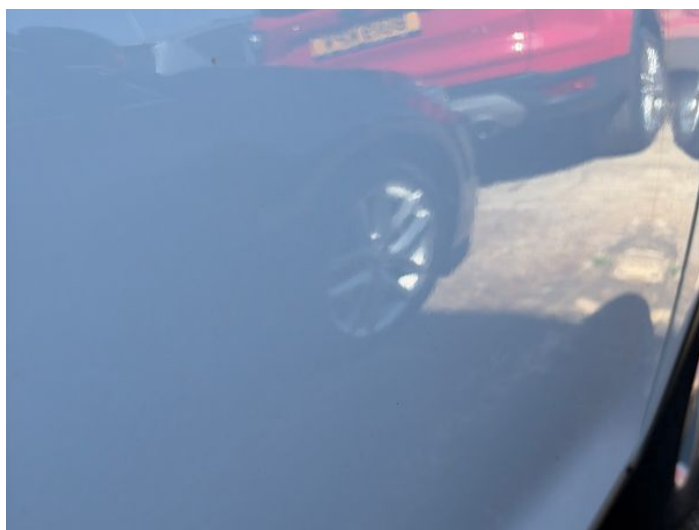
14: Door osf  
Dented  
Between 10mm + 30mm
