## VEHICLE INSPECTION REPORT

**GF59VEH**

### Volkswagen Passat 2.0 Highline TDI CR DPF 170 5dr

Accident Damage

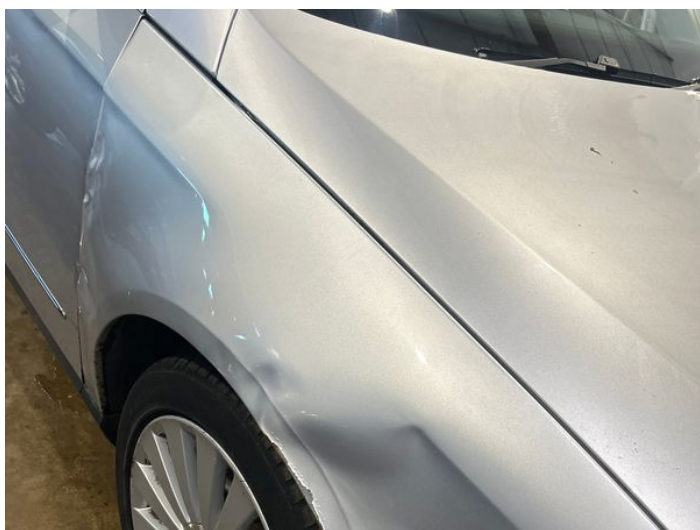
1: Wing osf  
Dented  
Over 30% Of Panel

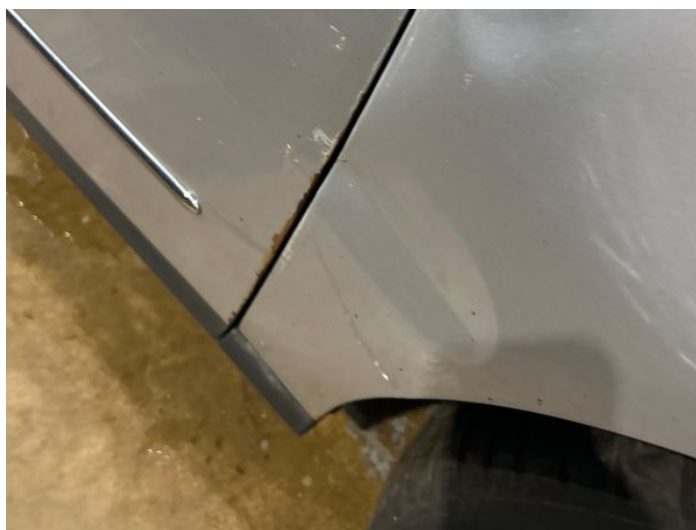
2: Door osf  
Dented  
With Paint Damage

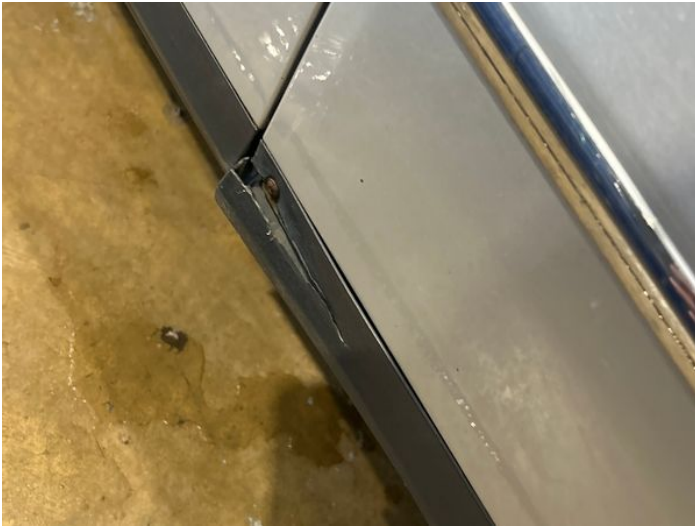
3: Door Moulding osf  
Broken  
Replace

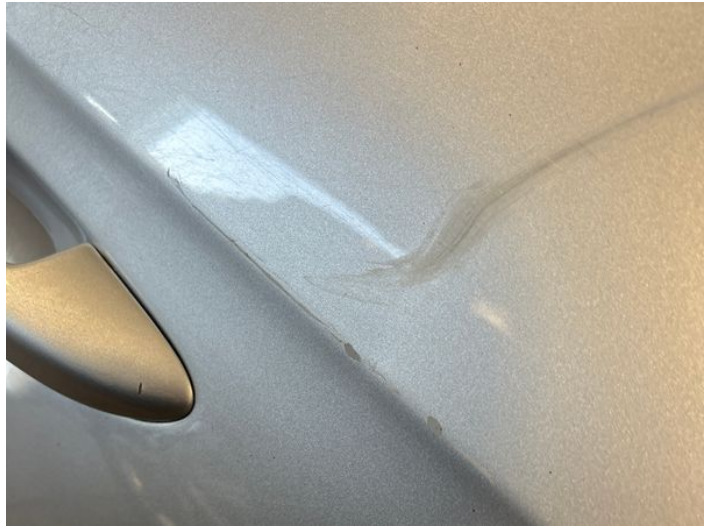
4: Door osr  
Scratched  
Over 25mm Thru Paint

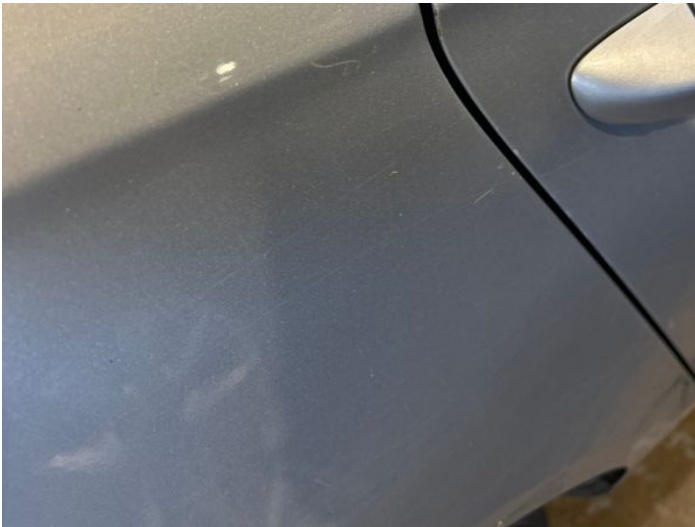
5: Qtr Panel osr  
Scratched  
UpTo 25mm Thru Paint

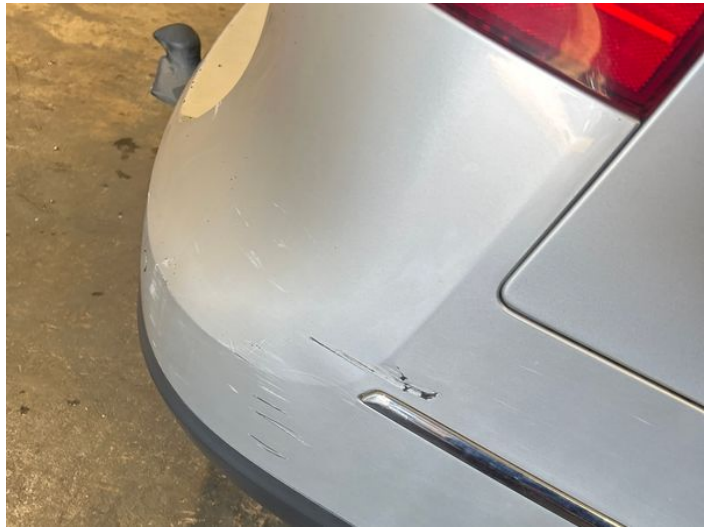
6: Bumper Rear  
Scratched  
Over 100mm Thru Paint

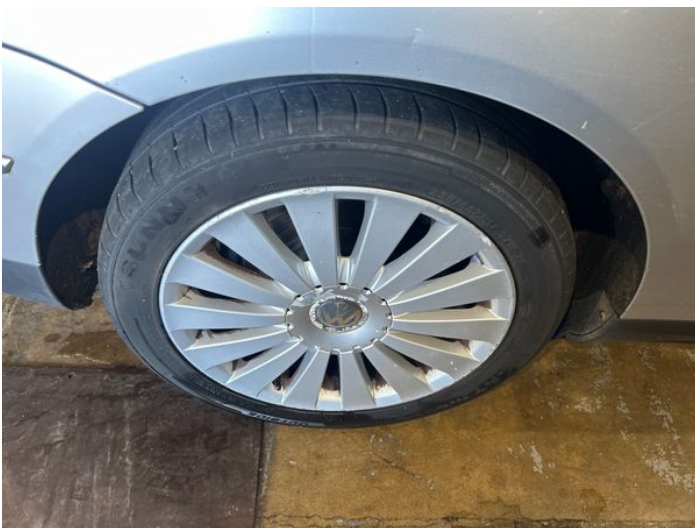
7: Wheel osr  
Scratched  
Over 50mm

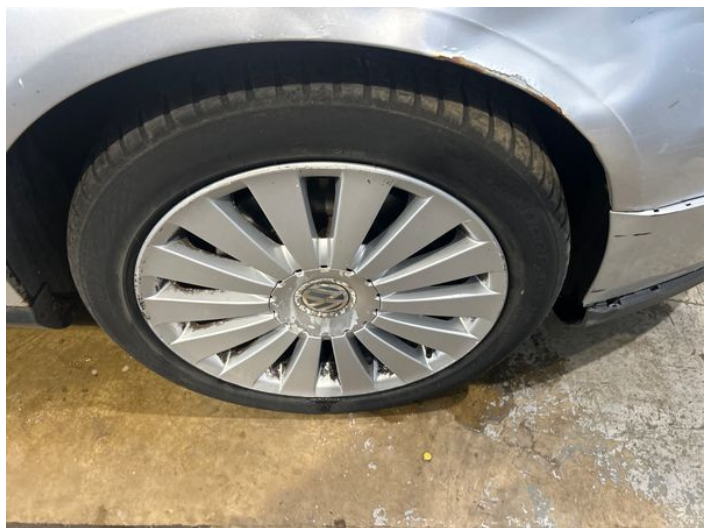
8: Wheel osf  
Scratched  
Over 50mm

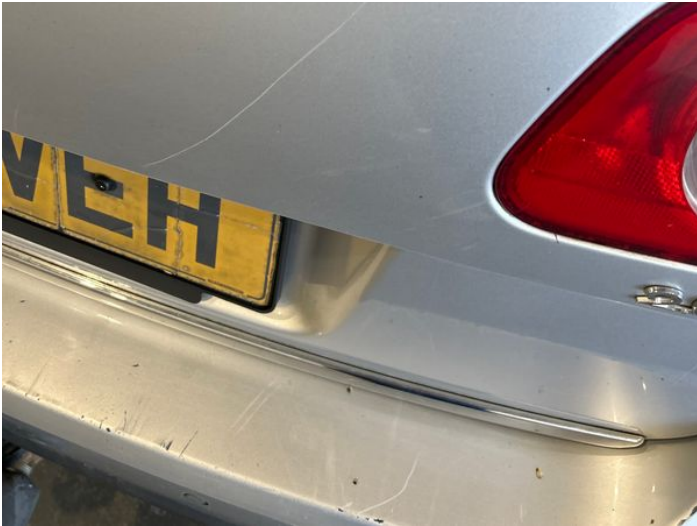
9: Tailgate  
Scratched  
Over 25mm Thru Paint

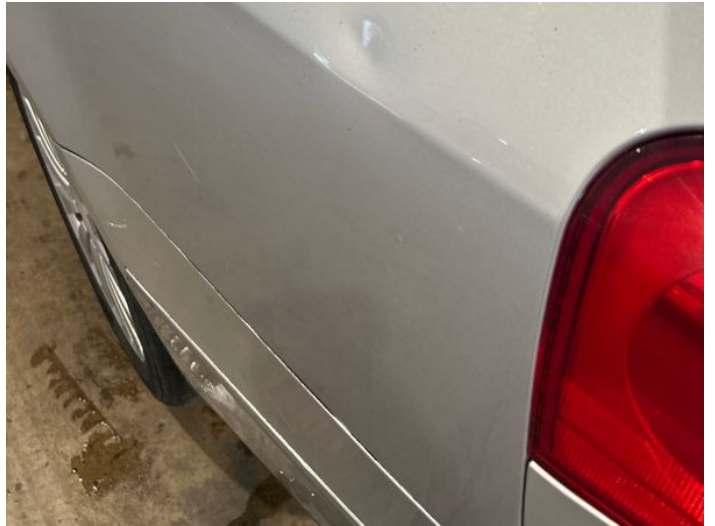
10: Qtr Panel nsr  
Dented  
Over 30mm

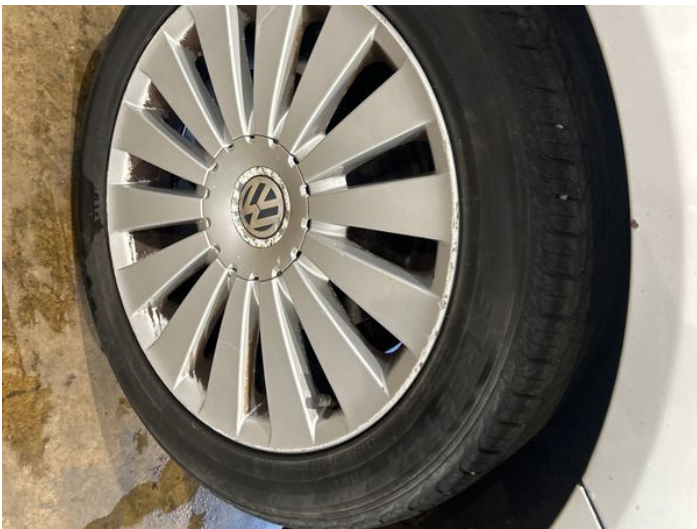
11: Wheel nsr  
Scratched  
Over 50mm

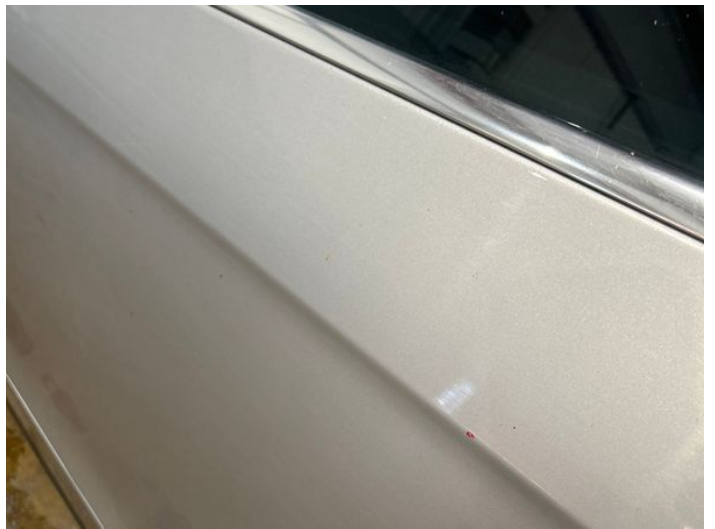
12: Door nsr  
Chipped  
1 To 5

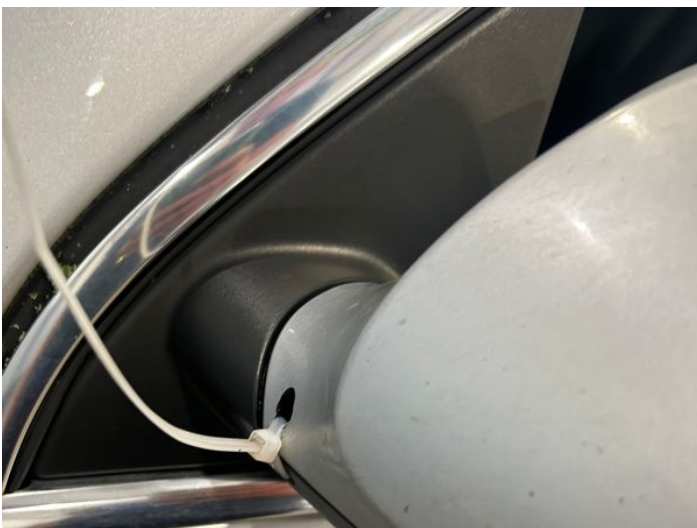
13: Door Mirror Assy nsf  
Broken  
Replace

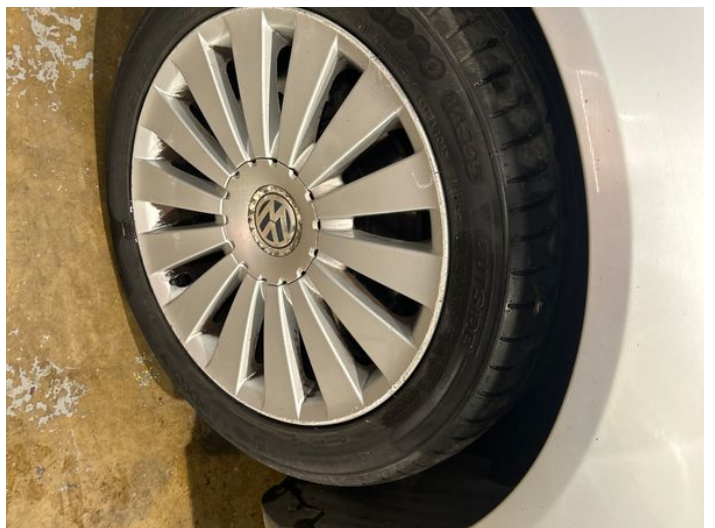
14: Wheel nsf  
Scratched  
Over 50mm

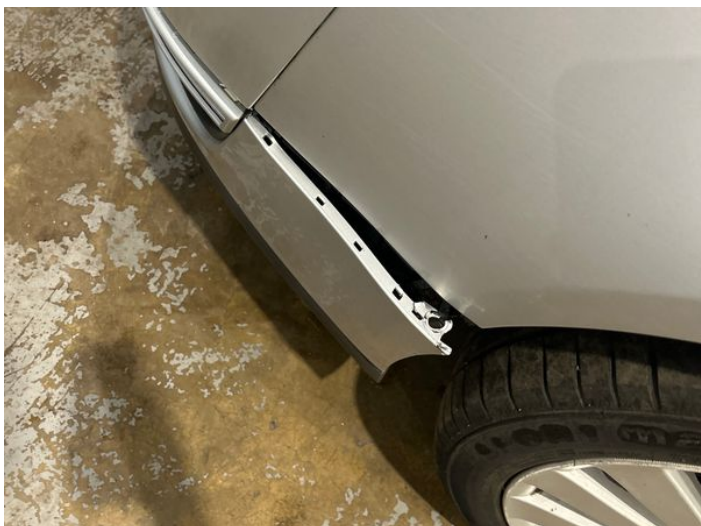
15: Bumper Front  
Insecure  
Action Required

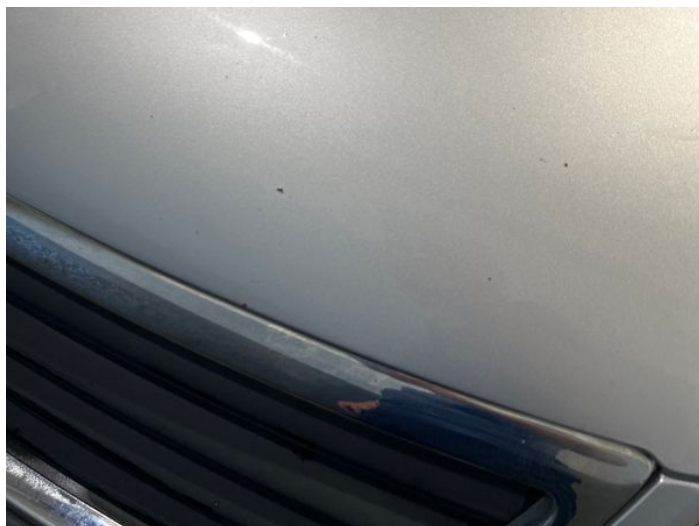
16: Bonnet  
Chipped  
Multiple Chips

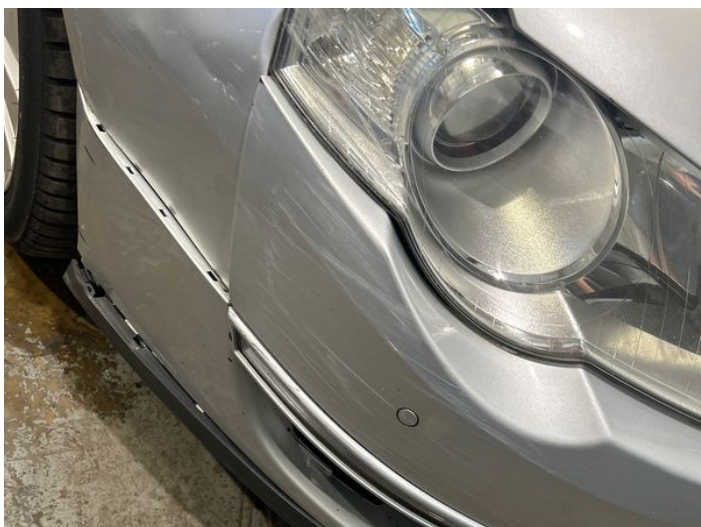
17: Bumper Front  
Scratched  
25 to 100mm Thru Paint

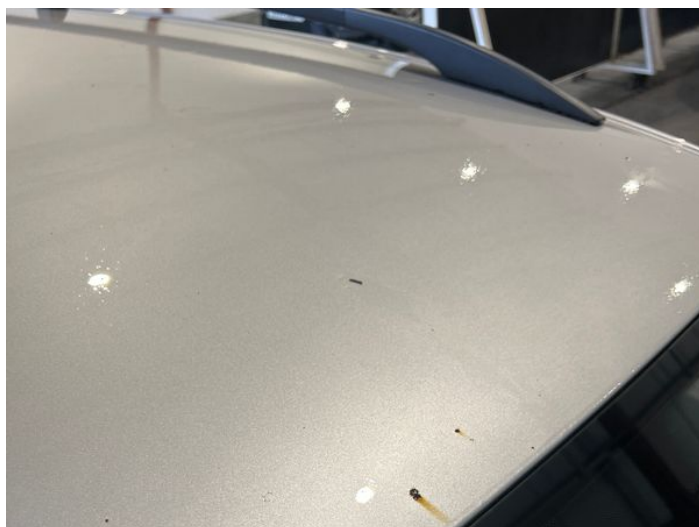
18: Roof  
Chipped  
1 To 5
