# VEHICLE INSPECTION REPORT

**FA17AXX**

## Ford KA+ 1.2 85 Zetec 5dr

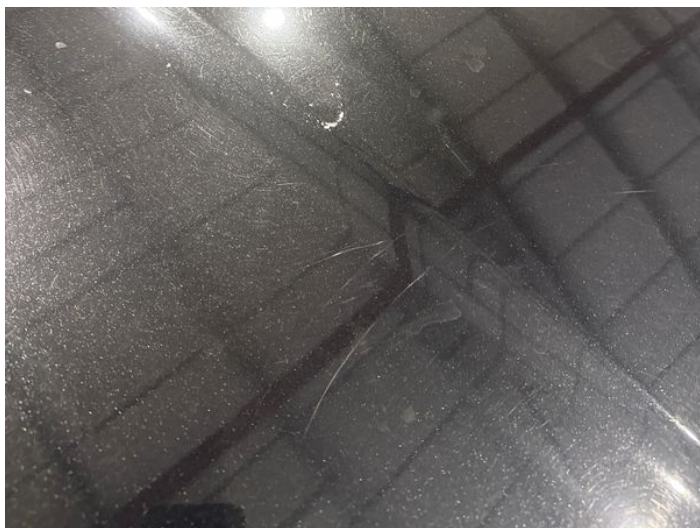
1: Bonnet  
Scratched  
Over 25mm Thru Paint

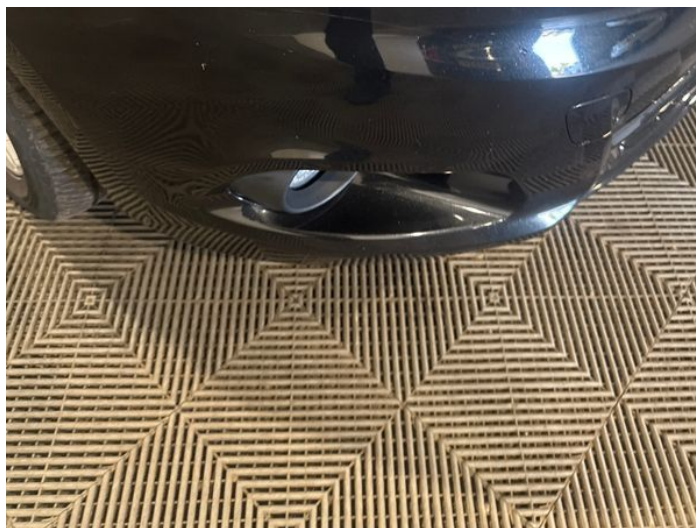
2: Bumper Front  
Scratched  
Over 100mm Thru Paint

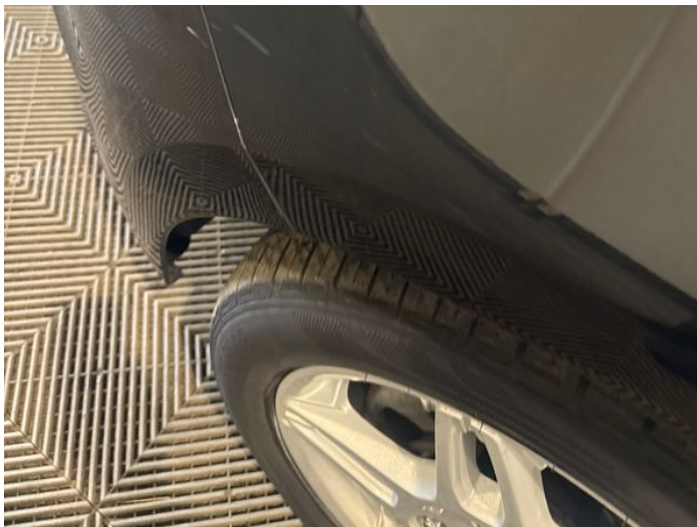
3: Wing nsf  
Scratched  
Over 25mm Thru Paint

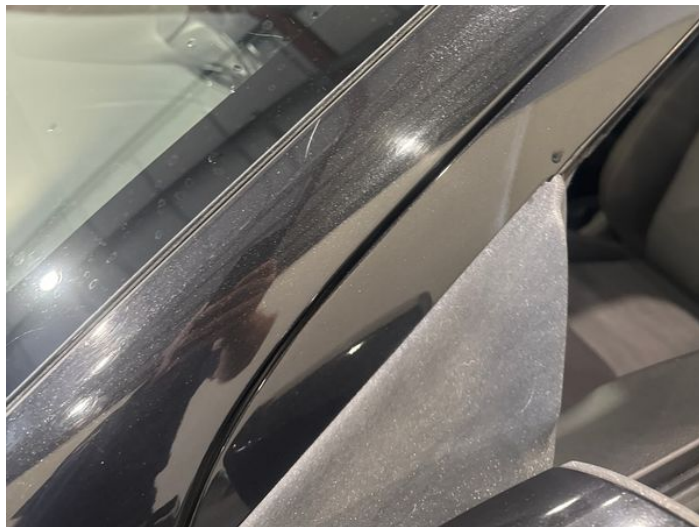
4: A Post ns  
Scratched  
UpTo 25mm Thru Paint

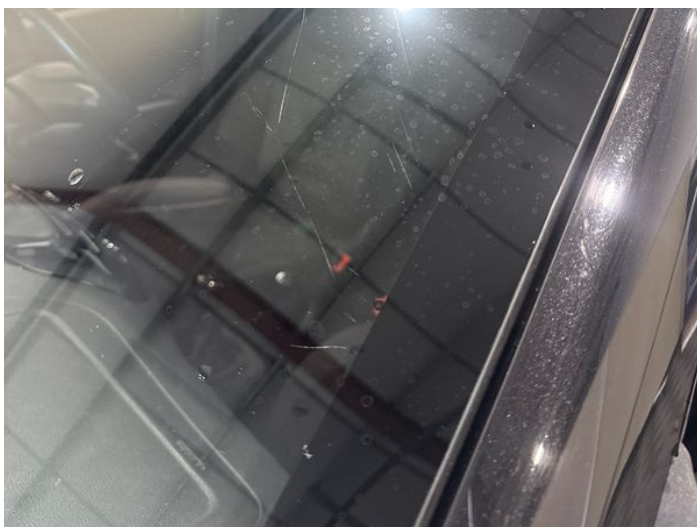
5: Screen Front  
Cracked  
Replace

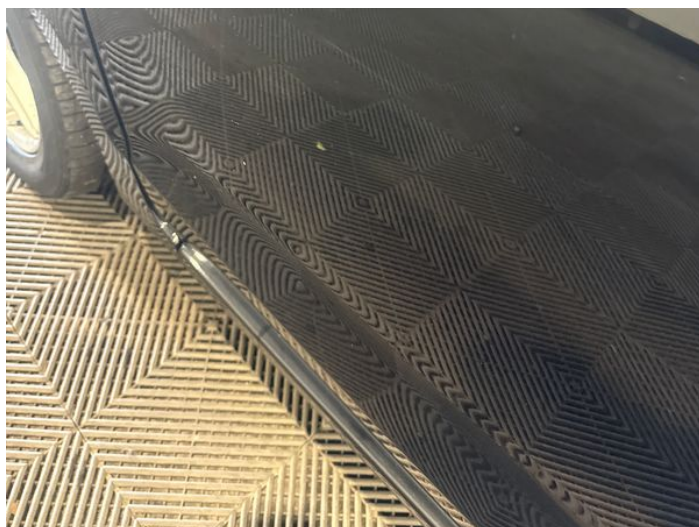
6: Door nsf  
Scratched  
Over 25mm Thru Paint

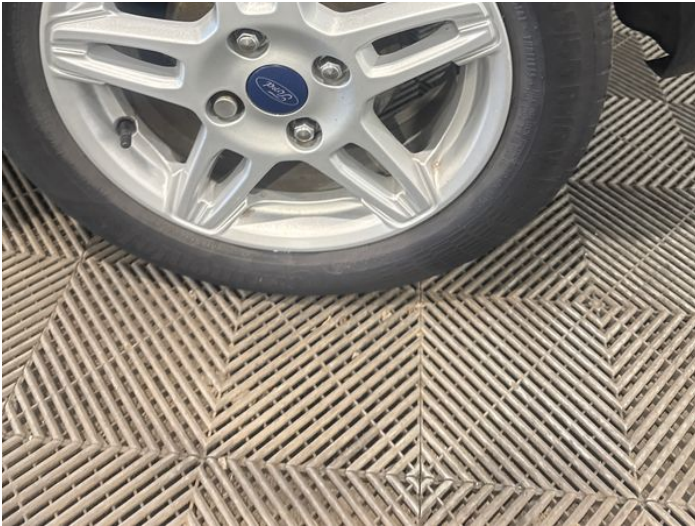
9: Wheel nsr  
Scratched  
Up To 50mm

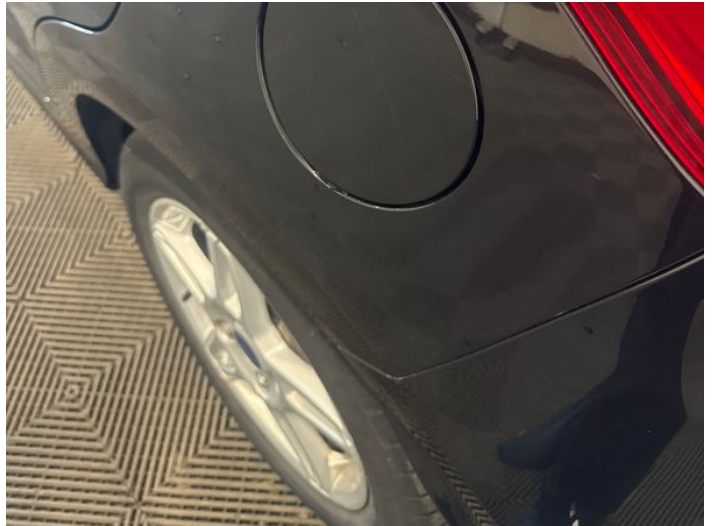
10: Qtr Panel nsr  
Scratched  
Over 25mm Thru Paint

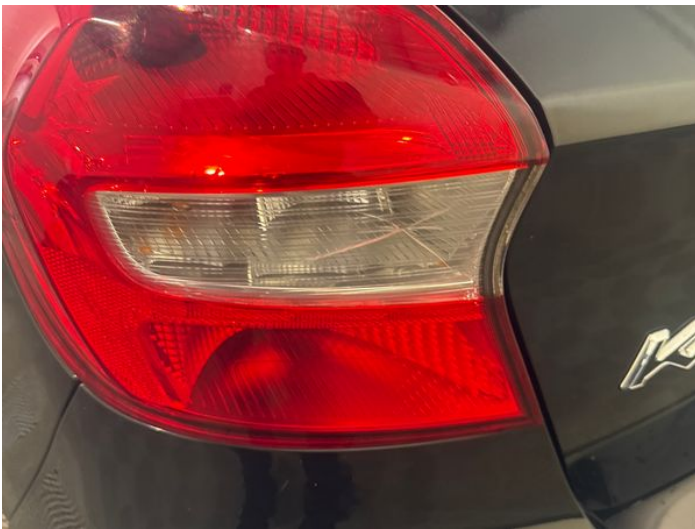
11: Lamp nsr  
Broken  
Replace

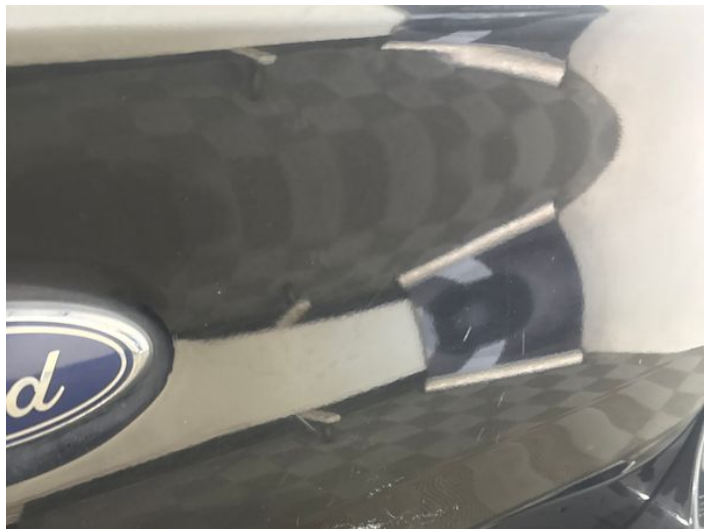
12: Tailgate  
Scratched  
Over 25mm Thru Paint

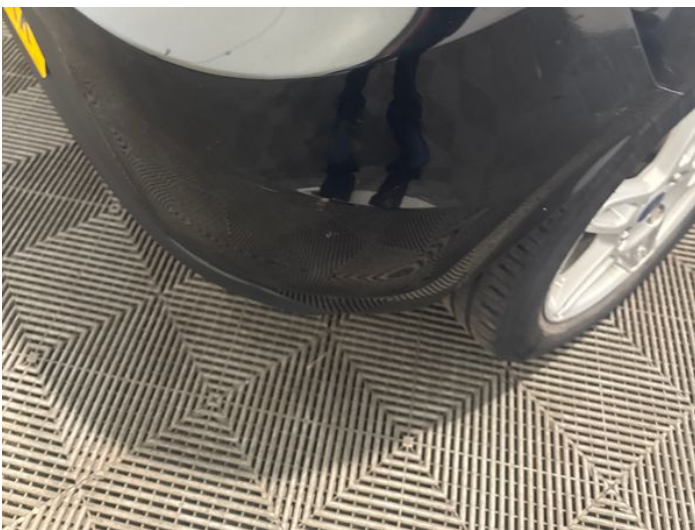
13: Bumper Rear  
Scratched  
Over 100mm Thru Paint

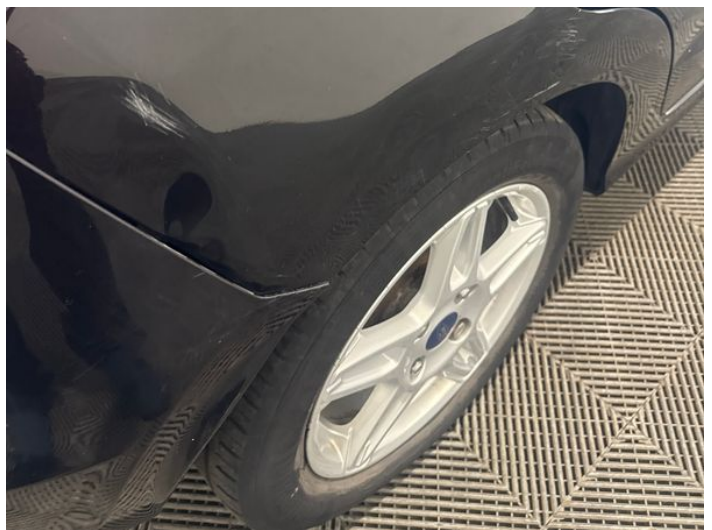
14: Qtr Panel osr  
Dented  
With Paint Damage

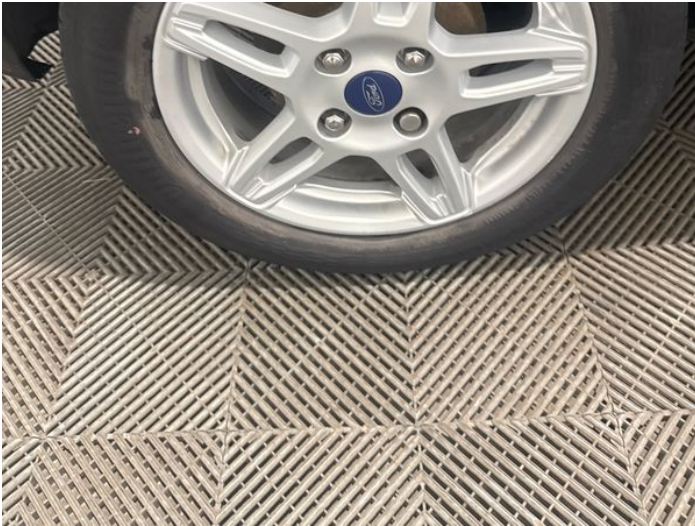
15: Wheel osr  
Scratched  
Over 50mm

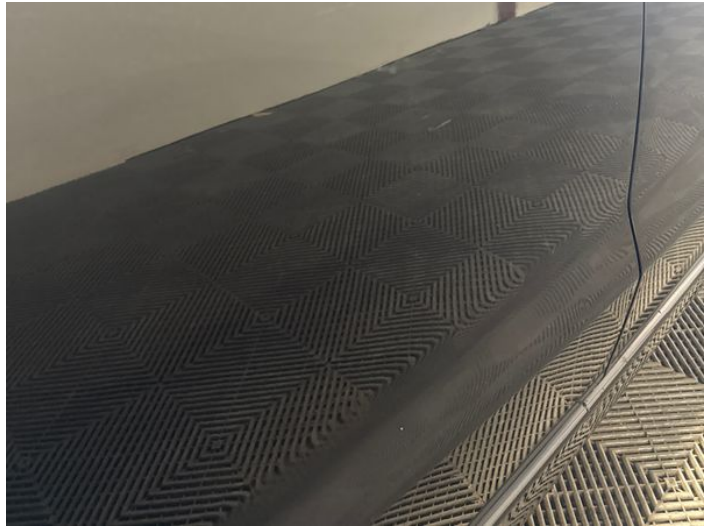
16: Door osr  
Scratched  
Over 25mm Thru Paint

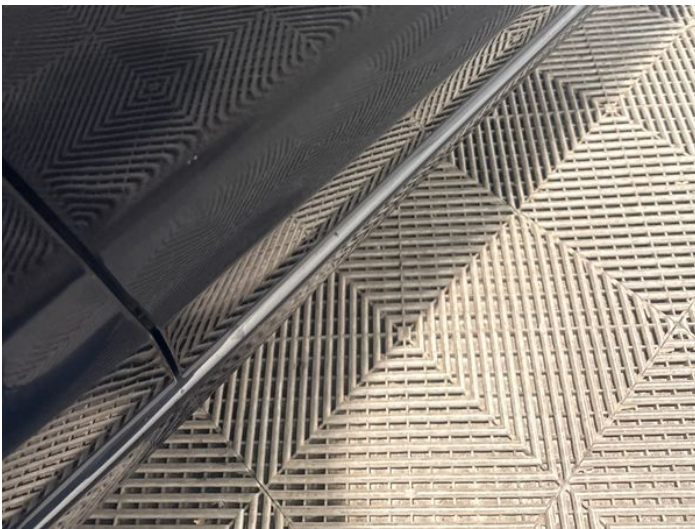
17: Door osf  
Chipped  
1 To 5

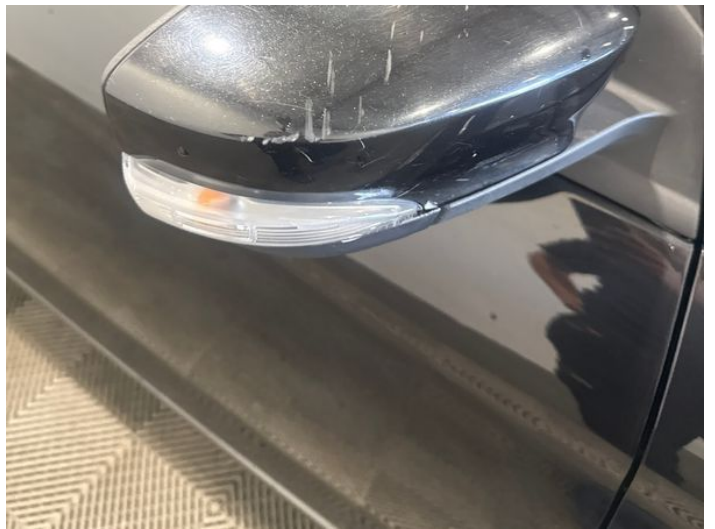
18: Door Mirror Assy osf  
Scratched (Painted)  
Over 25mm Thru Paint

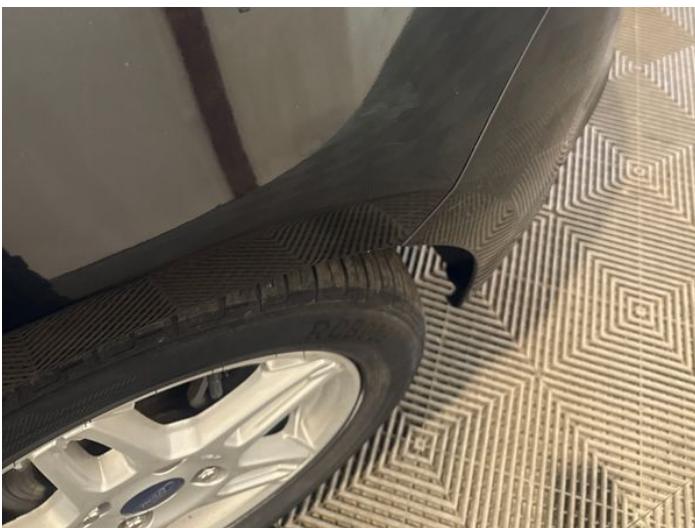
19: Wing osf  
Scratched  
Over 25mm Thru Paint

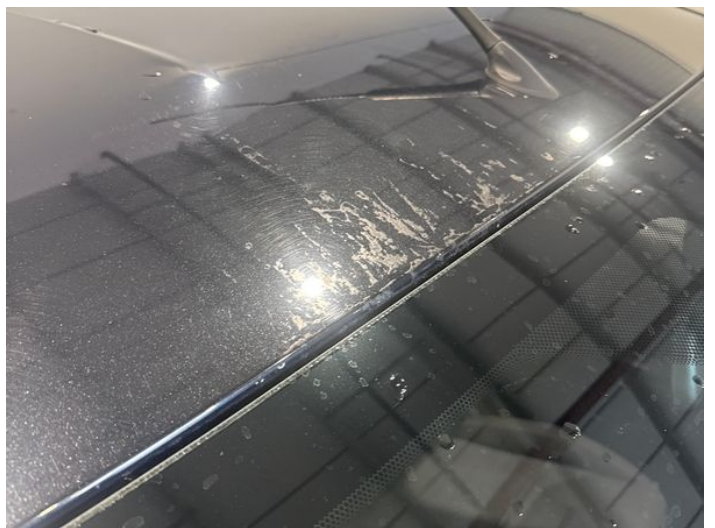
20: Roof  
Scratched  
Over 25mm Thru Paint

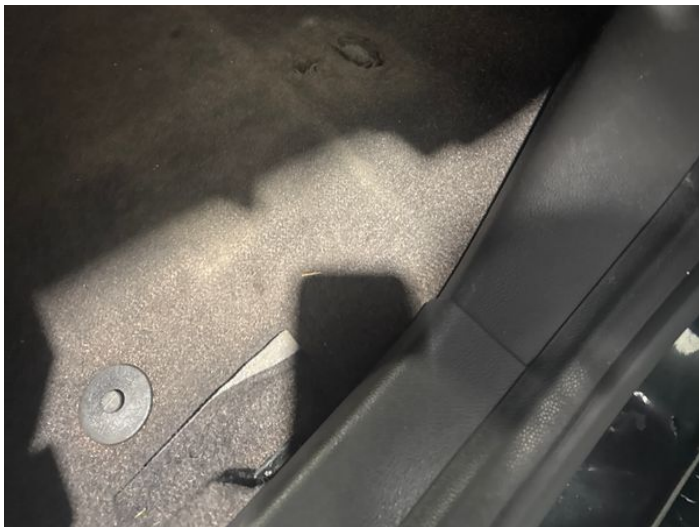
21: Carpets Front  
Torn  
Over 10mm
