# VEHICLE INSPECTION REPORT

**HV14AEP**

## Seat Toledo 1.4 TSI SE 5dr DSG

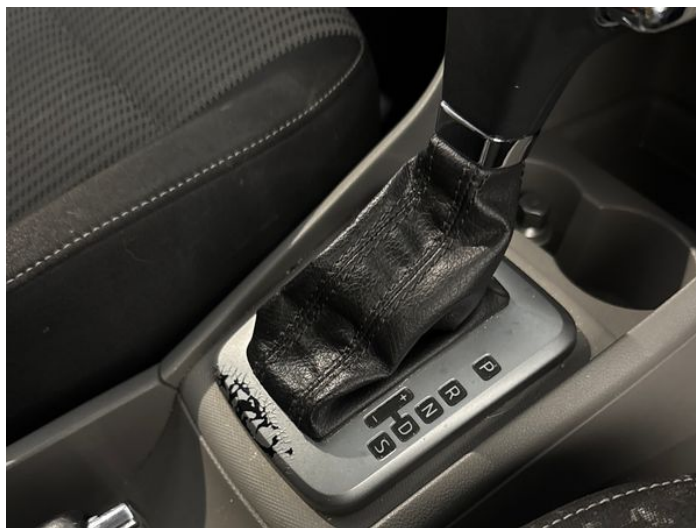
2: Centre Console Front  
Scuffed  
Over 25mm

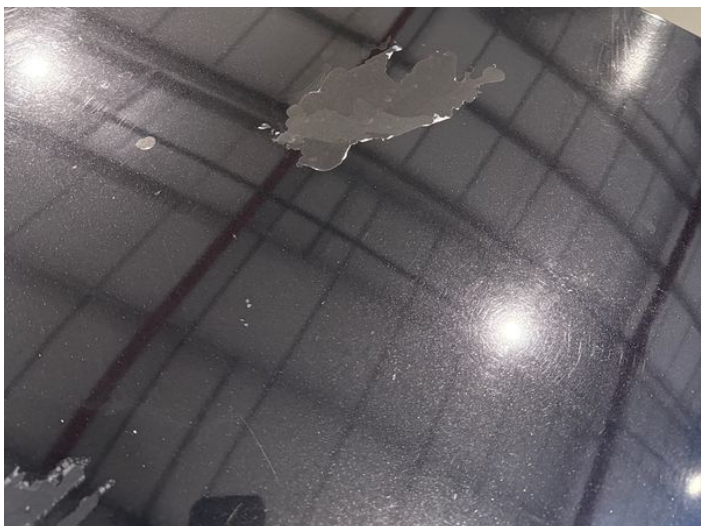
3: Bonnet  
Poor Previous Repair  
Paint Flake

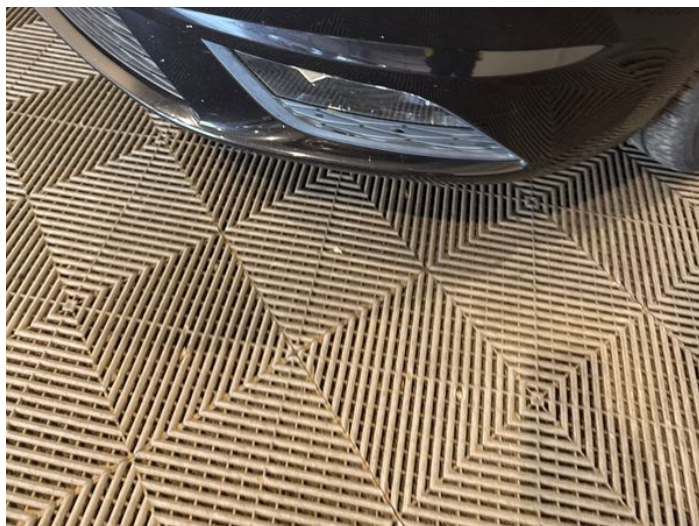
4: Bumper Front  
Scratched  
25 to 100mm Thru Paint

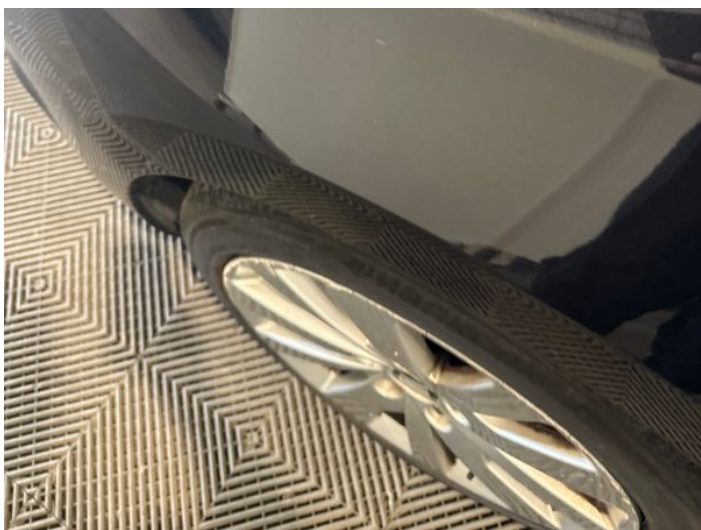
5: Wing nsf  
Scratched  
Over 25mm Thru Paint

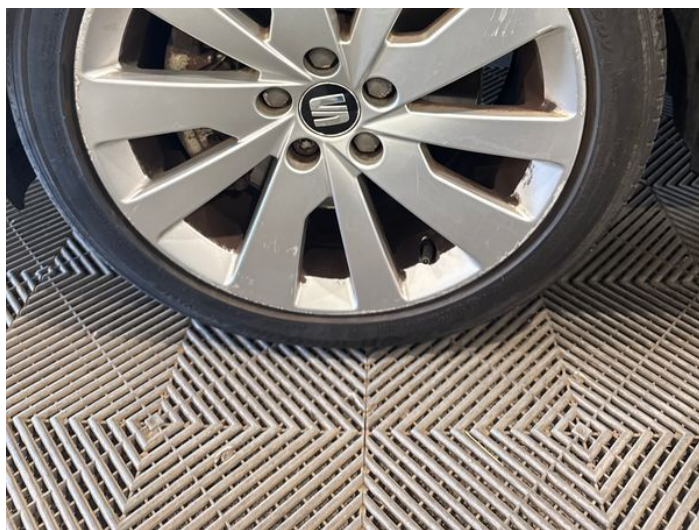
6: Wheel nsf  
Scratched  
Over 50mm

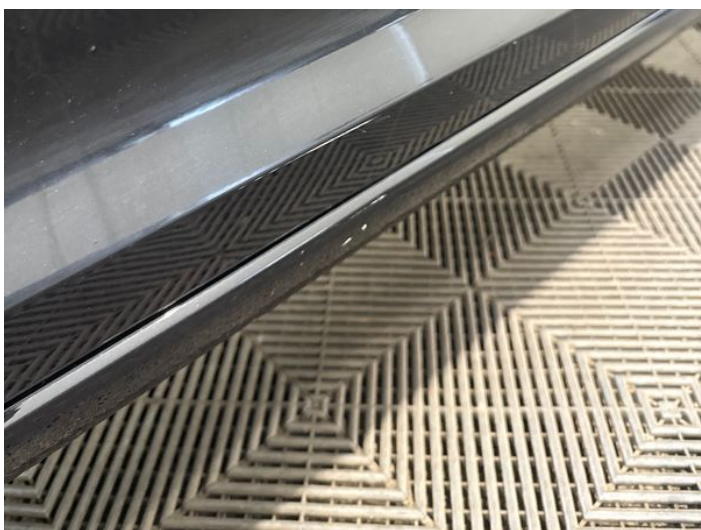
7: Door nsf  
Scratched  
Over 25mm Thru Paint

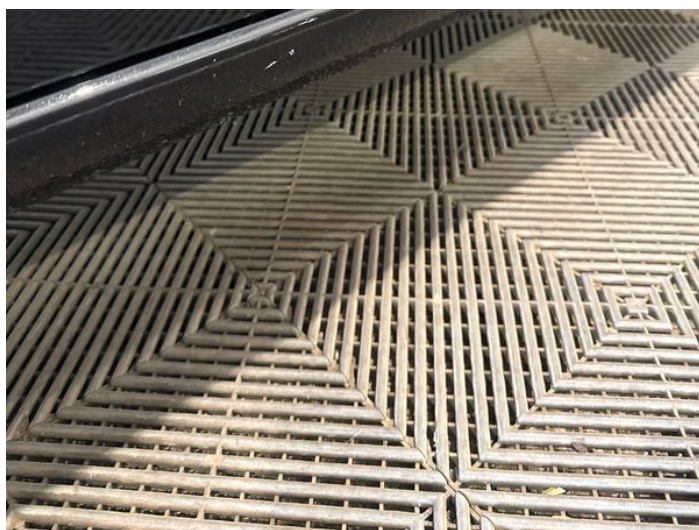
8: Sill ns  
Scratched  
UpTo 25mm Thru Paint

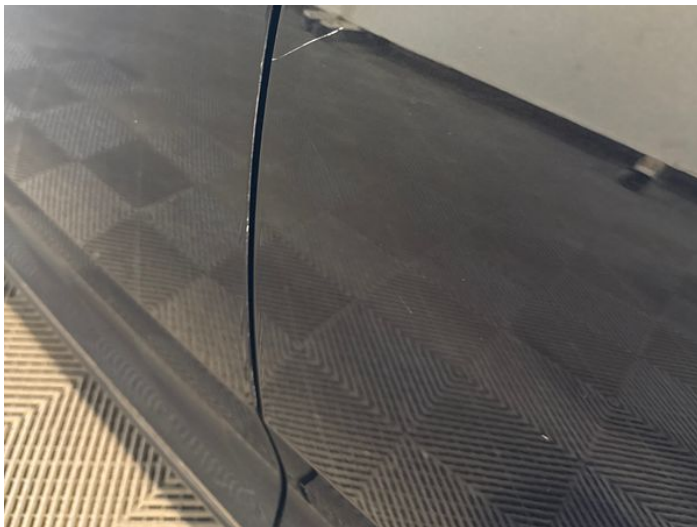
9: Door nsr  
Scratched  
UpTo 25mm Thru Paint

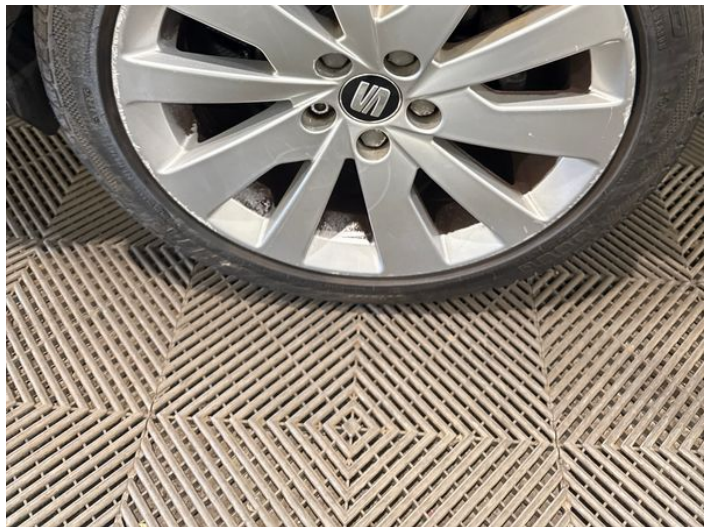
10: Wheel nsr  
Scratched  
Over 50mm

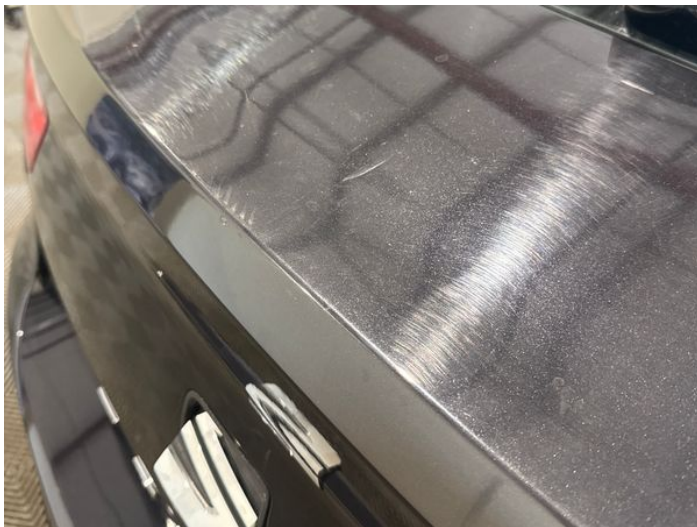
11: Boot Lid  
Scratched  
Over 25mm Thru Paint

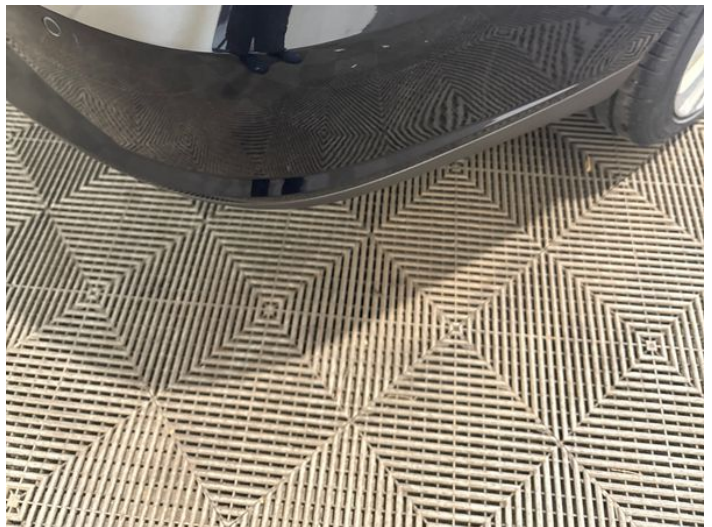
12: Bumper Rear  
Scratched  
25 to 100mm Thru Paint

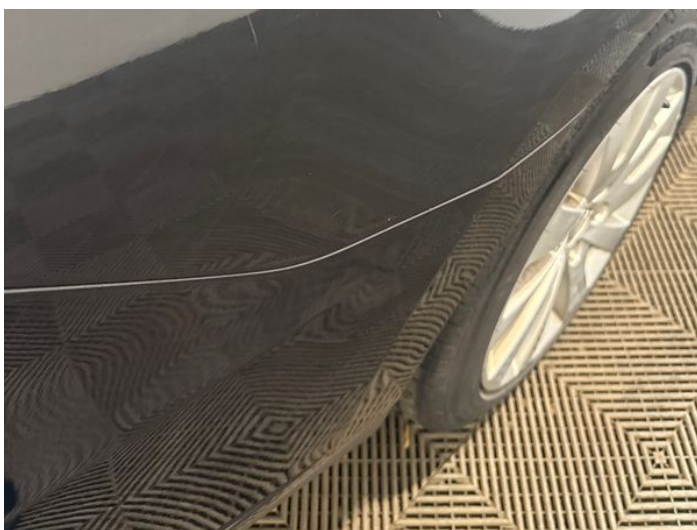
13: Qtr Panel osr  
Scratched  
Over 25mm Thru Paint

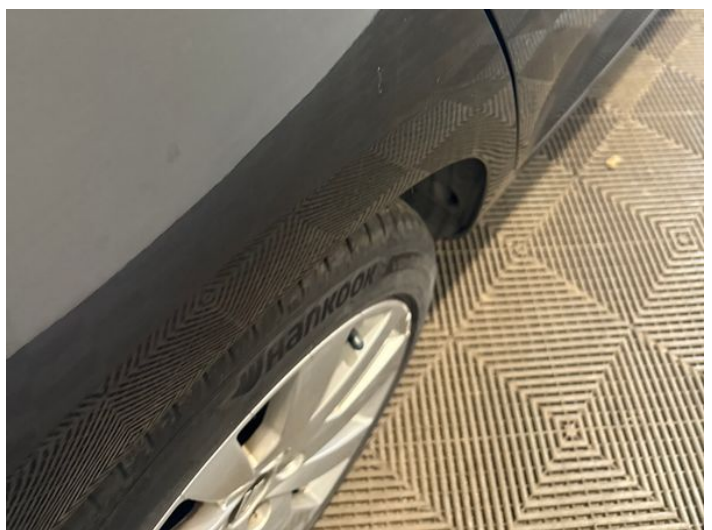
14: Qtr Panel osr  
Dented  
Between 10mm + 30mm

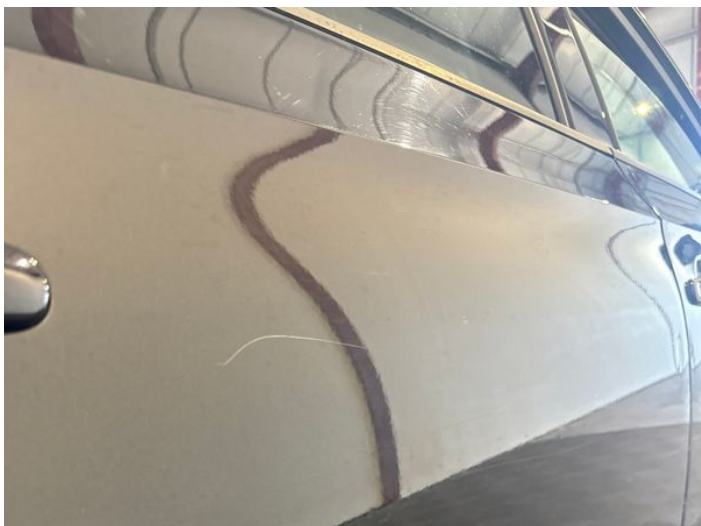
15: Door osr  
Scratched  
Over 25mm Thru Paint

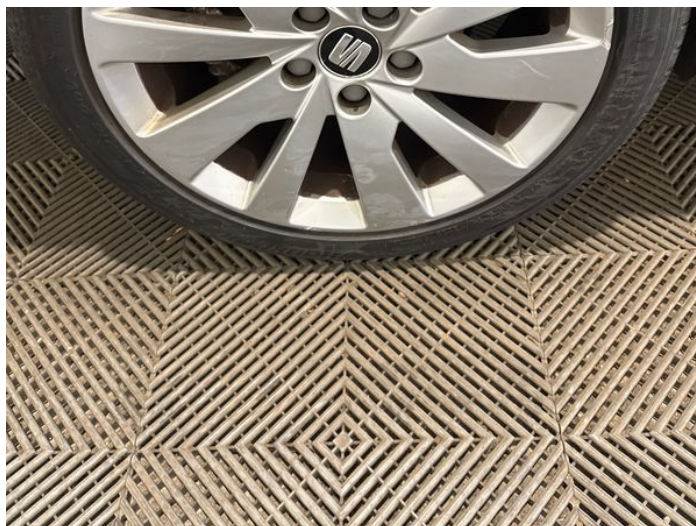
16: Wheel osr  
Scratched  
Over 50mm

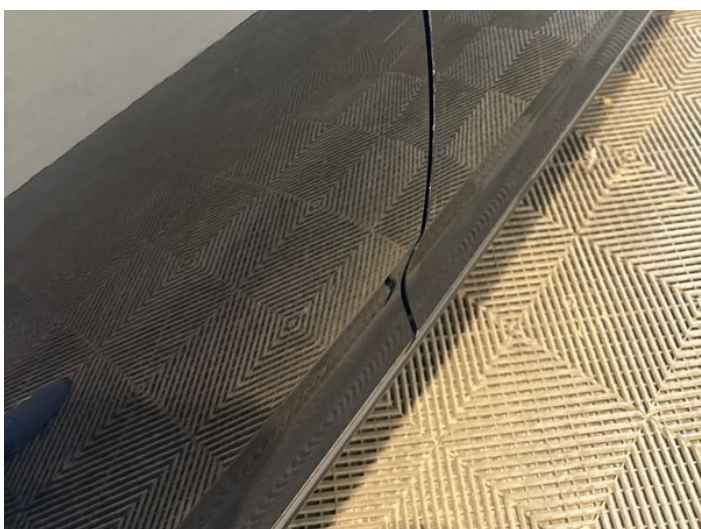
17: Door osr  
Dented  
Between 10mm + 30mm

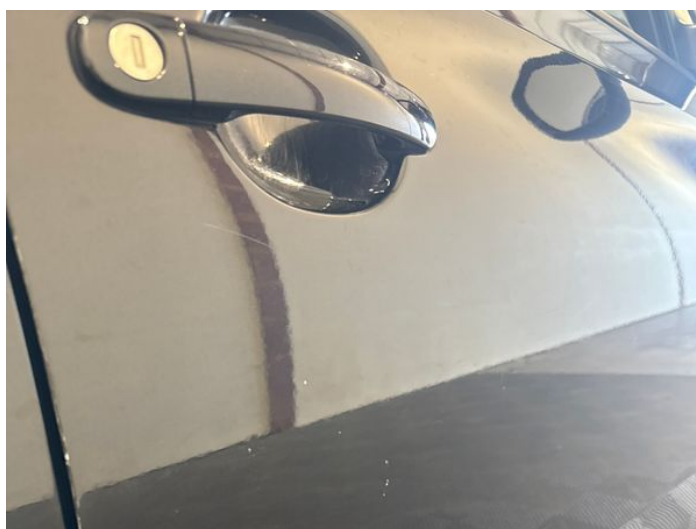
18: Door osf  
Scratched  
Over 25mm Thru Paint

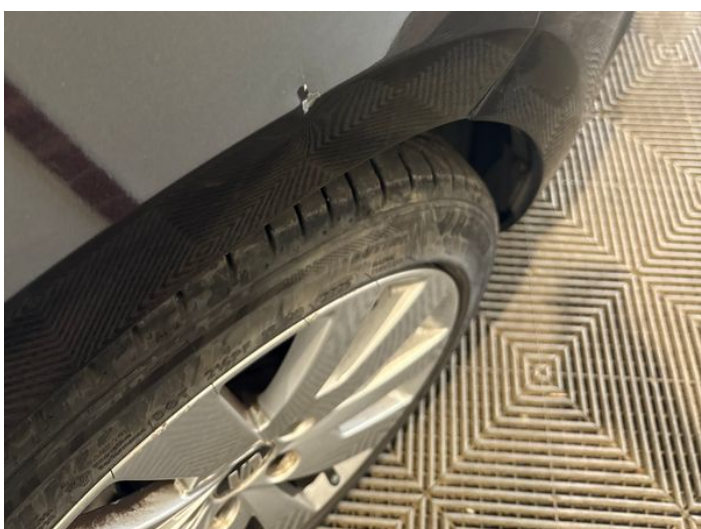
19: Wing osf  
Dented  
Between 10mm + 30mm

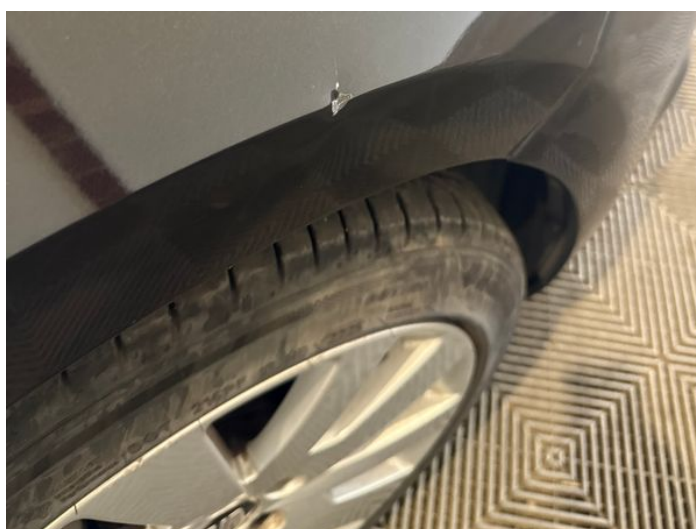
20: Wing osf  
Scratched  
UpTo 25mm Thru Paint

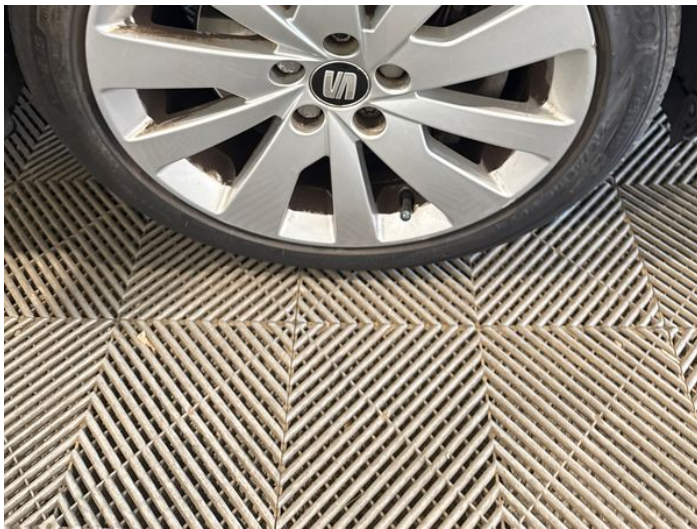
21: Wheel of  
Scratched  
Over 50mm

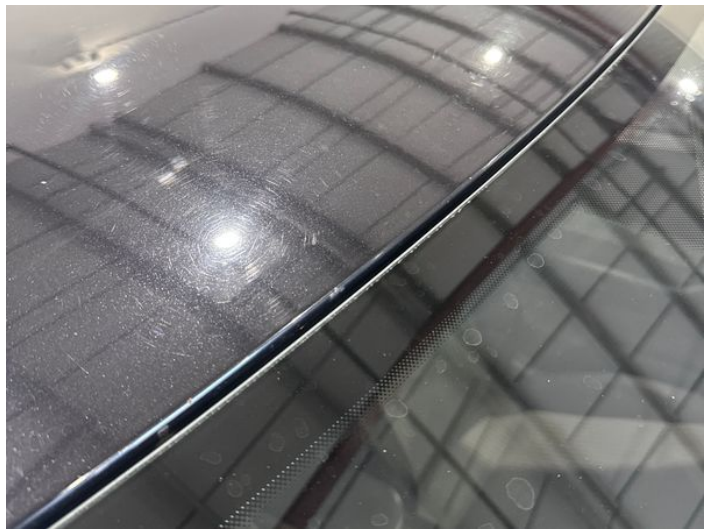
22: Roof  
Chipped  
Edge Chip
