# VEHICLE INSPECTION REPORT

**GX63BKK**

## VAUXHALL ASTRA 1.6T 16V SRi [180] 5dr

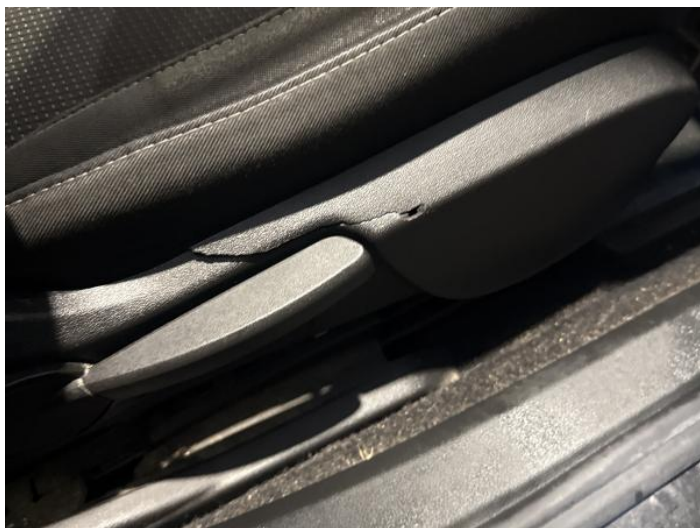
1: Fascia Trim  
Damaged  
Replace

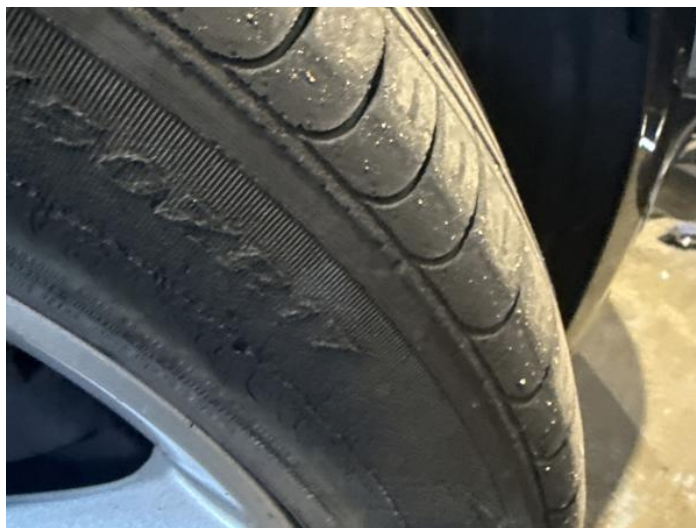
| OSF | NEXEN | Damaged |

2: Tyre osf  
Damaged  
Replace

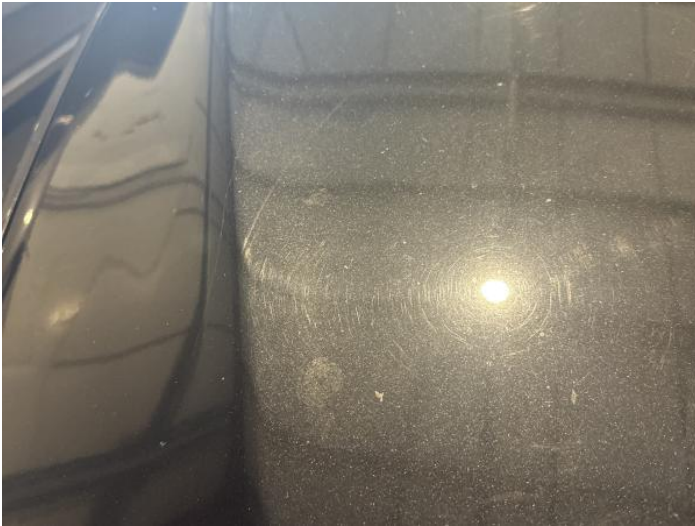
3: Bonnet  
Dented  
Between 10mm + 30mm

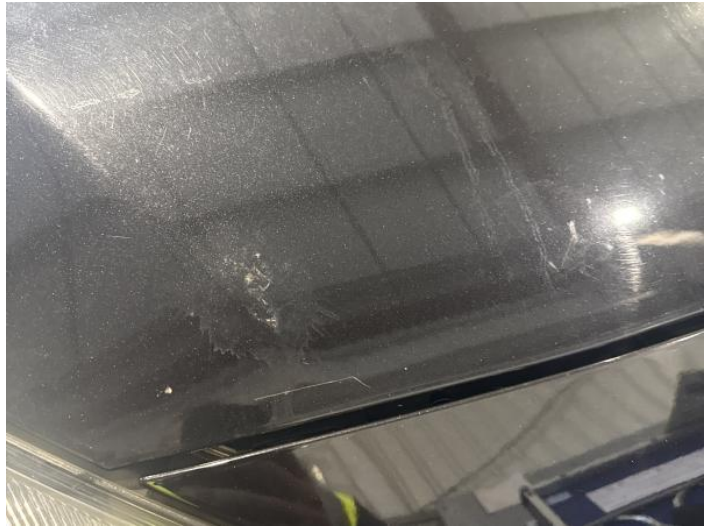
4: Bonnet  
Scratched  
Over 25mm Thru Paint

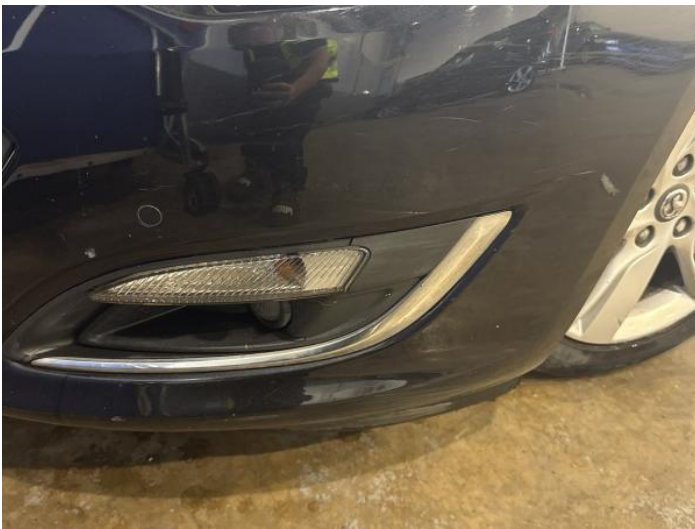
5: Bumper Front  
Scratched  
25 to 100mm Thru Paint

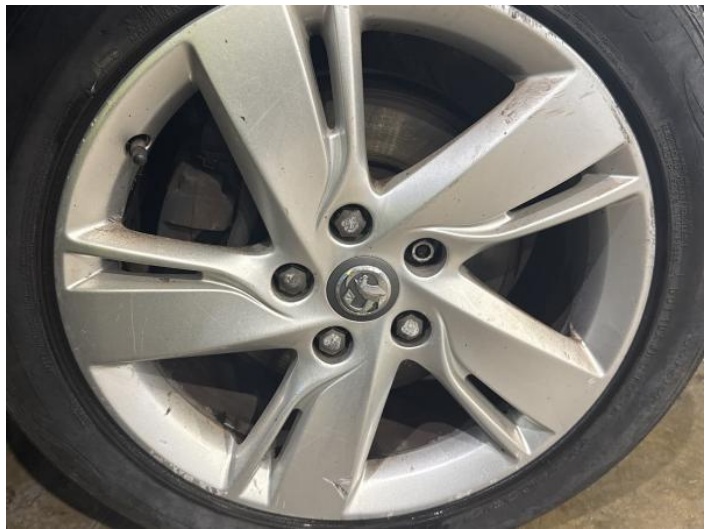
6: Wheel nsf  
Scratched  
Over 50mm

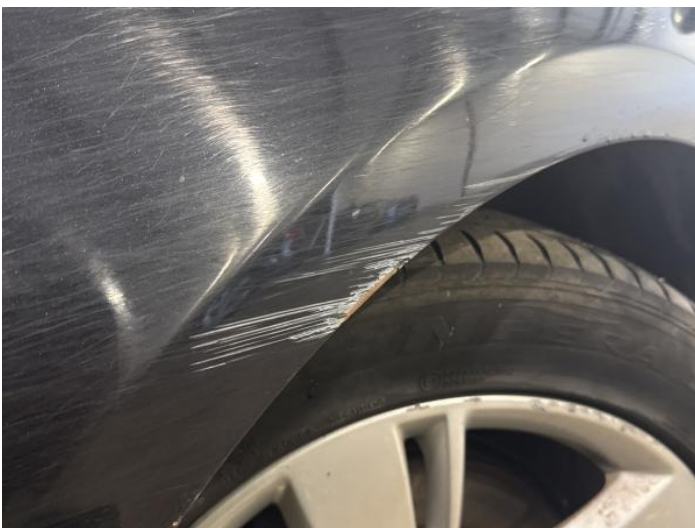
7: Wing nsf  
Scratched  
Over 25mm Thru Paint

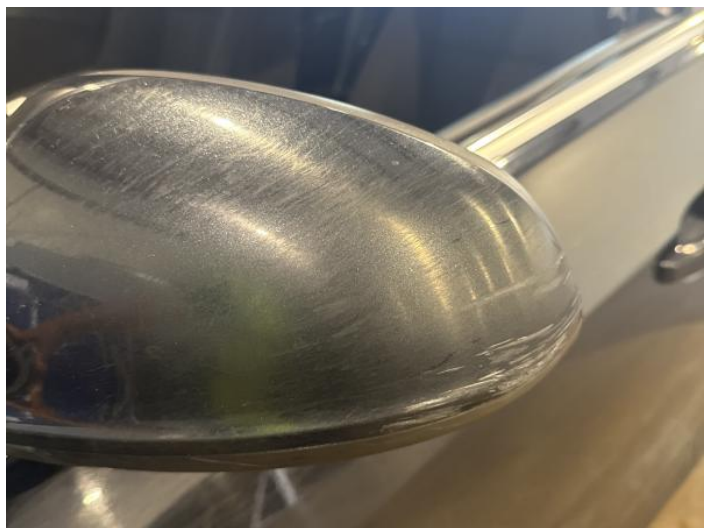
8: Door Mirror Assy nsf  
Scratched (Painted)  
Over 25mm Thru Paint

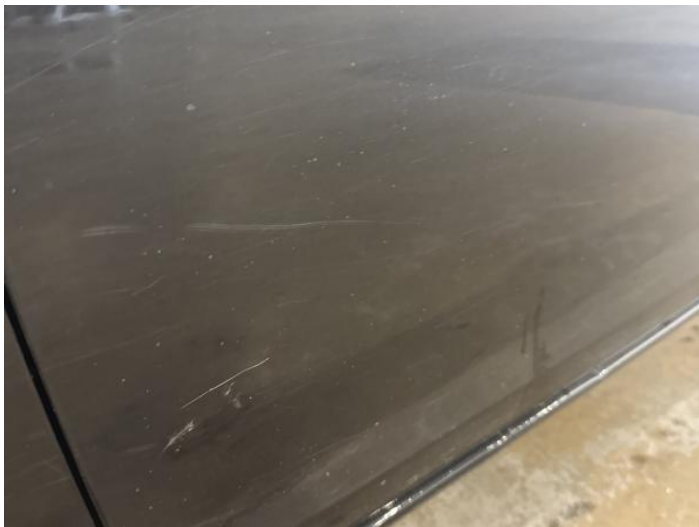
9: Door nsf  
Dented  
With Paint Damage

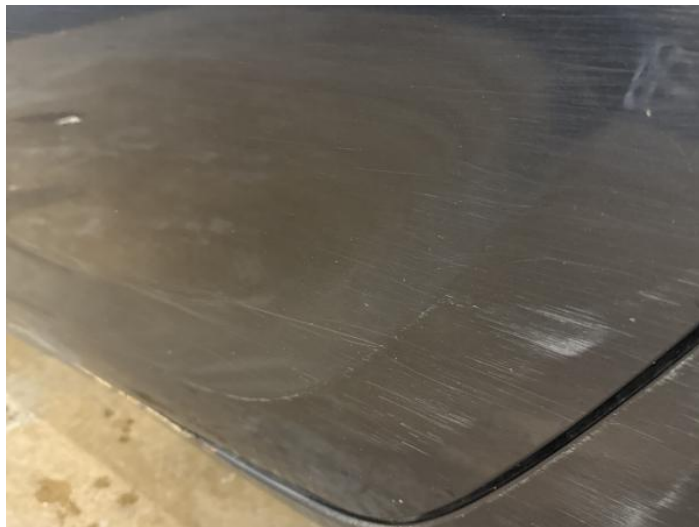
10: Door nsr  
Scratched  
Over 25mm Thru Paint

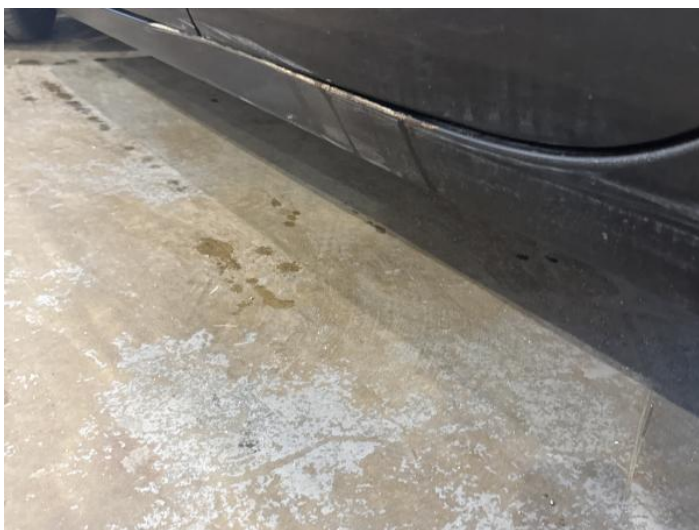
11: Sill ns  
Dented  
With Paint Damage

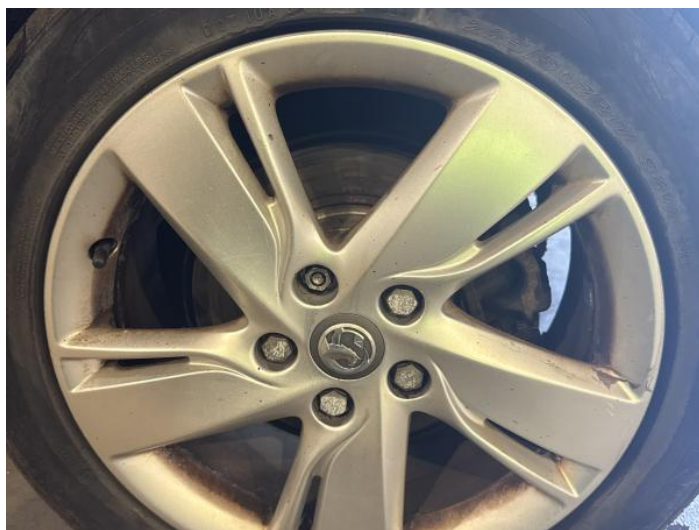
12: Wheel nsr  
Scratched  
Over 50mm

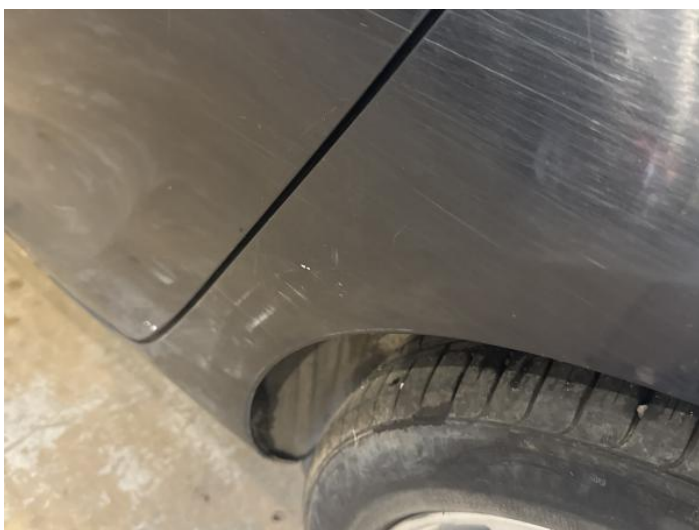
13: Qtr Panel nsr  
Scratched  
Over 25mm Thru Paint

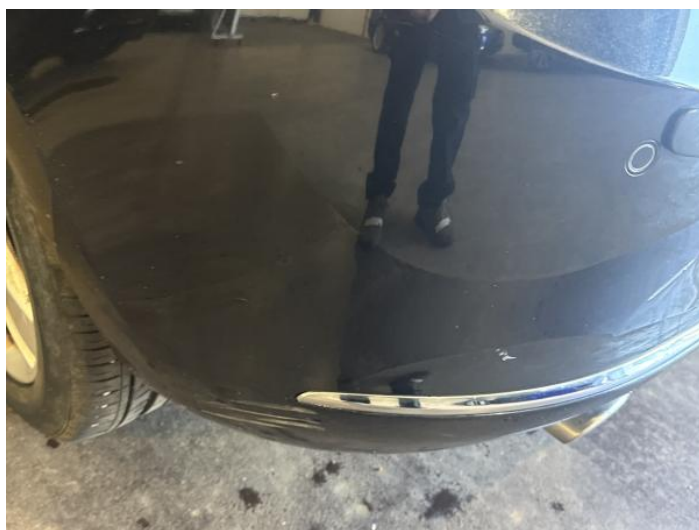
14: Bumper Rear  
Scratched  
Over 100mm Thru Paint

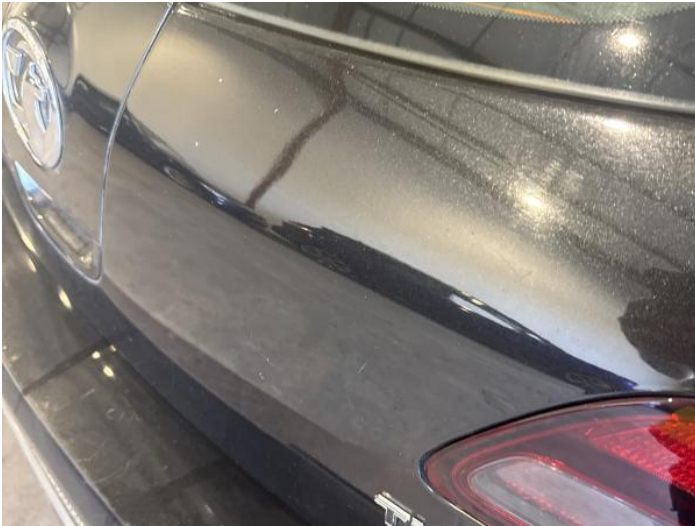
15: Tailgate  
Scratched  
Over 25mm Thru Paint

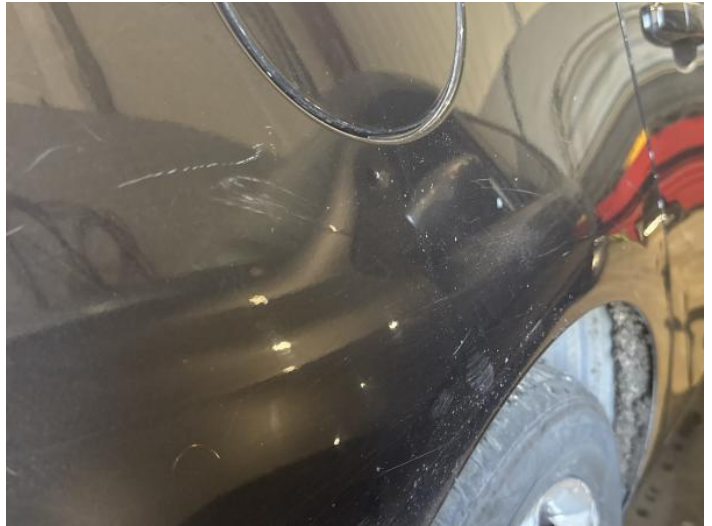
16: Qtr Panel osr  
Dented  
With Paint Damage

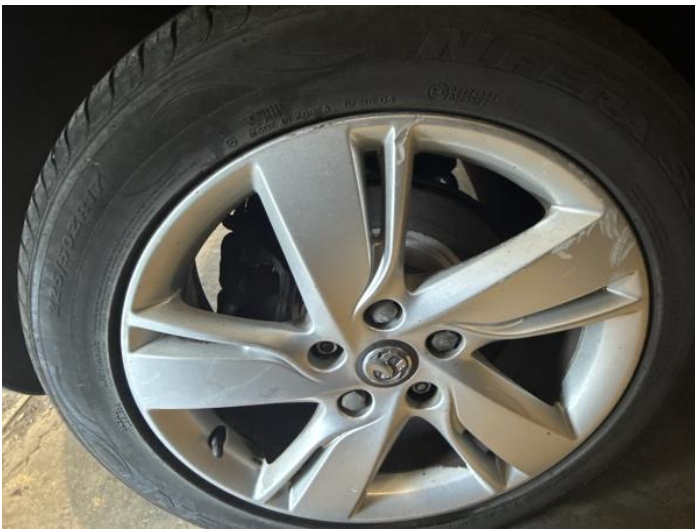
17: Wheel osr  
Scratched  
Over 50mm

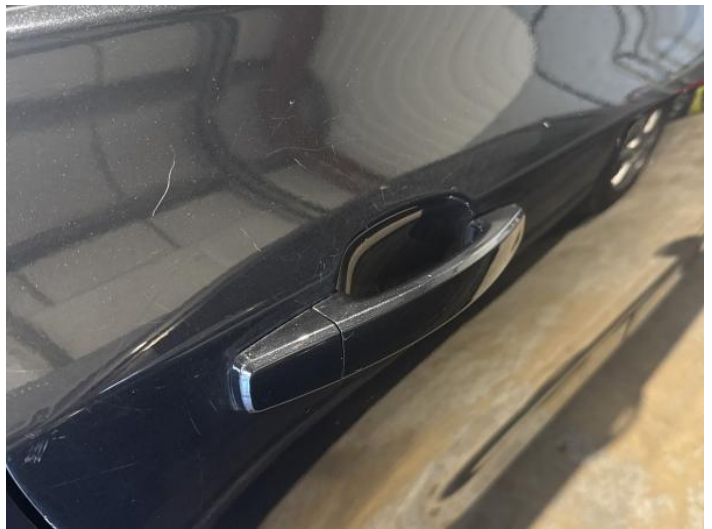
18: Door osr  
Scratched  
Over 25mm Thru Paint

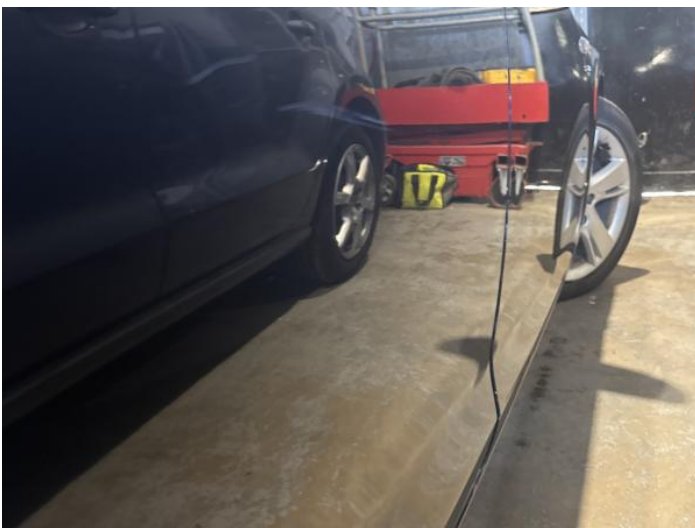
19: Door osr  
Dented  
Between 10mm + 30mm

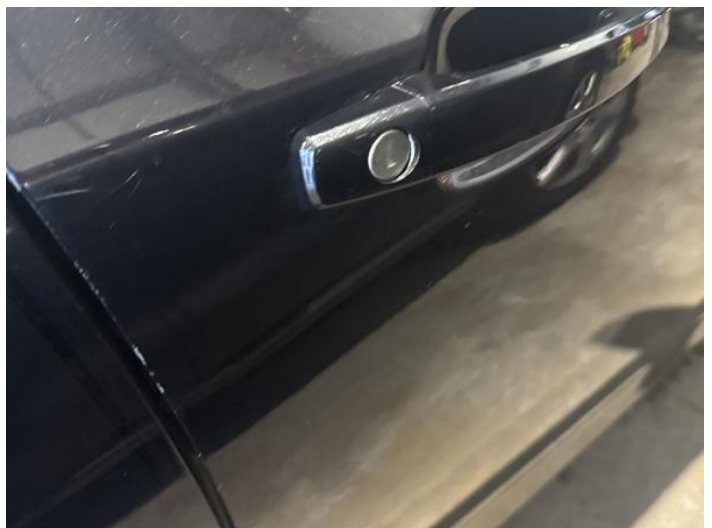
20: Door osf  
Scratched  
Over 25mm Thru Paint

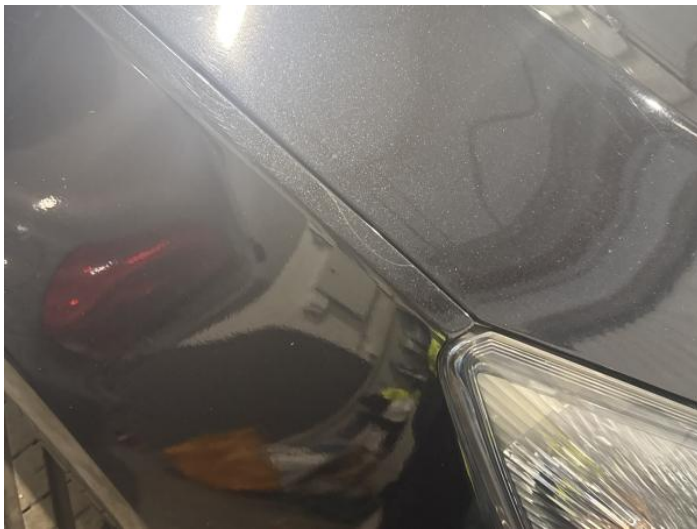
21: Wing osf  
Scratched  
Over 25mm Thru Paint

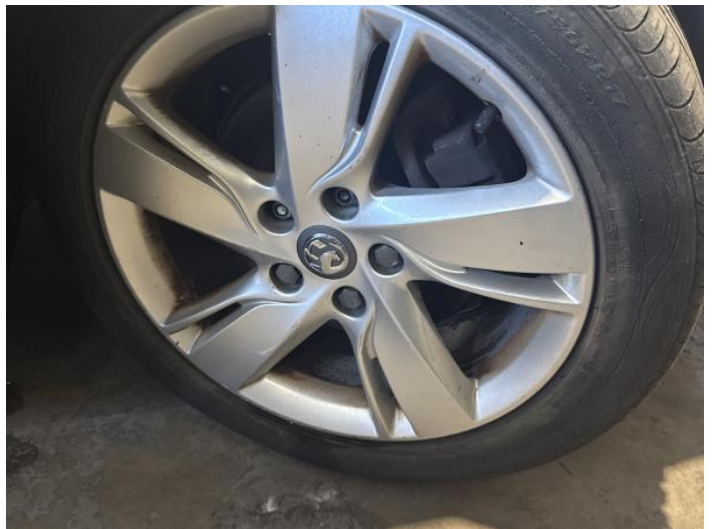
22: Wheel osf  
Scratched  
Over 50mm
