# VEHICLE INSPECTION REPORT

**MM17WPW**

## Vauxhall Astra 1.6 CDTi 16V SRi 5dr

Cat: S

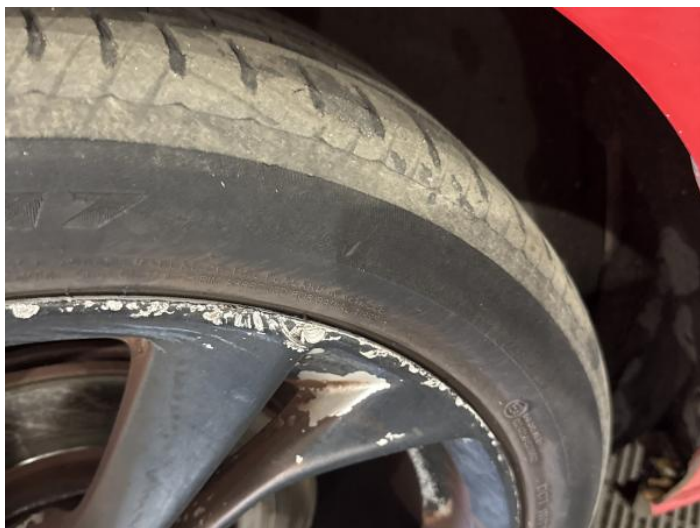
1: Tyre nsf  
Damaged  
Replace

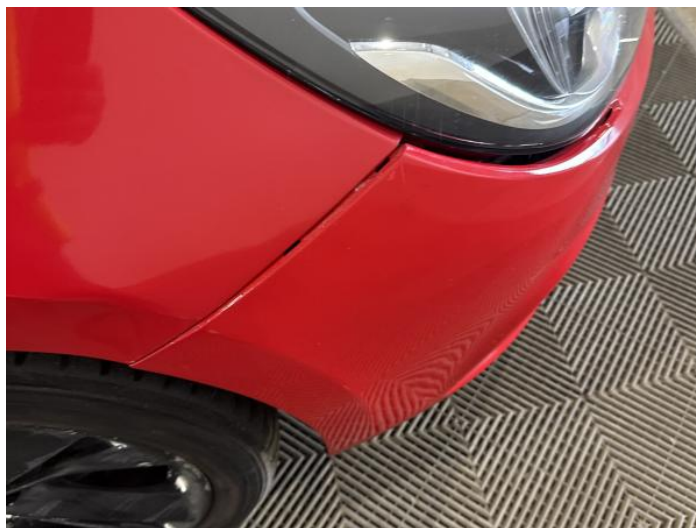
2: Bumper Front  
Insecure  
Action Required

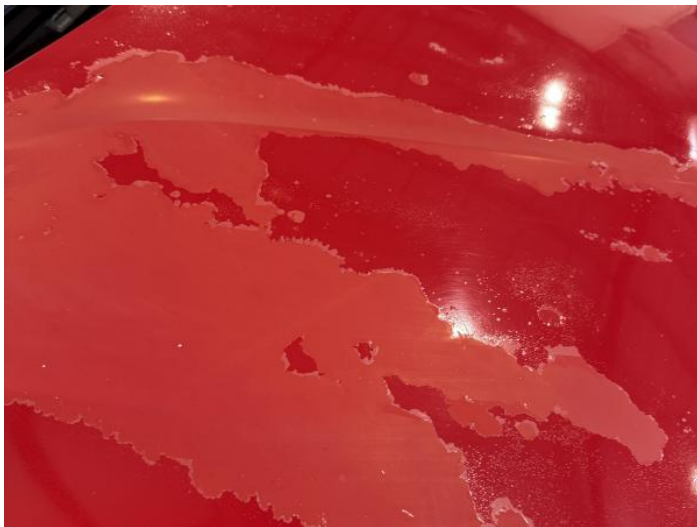
3: Bonnet  
Poor Previous Repair  
Paint Flake

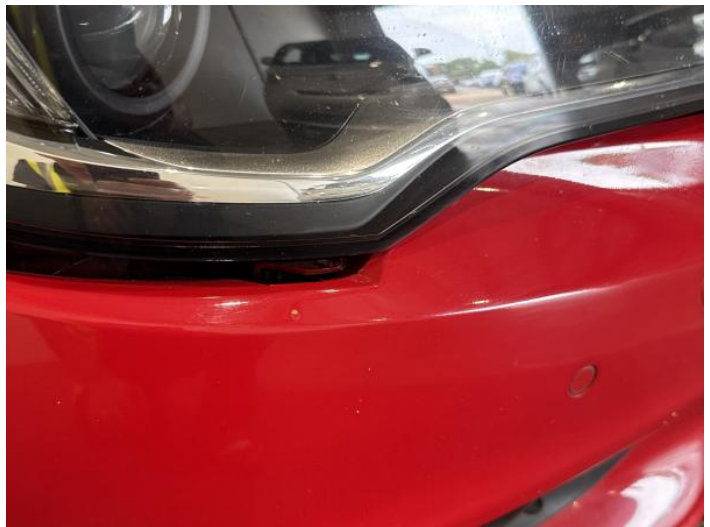
4: Bumper Front  
Poor Previous Repair  
Poor Paint

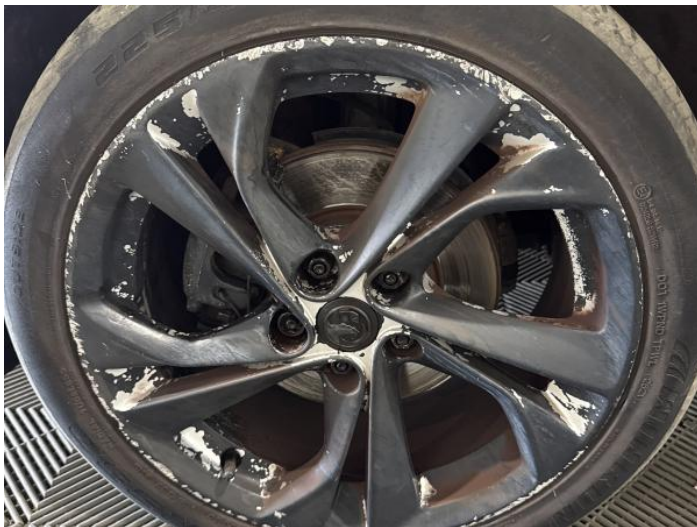
5: Wheel nsf  
Scratched  
Over 50mm

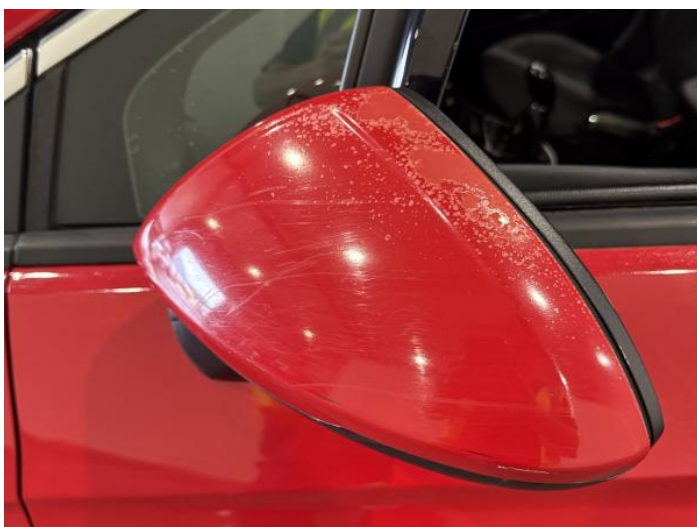
7: Door Mirror Assy nsf  
Scratched (Painted)  
Over 25mm Thru Paint

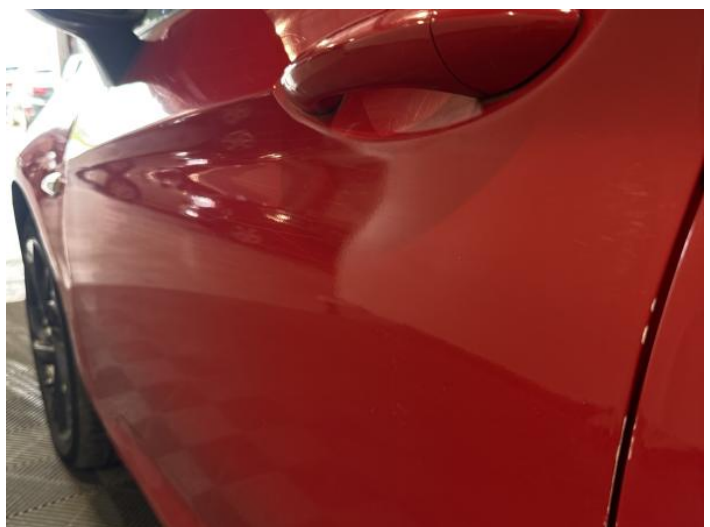
8: Door nsf  
Poor Previous Repair  
Rippled UpTo 30%

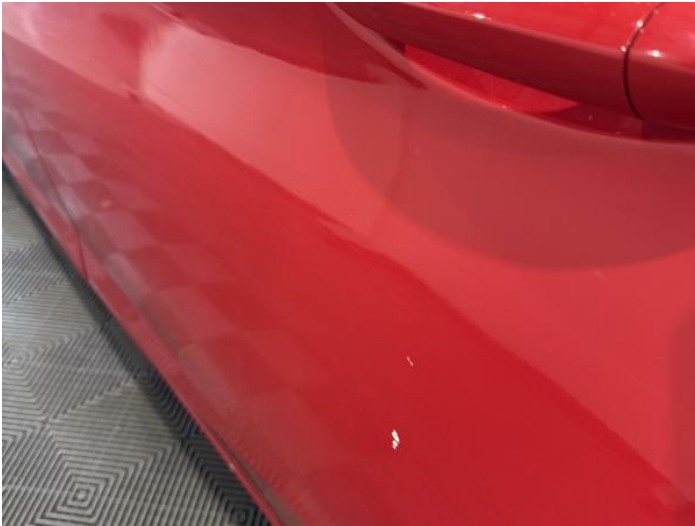
9: Door nsr  
Poor Previous Repair  
Rippled UpTo 30%

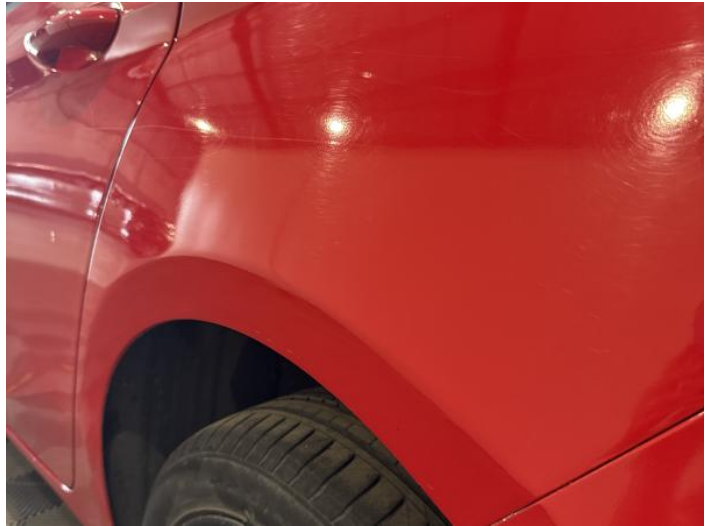
10: Qtr Panel nsr  
Poor Previous Repair  
Poor Paint

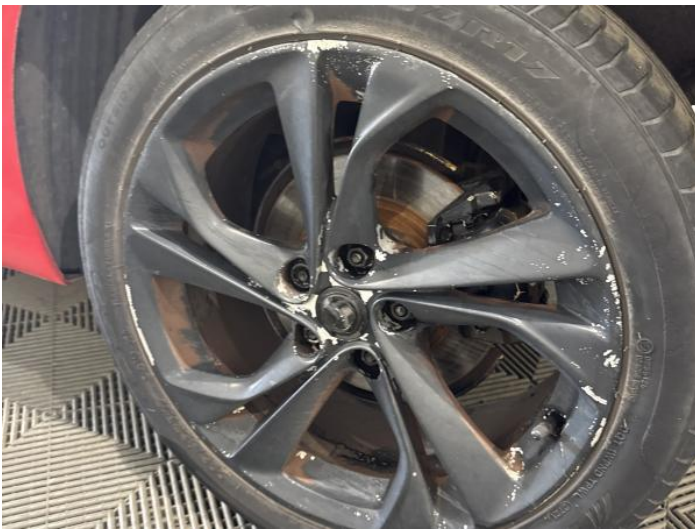
11: Wheel nsr  
Scratched  
Over 50mm

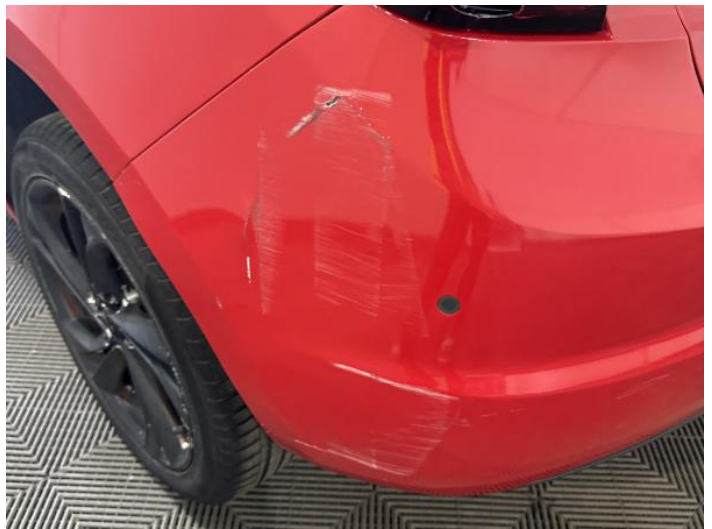
12: Bumper Rear  
Dented  
With Paint Damage

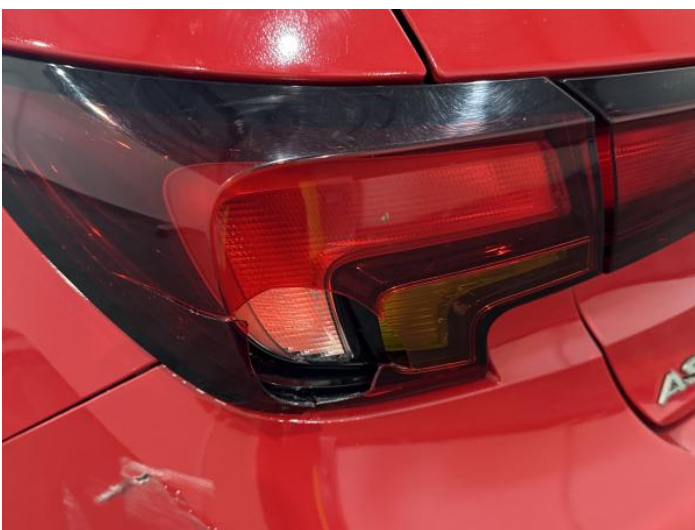
13: Lamp nsr  
Broken  
Replace

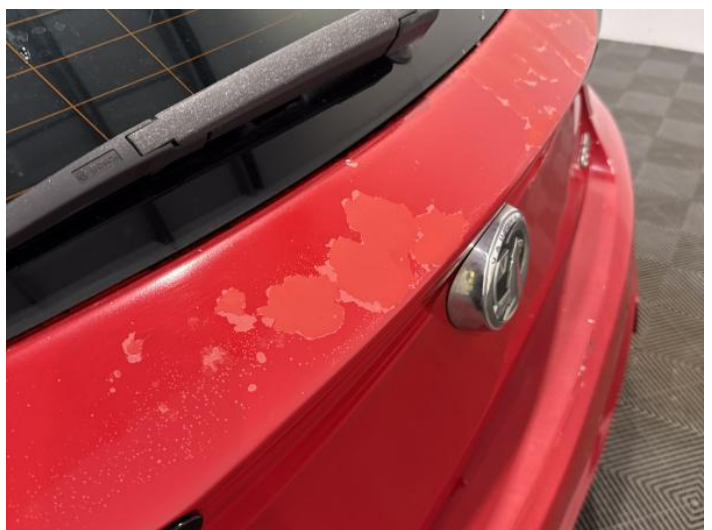
14: Tailgate  
Poor Previous Repair  
Paint Flake

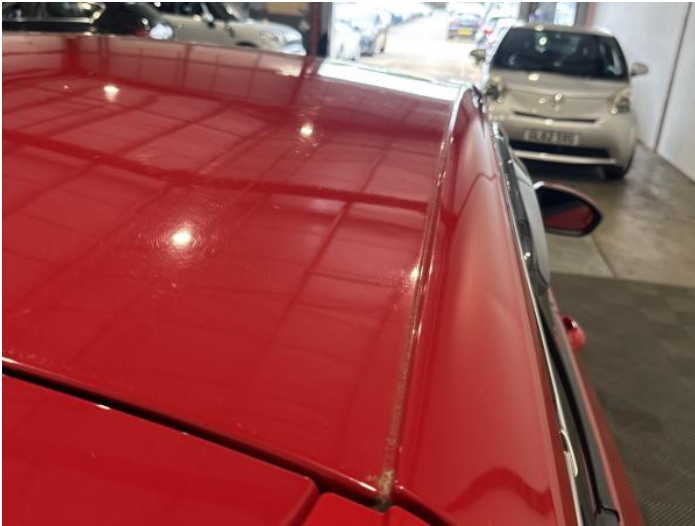
15: Roof  
Dented  
Over 30mm

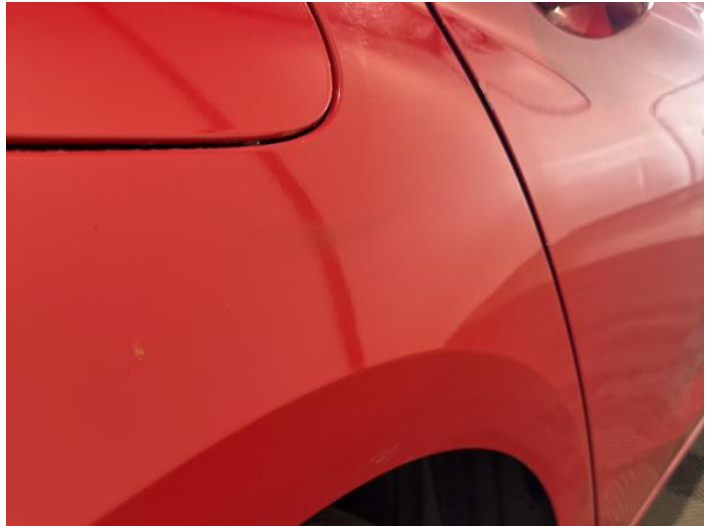
16: Qtr Panel osr  
Dented  
Over 30mm

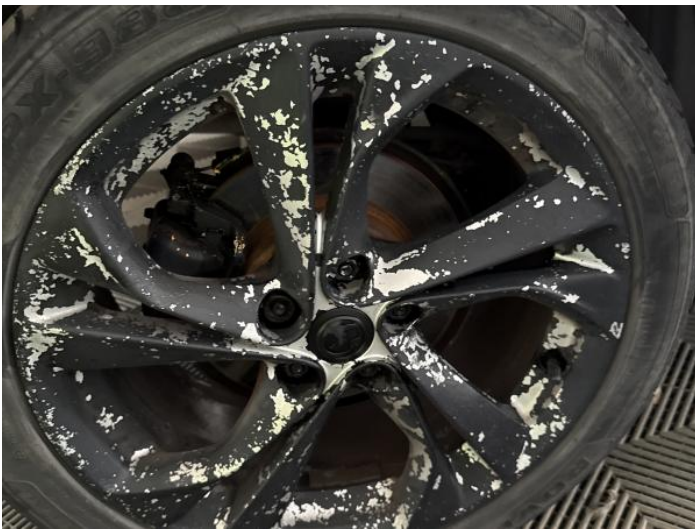
17: Wheel osr  
Scratched  
Over 50mm

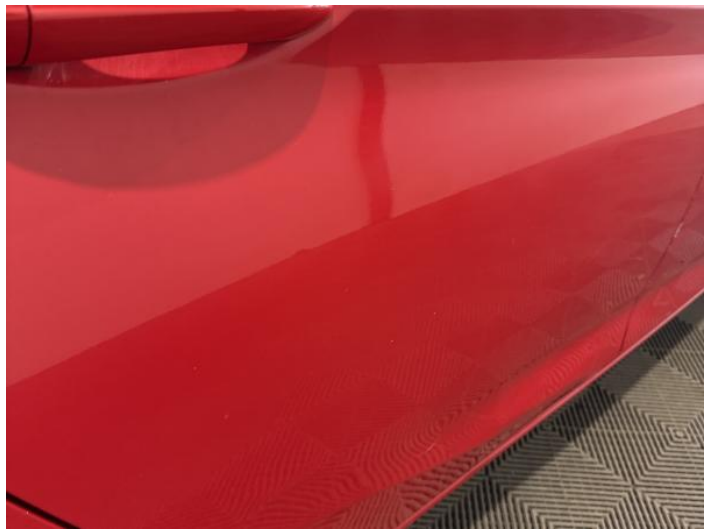
18: Door osr  
Dented  
Over 30mm

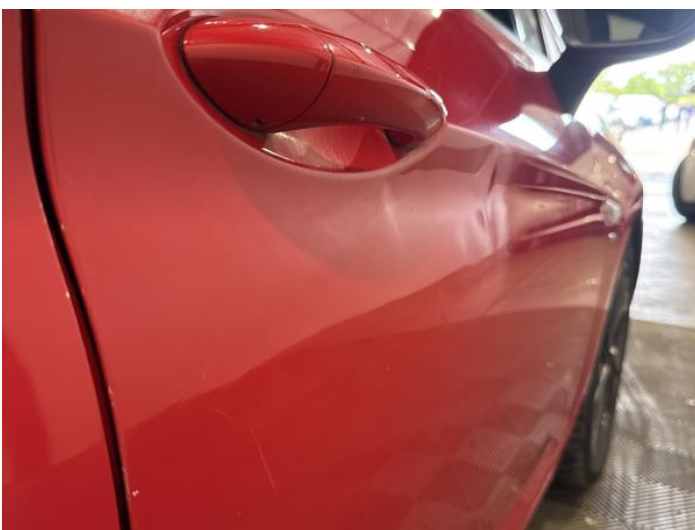
19: Door osf  
Poor Previous Repair  
Rippled UpTo 30%

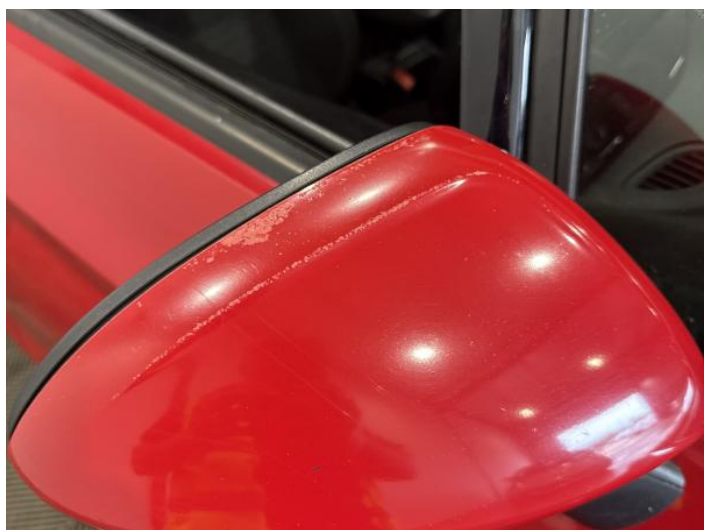
20: Door Mirror Assy osf  
Scratched (Painted)  
Over 25mm Thru Paint

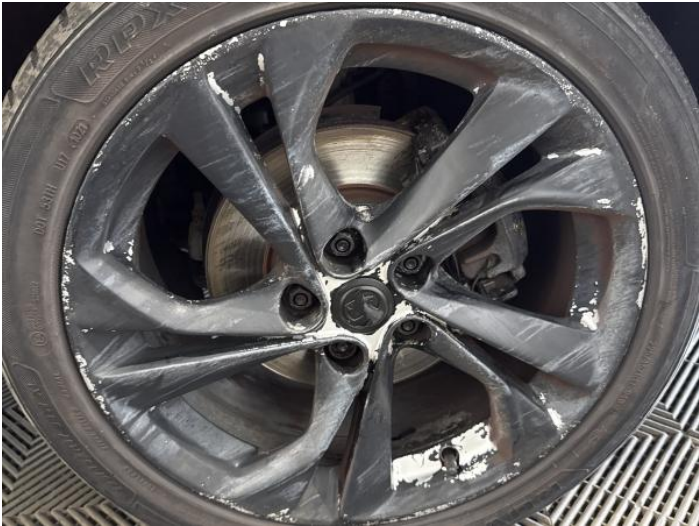
21: Wheel osf  
Scratched  
Over 50mm

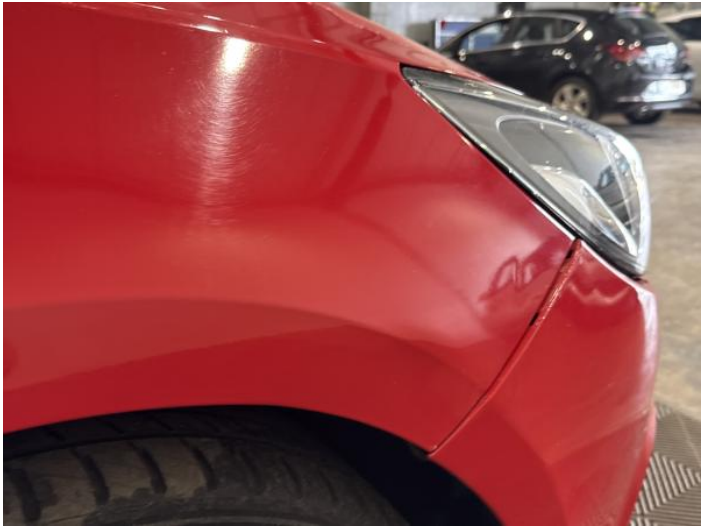
22: Wing osf  
Dented  
Over 30mm
