# VEHICLE INSPECTION REPORT

**GY67JVO**

## Toyota C-Hr 1.2T Dynamic 5dr

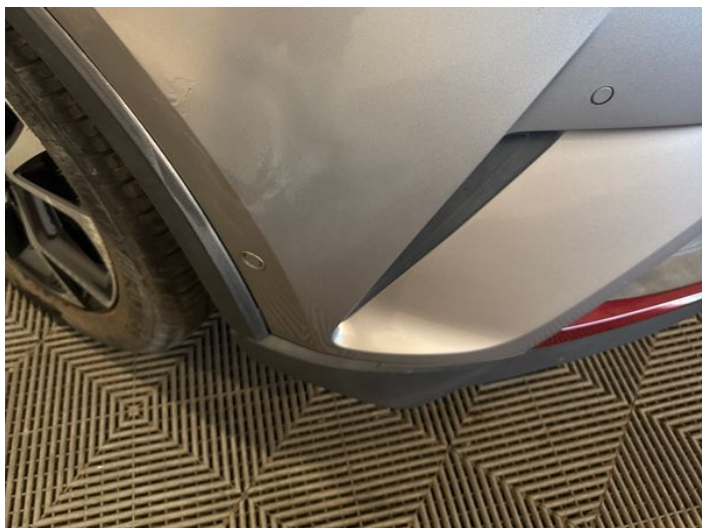
1: Bumper Front  
Poor Previous Repair  
Poor Paint

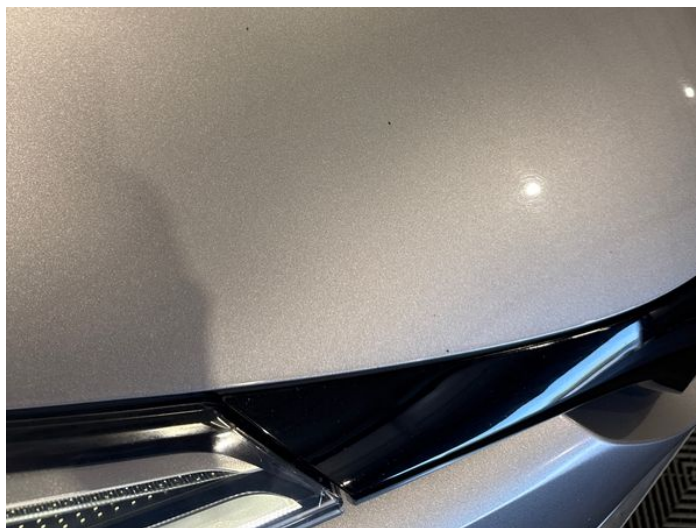
2: Bonnet  
Chipped  
1 To 5

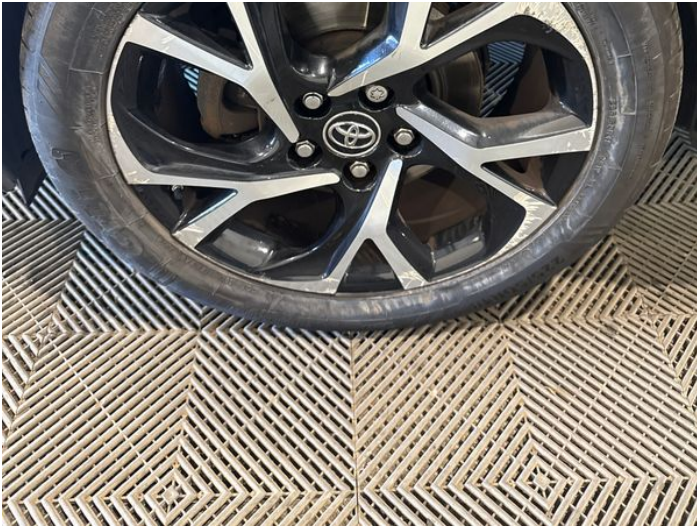
3: Wheel nsf  
Scratched  
Over 50mm

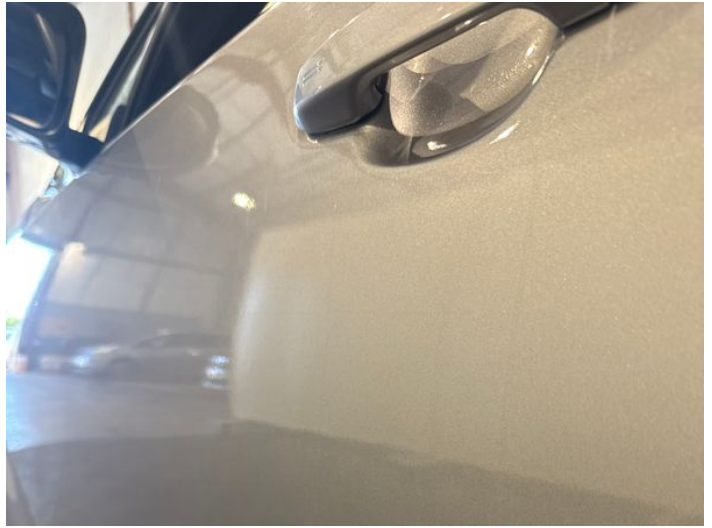
4: Door nsf  
Poor Previous Repair  
Rippled Up To 30%

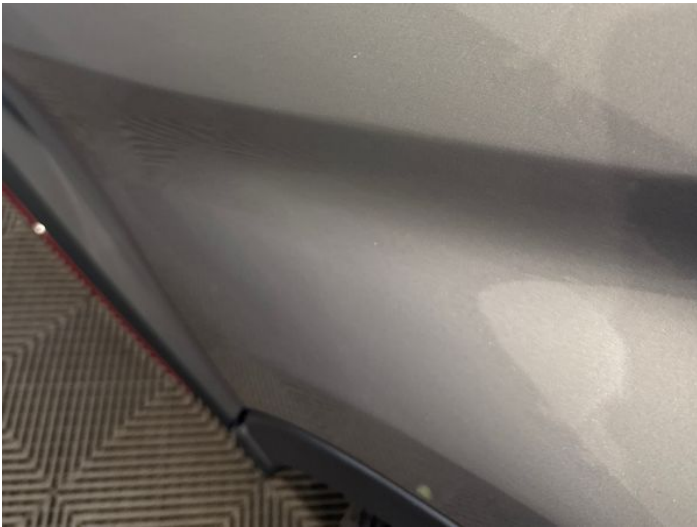
5: Door nsr  
Chipped  
1 To 5

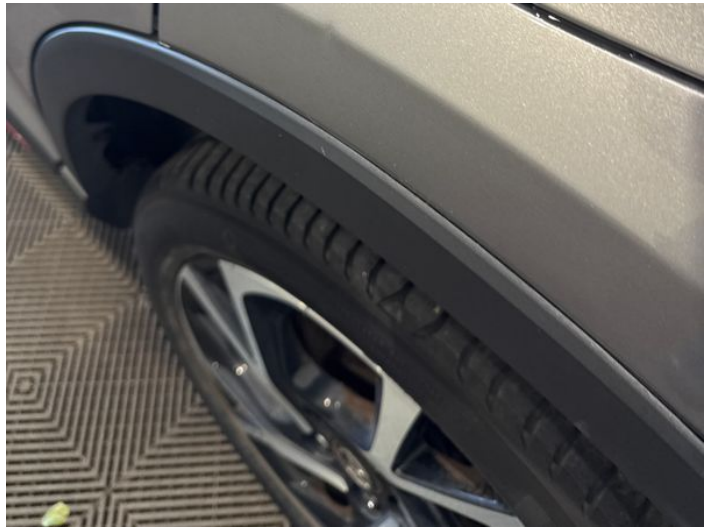
6: Qtr Panel nsr  
Dented  
Between 10mm + 30mm

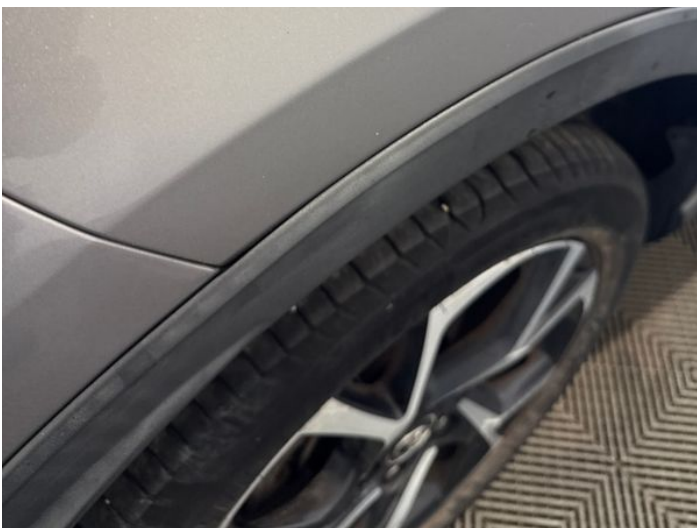
7: Qtr Panel osr  
Chipped  
1 To 5

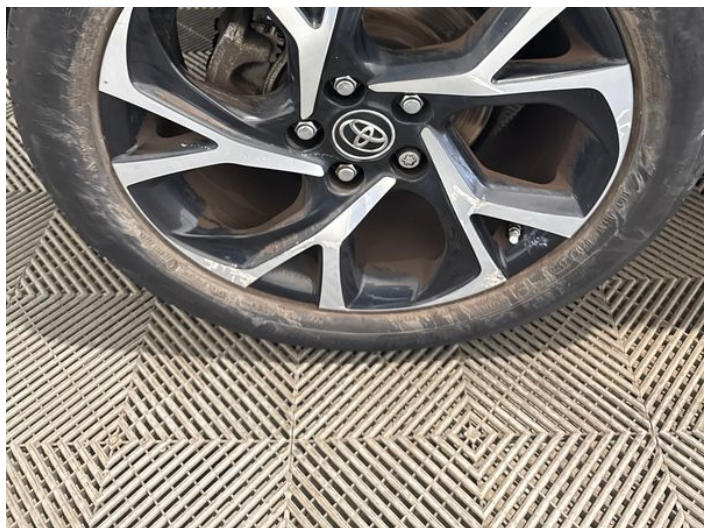
8: Wheel osr  
Scratched  
Over 50mm

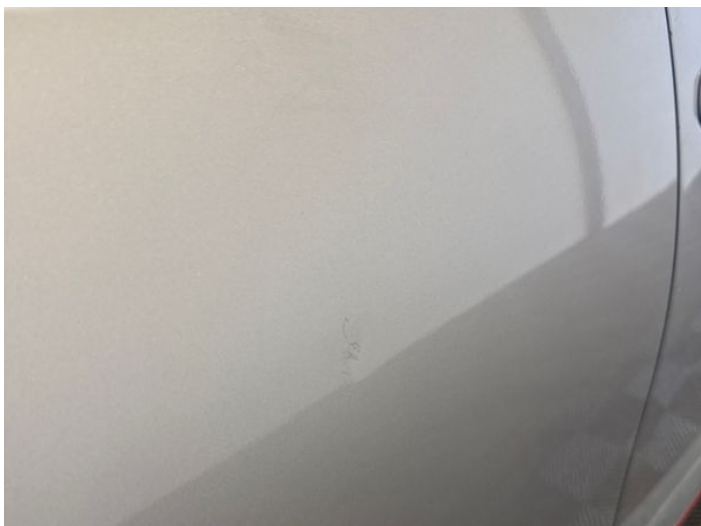
9: Door osr  
Dented  
Between 10mm + 30mm

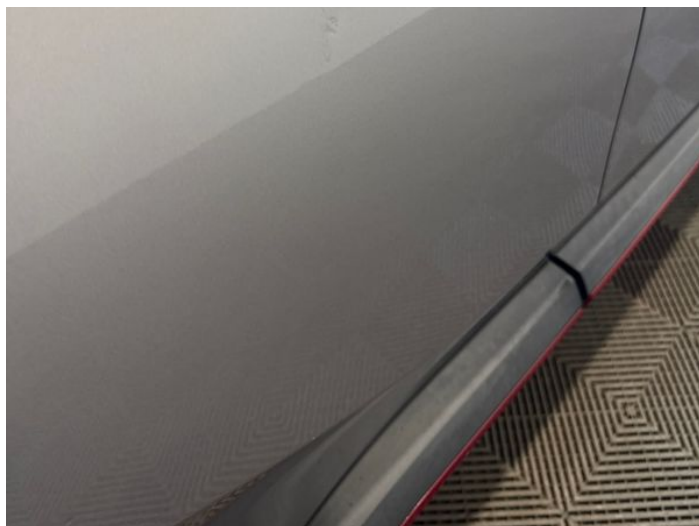
10: Door osr  
Scratched  
UpTo 25mm Thru Paint

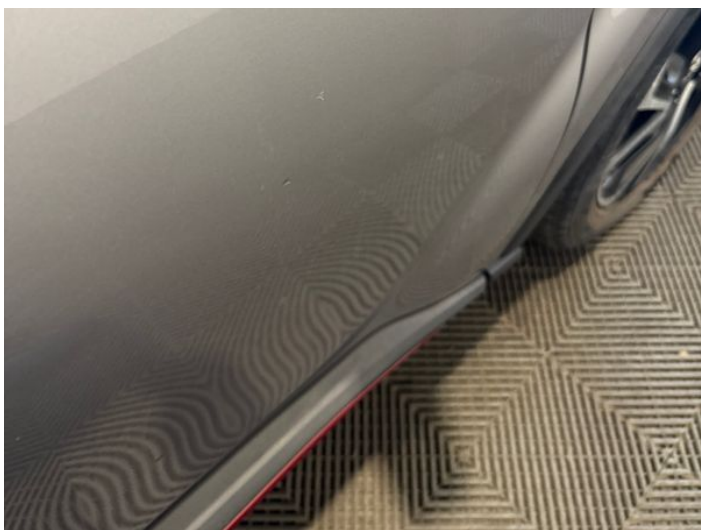
11: Door osf  
Chipped  
1 To 5

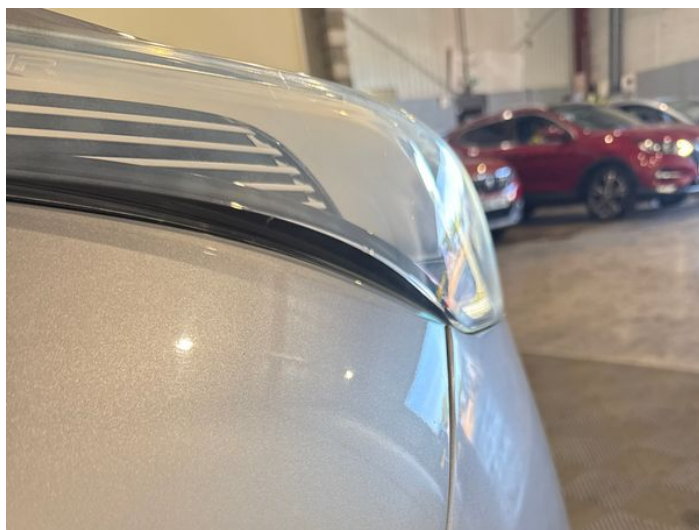
12: Wing osf  
Chipped  
1 To 5

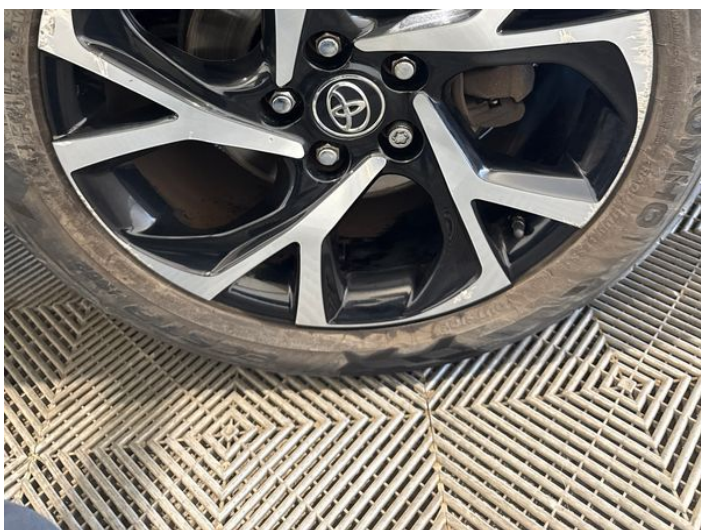
13: Wheel osf  
Scratched  
Over 50mm

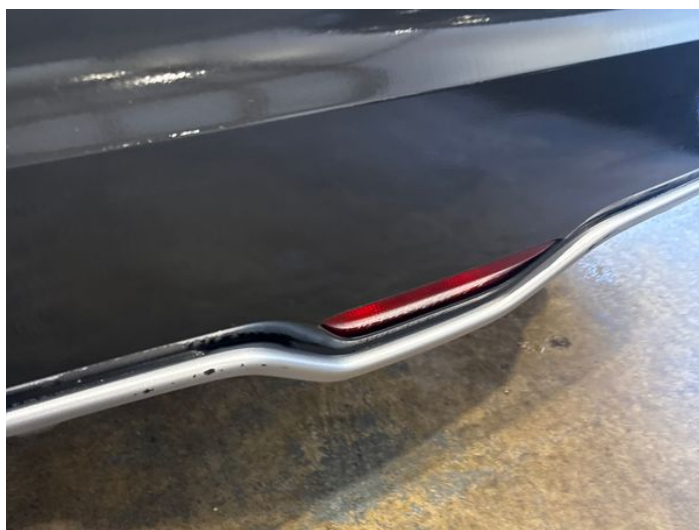
14: Bumper Rear Moulding  
Scratched (Painted)  
Over 25mm Thru Paint
