# VEHICLE INSPECTION REPORT

RE56OFR

## Honda Jazz 1.4 i-DSi Sport 5dr CVT-7

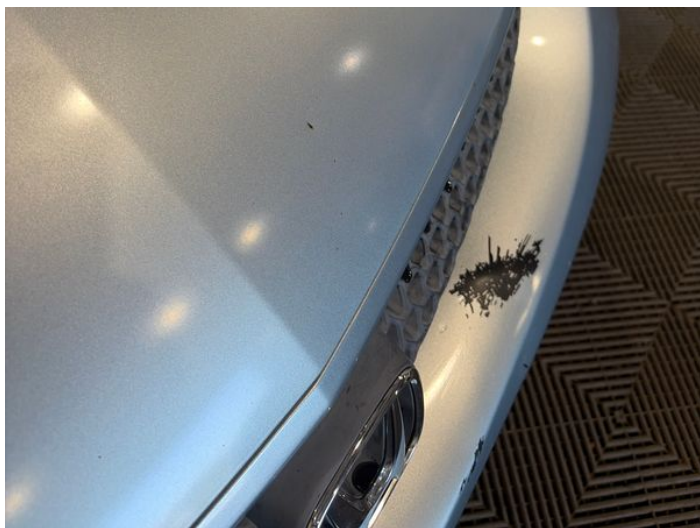
1: Bonnet  
Dented  
Between 10mm + 30mm

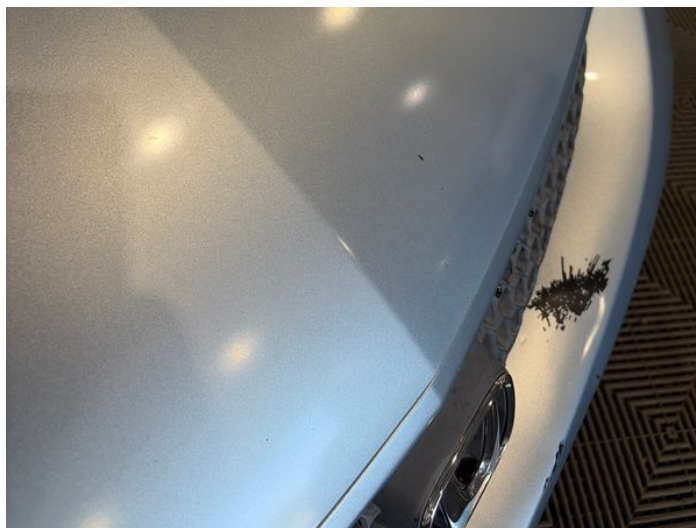
2: Bonnet  
Chipped  
Multiple Chips

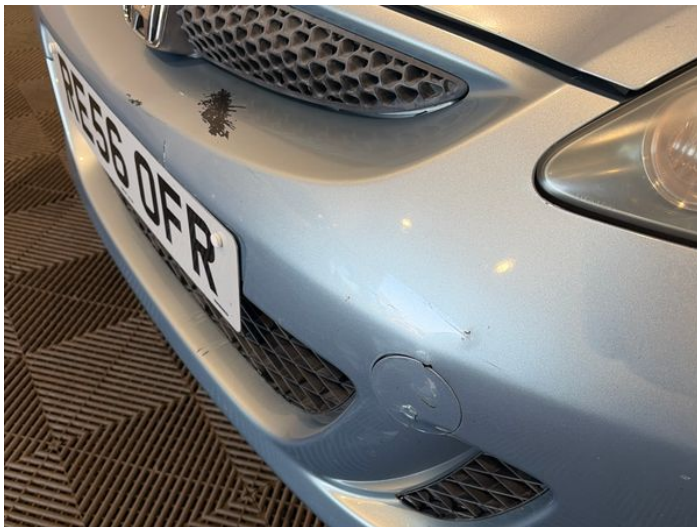
3: Bumper Front  
Dented  
With Paint Damage

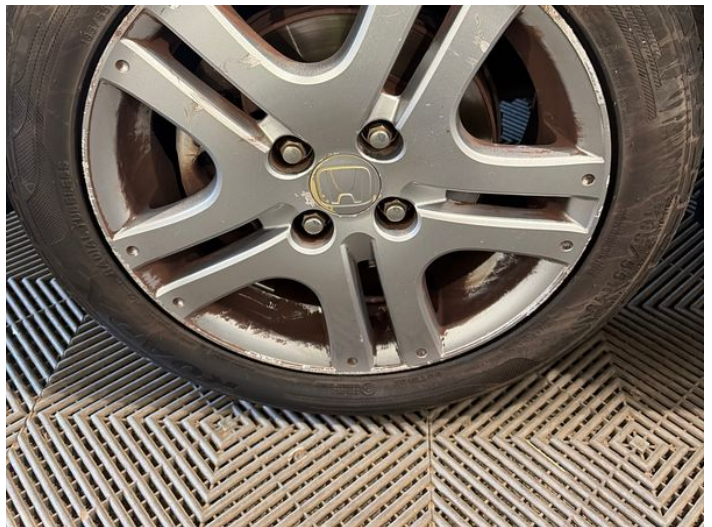
4: Wheel nsf  
Scratched  
Over 50mm

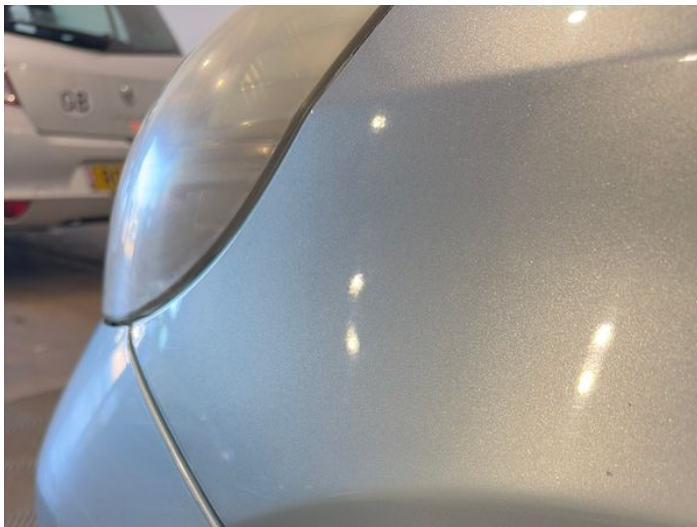
5: Wing nsf  
Scratched  
UpTo 25mm Thru Paint

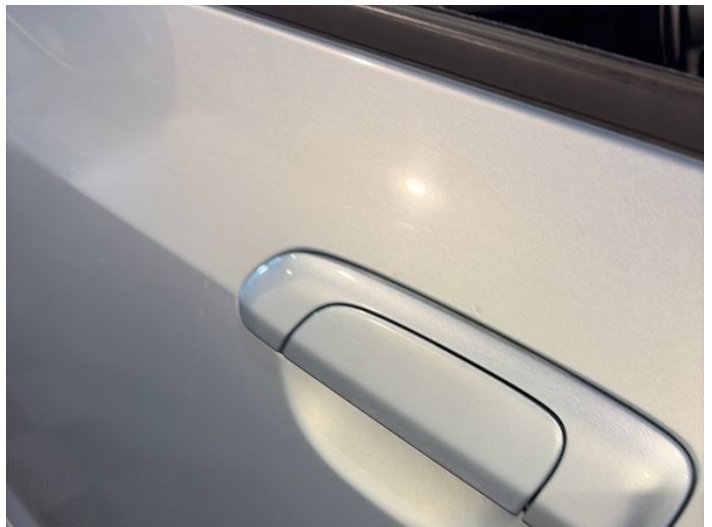
6: Door nsf  
Scratched  
Over 25mm Thru Paint

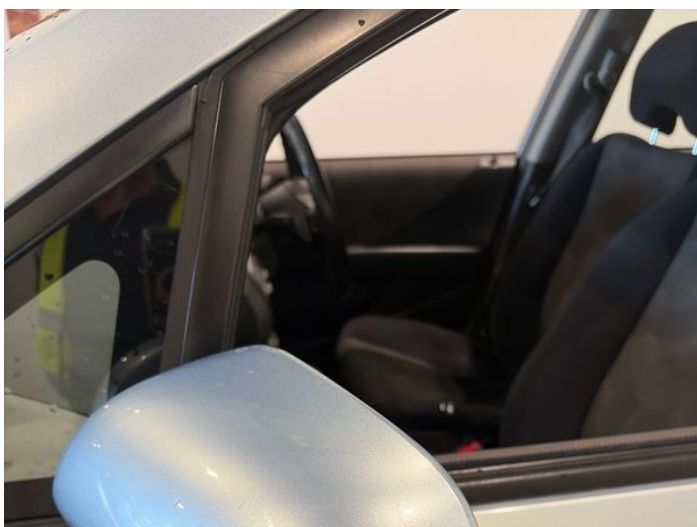
7: Door Mirror Assy nsf  
Scratched (Painted)  
UpTo 25mm Thru Paint

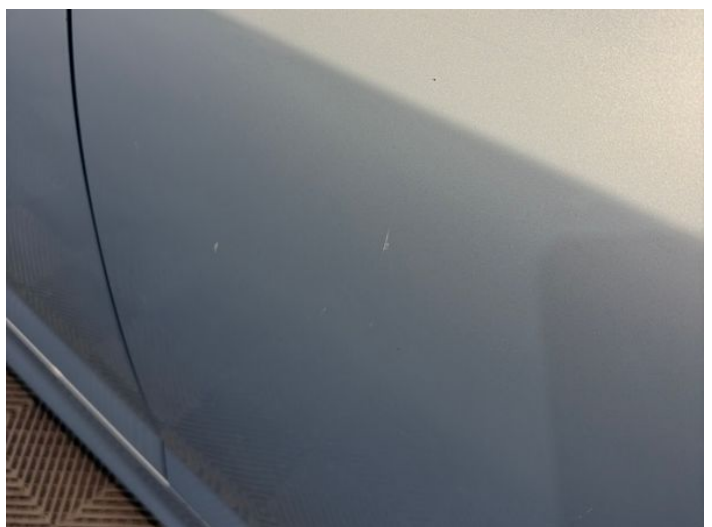
8: Door nsr  
Scratched  
UpTo 25mm Thru Paint

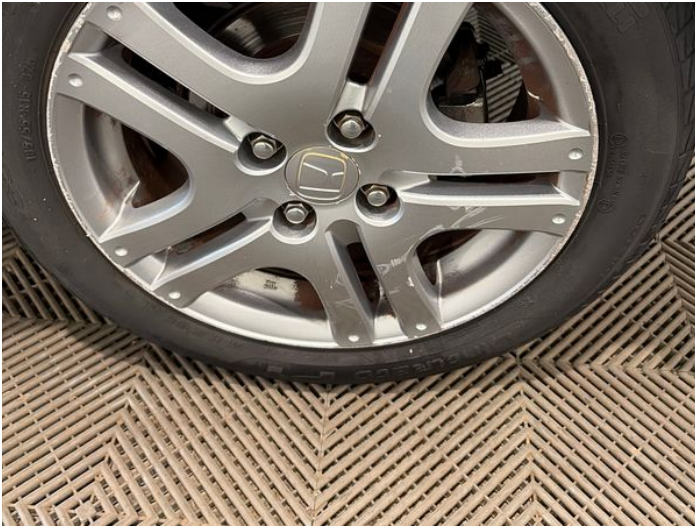
9: Wheel nsr  
Scratched  
Over 50mm

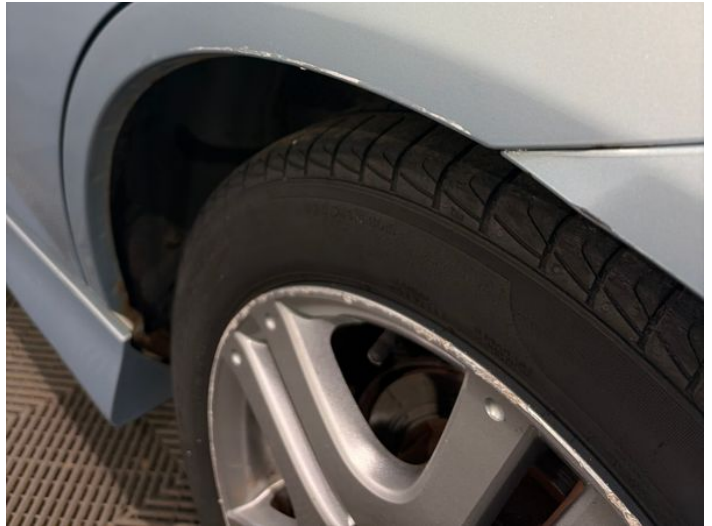
10: Qtr Panel nsr  
Scratched  
Over 25mm Thru Paint

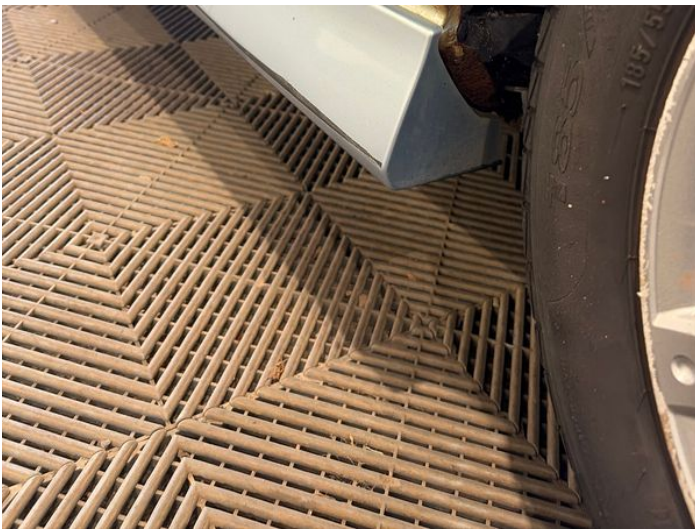
11: Sill Panel Trim ns  
Scratched (Painted)  
Over 25mm Thru Paint

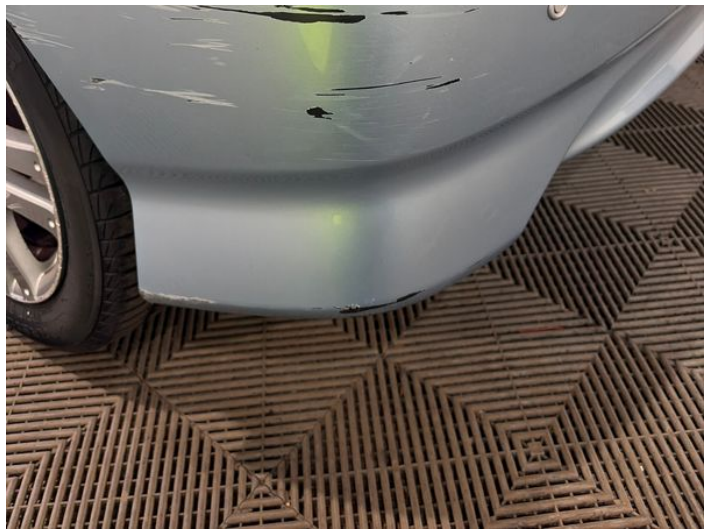
12: Bumper Rear  
Dented  
With Paint Damage

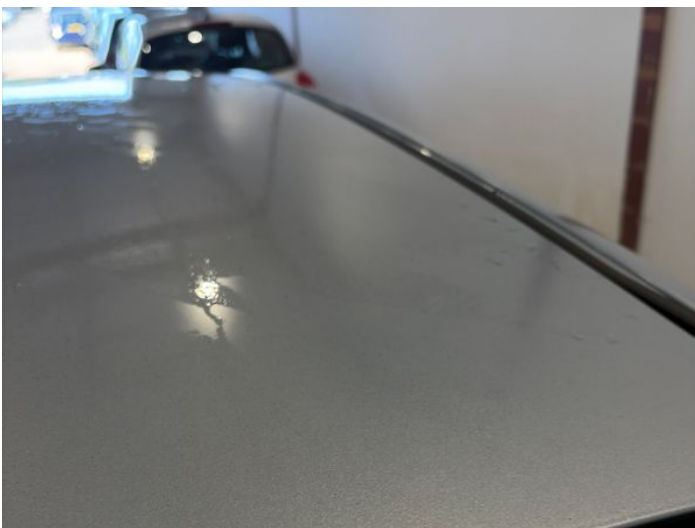
13: Roof  
Dented  
2 Or Less UpTo 10mm

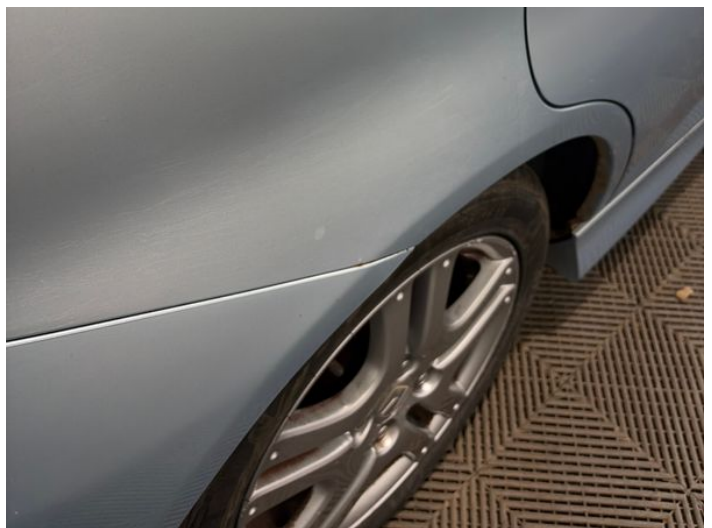
14: Qtr Panel osr  
Poor Previous Repair  
Rippled UpTo 30%

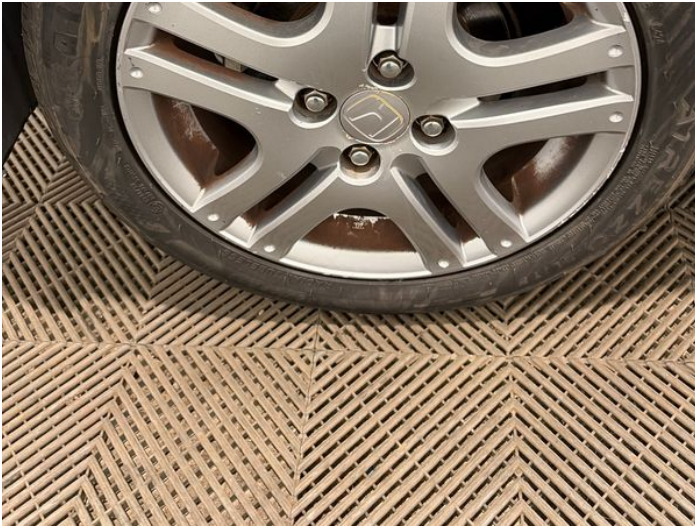
15: Wheel osr  
Scratched  
Over 50mm

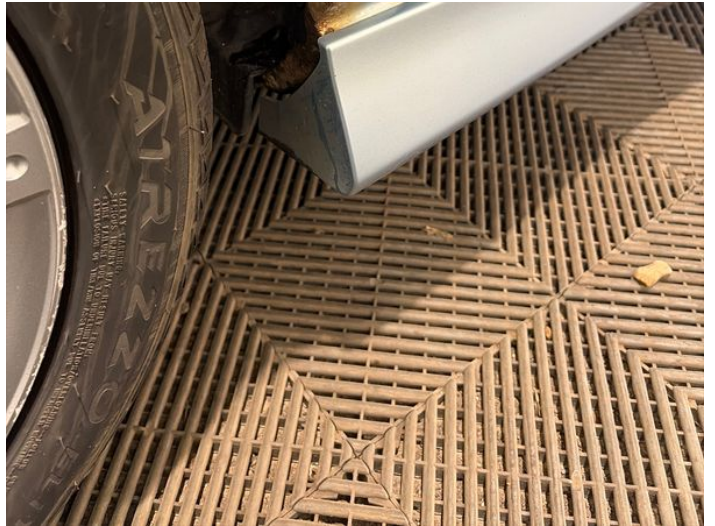
16: Sill os  
Rusted  
Over 5mm

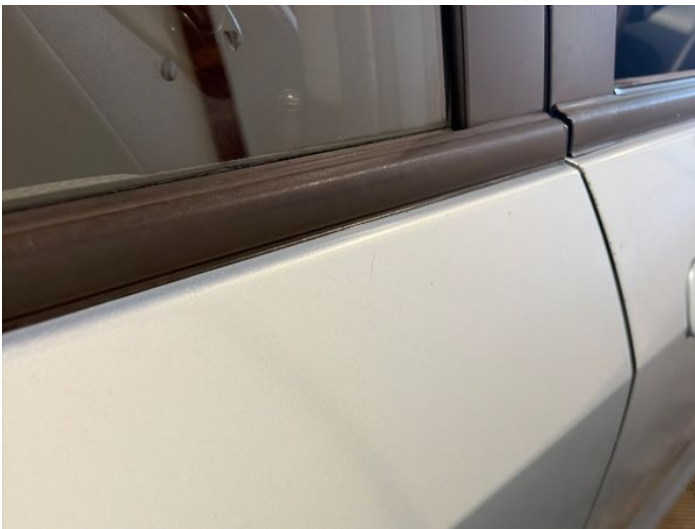
17: Door osr  
Dented  
With Paint Damage

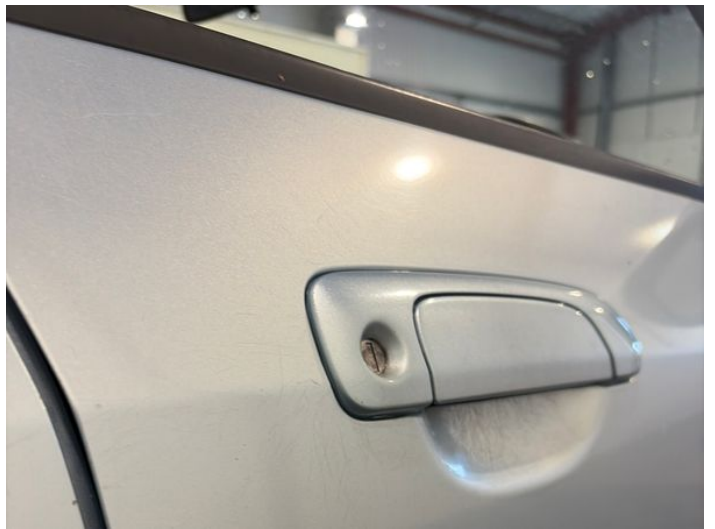
18: Door osf  
Scratched  
Over 25mm Thru Paint

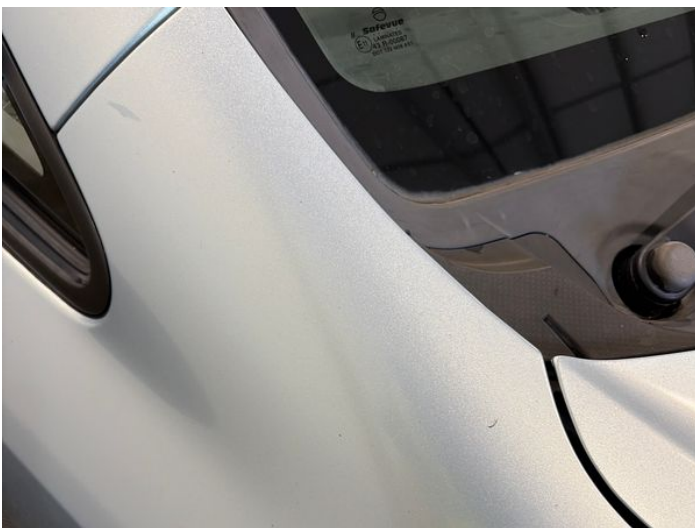
19: Wing osf  
Scratched  
Over 25mm Thru Paint

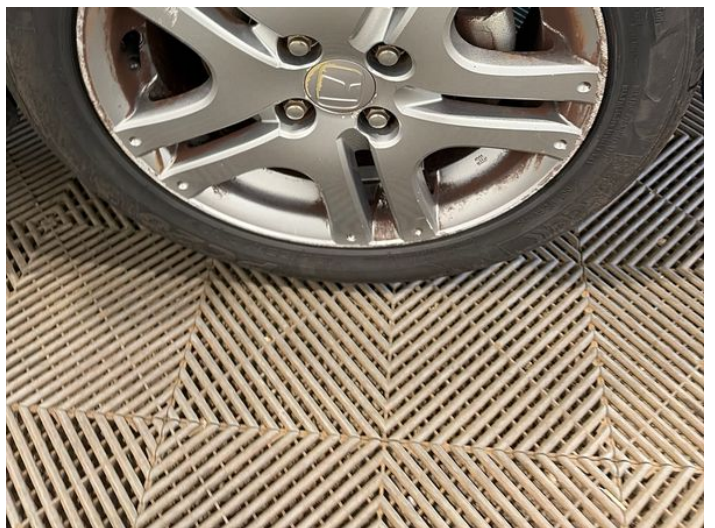
20: Wheel osf  
Scratched  
Over 50mm
