## VEHICLE INSPECTION REPORT

**YS70YGD**

### Ford Transit Custom 2.0 EcoBlue 130ps Low Roof Limited Van

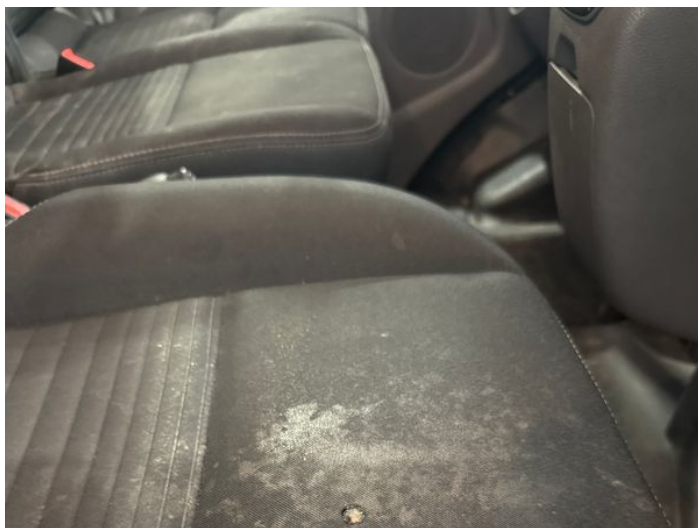
1: Seat Base Cover osf  
Burn  
Over 3mm

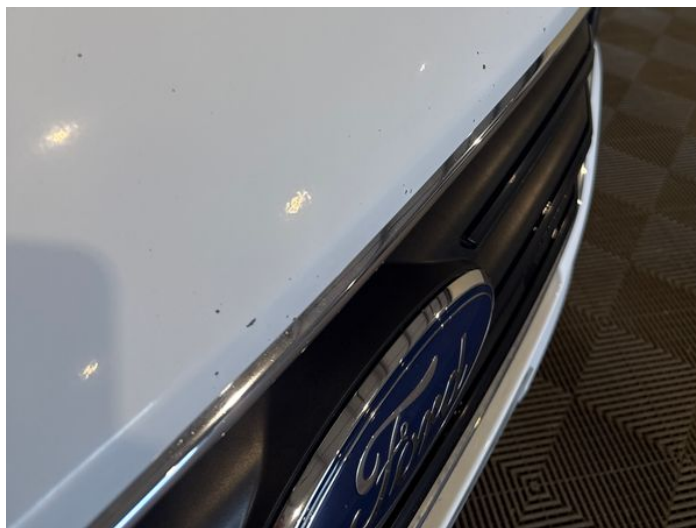
2: Bonnet  
Dented  
With Paint Damage

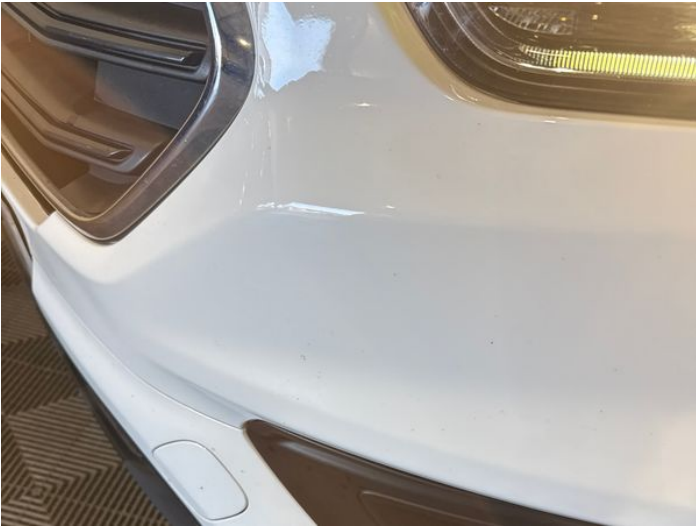
3: Bumper Front  
Chipped  
Multiple Chips

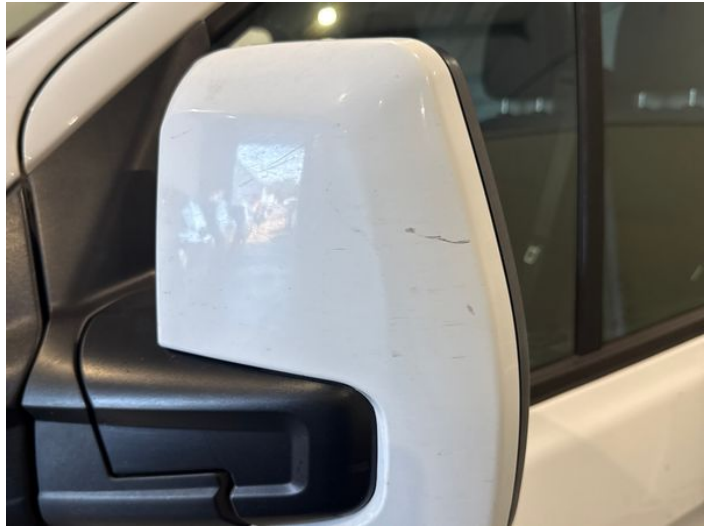
4: Door Mirror Assy nsf  
Scratched (Painted)  
UpTo 25mm Thru Paint

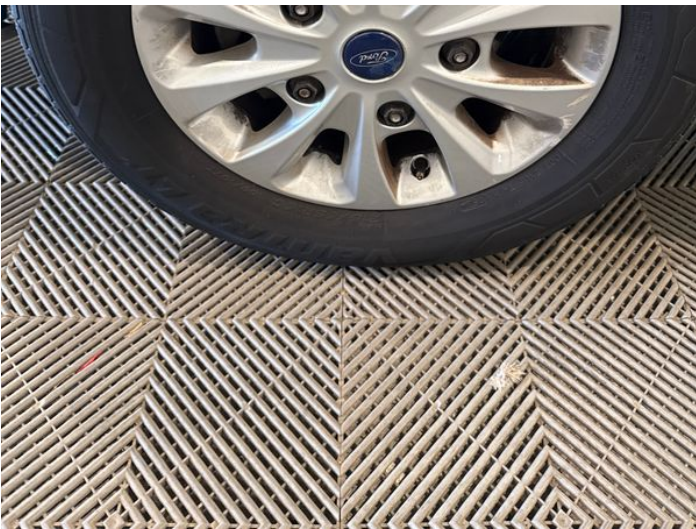
5: Wheel nsf  
Scratched  
Over 50mm

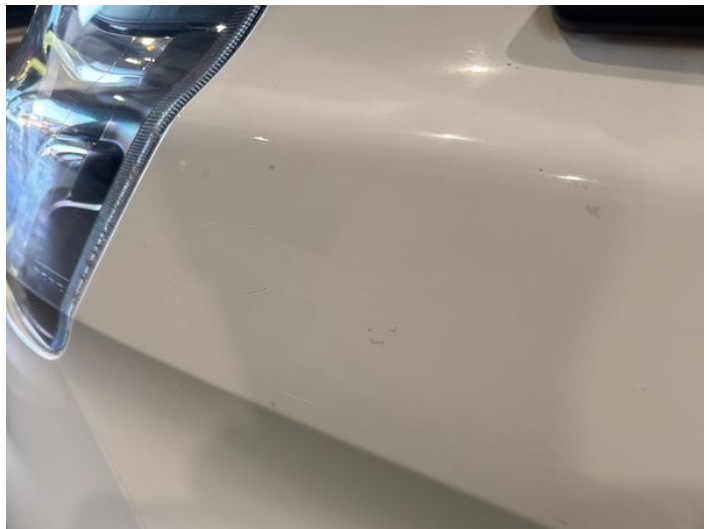
6: Wing nsf  
Scratched  
Over 25mm Thru Paint

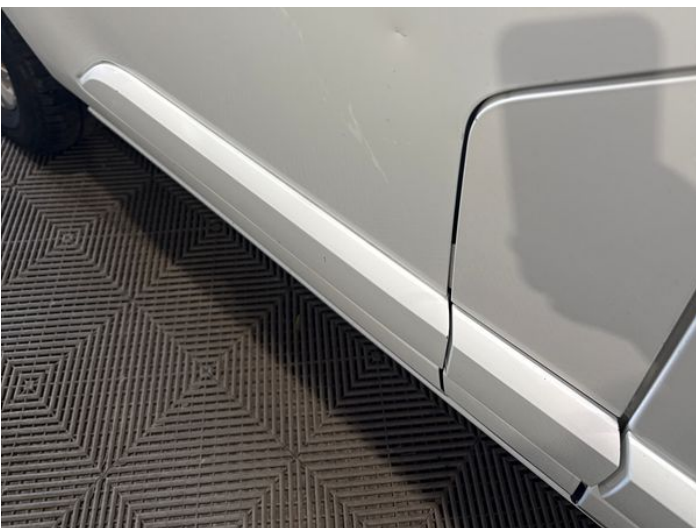
7: Door nsf  
Dented  
With Paint Damage

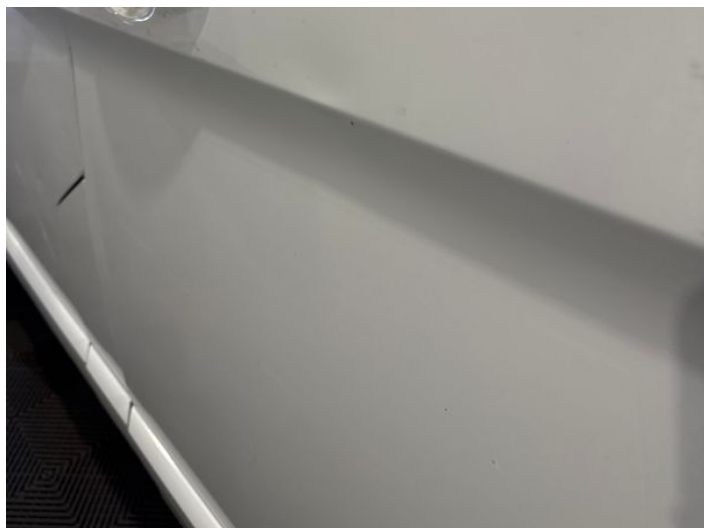
8: Door nsr  
Dented  
Over 30mm

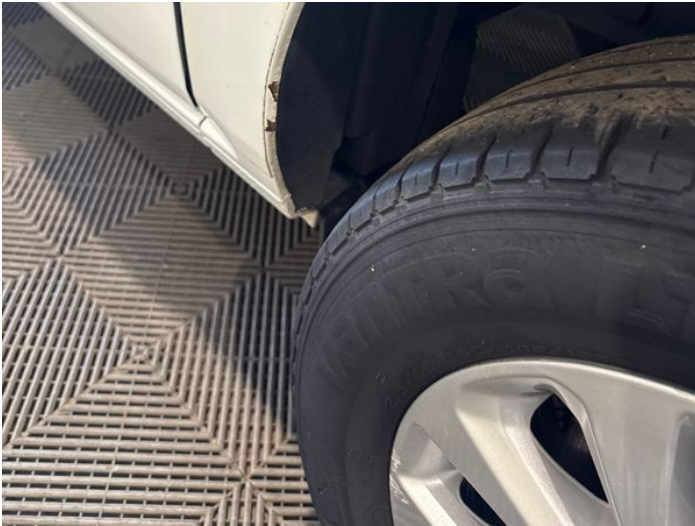
9: Qtr Panel nsr  
Rusted  
Over 5mm

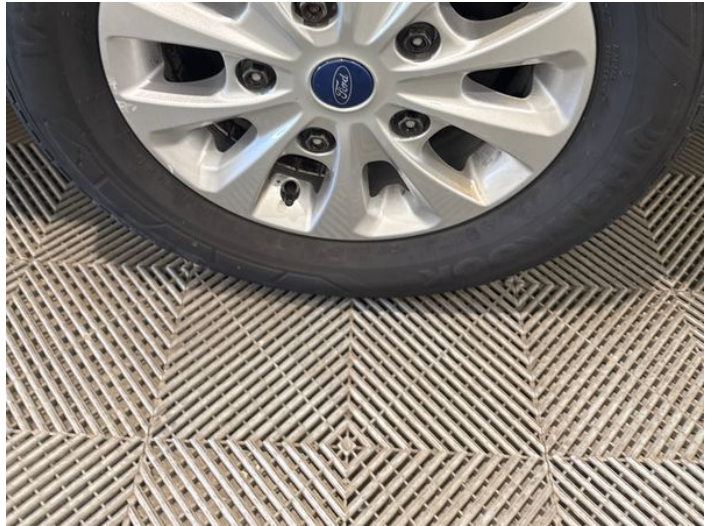
10: Wheel nsr  
Scratched  
Over 50mm

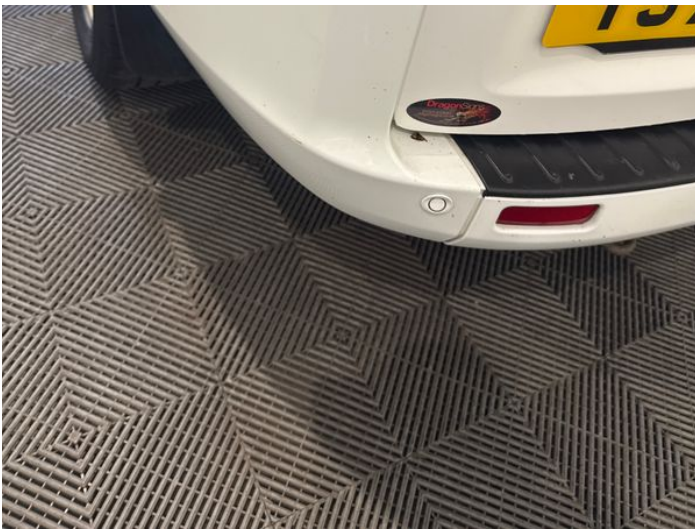
11: Bumper Rear  
Scratched  
25 to 100mm Thru Paint

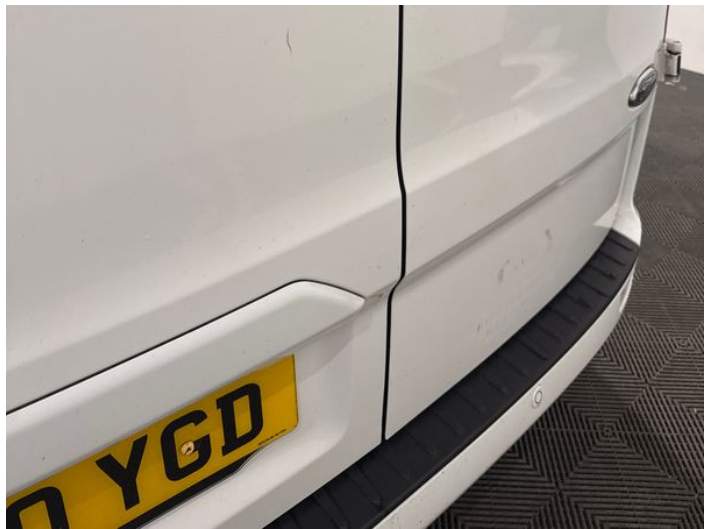
12: Tailgate  
Dented  
With Paint Damage

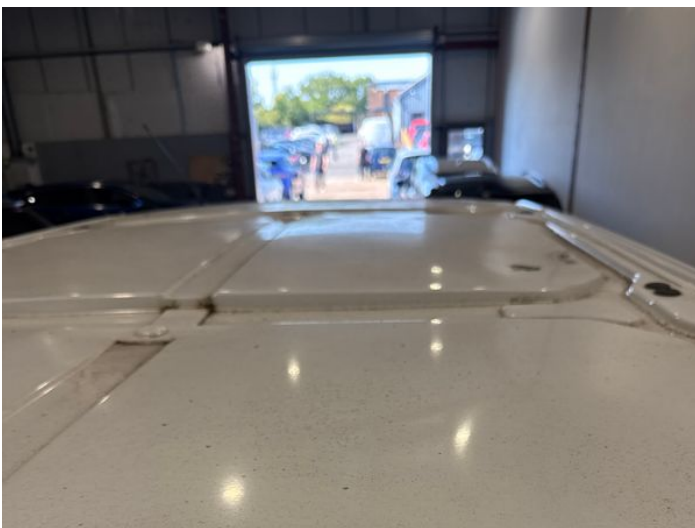
13: Roof  
Dented  
Over 30mm

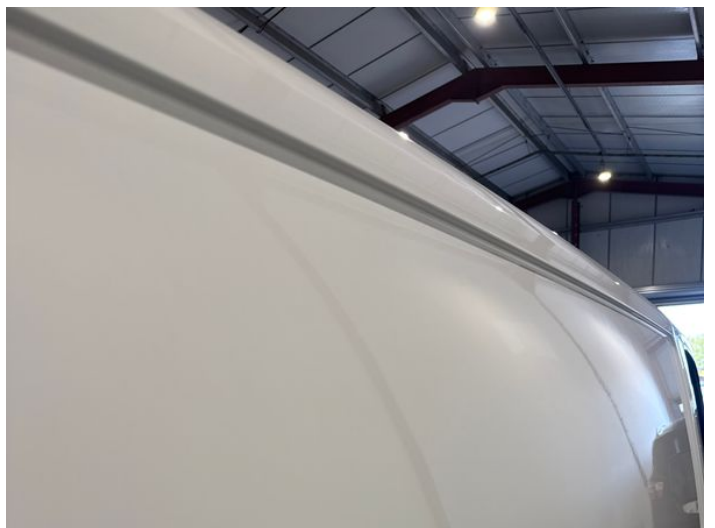
14: Qtr Panel osr  
Dented  
Over 30mm

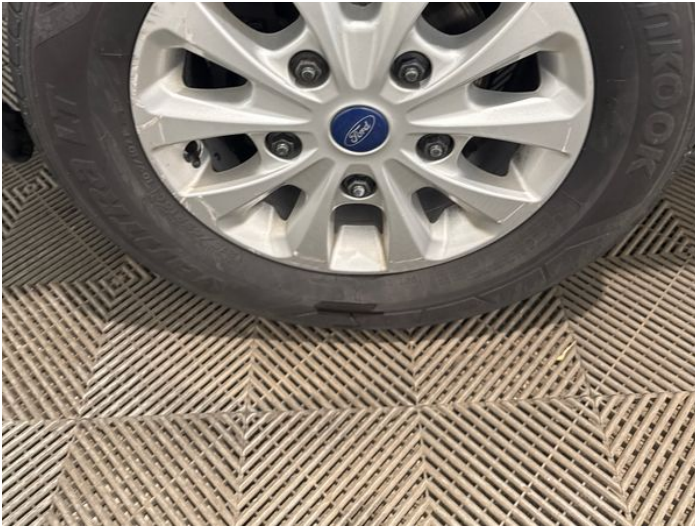
15: Wheel osr  
Scratched  
Over 50mm

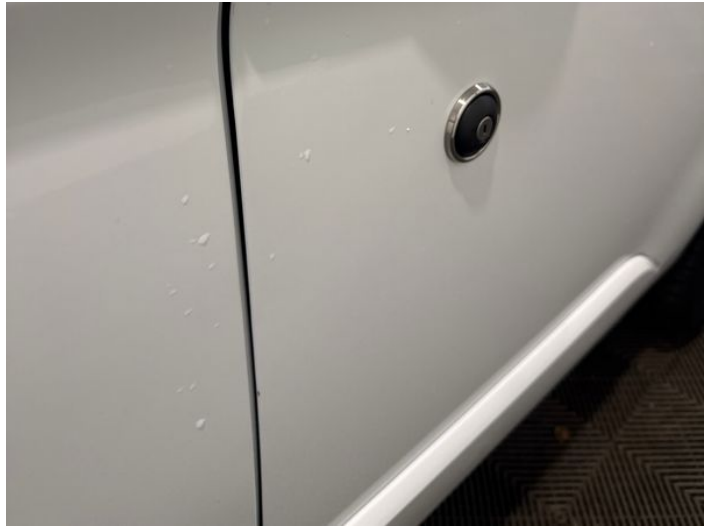
16: Door osf  
Chipped  
Edge Chip

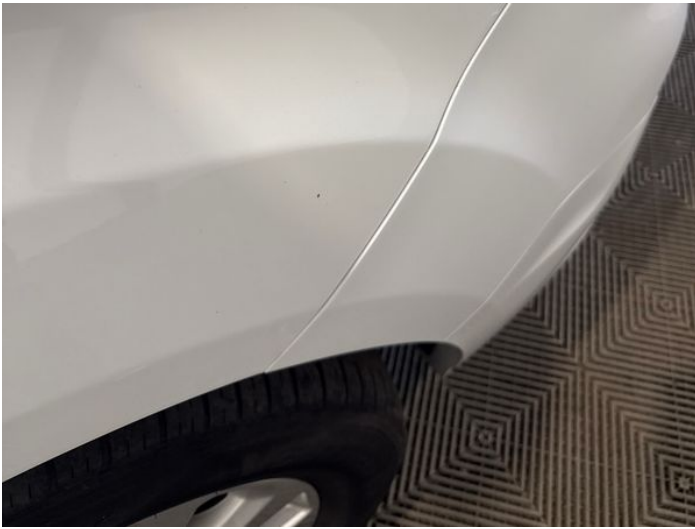
17: Wing osf  
Chipped  
1 To 5

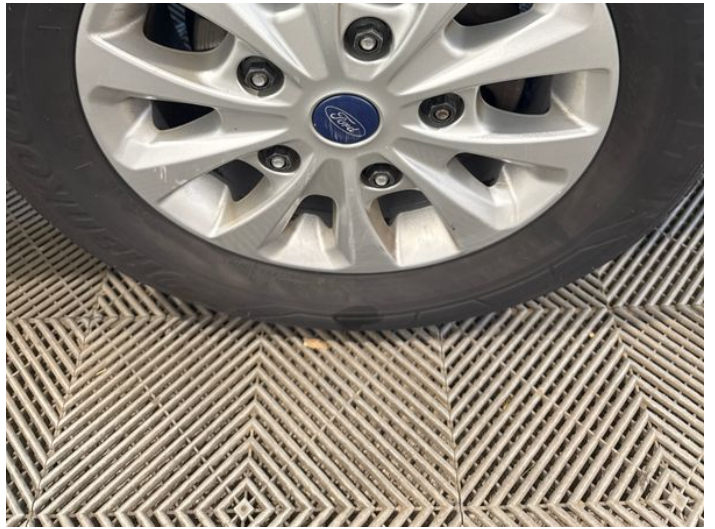
18: Wheel osf  
Scratched  
Over 50mm

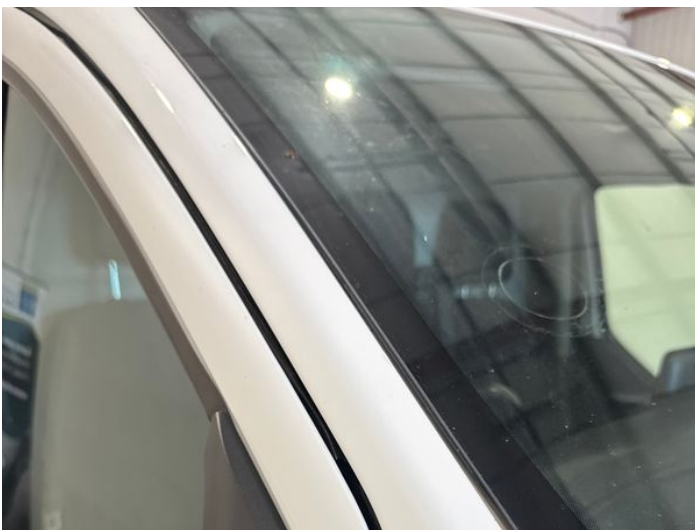
19: A Post os  
Chipped  
1 To 5

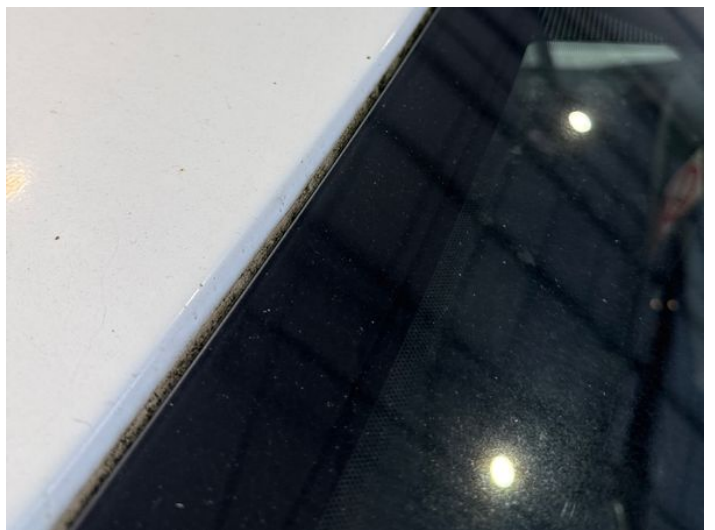
20: Roof  
Chipped  
Edge Chip

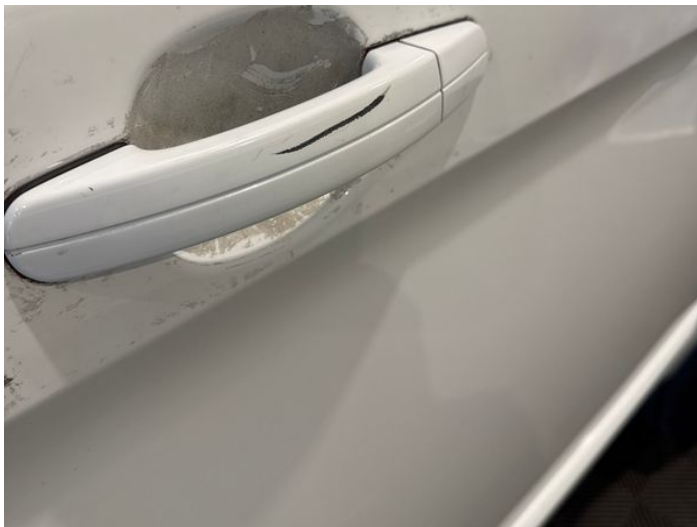
21: Handle Outer nsr  
Scratched (Painted)  
Over 25mm Thru Paint

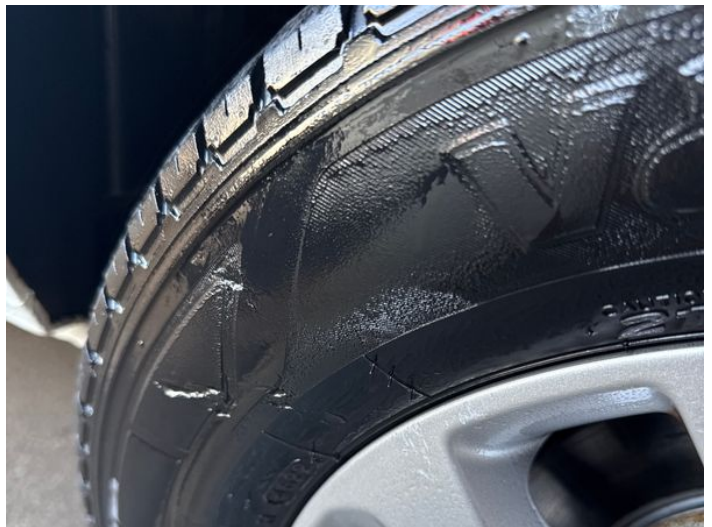
22: Tyre nsr  
Damaged  
Replace
