## VEHICLE INSPECTION REPORT

**LX66HHL**

### Mitsubishi Outlander 2.2 DI-D 4 5dr Auto

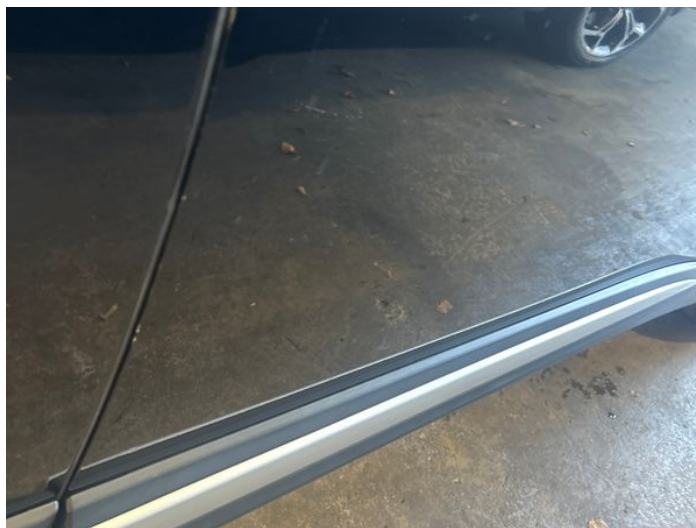
2: Door osf  
Chipped  
Edge Chip

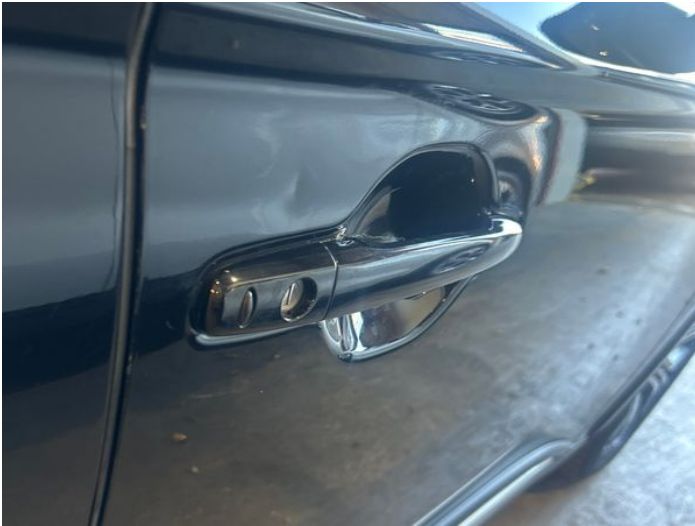
3: Door osf  
Dented  
Between 10mm + 30mm

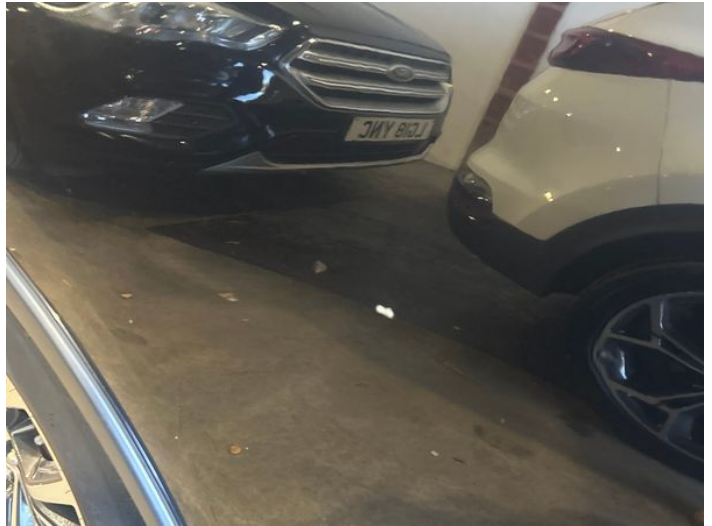
4: Door osr  
Chipped  
1 To 5

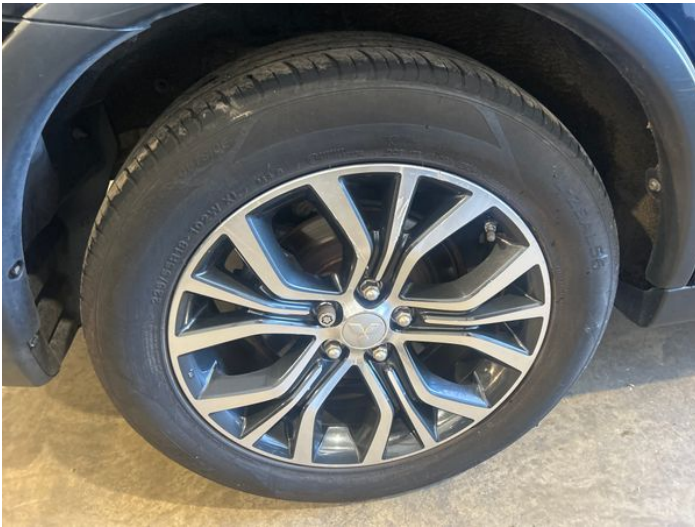
5: Wheel osr  
Scratched  
Over 50mm

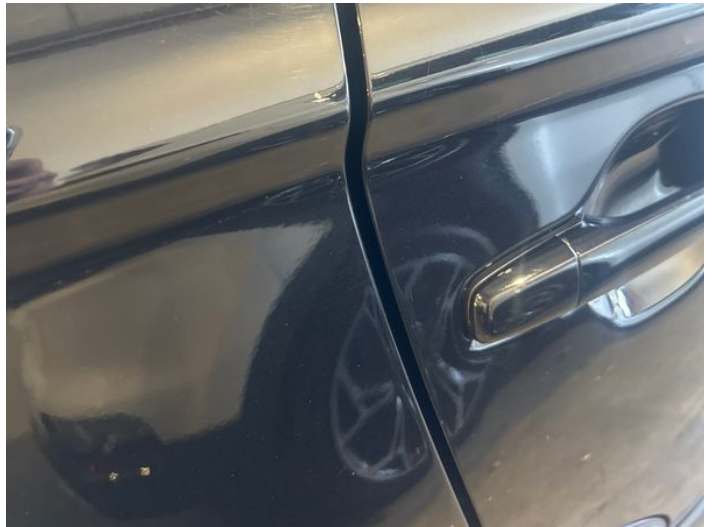
6: Qtr Panel osr  
Chipped  
1 To 5

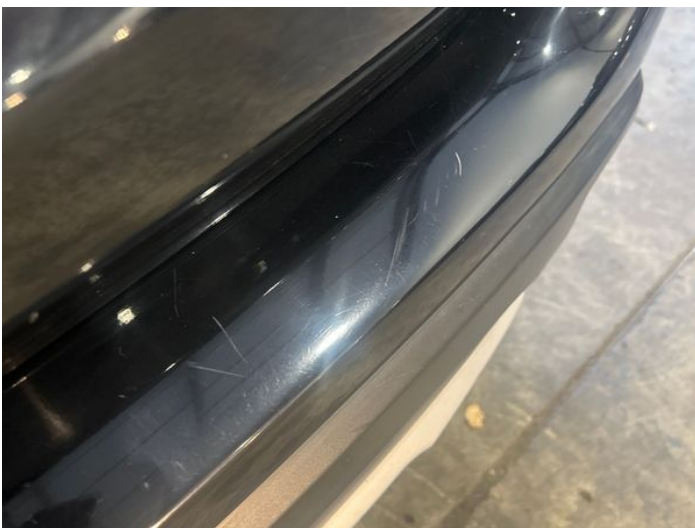
7: Bumper Rear  
Scratched  
25 to 100mm Thru Paint

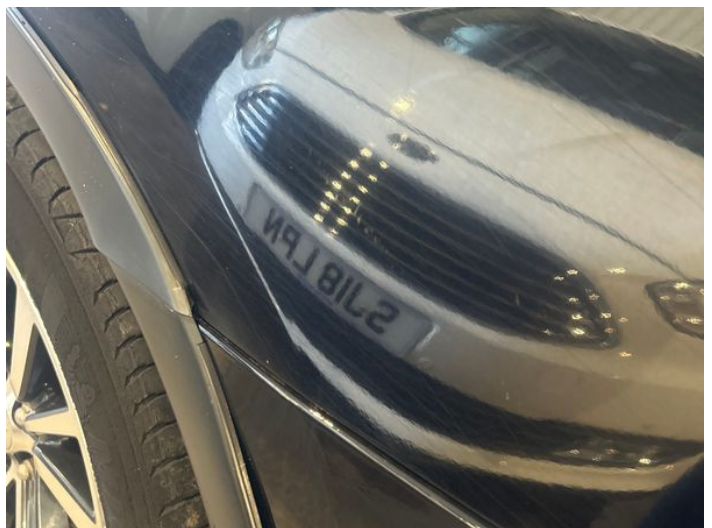
8: Qtr Panel nsr  
Chipped  
1 To 5

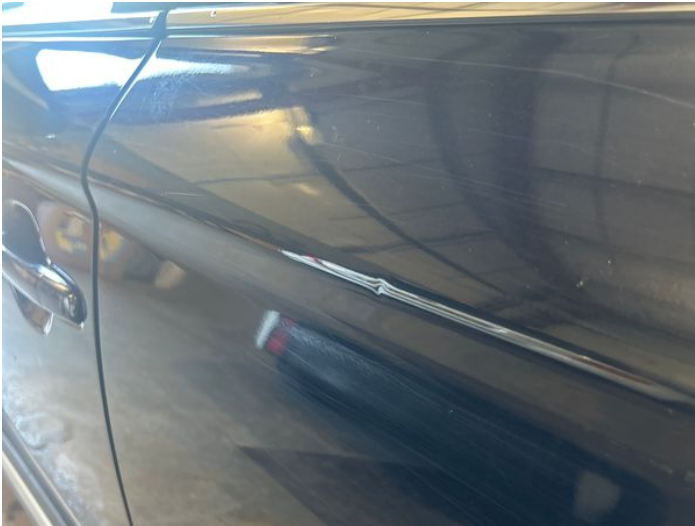
9: Door nsr  
Dented  
2 Or Less UpTo 10mm

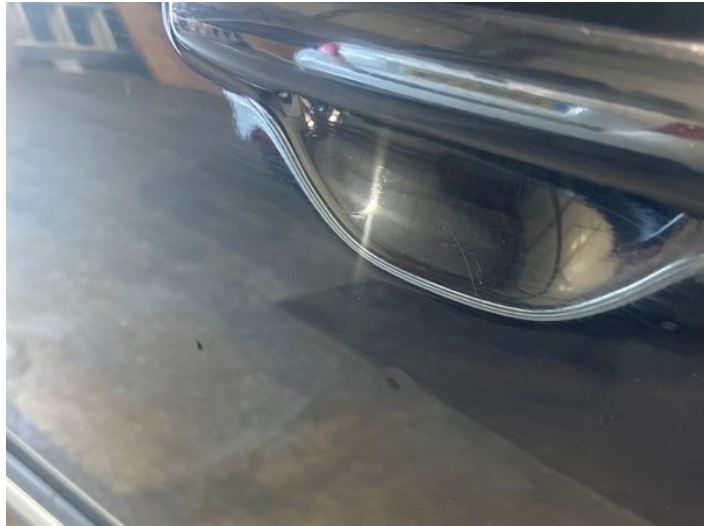
10: Door nsf  
Dented  
2 Or Less UpTo 10mm

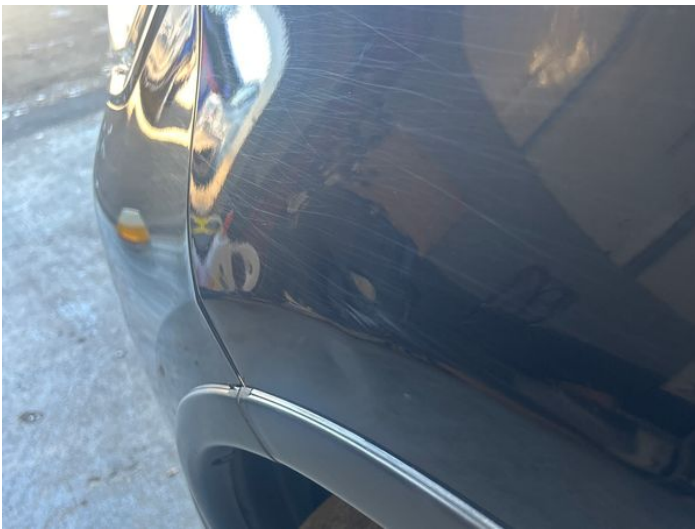
11: Wing nsf  
Dented  
Over 30mm

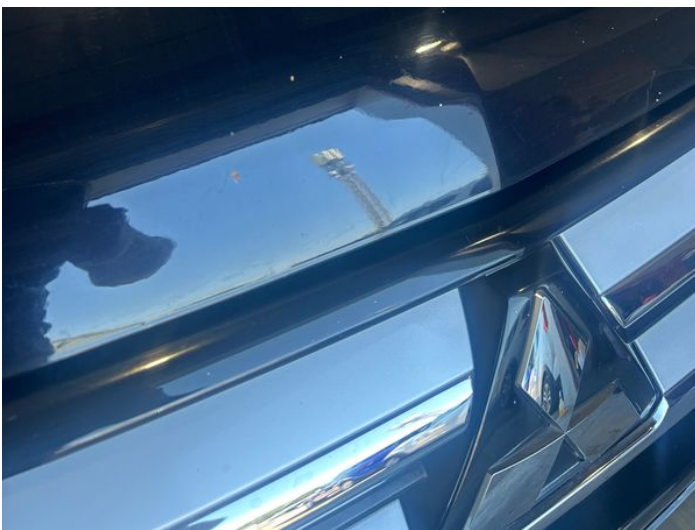
13: Bonnet  
Chipped  
1 To 5

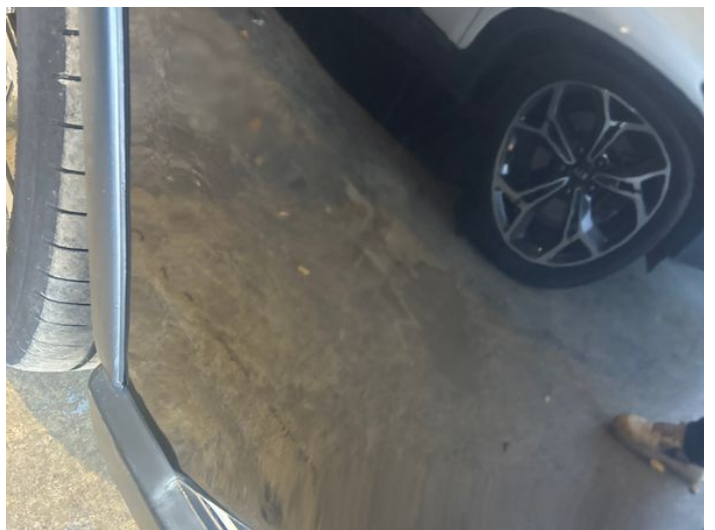
14: Bumper Front  
Scratched  
25 to 100mm Thru Paint

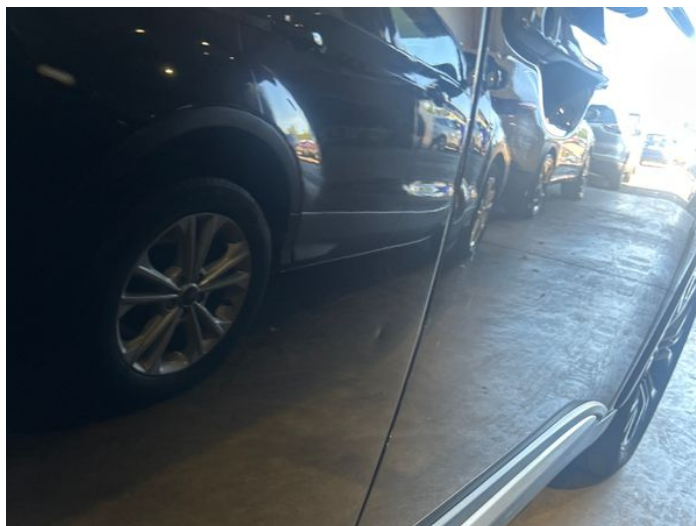
16: Door osr  
Dented  
Between 10mm + 30mm
