## VEHICLE INSPECTION REPORT

**GF23YWZ**

### Dacia Duster 1.5 Blue dCi Extreme SE 5dr 4X4

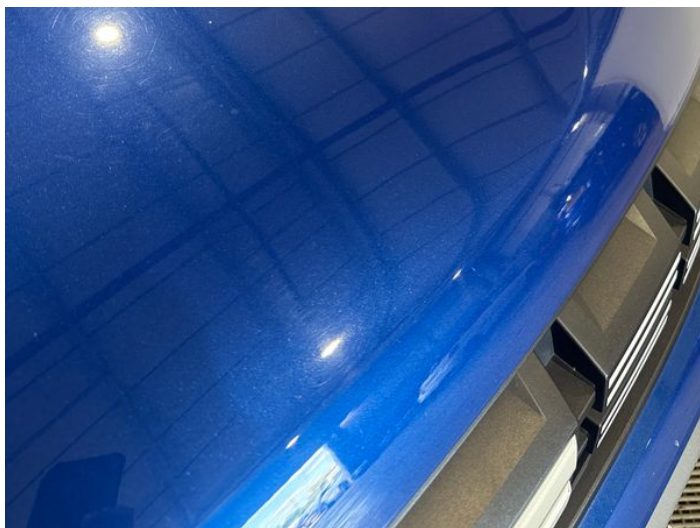
1: Bonnet  
Chipped  
1 To 5

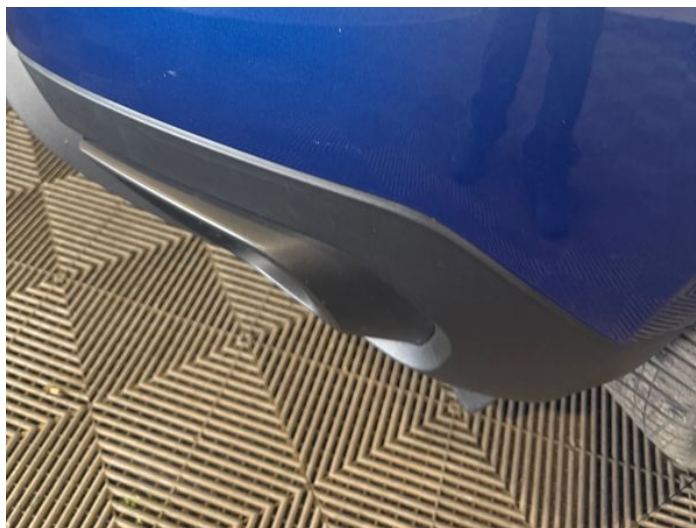
2: Bumper Front  
Scratched  
UpTo 25mm Thru Paint

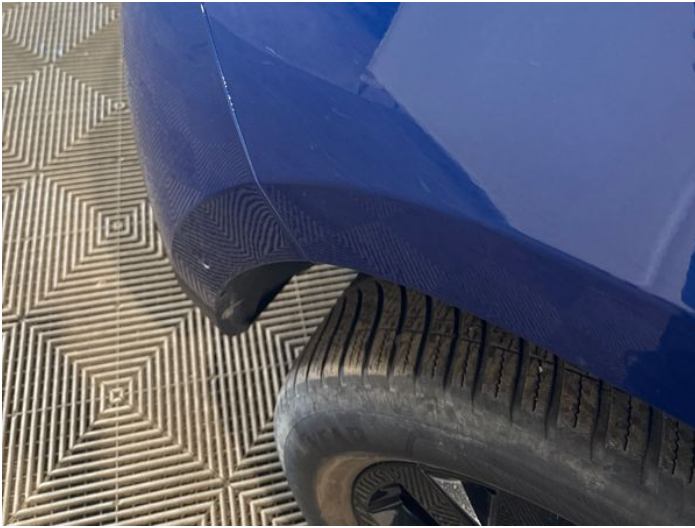
3: Wing nsf  
Scratched  
UpTo 25mm Thru Paint

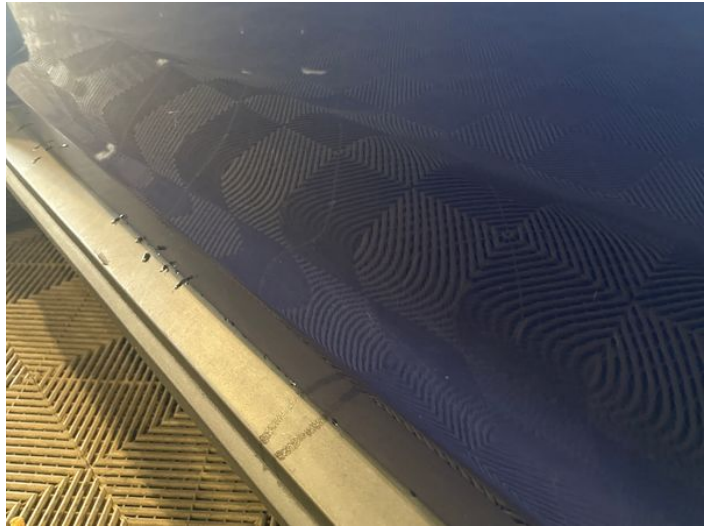
4: Door nsf  
Scratched  
UpTo 25mm Thru Paint

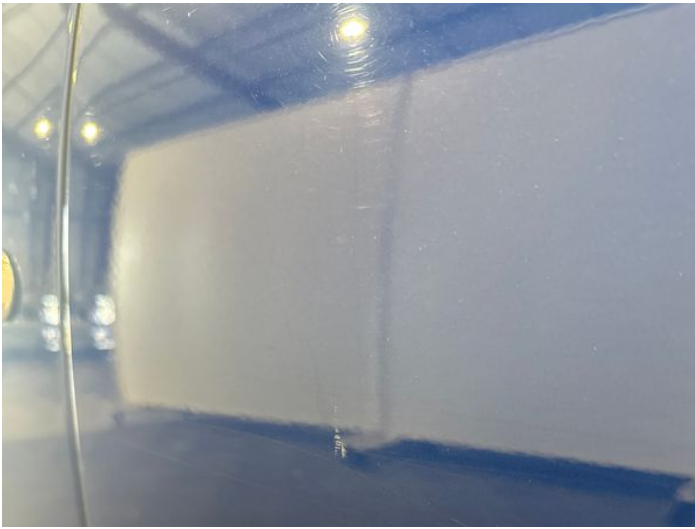
5: Door nsr  
Scratched  
UpTo 25mm Thru Paint

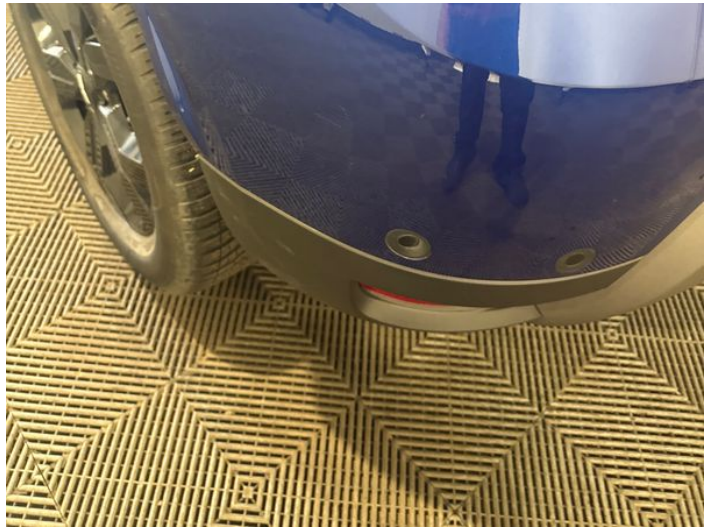
6: Bumper Rear  
Scratched  
25 to 100mm Thru Paint

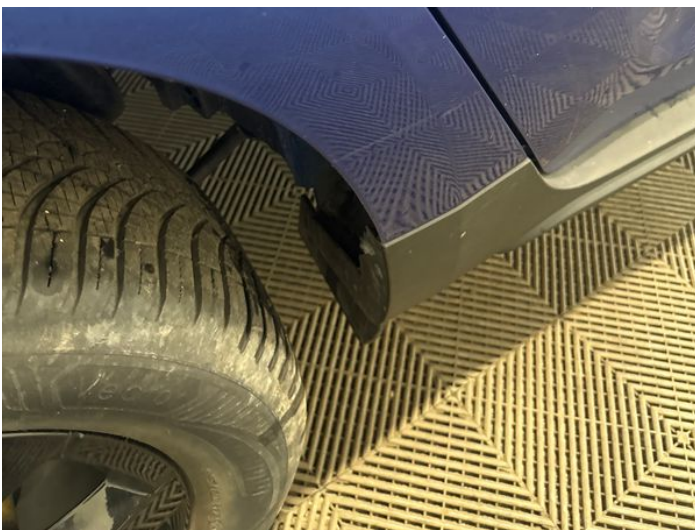
7: Qtr Panel osr  
Scratched  
Over 25mm Thru Paint

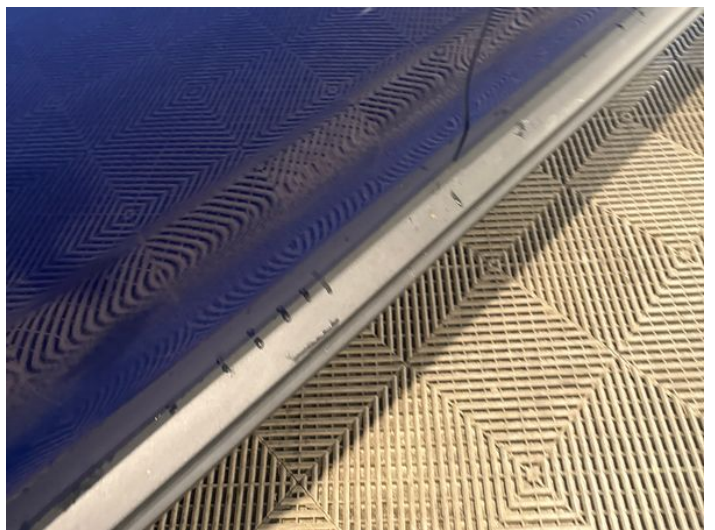
8: Door osr  
Scratched  
UpTo 25mm Thru Paint

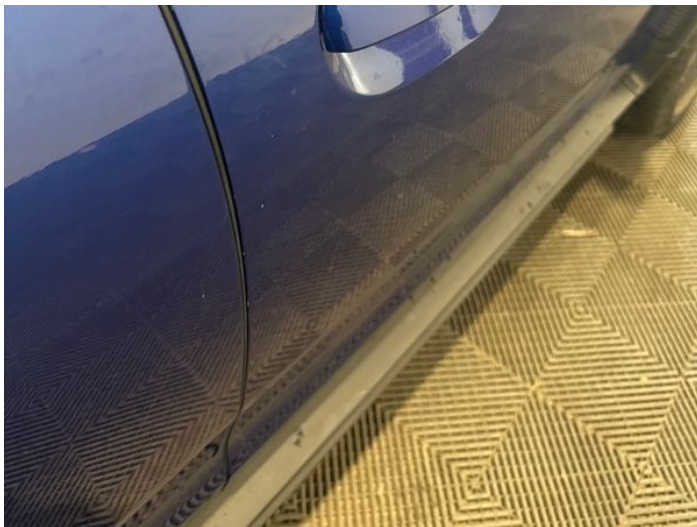
9: Door osf  
Chipped  
1 To 5

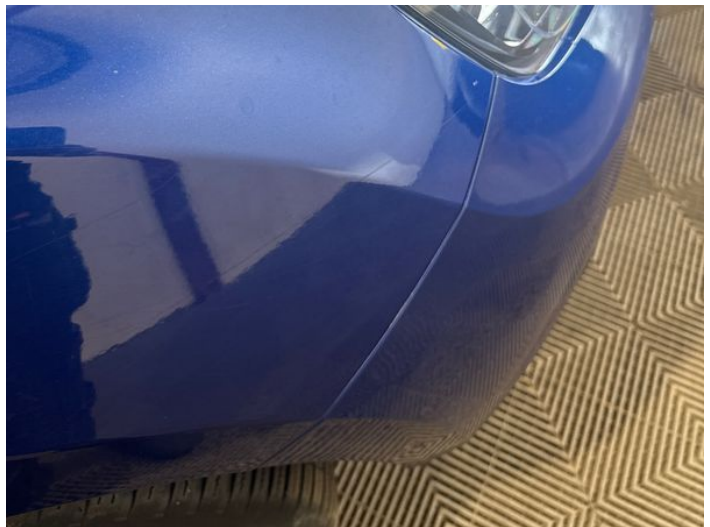
10: Wing osf  
Chipped  
1 To 5
