# VEHICLE INSPECTION REPORT

**LL61KVZ**

## Mercedes-Benz SLK SLK 200 BlueEFFICIENCY 2dr Tip Auto

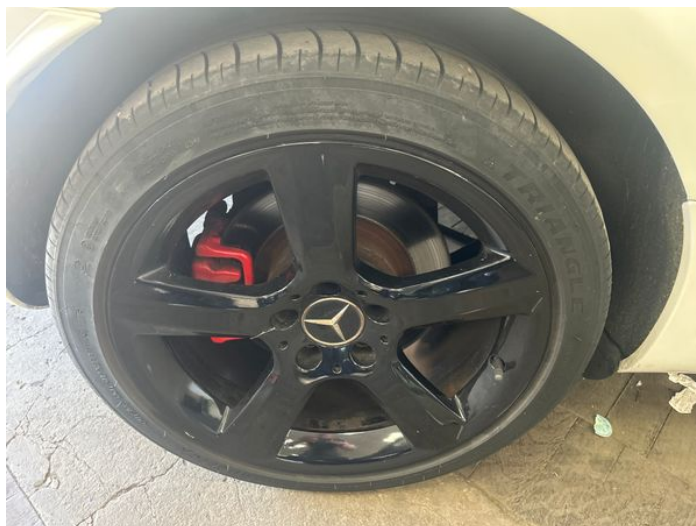
2: Wheel osr  
Scratched  
Up To 50mm

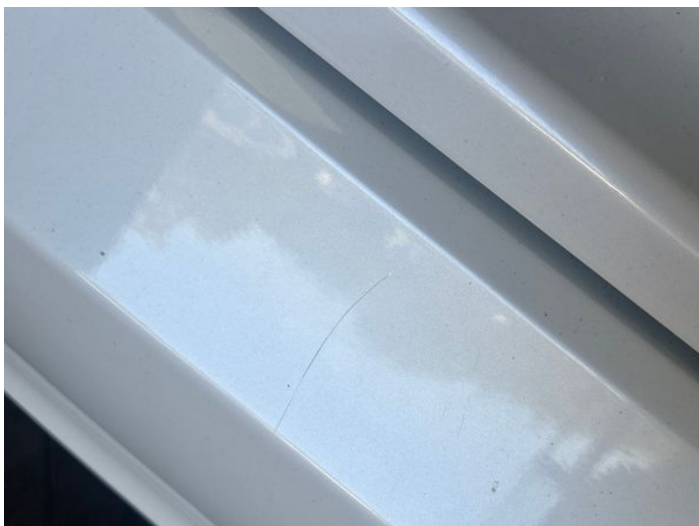
3: Bumper Rear  
Scratched  
25 to 100mm Thru Paint

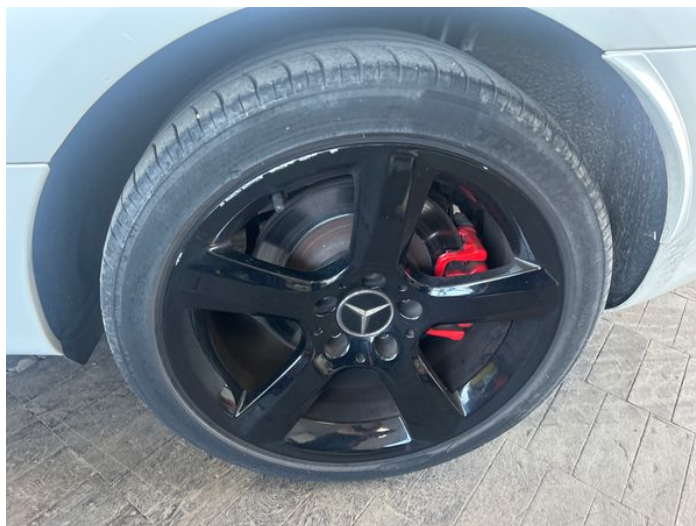
4: Wheel nsr  
Scratched  
Over 50mm

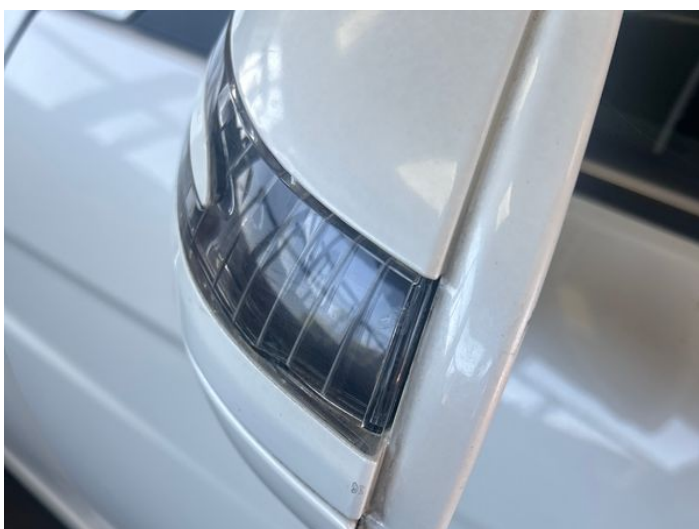
5: Door Mirror Assy nsf  
Scratched (Painted)  
UpTo 25mm Thru Paint

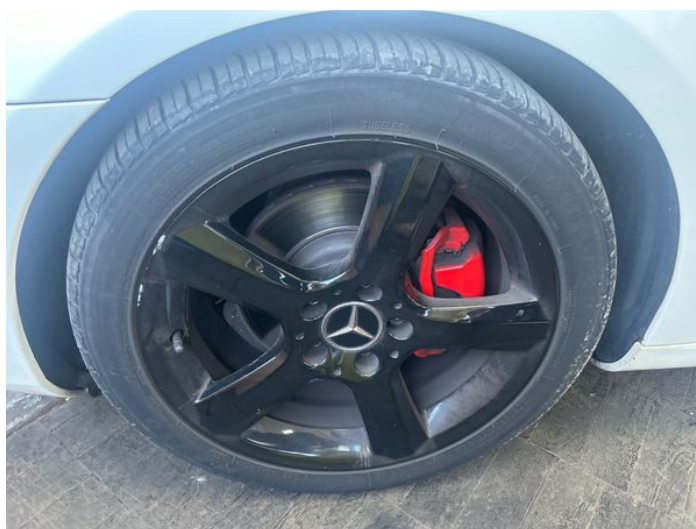
6: Wheel nsf  
Scratched  
Up To 50mm

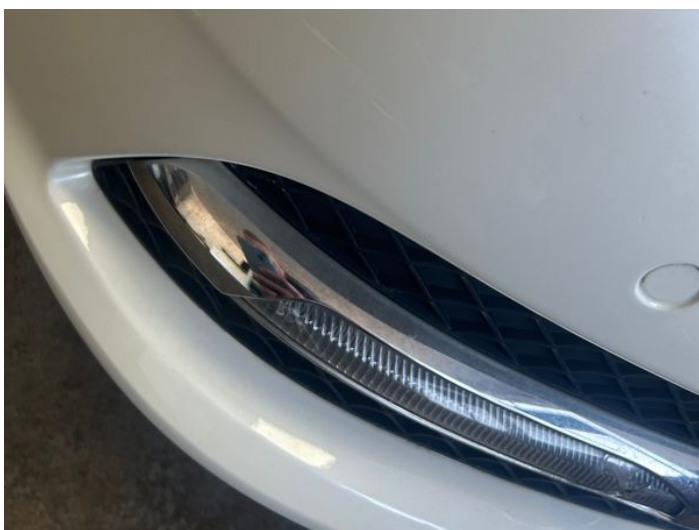
7: Bumper Front  
Scratched  
UpTo 25mm Thru Paint

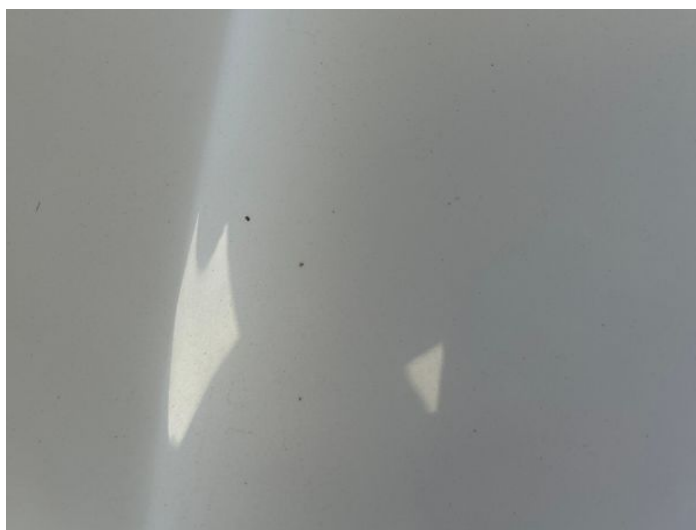
8: Bonnet  
Chipped  
1 To 5

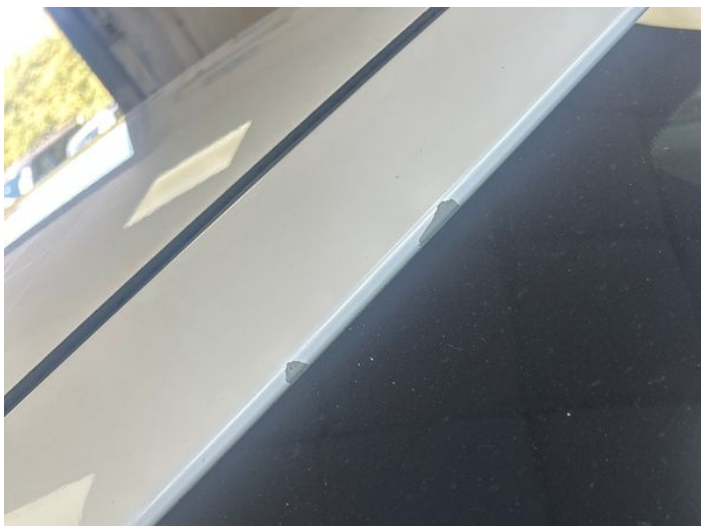
9: Roof  
Poor Previous Repair  
Paint Flake

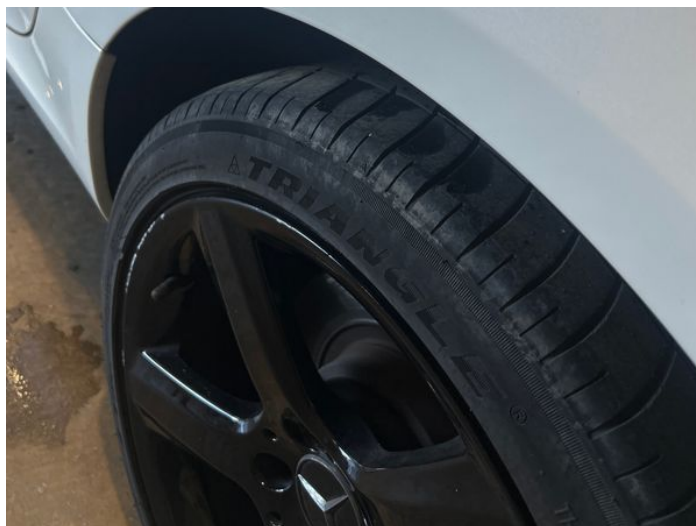
10: Qtr Panel nsr  
Dented  
Between 10mm + 30mm

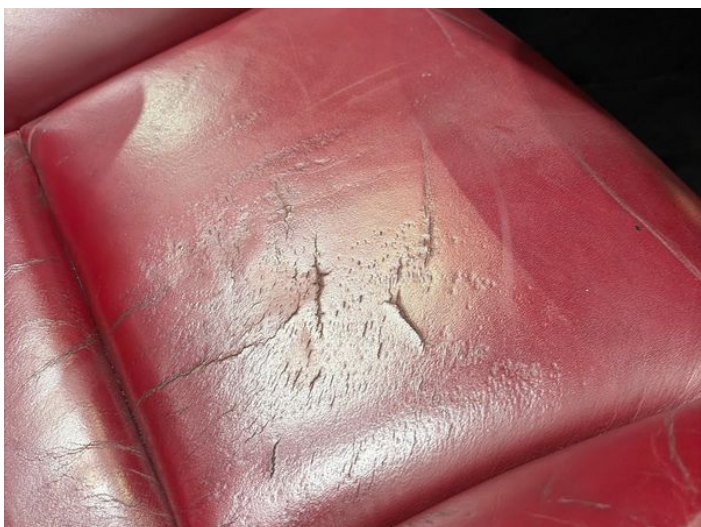
11: Seat Base Cover osf  
Torn  
Over 3mm

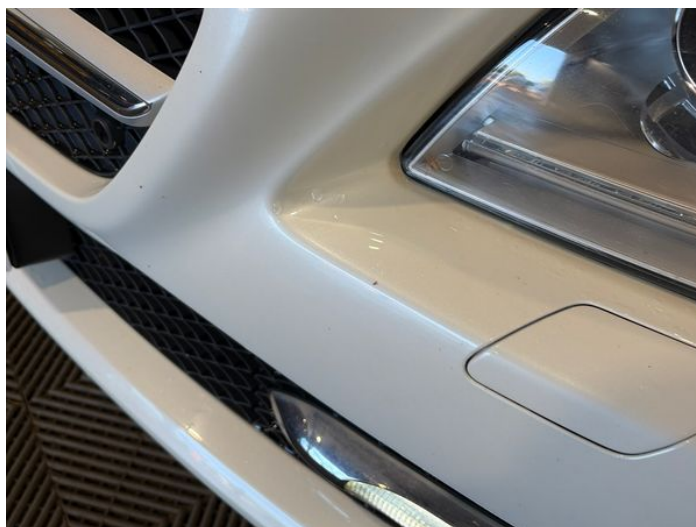
12: Bumper Front  
Chipped  
1 To 5

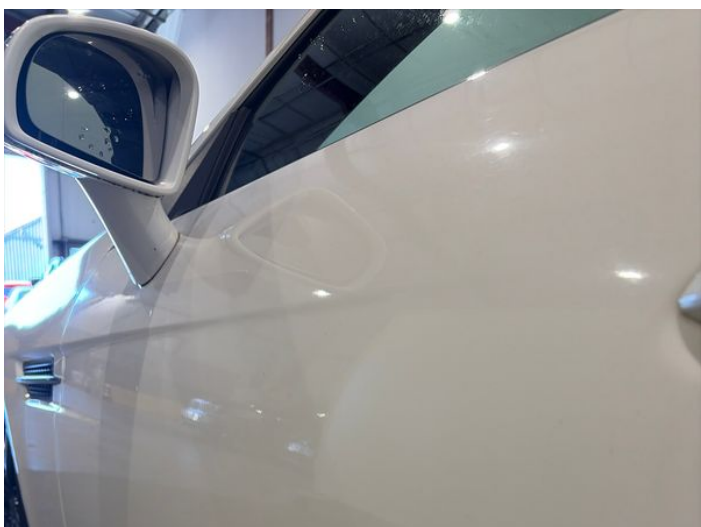
13: Door nsf  
Dented  
Between 10mm + 30mm

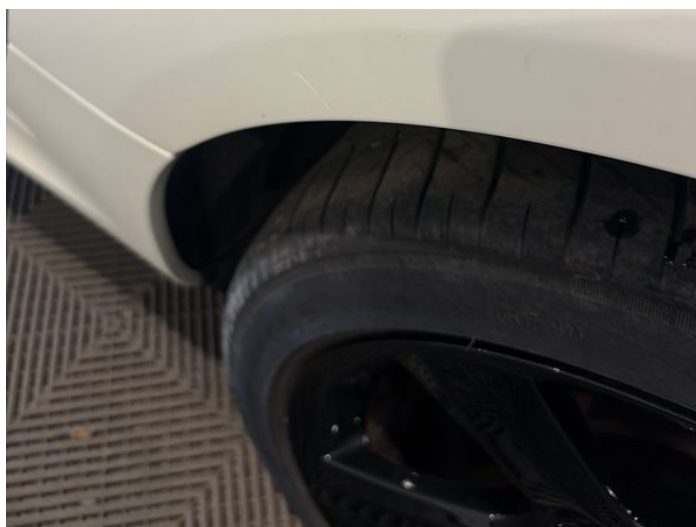
14: Qtr Panel nsr  
Scratched  
UpTo 25mm Thru Paint

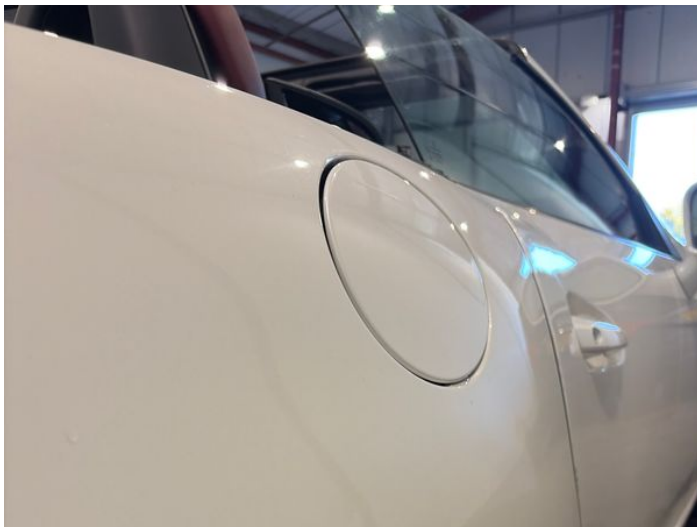
15: Qtr Panel osr  
Dented  
2 Or Less UpTo 10mm

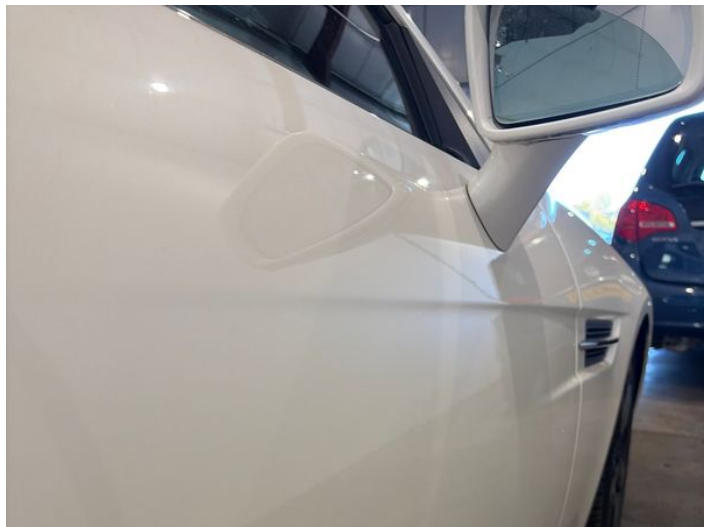
16: Door osf  
Dented  
Over 30mm
