# VEHICLE INSPECTION REPORT

**YD61PVT**

## Nissan Juke 1.6 DiG-T Tekna 5dr 4WD CVT

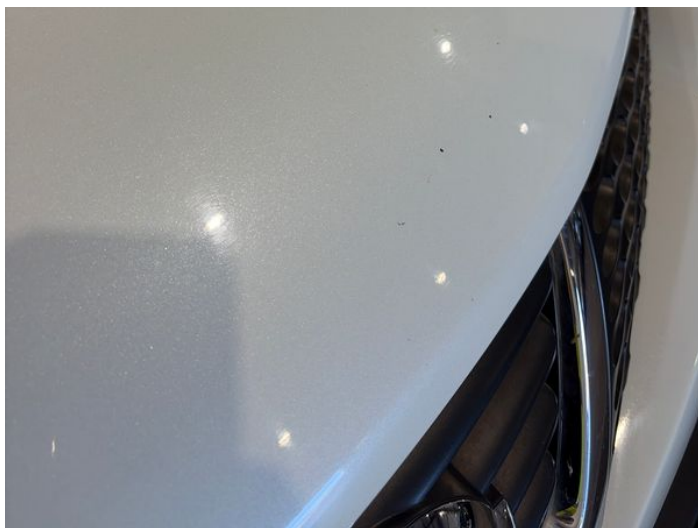
1: Bonnet  
Chipped  
1 To 5

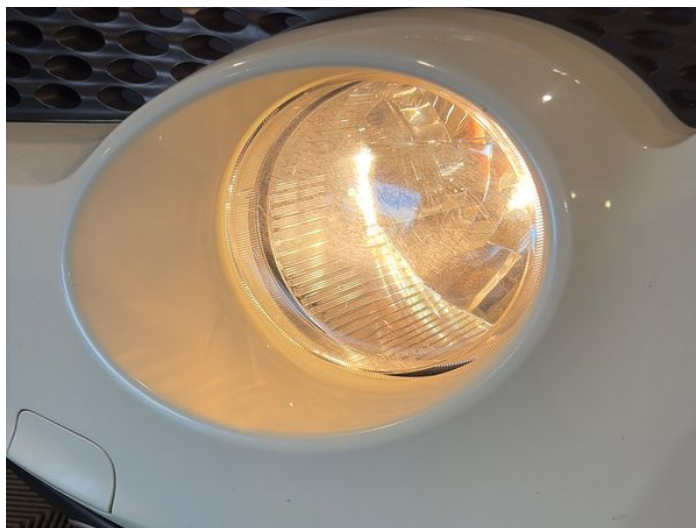
2: Bumper Front  
Chipped  
1 To 5

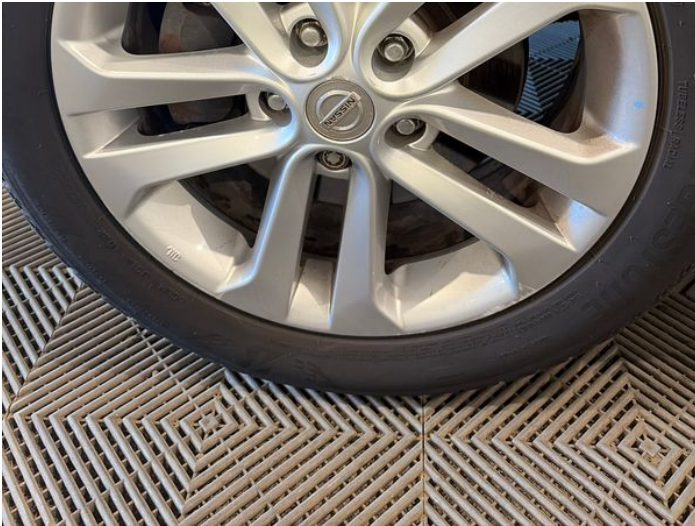
3: Wheel nsf  
Scratched  
Over 50mm

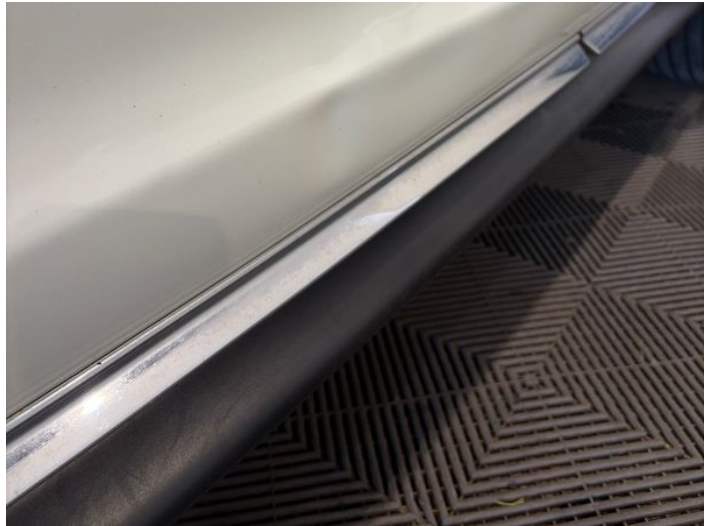
4: Door nsf  
Dented  
Over 30mm

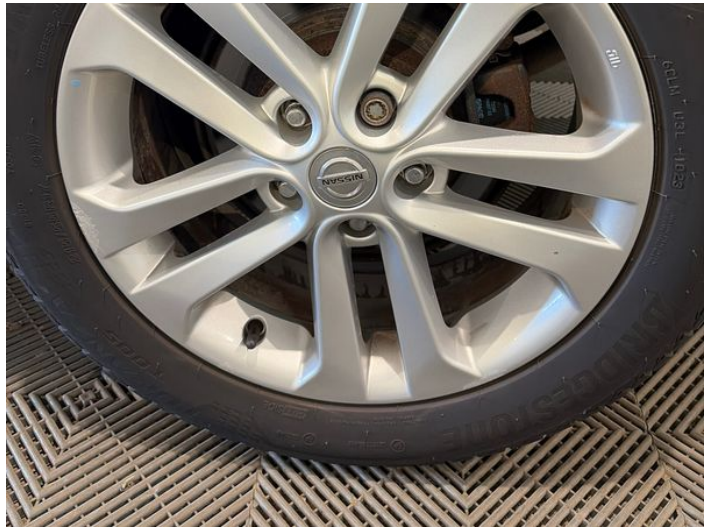
6: Wheel nsr  
Scratched  
Over 50mm

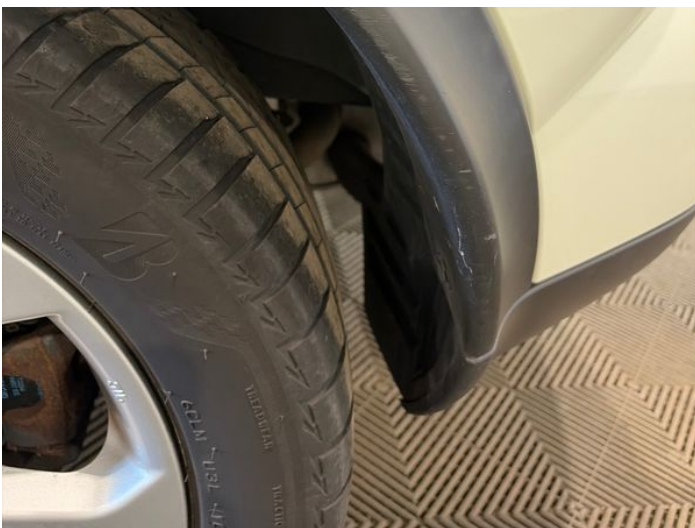
7: Qtr Panel Arch Extension ns  
Scuffed (Unpainted)  
Over 100mm

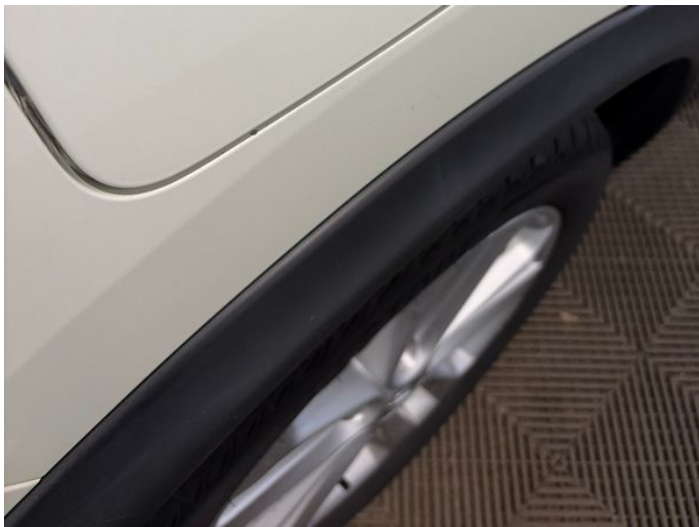
9: Qtr Panel osr  
Chipped  
1 To 5

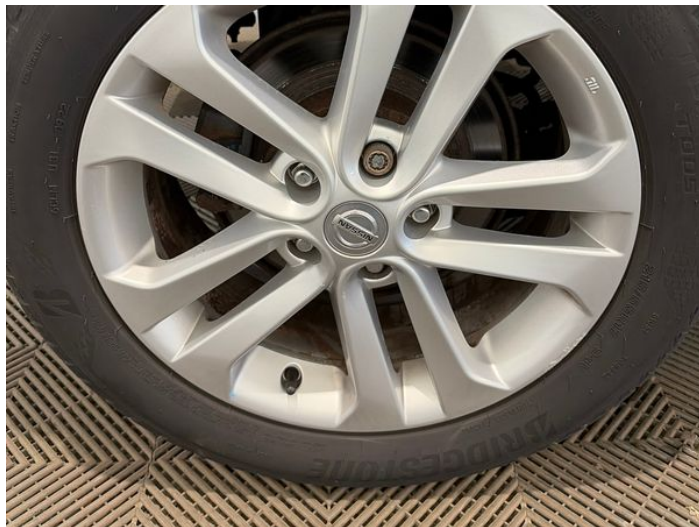
10: Wheel osr  
Scratched  
Over 50mm

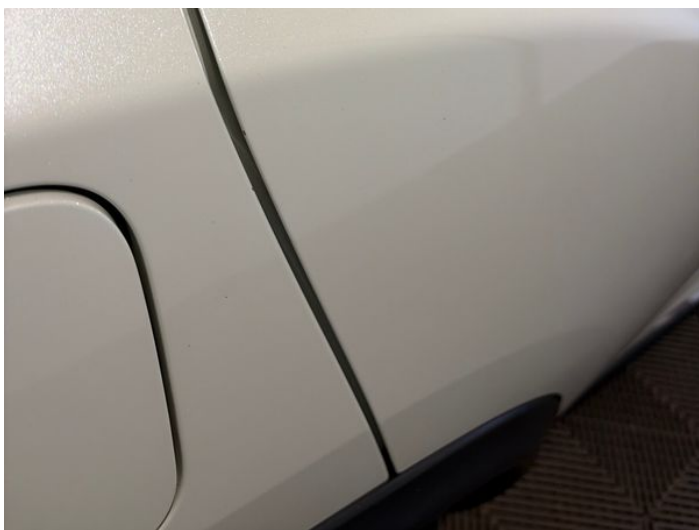
11: Door osr  
Chipped  
Edge Chip

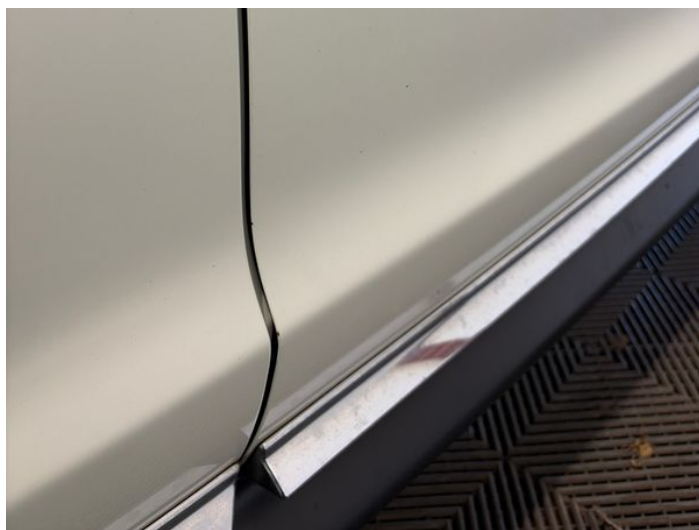
12: Door osf  
Chipped  
Edge Chip

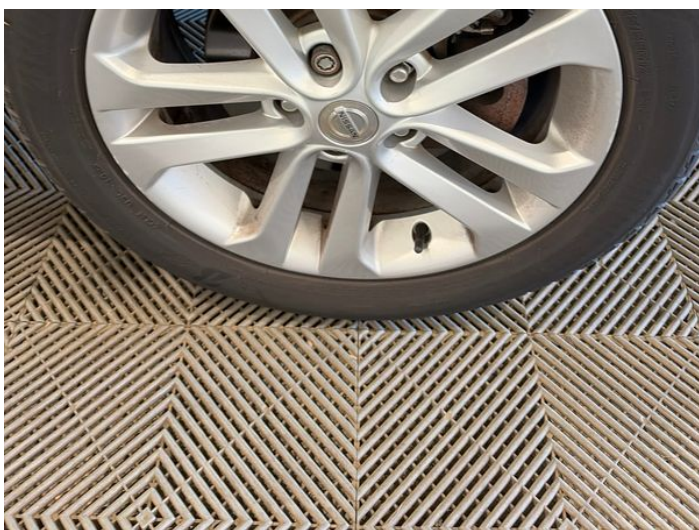
13: Wheel osf  
Scratched  
Over 50mm

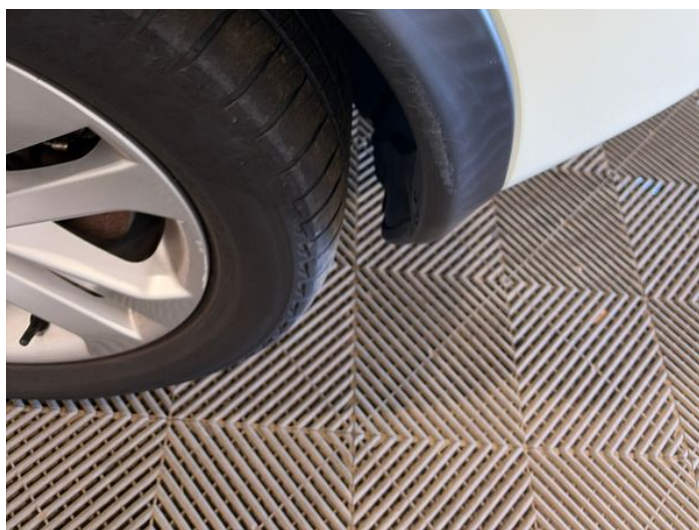
14: Wing Front Arch Extension os  
Scuffed (Unpainted)  
Over 100mm

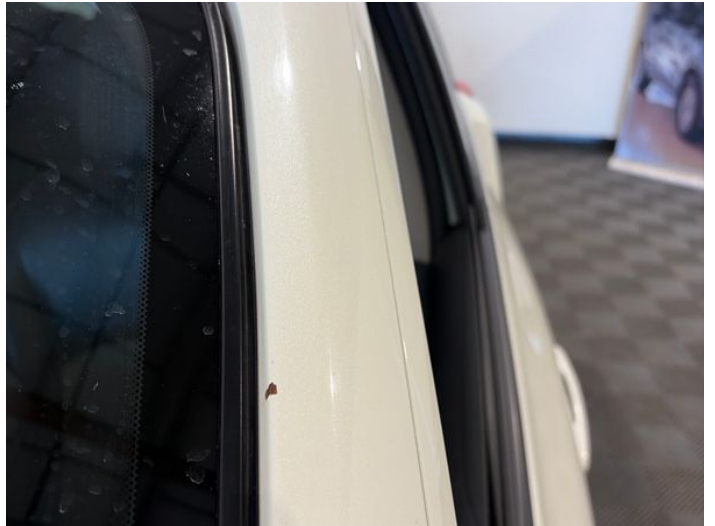
16: A Post ns  
Chipped  
Over 5mm

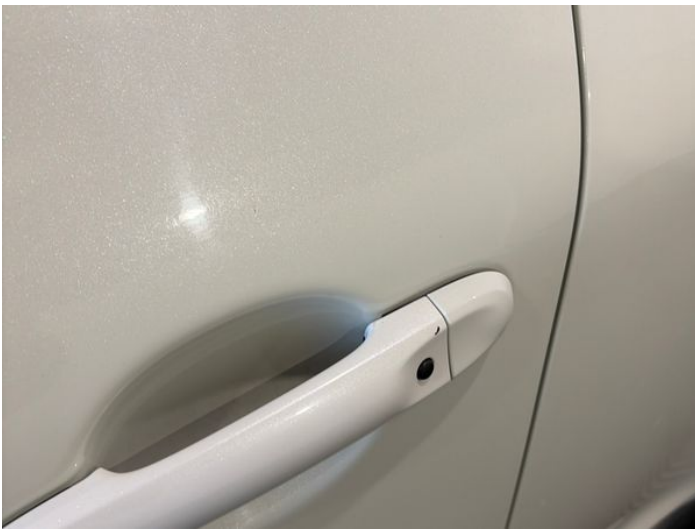
17: Handle Outer nsf  
Scratched (Painted)  
UpTo 25mm Thru Paint

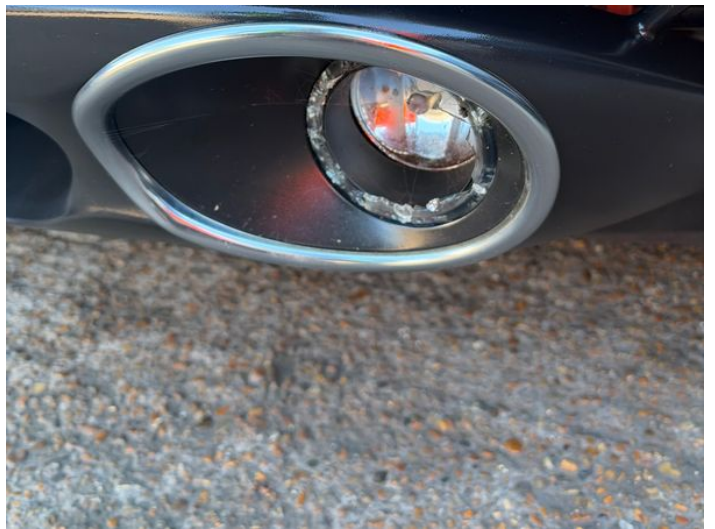
18: Fogdriving Lamp nsf  
Broken  
Replace

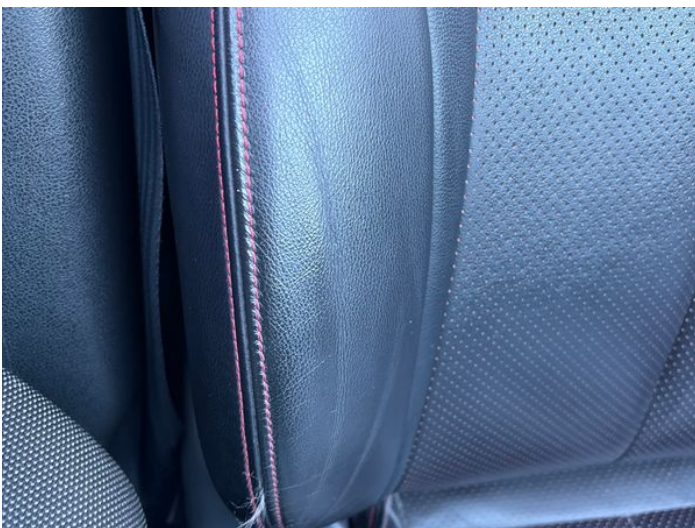
19: Seat Back Cover osf  
Scuffed  
UpTo 25mm
