# VEHICLE INSPECTION REPORT

**YF09FYB**

## Volkswagen Polo 1.2 Match 60 3dr

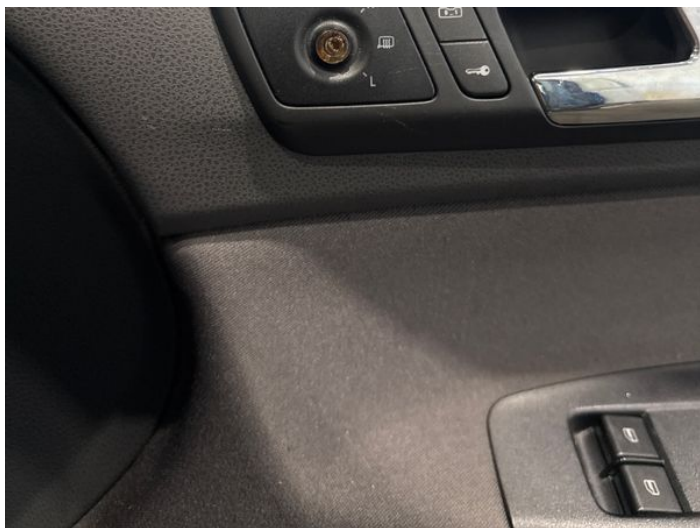
1: Switches And Controls  
Broken  
Replace

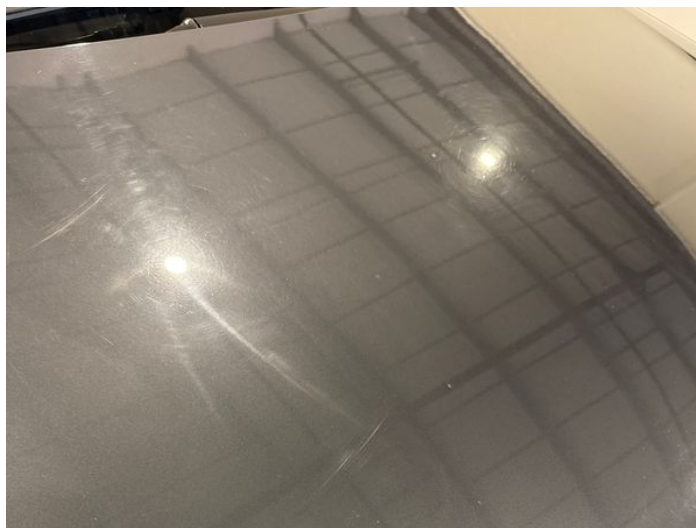
2: Bonnet  
Scratched  
Over 25mm Thru Paint

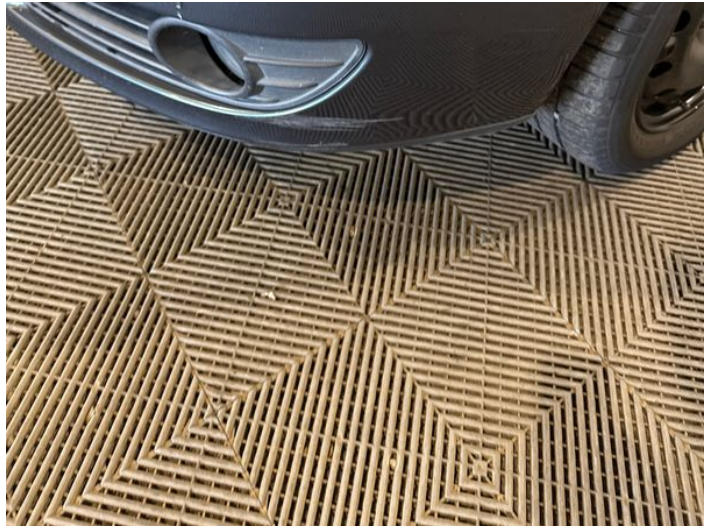
4: Bumper Front  
Scratched  
Over 100mm Thru Paint

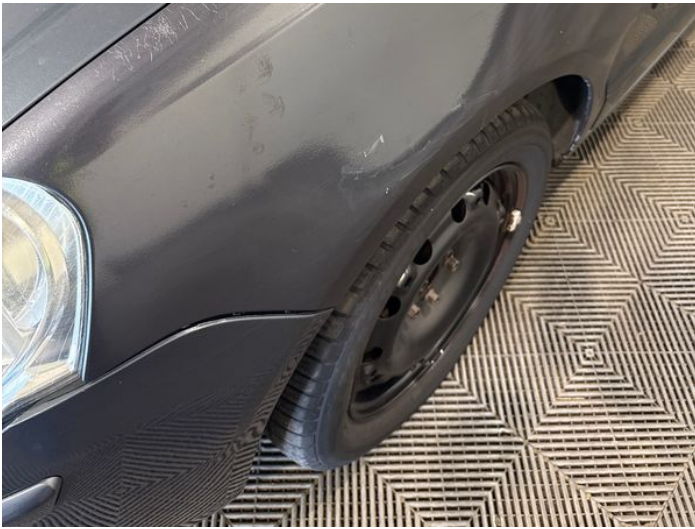
5: Wing nsf  
Poor Previous Repair  
Rippled UpTo 30%

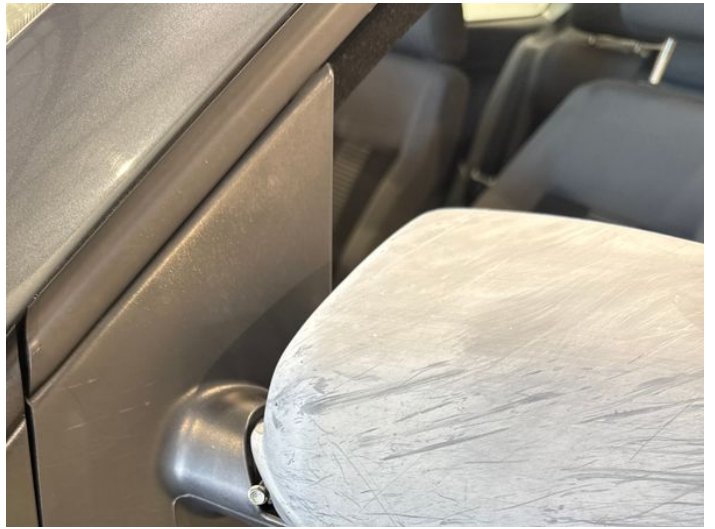
6: Door Mirror Assy nsf  
Scuffed (Unpainted)  
Over 100mm

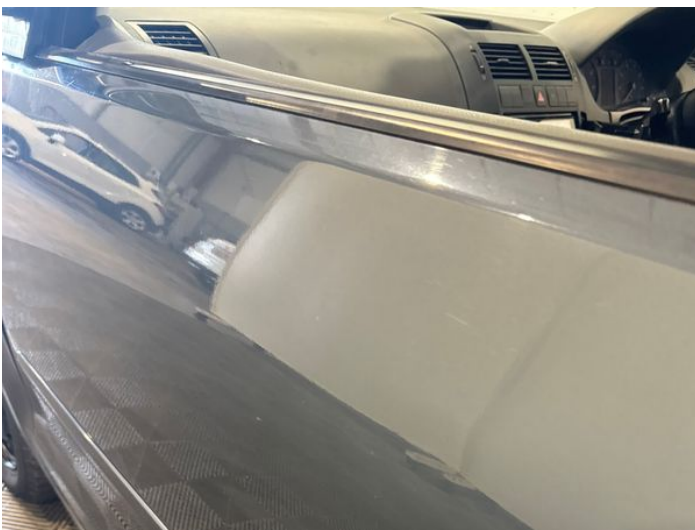
7: Door nsf  
Dented  
Over 30mm

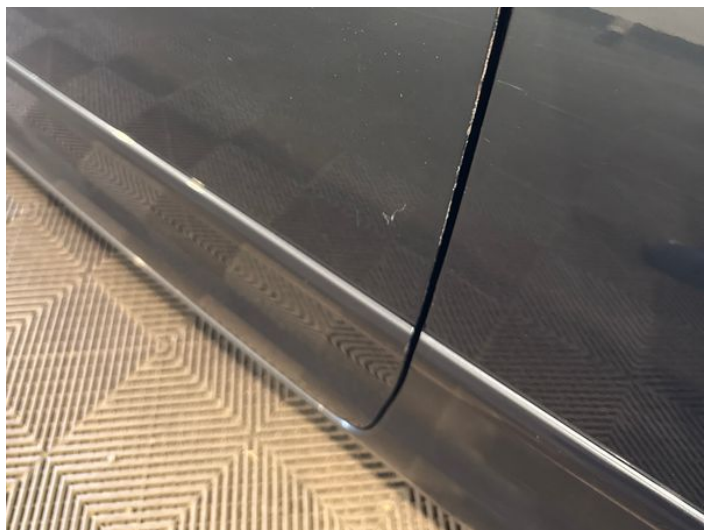
8: Door nsf  
Scratched  
Over 25mm Thru Paint

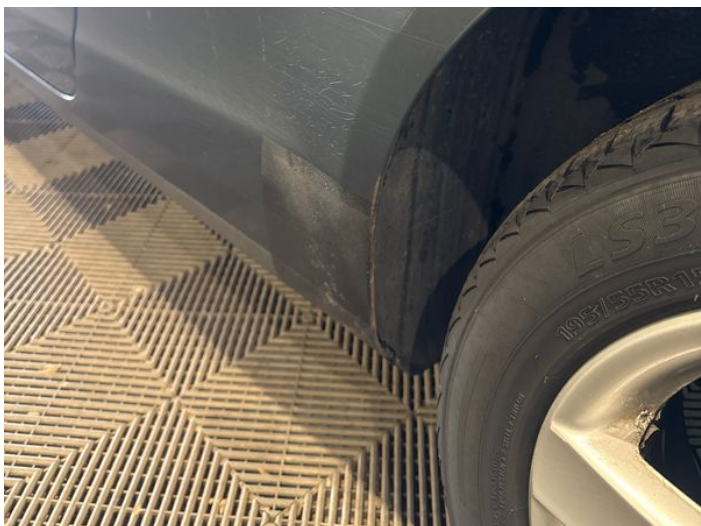
9: Qtr Panel nsr  
Poor Previous Repair  
Rippled UpTo 30%

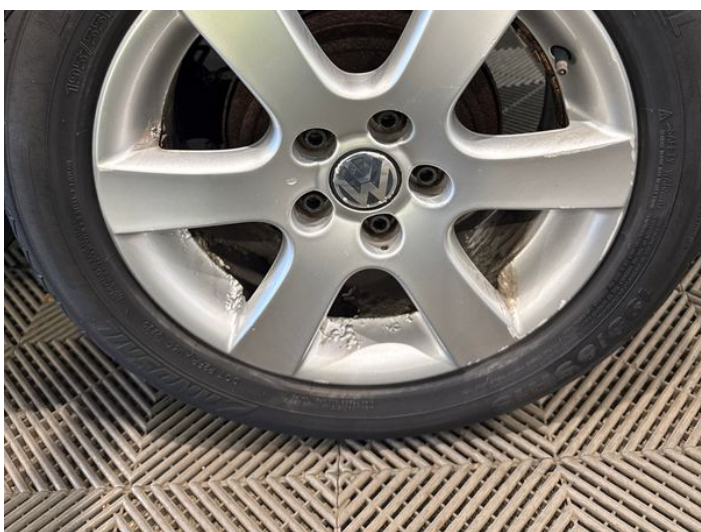
11: Wheel nsr  
Scratched  
Over 50mm

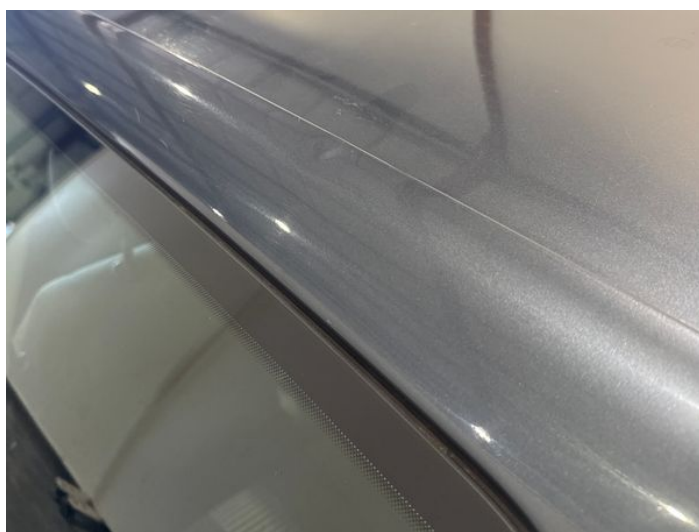
12: B Post ns  
Dented  
Between 10mm + 30mm

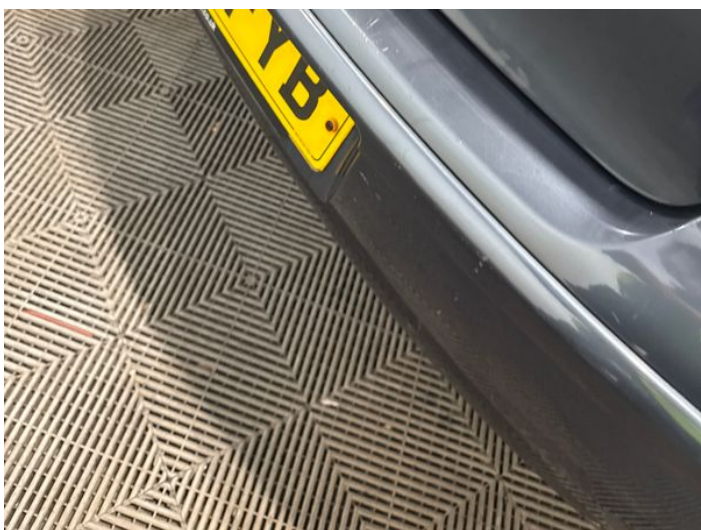
13: Bumper Rear  
Scratched  
25 to 100mm Thru Paint

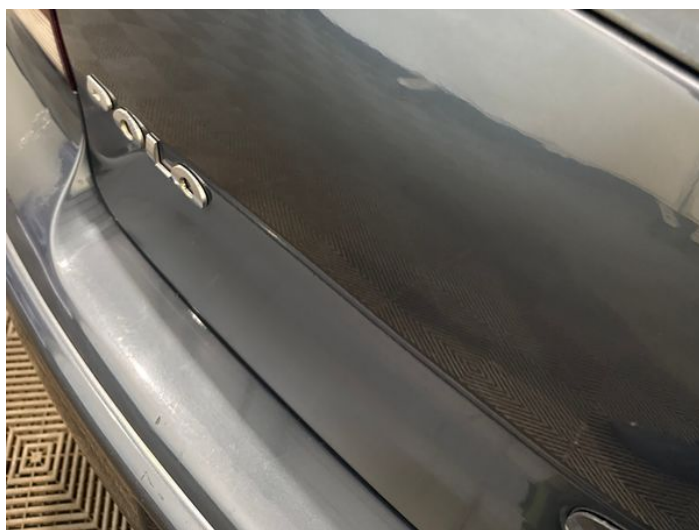
14: Tailgate  
Rusted  
Over 5mm

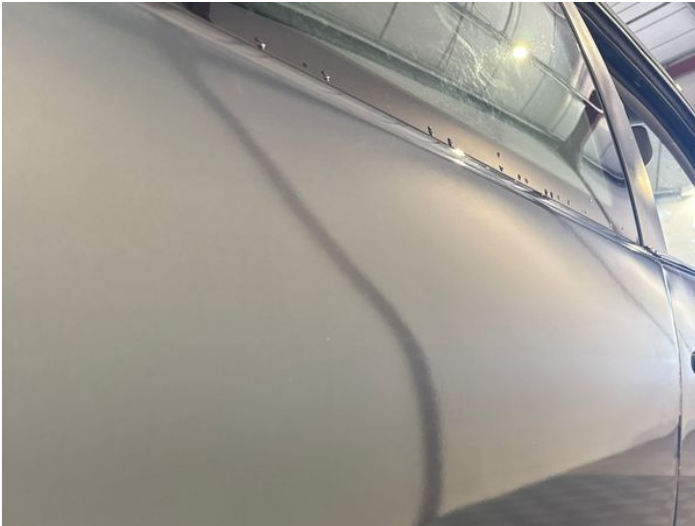
15: Qtr Panel osr  
Poor Previous Repair  
Rippled UpTo 30%

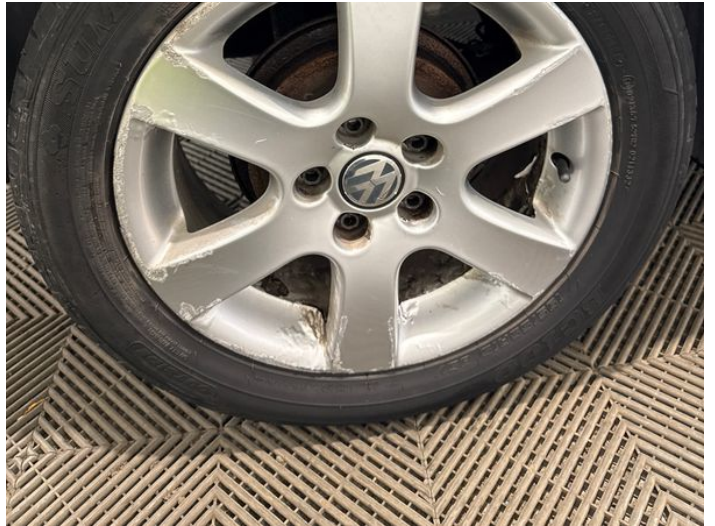
16: Wheel osr  
Scratched  
Over 50mm

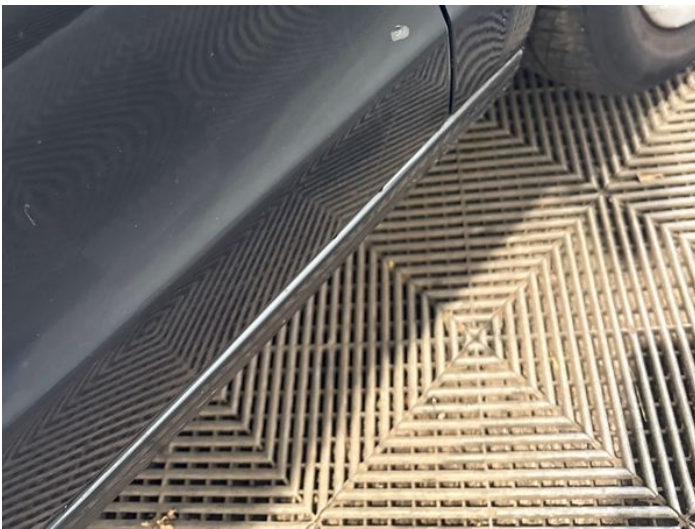
17: Door osf  
Chipped  
Over 5mm

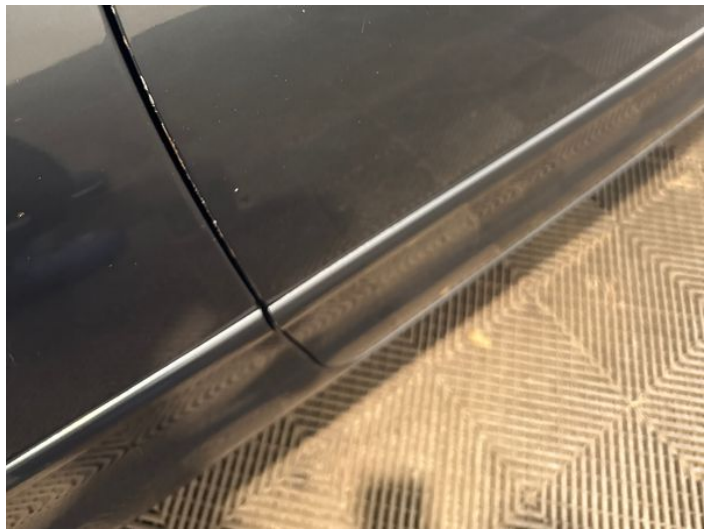
18: Door osf  
Dented  
Between 10mm + 30mm

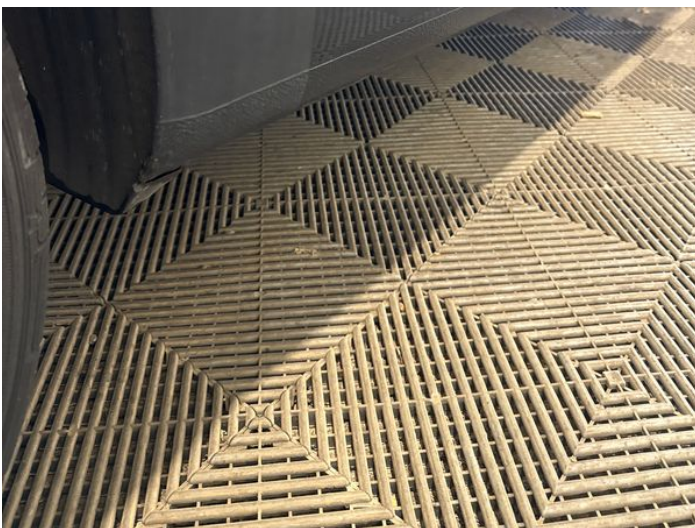
19: Sill os  
Poor Previous Repair  
Poor Paint

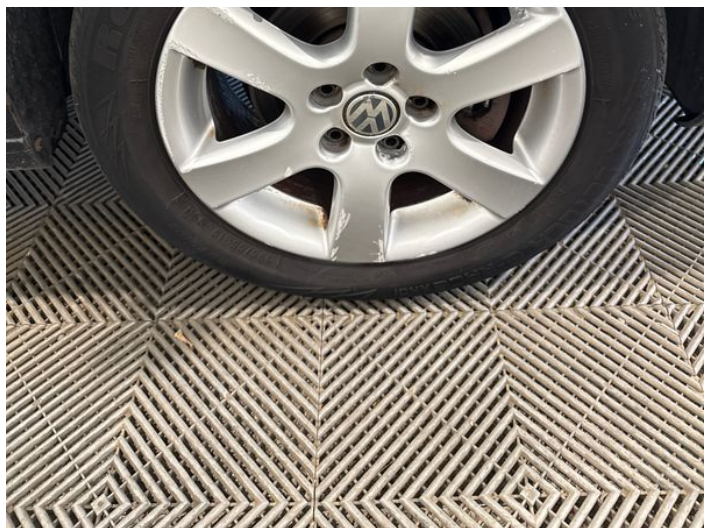
20: Wheel osf  
Scratched  
Over 50mm

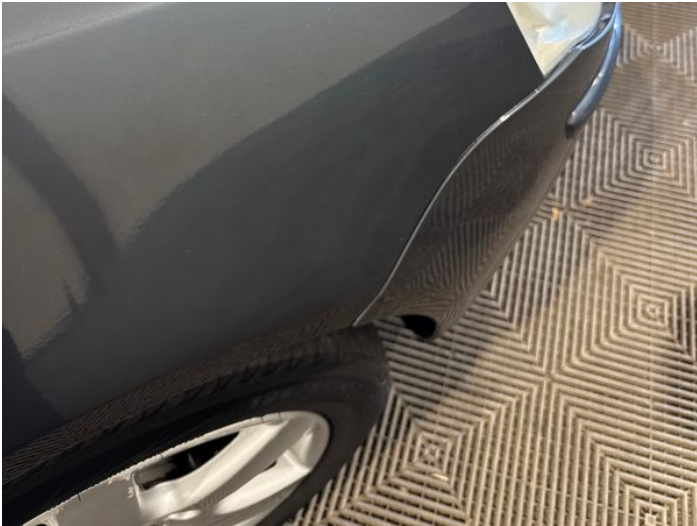
21: Wing osf  
Poor Previous Repair  
Poor Paint

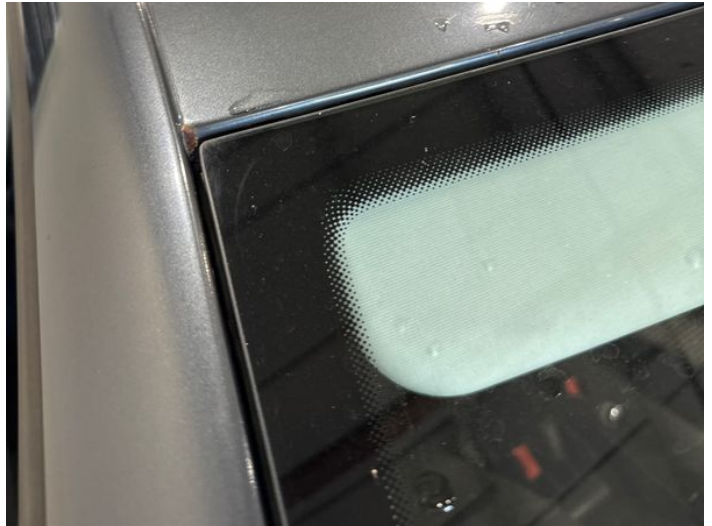
22: Roof  
Rusted  
Over 5mm

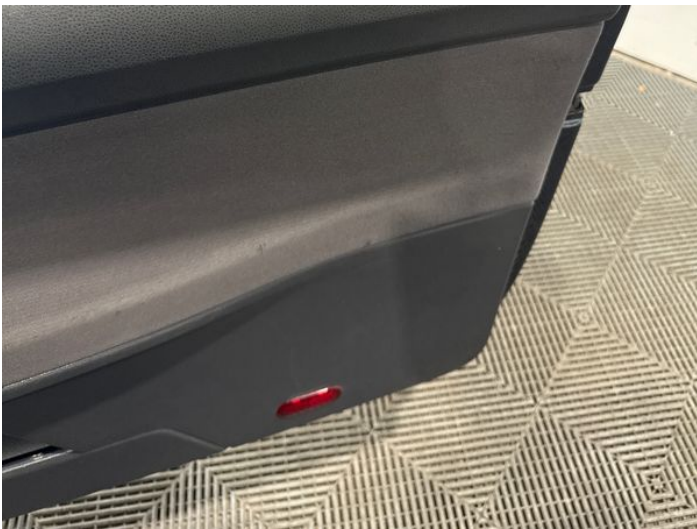
23: Door Pad osf  
Broken  
Replace

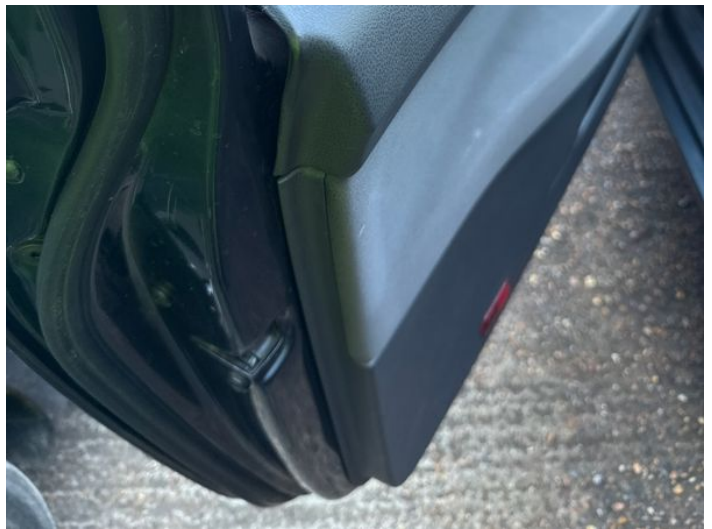
24: Door Pad nsf  
Scuffed  
Over 25mm

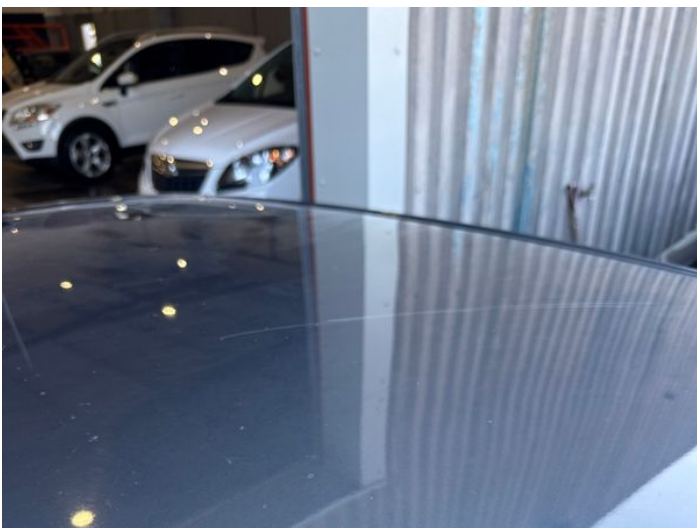
25: Roof  
Scratched  
Over 25mm Thru Paint

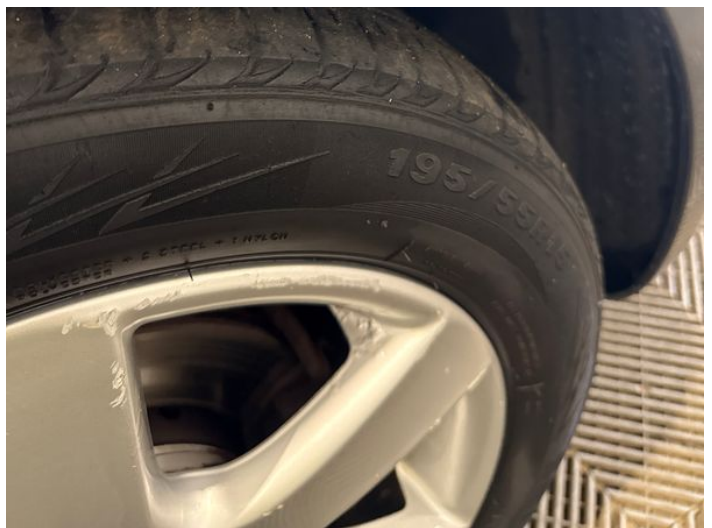
| OSF | ROTALLA | Damaged |

26: Tyre osf  
Damaged  
Replace
