## VEHICLE INSPECTION REPORT

**GU14YYS**

### Citroen DS4 1.6 e-HDi 115 DStyle 5dr

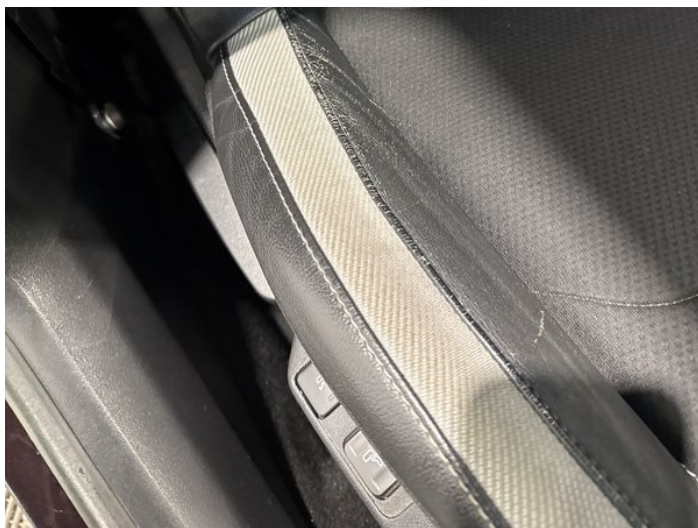
1: Seat Base Cover osf  
Scuffed  
Over 25mm

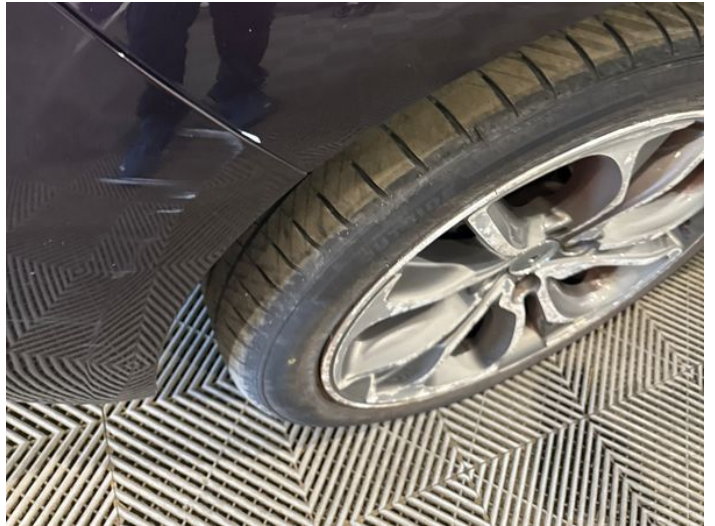
4: Wing nsf  
Scratched  
UpTo 25mm Thru Paint

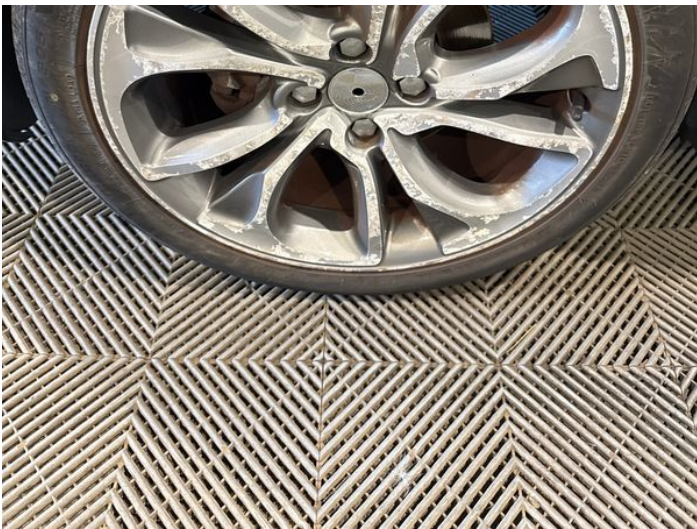
5: Wheel nsf  
Scratched  
Over 50mm

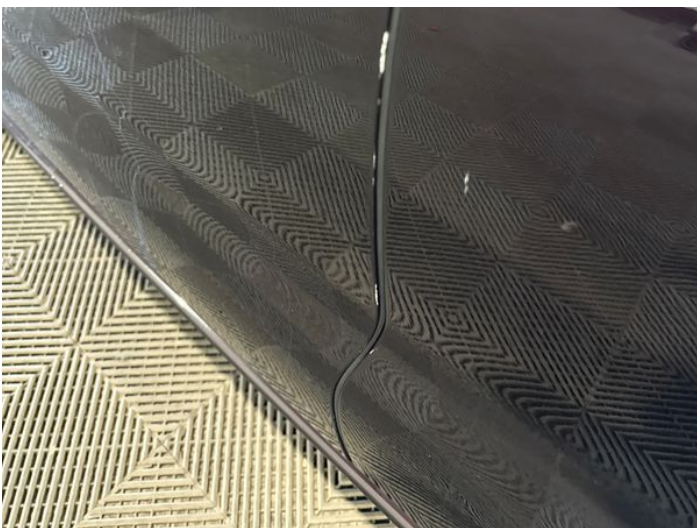
7: Door nsf  
Chipped  
Edge Chip

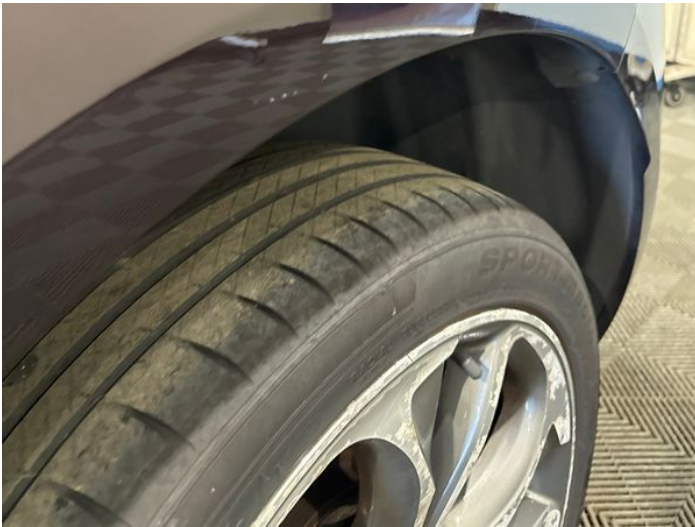
11: Qtr Panel nsr  
Dented  
Over 30mm

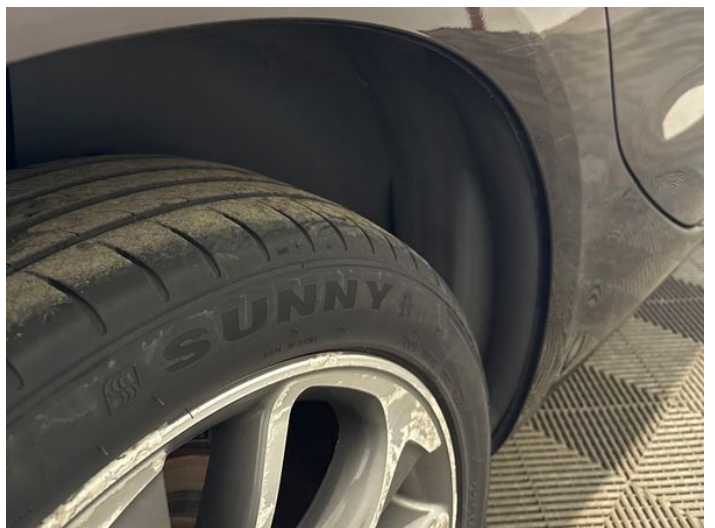
14: Qtr Panel osr  
Dented  
With Paint Damage
