# VEHICLE INSPECTION REPORT

**GF68WBP**

## MG Mg 3 EXCLUSIVE VTI-TECH

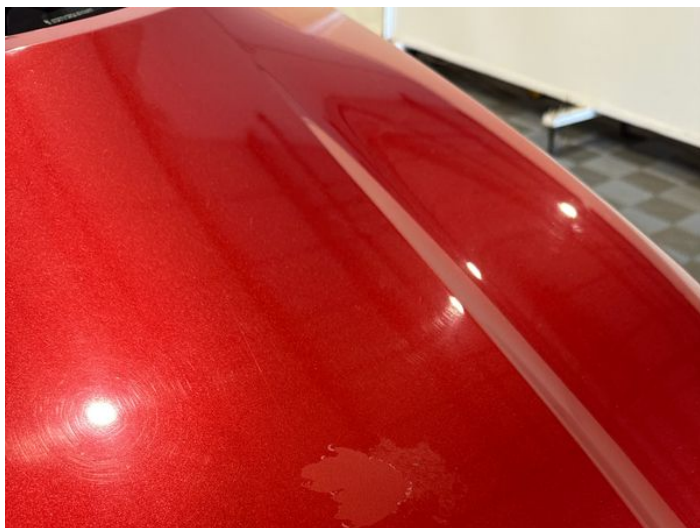
1: Bonnet  
Poor Previous Repair  
Paint Flake

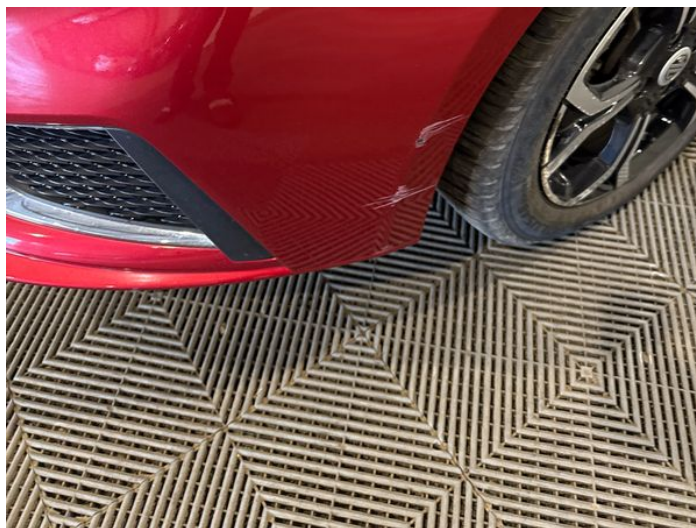
2: Bumper Front  
Scratched  
25 to 100mm Thru Paint

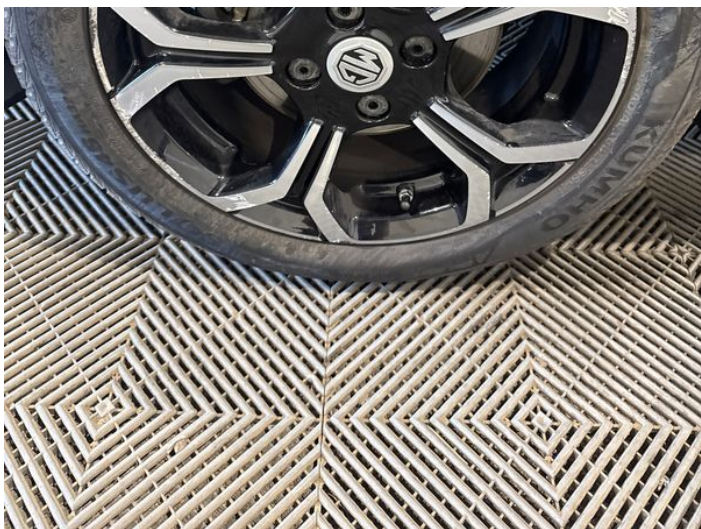
3: Wheel nsf  
Scratched  
Over 50mm

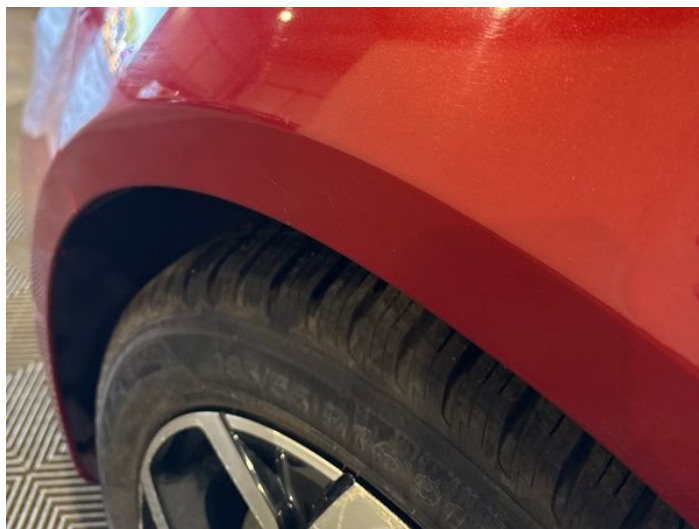
4: Wing nsf  
Poor Previous Repair  
Poor Paint

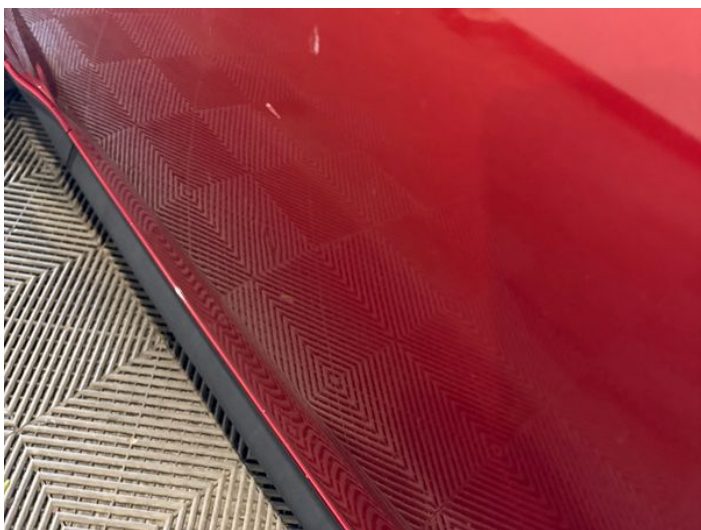
5: Door nsf  
Poor Previous Repair  
Rippled UpTo 30%

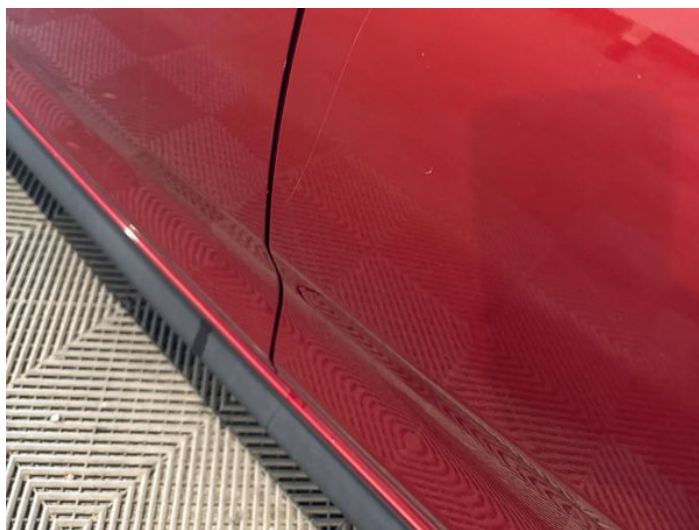
6: Door nsr  
Poor Previous Repair  
Rippled UpTo 30%

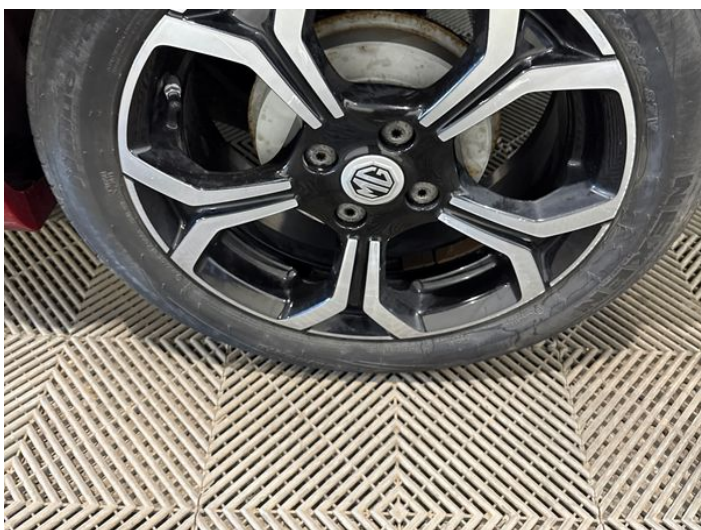
7: Wheel nsr  
Scratched  
Over 50mm

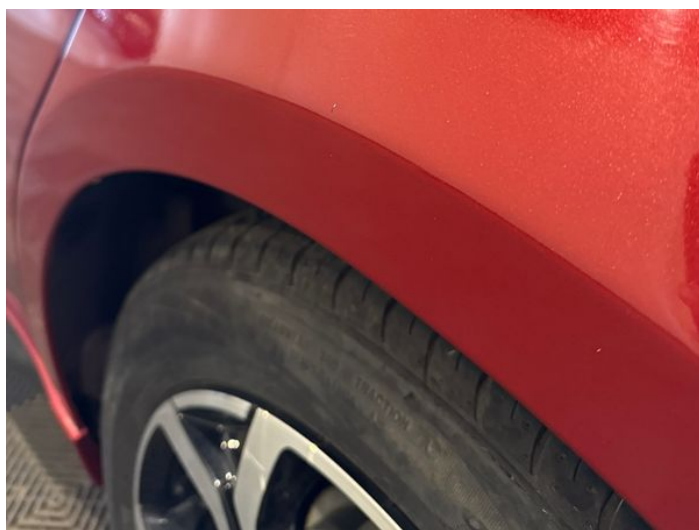
8: Qtr Panel nsr  
Scratched  
UpTo 25mm Thru Paint

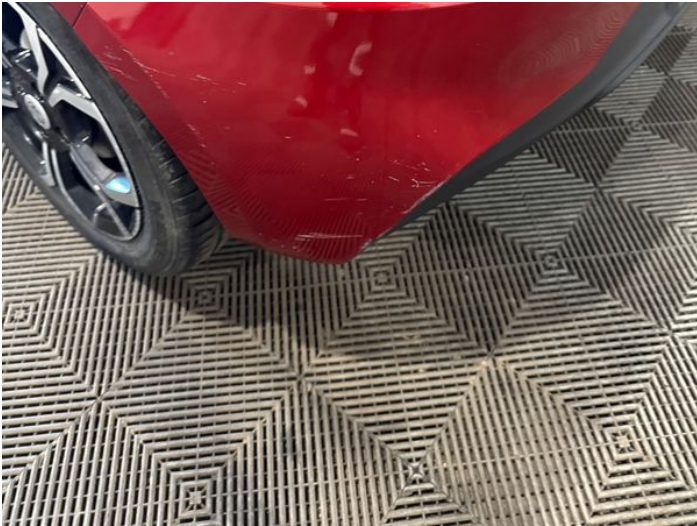
9: Bumper Rear  
Scratched  
Over 100mm Thru Paint

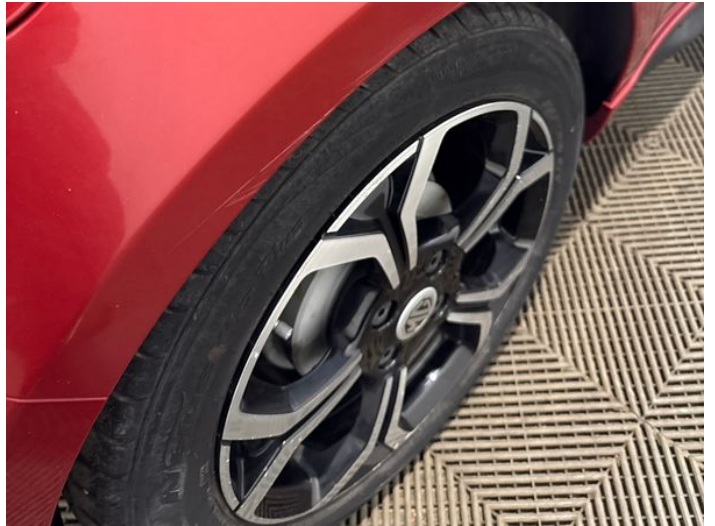
10: Qtr Panel osr  
Scratched  
Over 25mm Thru Paint

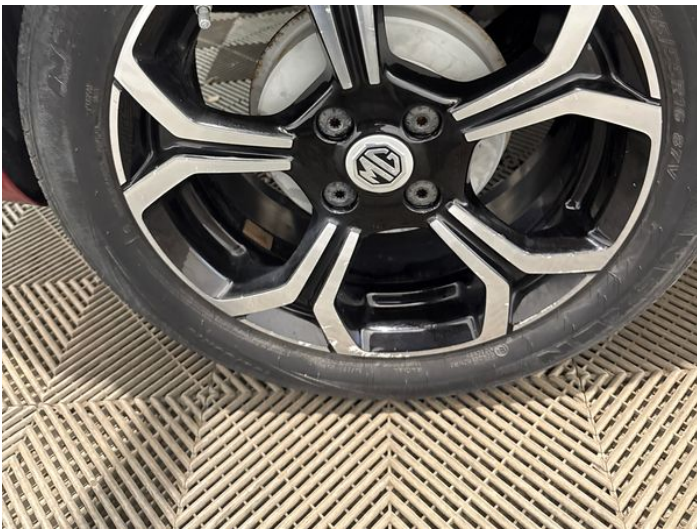
11: Wheel osr  
Scratched  
Over 50mm

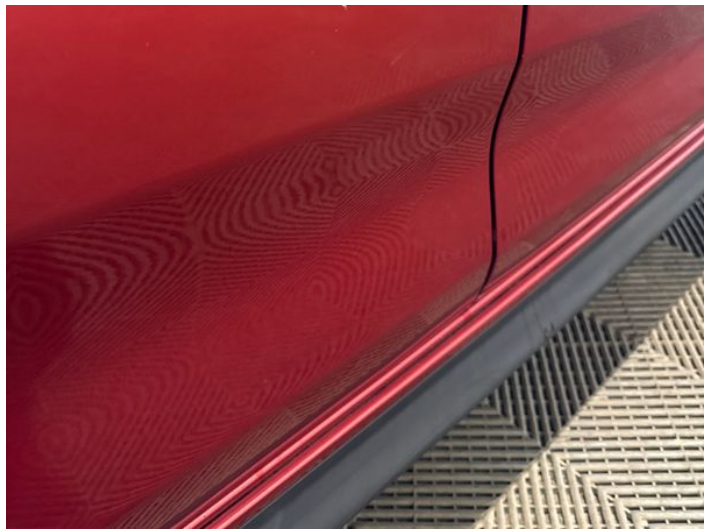
12: Door osr  
Scratched  
Over 25mm Thru Paint

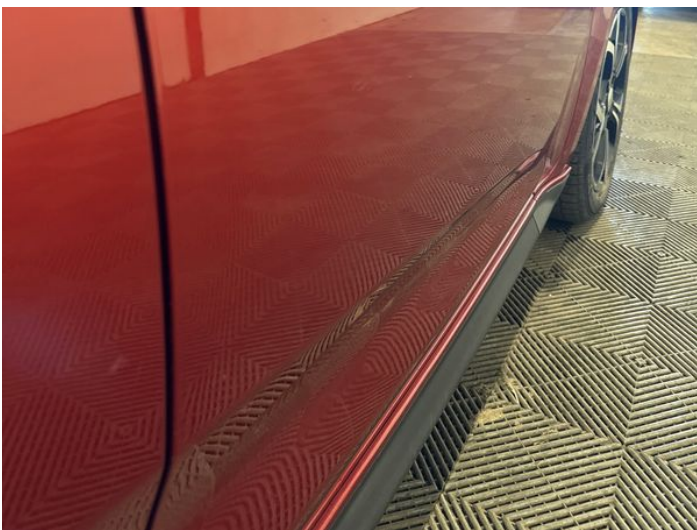
13: Door osf  
Dented  
Over 30mm

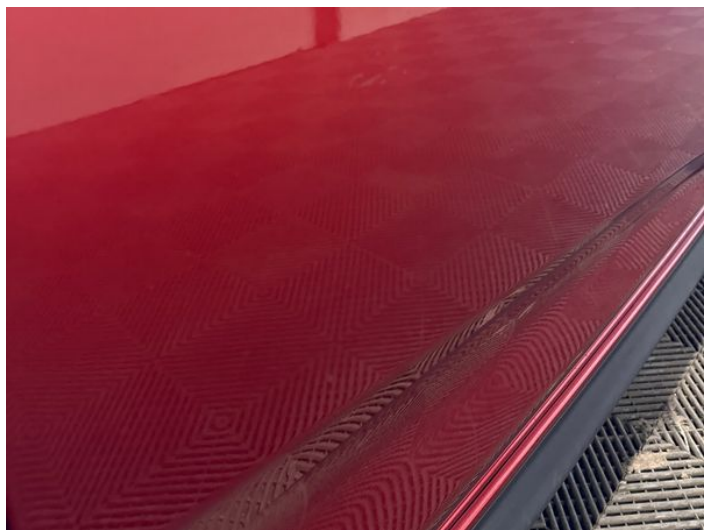
14: Door osf  
Scratched  
UpTo 25mm Thru Paint

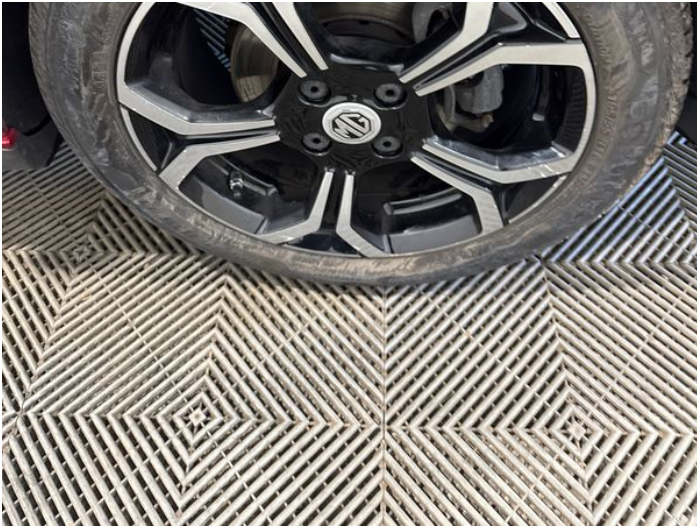
15: Wheel osf  
Scratched  
Over 50mm

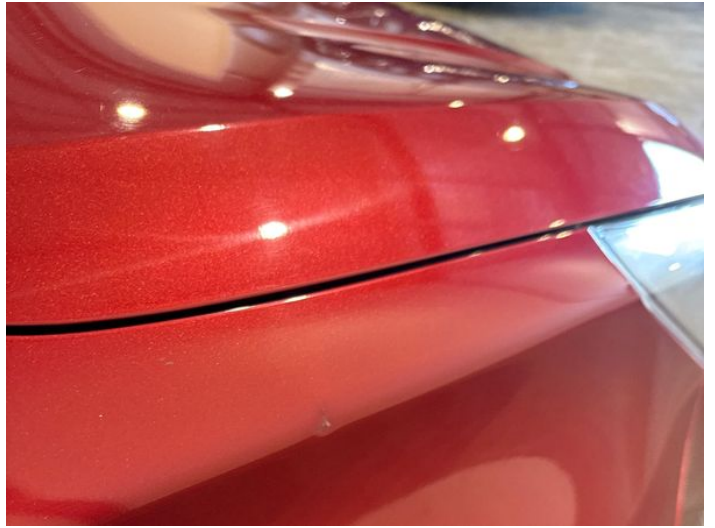
16: Wing osf  
Dented  
Between 10mm + 30mm

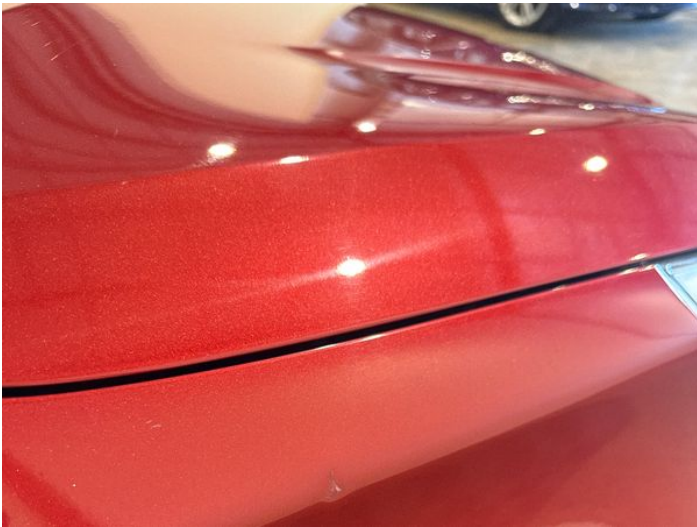
17: Wing osf  
Scratched  
UpTo 25mm Thru Paint

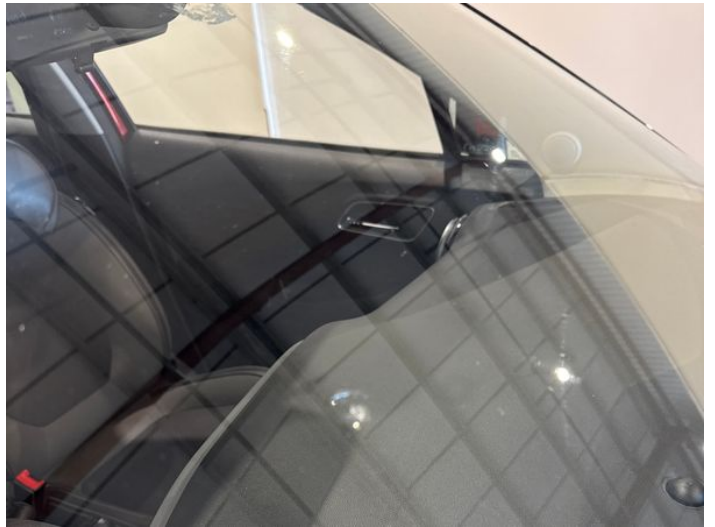
18: Screen Front  
Cracked  
Replace

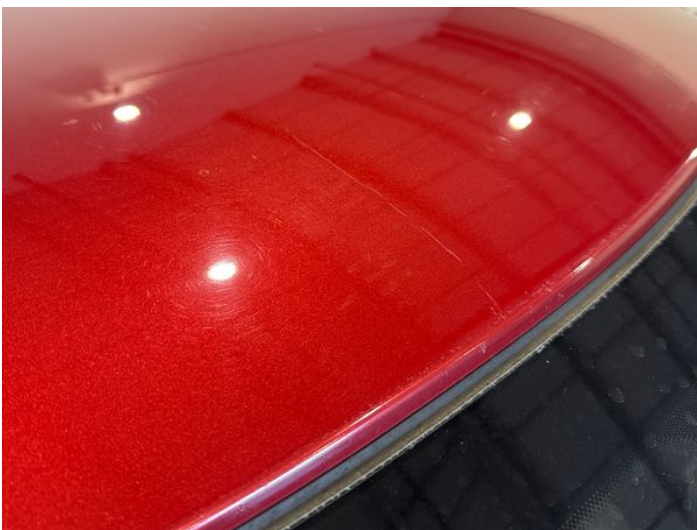
19: Roof  
Scratched  
Over 25mm Thru Paint
