# VEHICLE INSPECTION REPORT

**GU60DXS**

## Honda CR-V 2.0 i-VTEC SE-T 5dr Auto

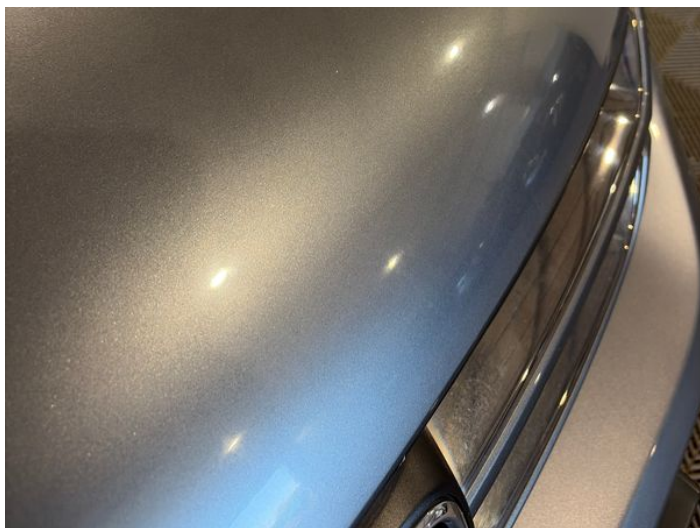
1: Bonnet  
Chipped  
1 To 5

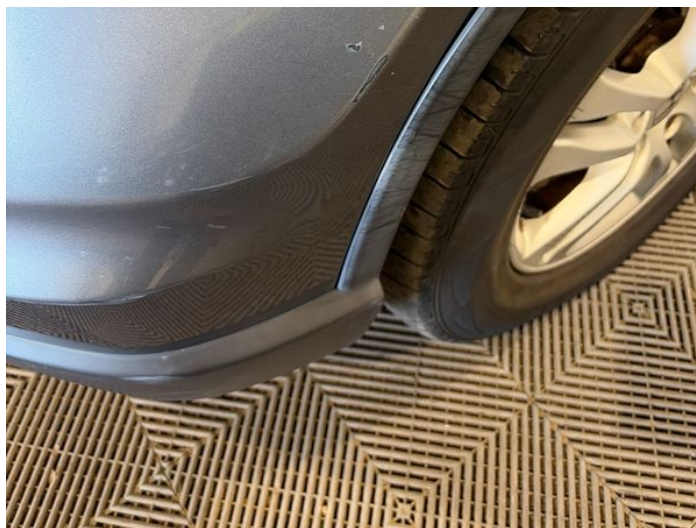
2: Bumper Front  
Scratched  
25 to 100mm Thru Paint

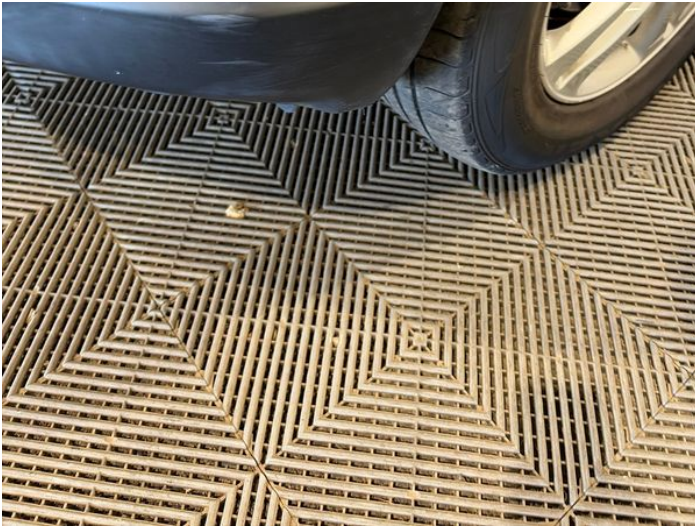
3: Bumper Front Moulding  
Scuffed (Unpainted)  
Over 100mm

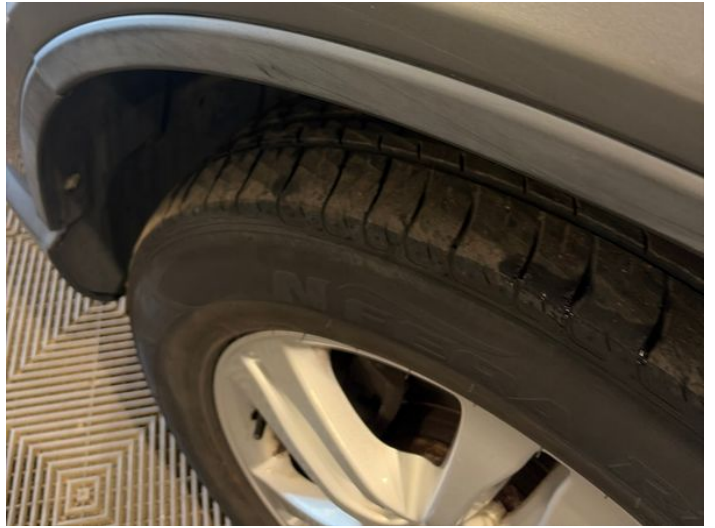
4: Wing nsf  
Scratched  
Over 25mm Thru Paint

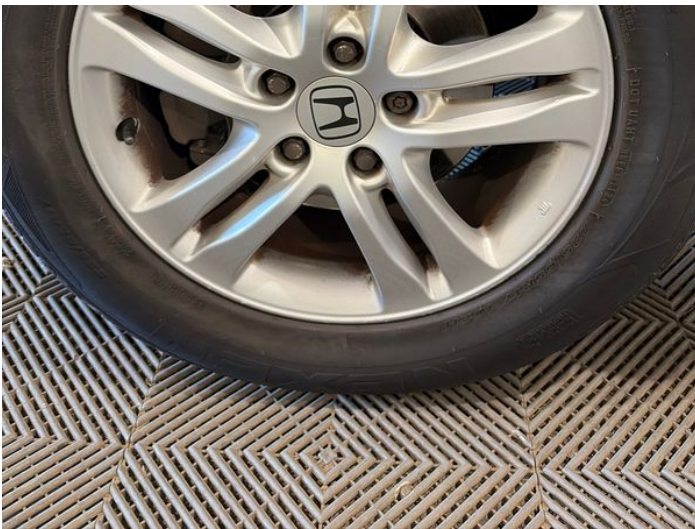
5: Wheel nsf  
Scratched  
Up To 50mm

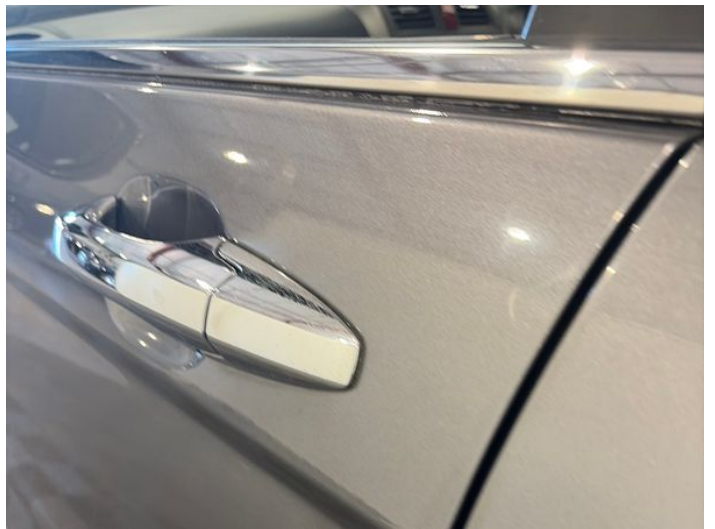
6: Door nsf  
Dented  
Between 10mm + 30mm

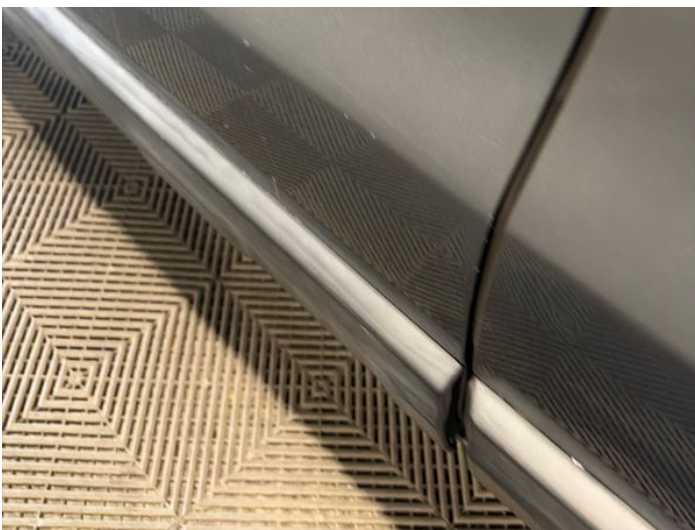
7: Door nsf  
Chipped  
1 To 5

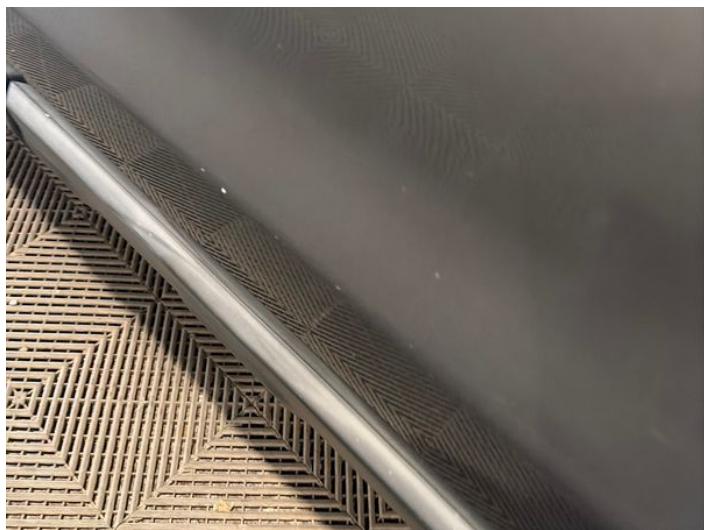
8: Door nsr  
Poor Previous Repair  
Rippled Up To 30%

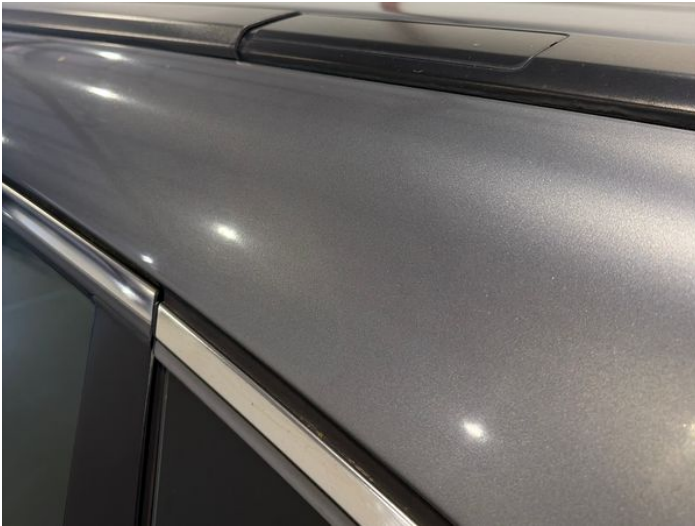
9: C Post ns  
Poor Previous Repair  
Poor Paint

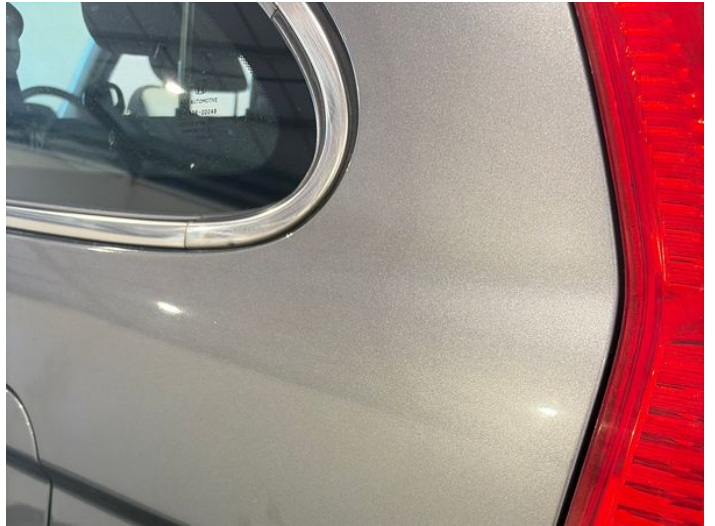
10: Qtr Panel nsr  
Poor Previous Repair  
Poor Paint

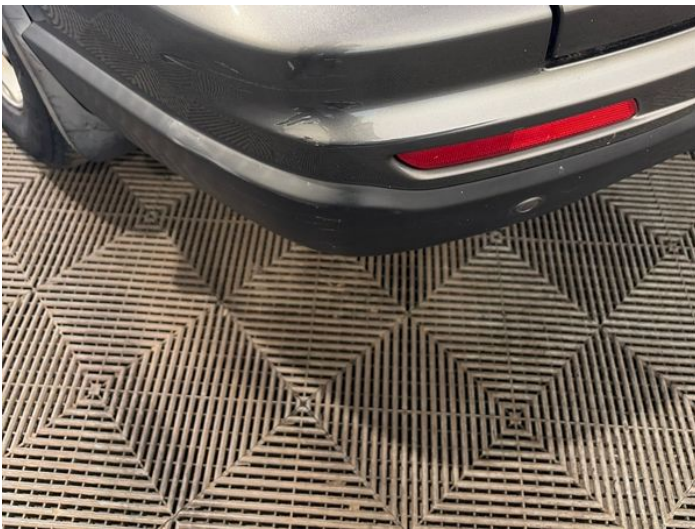
11: Bumper Rear  
Dented  
With Paint Damage

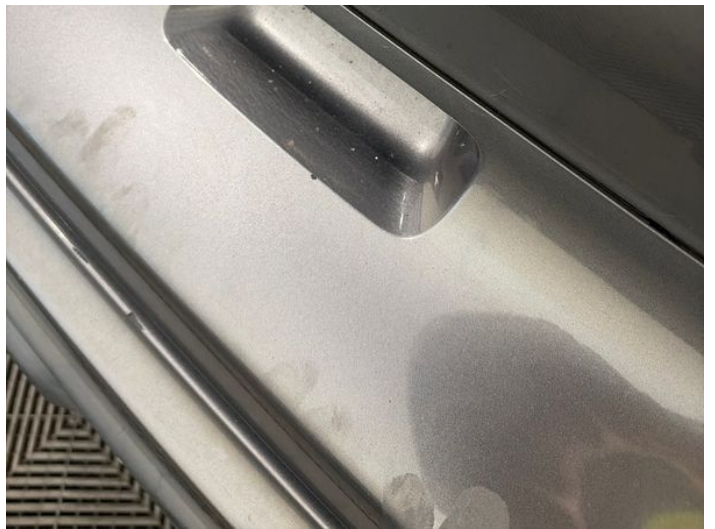
12: Tailgate  
Scratched  
UpTo 25mm Thru Paint

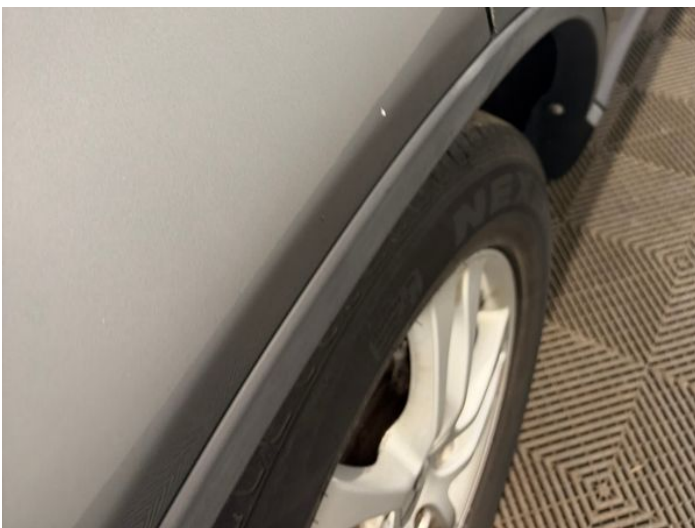
13: Qtr Panel osr  
Chipped  
1 To 5

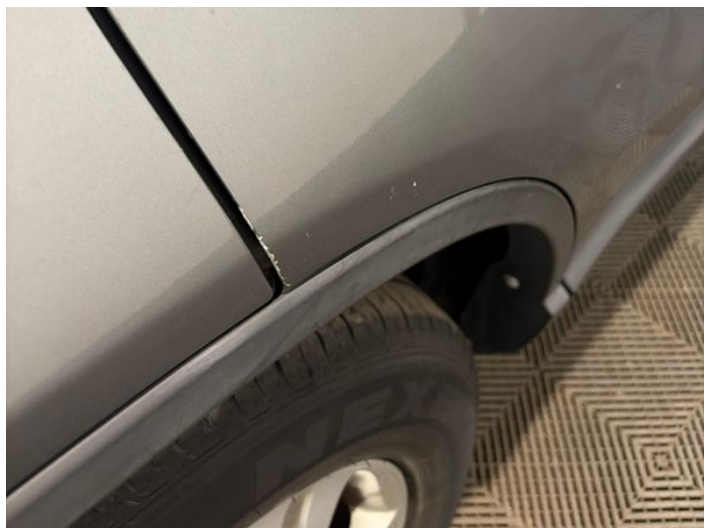
14: Door osr  
Chipped  
Edge Chip

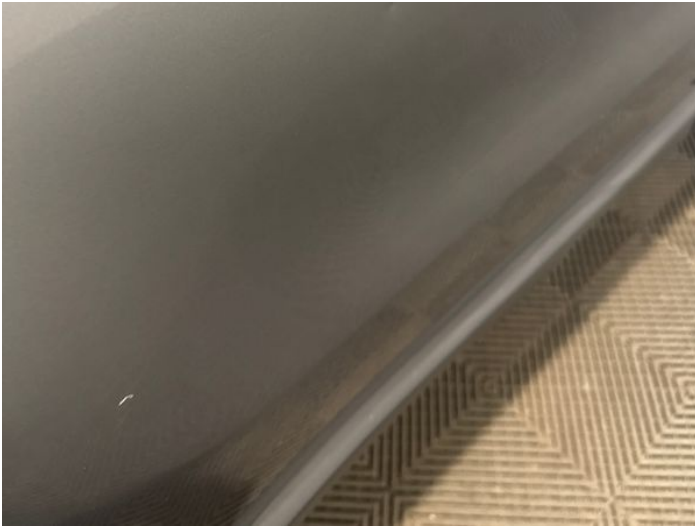
15: Door osr  
Dented  
Between 10mm + 30mm

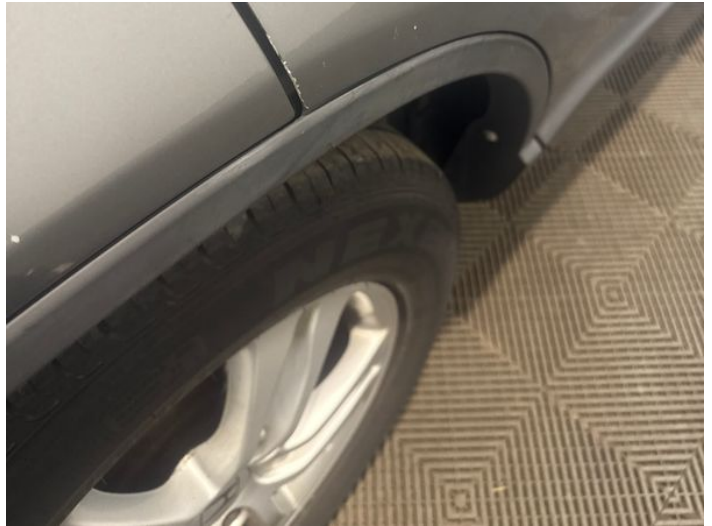
16: Door osr  
Chipped  
Edge Chip

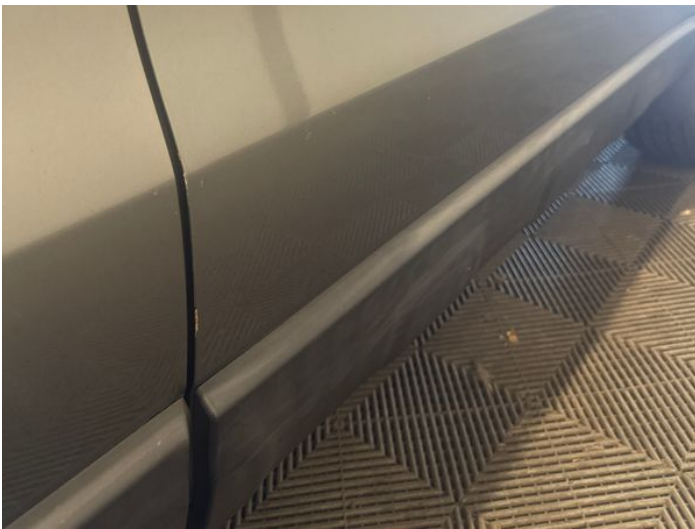
17: Door osf  
Scratched  
Over 25mm Thru Paint

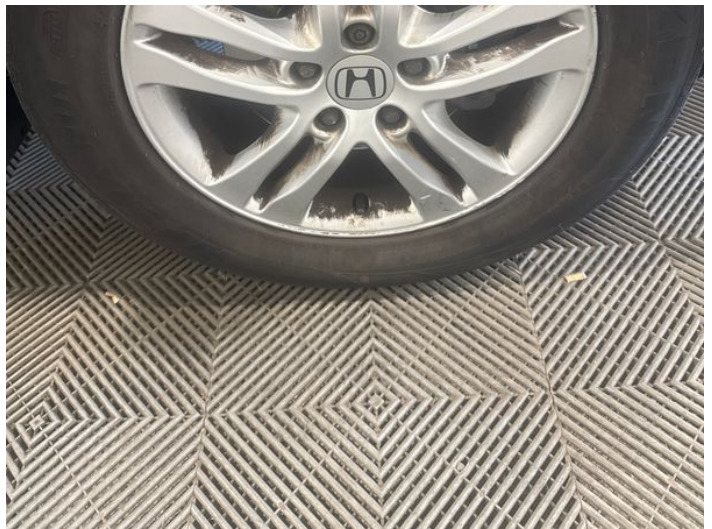
18: Wheel osf  
Scratched  
Over 50mm

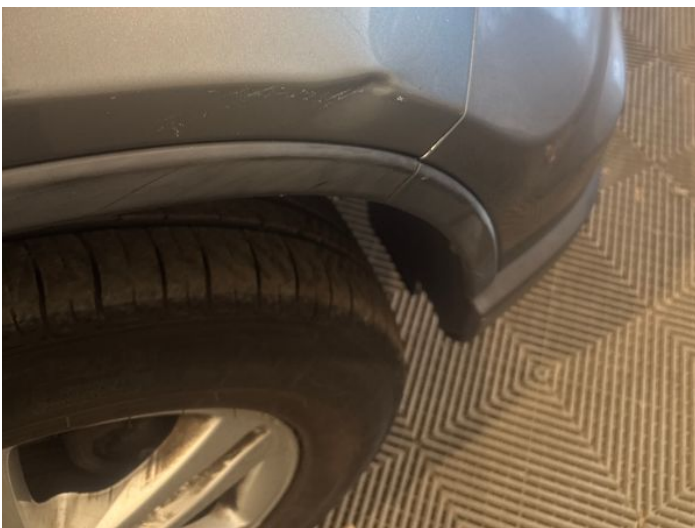
19: Wing osf  
Dented  
With Paint Damage

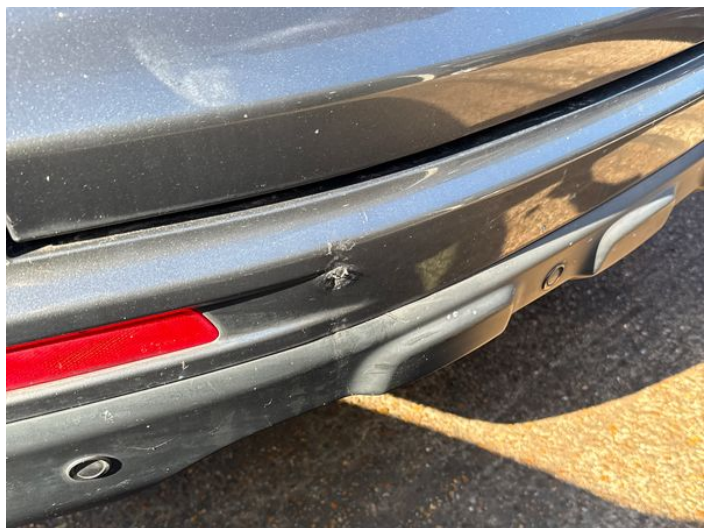
20: Bumper Rear Moulding  
Scuffed (Unpainted)  
Over 100mm
