# VEHICLE INSPECTION REPORT

**RO60XGJ**

## Renault Clio 1.2 TCE Dynamique TomTom 5dr

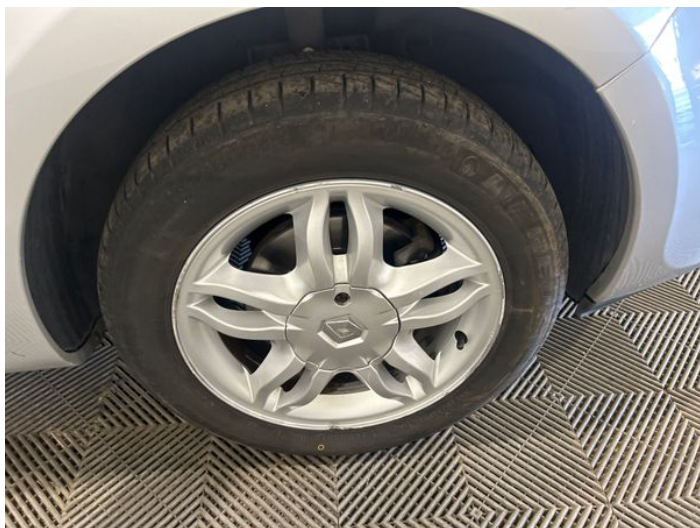
1: Wheel of  
Dented  
UpTo 30mm (Alloy)

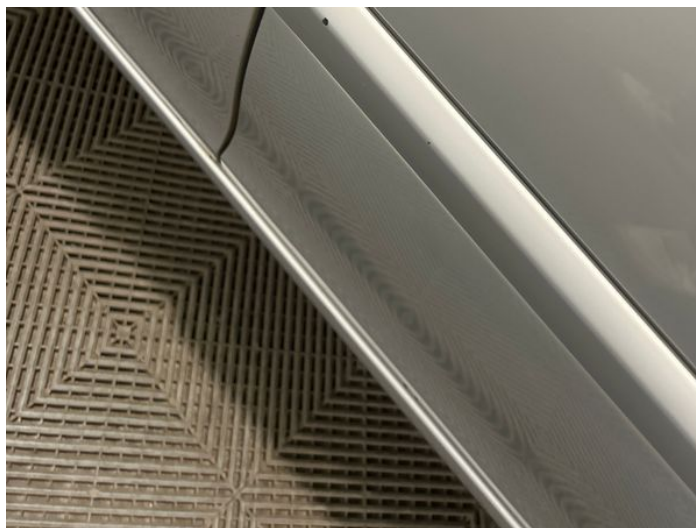
2: Door Moulding of  
Scratched (Painted)  
UpTo 25mm Thru Paint

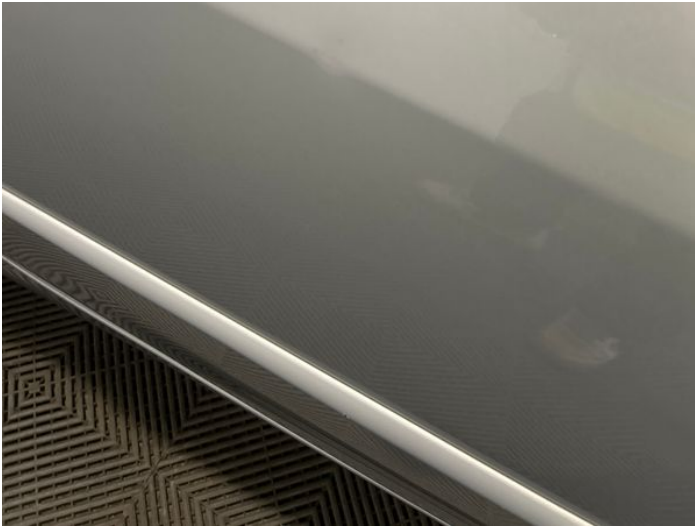
3: Door osr  
Dented  
Between 10mm + 30mm

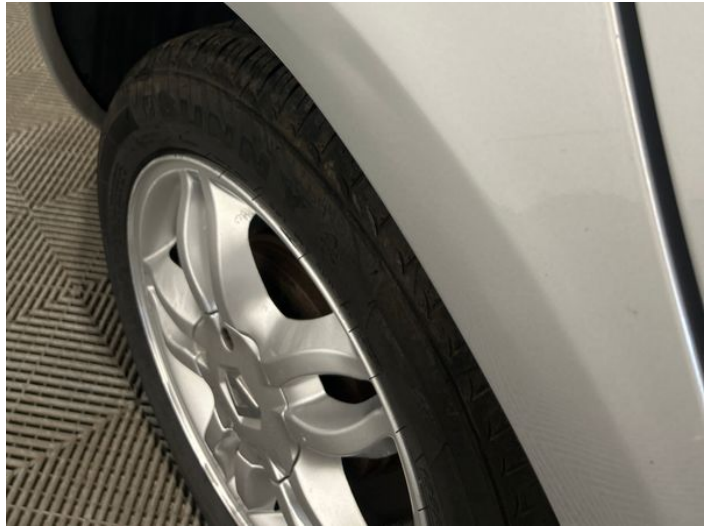
4: Qtr Panel osr  
Dented  
Over 30mm

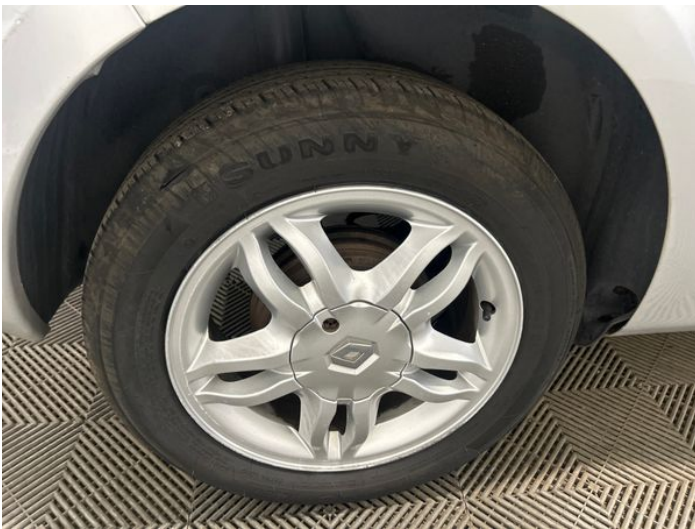
5: Wheel osr  
Scratched  
Over 50mm

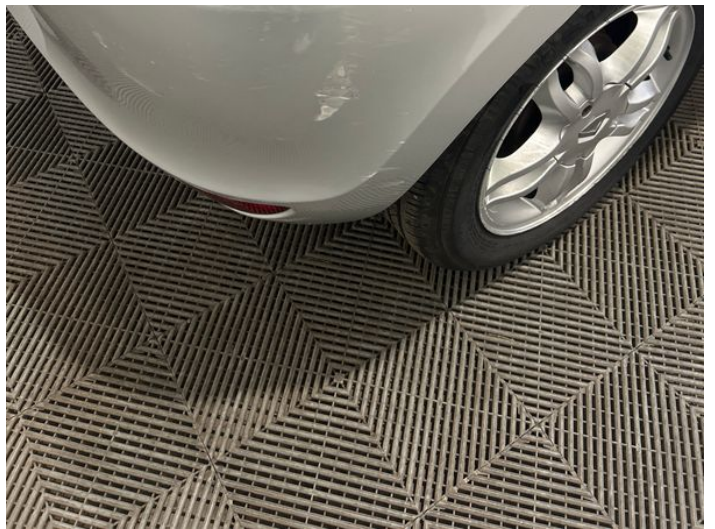
6: Bumper Rear  
Scratched  
Over 100mm Thru Paint

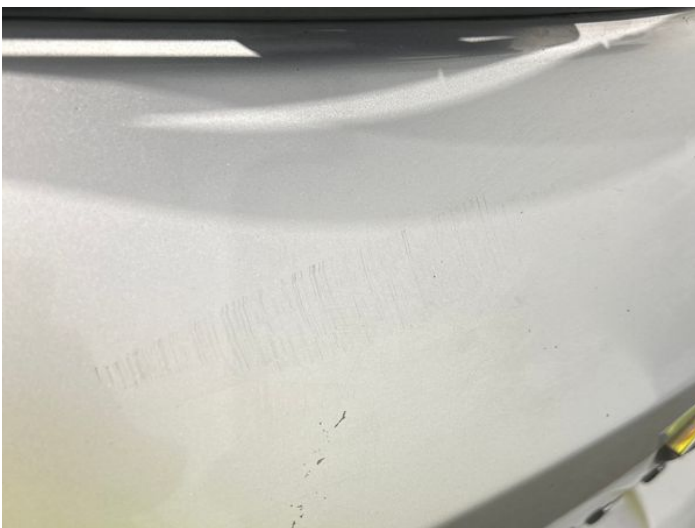
7: Tailgate  
Scratched  
Over 25mm Thru Paint

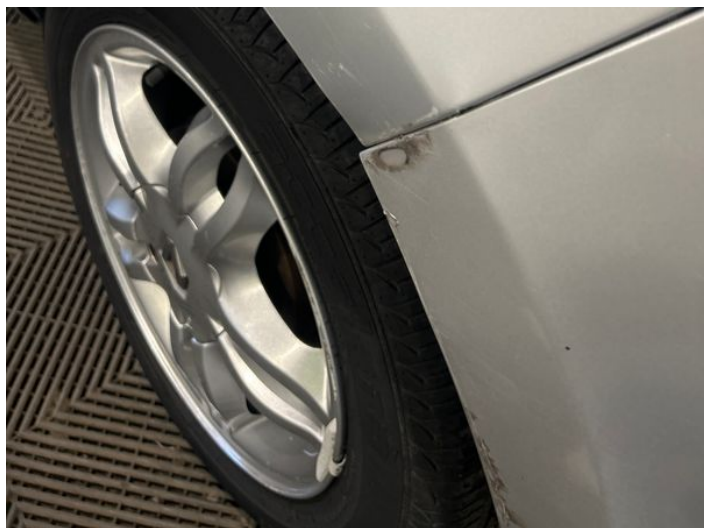
8: Qtr Panel nsr  
Dented  
With Paint Damage

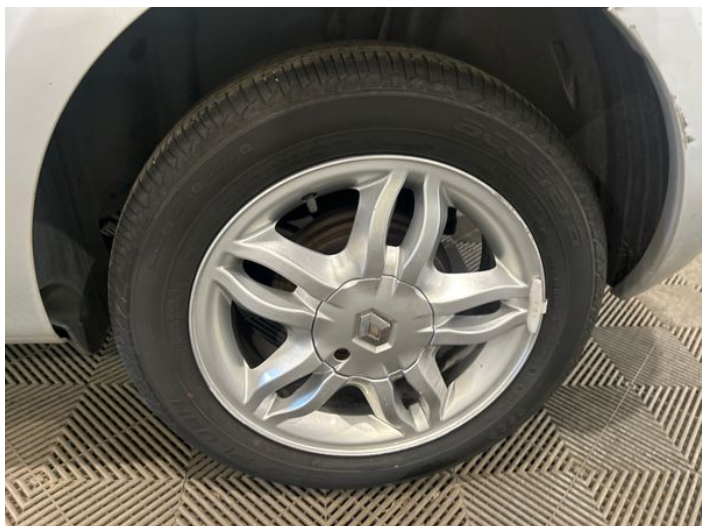
9: Wheel nsr  
Scratched  
Over 50mm

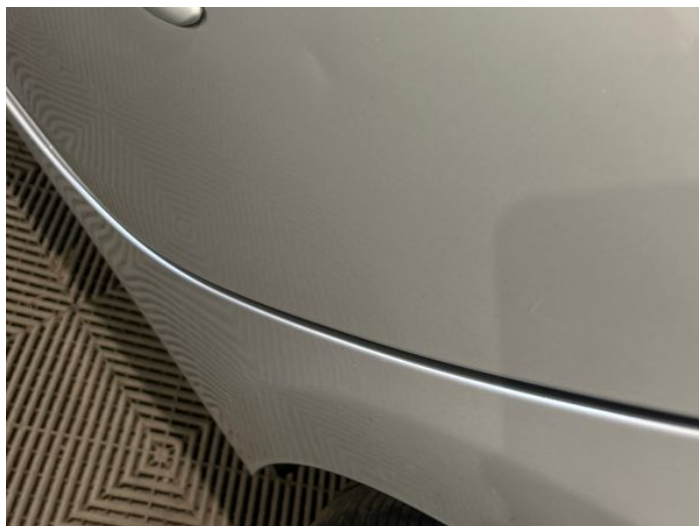
10: Door nsr  
Dented  
Between 10mm + 30mm

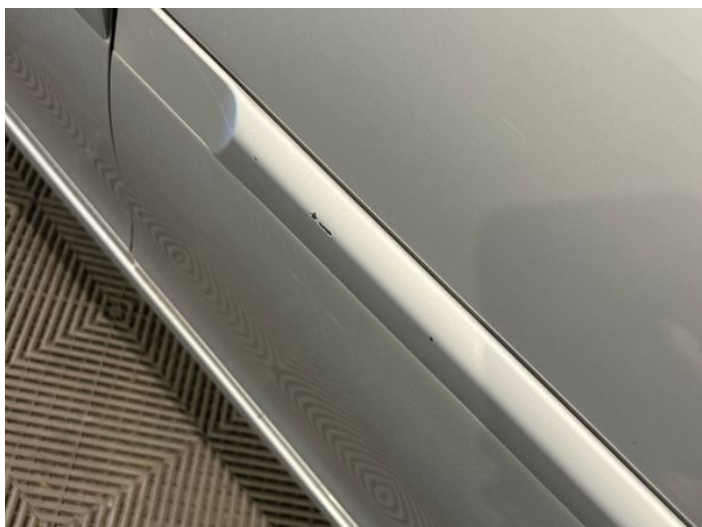
11: Door Moulding nsr  
Scratched (Painted)  
UpTo 25mm Thru Paint

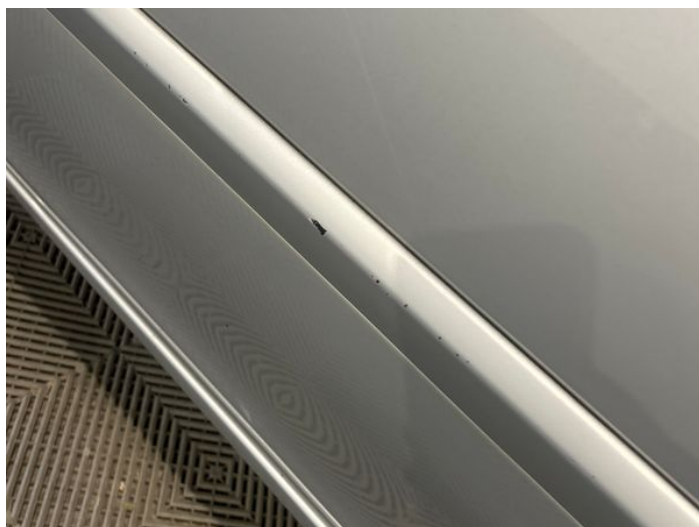
12: Door Moulding nsf  
Scratched (Painted)  
UpTo 25mm Thru Paint

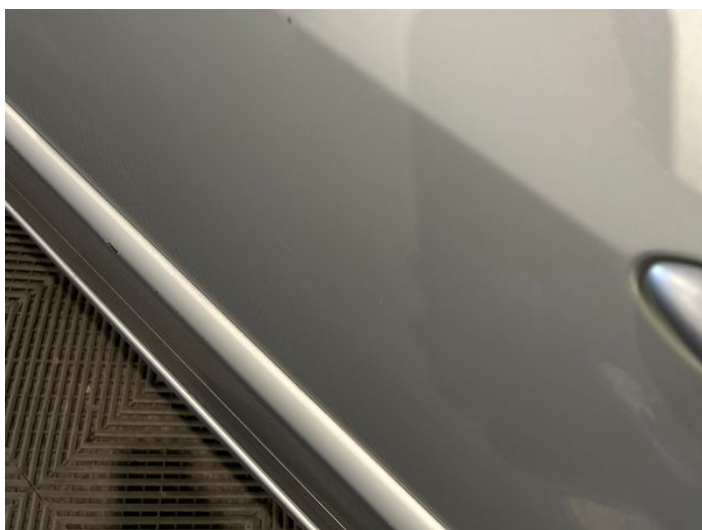
13: Door nsf  
Chipped  
1 To 5

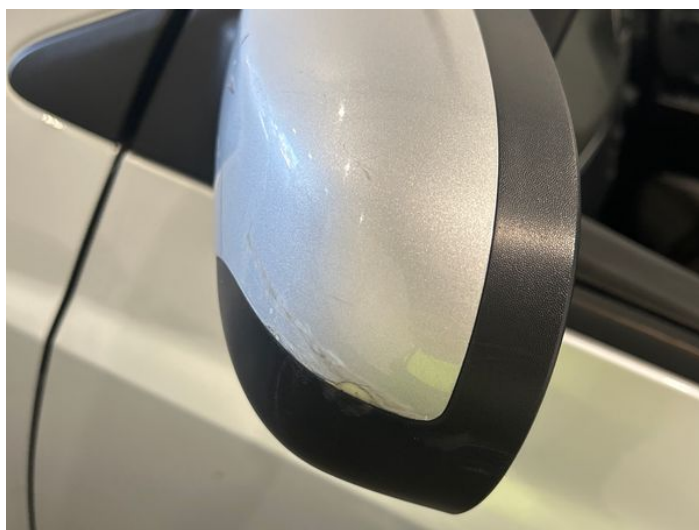
14: Door Mirror Assy nsf  
Scratched (Painted)  
Over 25mm Thru Paint

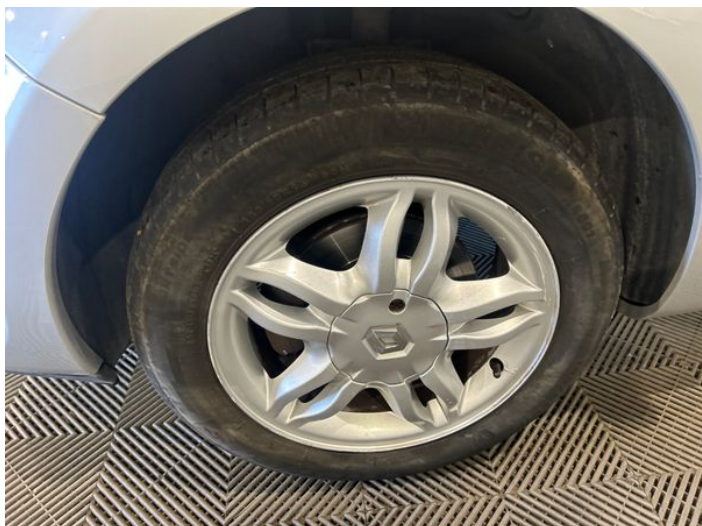
15: Wheel nsf  
Scratched  
Over 50mm

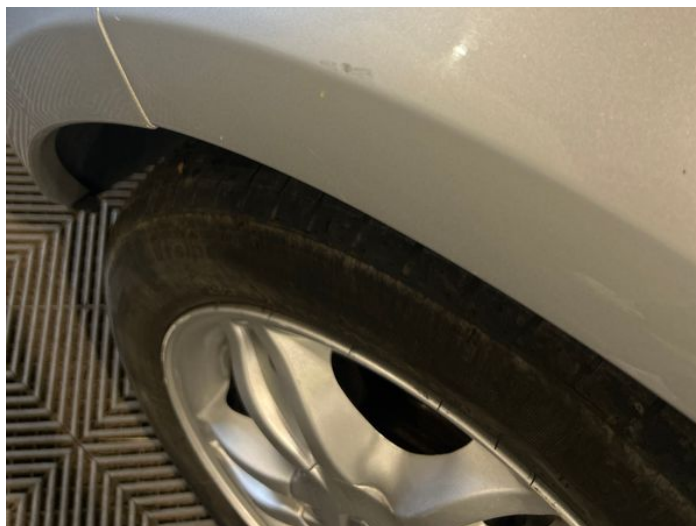
16: Wing nsf  
Chipped  
1 To 5

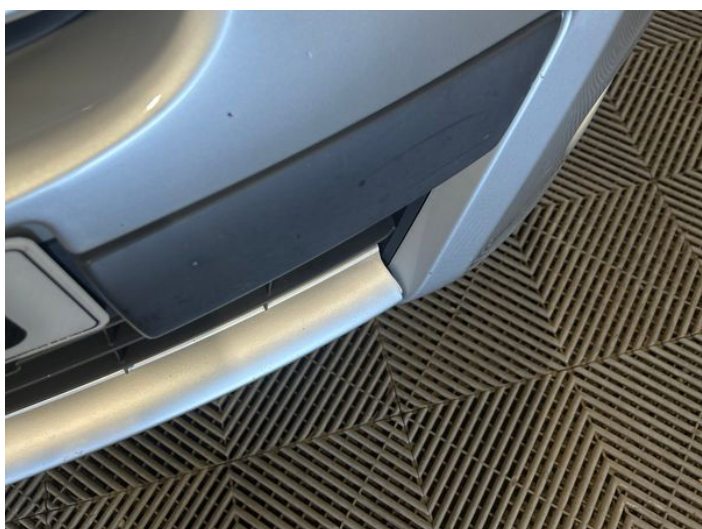
17: Bumper Front  
Chipped  
1 To 5

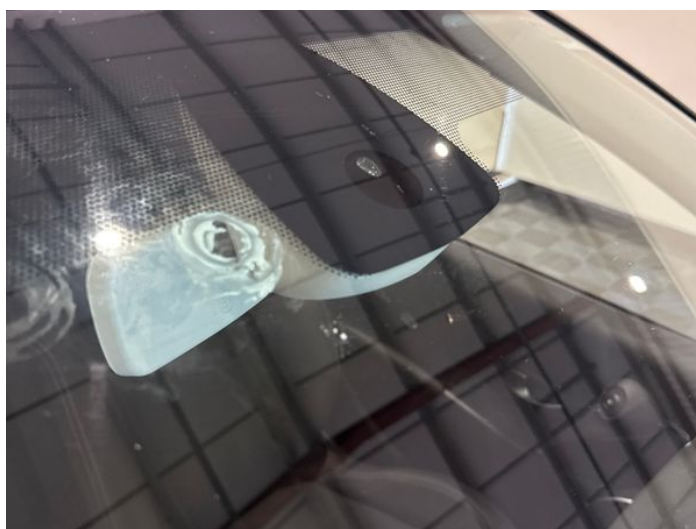
18: Screen Front  
Cracked  
Replace

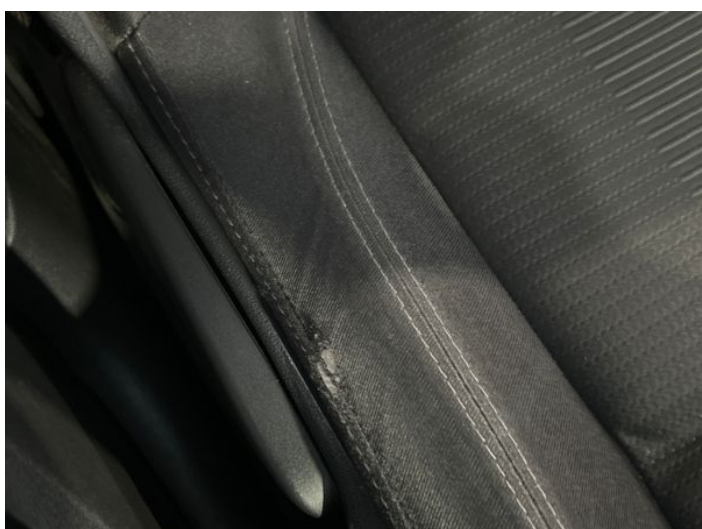
19: Seat Base Cover osf  
Torn  
UpTo 3mm
