# VEHICLE INSPECTION REPORT

**GU64JYA**

## Citroen C3 1.2 VTi VTR+ 5dr

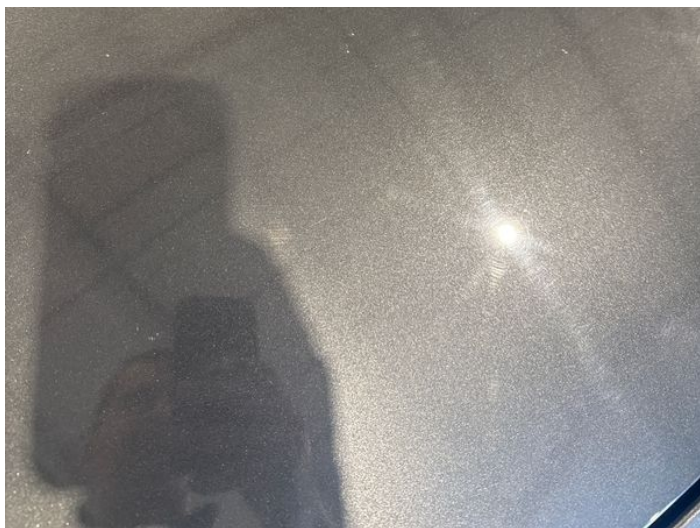
1: Bonnet  
Chipped  
1 To 5

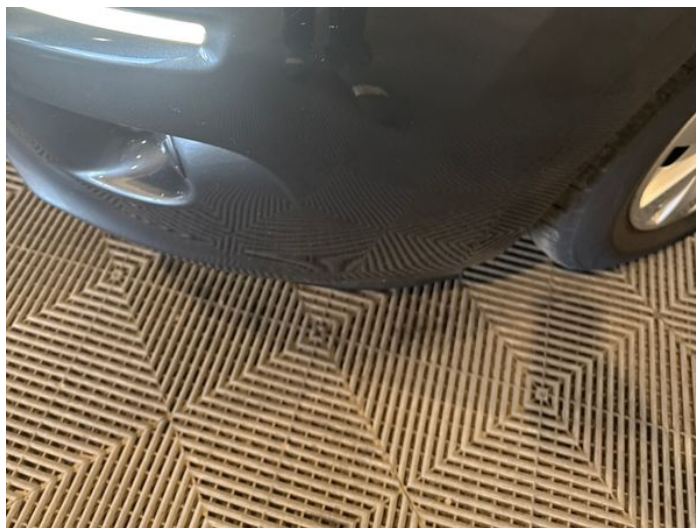
2: Bumper Front  
Chipped  
1 To 5

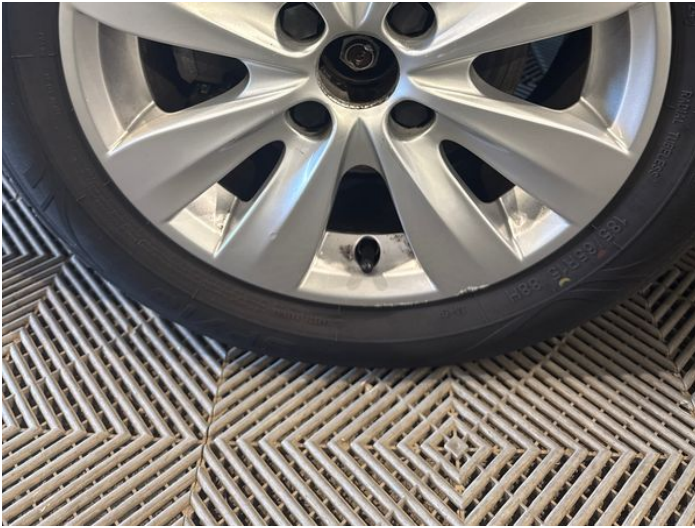
3: Wheel nsf  
Scratched  
Over 50mm

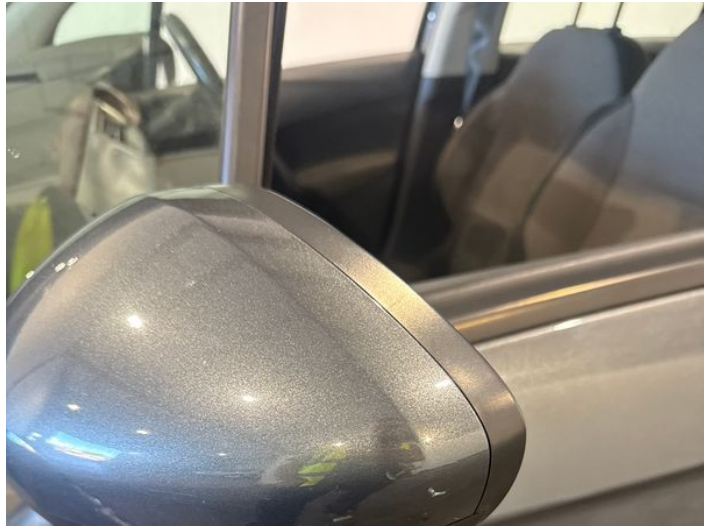
4: Door Mirror Assy nsf  
Scratched (Painted)  
UpTo 25mm Thru Paint

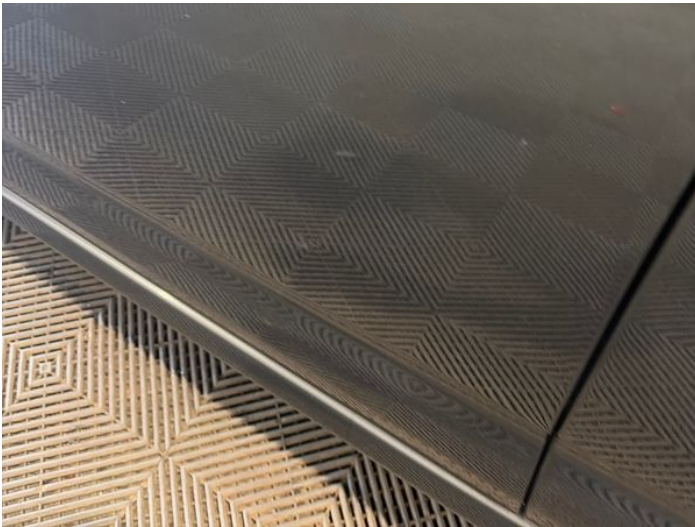
5: Door nsf  
Chipped  
1 To 5

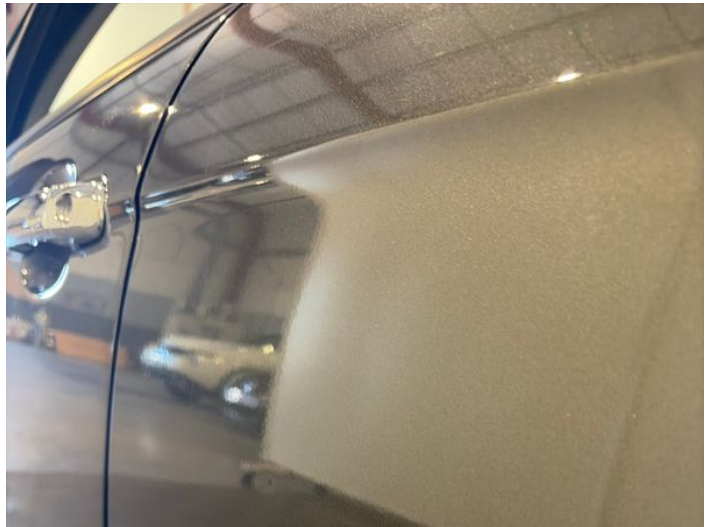
6: Door nsr  
Dented  
Between 10mm + 30mm

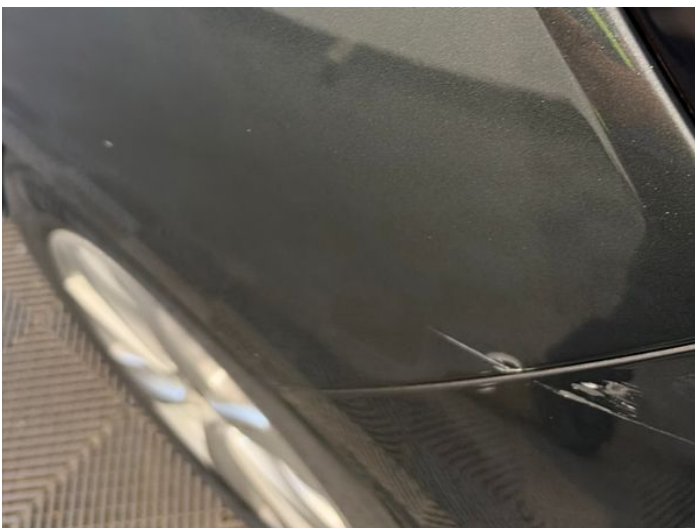
7: Qtr Panel nsr  
Scratched  
UpTo 25mm Thru Paint

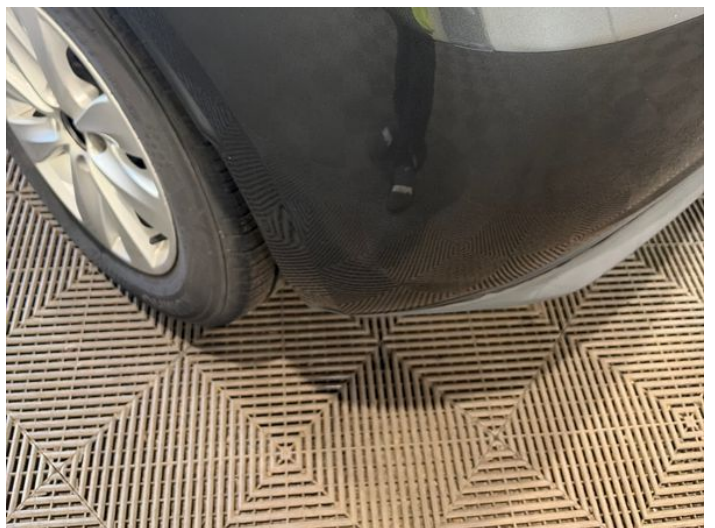
8: Bumper Rear  
Scratched  
25 to 100mm Thru Paint

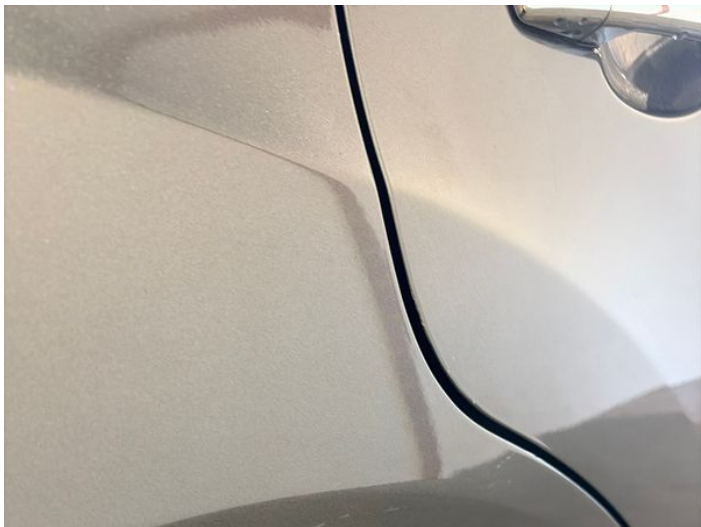
9: Qtr Panel osr  
Chipped  
1 To 5

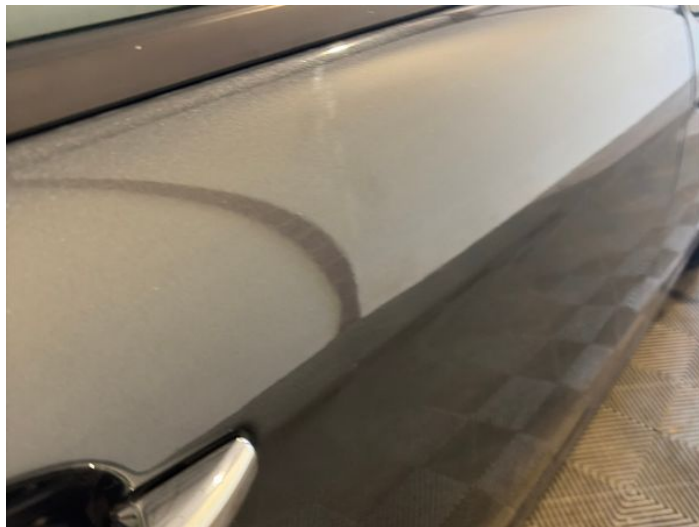
10: Door osr  
Dented  
Between 10mm + 30mm

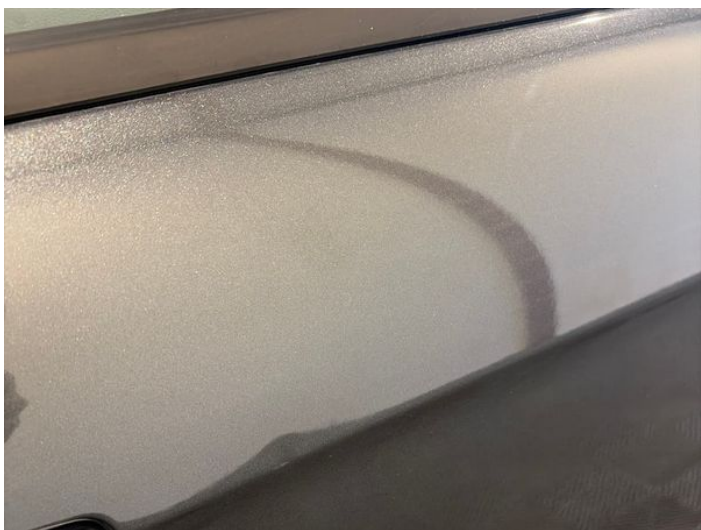
11: Door osr  
Chipped  
1 To 5

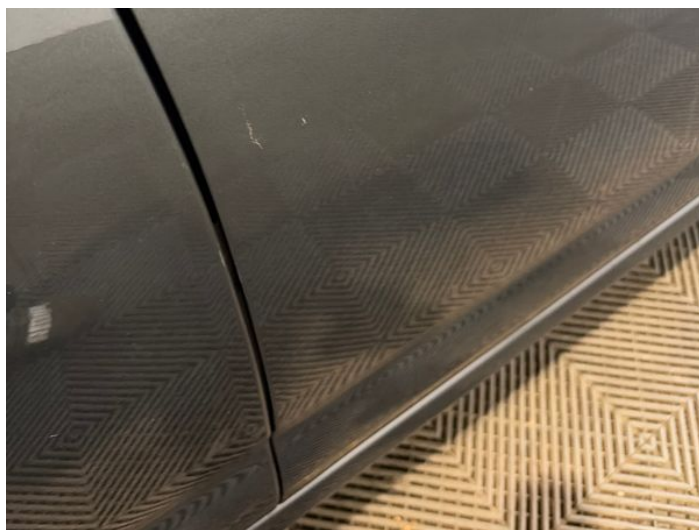
12: Door osf  
Scratched  
UpTo 25mm Thru Paint

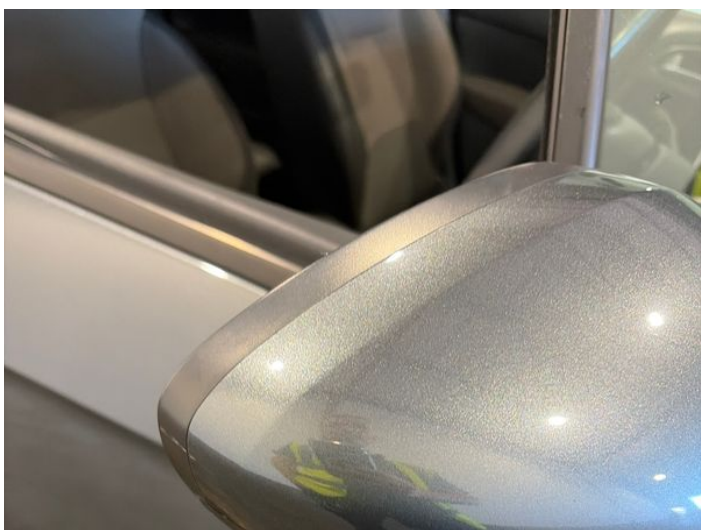
13: Door Mirror Assy osf  
Scratched (Painted)  
UpTo 25mm Thru Paint

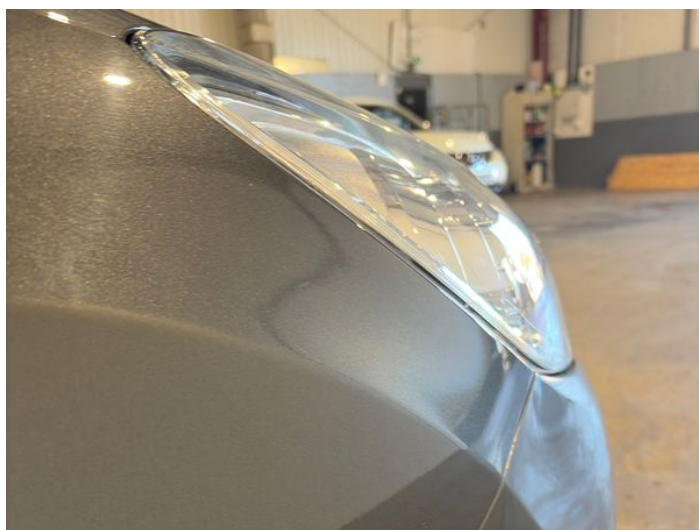
14: Wing osf  
Chipped  
1 To 5

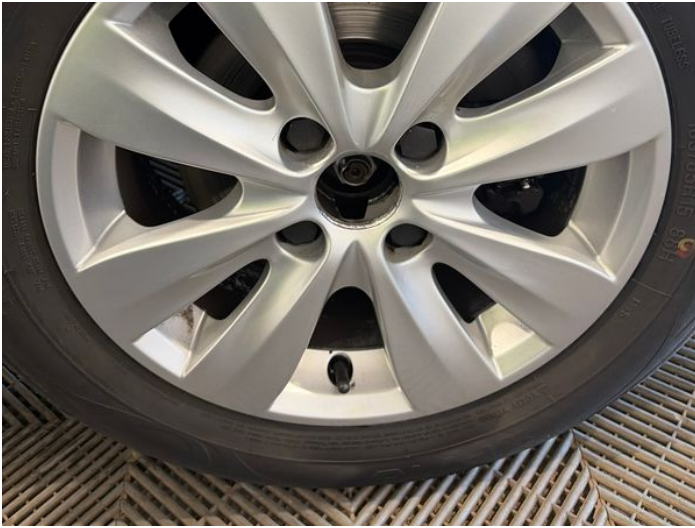
15: Wheel osf  
Scratched  
Up To 50mm

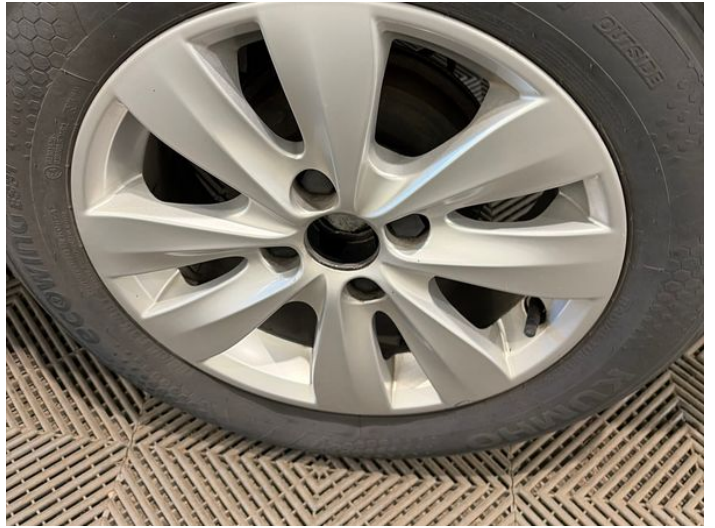
16: Wheel nsr  
Scratched  
Up To 50mm

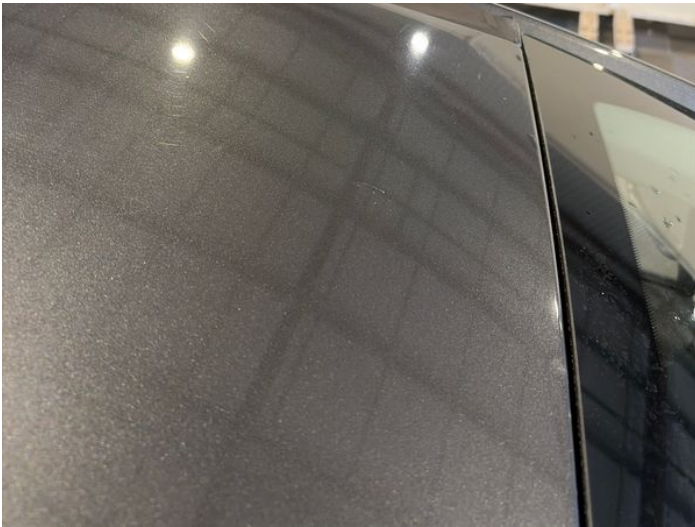
17: Roof  
Chipped  
1 To 5

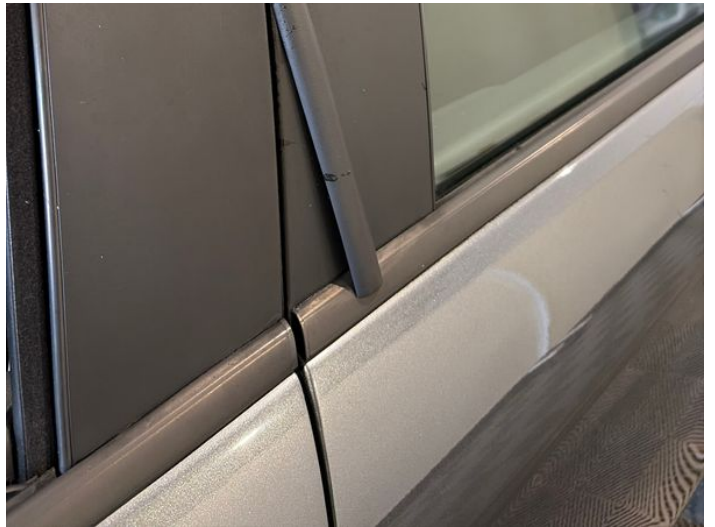
18: Aperture Seal nsr  
Broken  
Replace

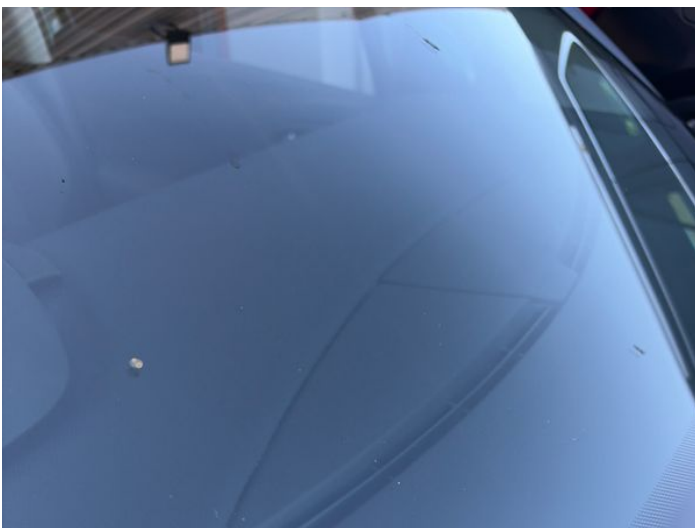
19: Screen Front  
Chipped  
Over 10mm
