# VEHICLE INSPECTION REPORT

**LY19HDE**

## Suzuki Jimny 1.5 SZ5 ALLGRIP Auto 3dr

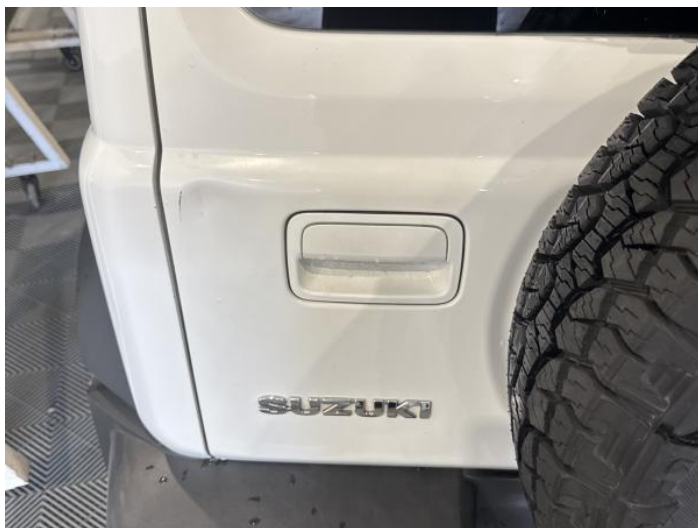
1: Boot Lid  
Dented  
With Paint Damage

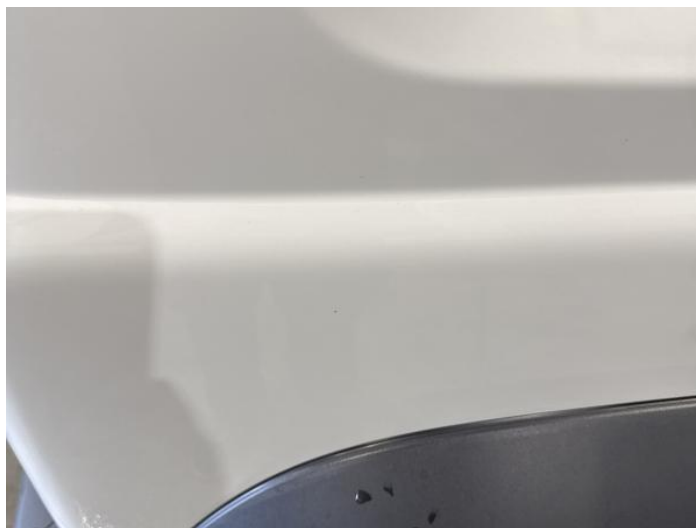
2: Qtr Panel or  
Chipped  
1 To 5

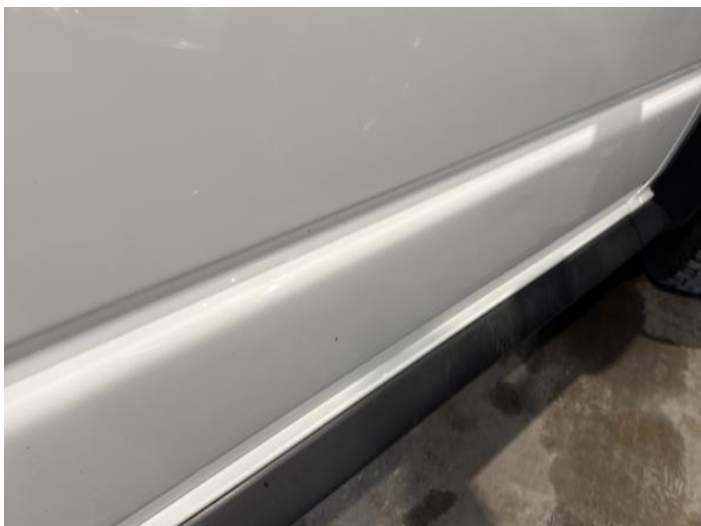
3: Door osf  
Chipped  
1 To 5

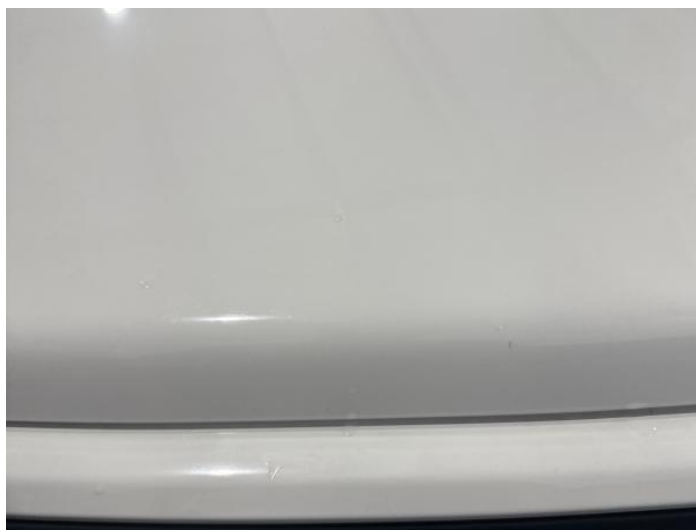
6: Bonnet  
Chipped  
1 To 5

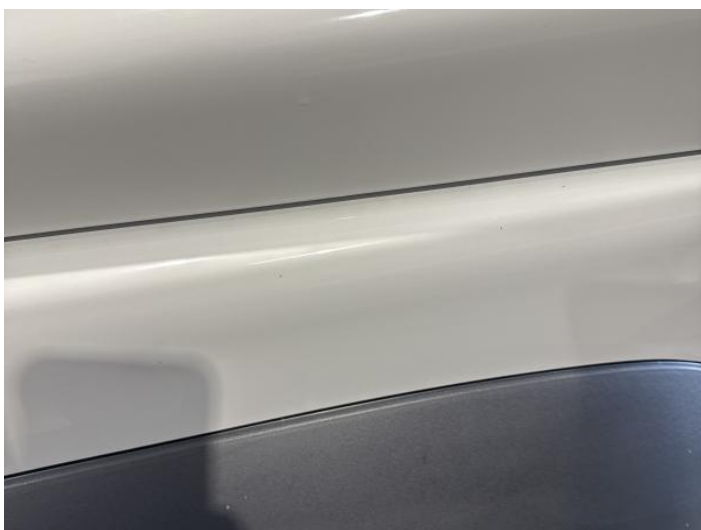
7: Wing nsf  
Chipped  
1 To 5
