VEHICLE INSPECTION REPORT

YE19FMG

Seat Leon 2.0 TSI 190 FR [EZ] 5dr DSG

nama
GRADE
2

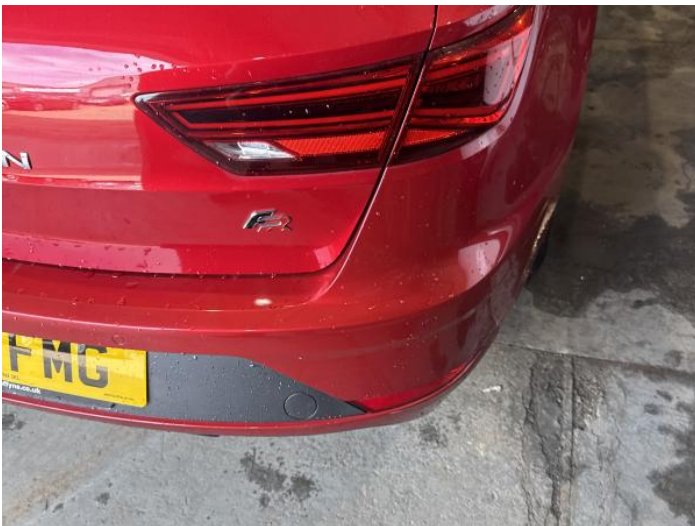
1: Bumper Rear
Chipped
Multiple Chips

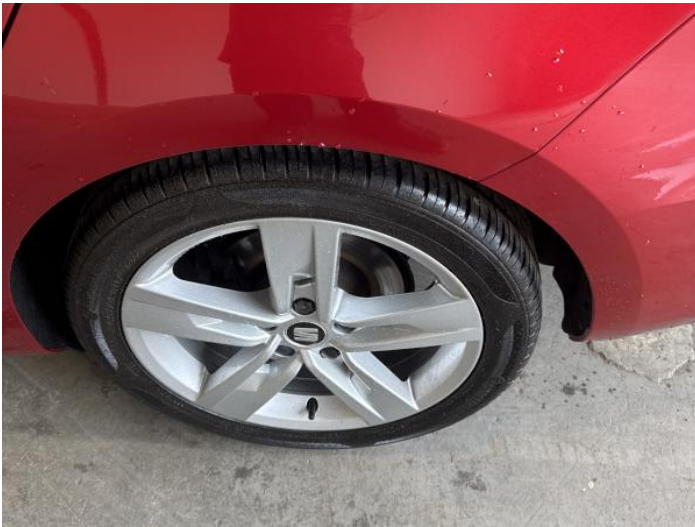
5: Wheel nsr
Scratched
Up To 50mm

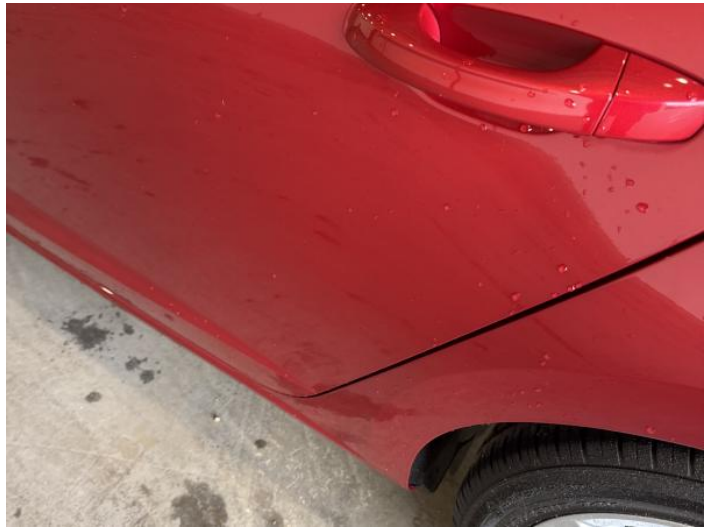
6: Door nsr
Chipped
1 To 5

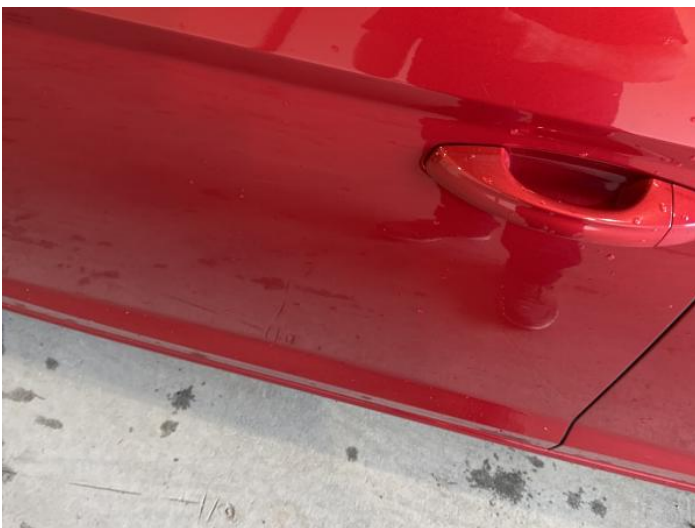
7: Door nsf
Dented
2 Or Less UpTo 10mm

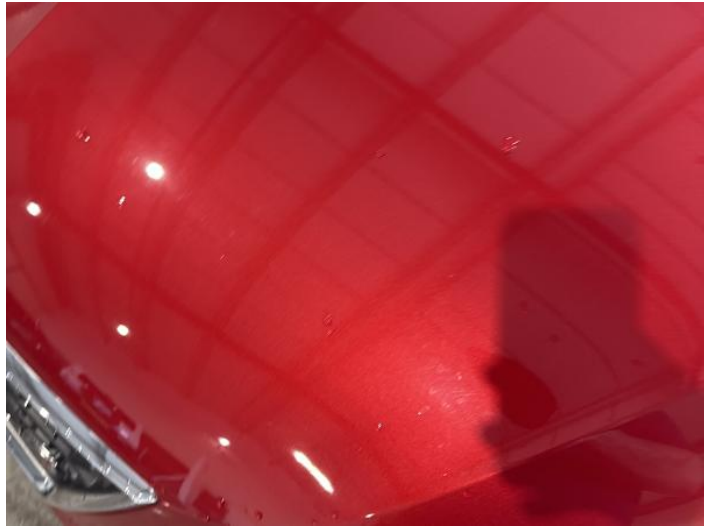
9: Wing nsf
Scratched
Over 25mm Not Thru Paint

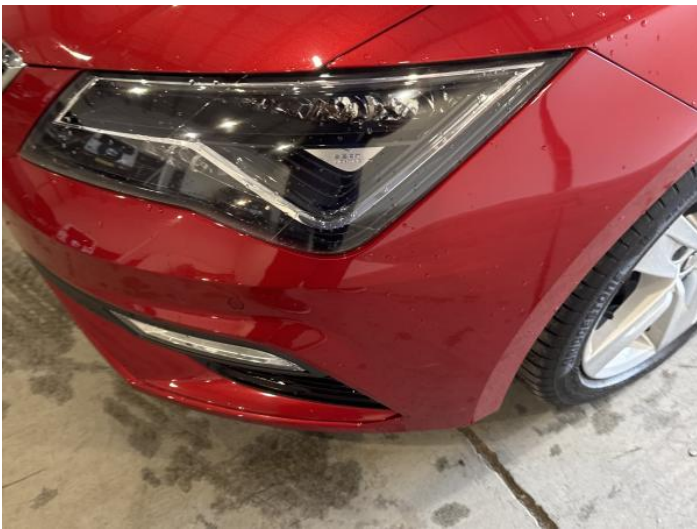
11: Bumper Front
Scratched
25 to 100mm Thru Paint

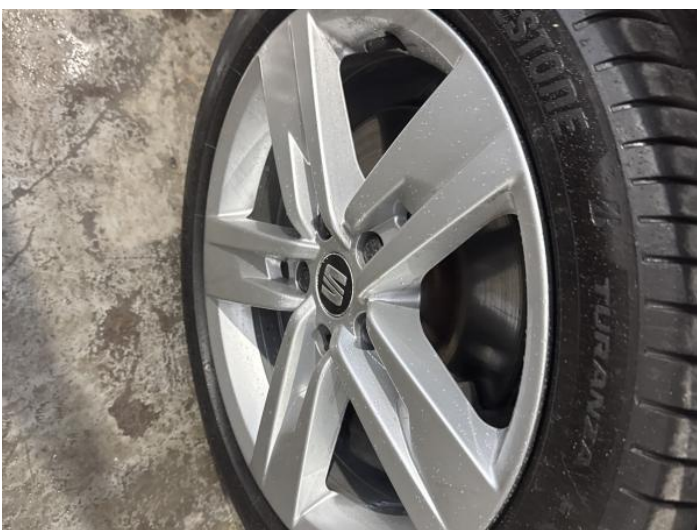
13: Wheel osf
Scratched
Up To 50mm

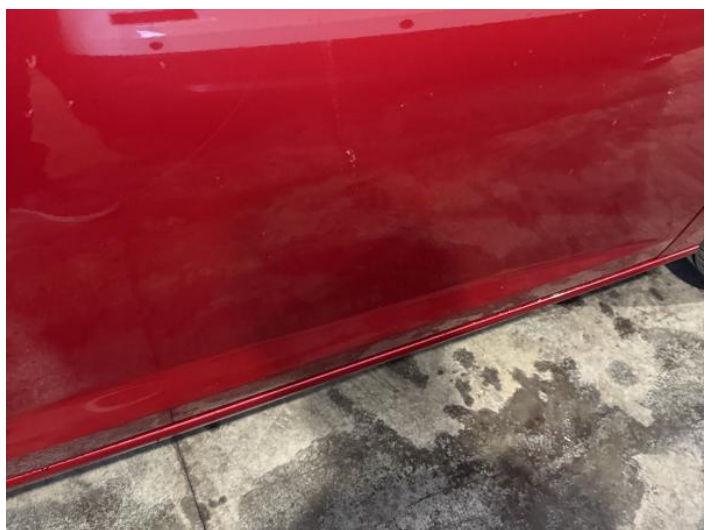
14: Door osf
Chipped
1 To 5

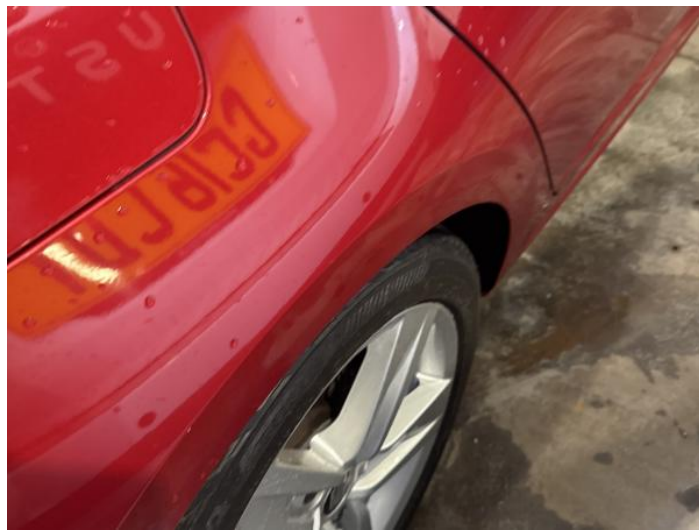
17: Qtr Panel osr
Dented
2 Or Less UpTo 10mm

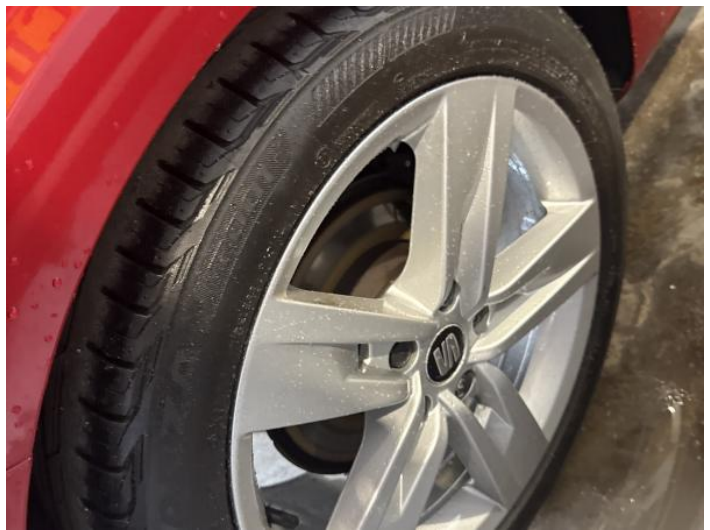
18: Wheel osr
Scratched
Up To 50mm
