VEHICLE INSPECTION REPORT

OY16AKF

Land Rover Discovery Sport 2.0 TD4 180 HSE Luxury 5dr Auto

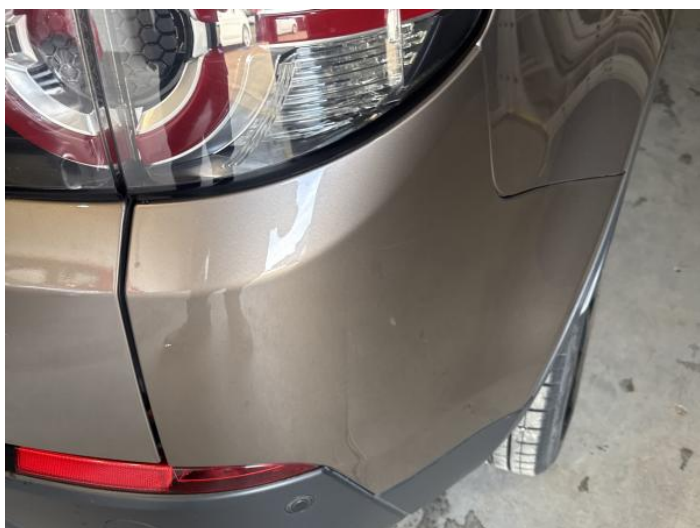
1: Bumper Rear
Chipped
Multiple Chips

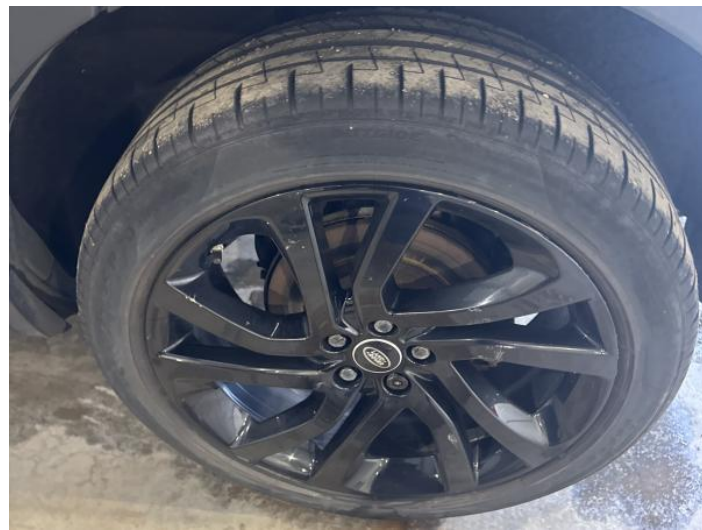
5: Wheel nsr
Scratched
Over 50mm

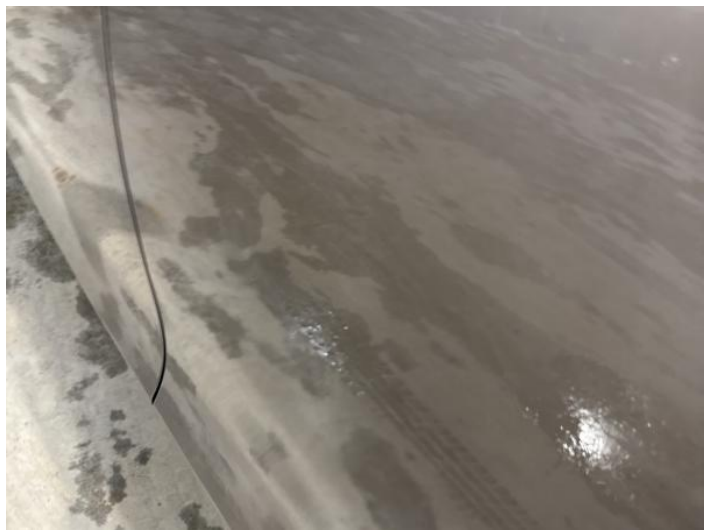
6: Door nsr
Dented
Between 10mm + 30mm

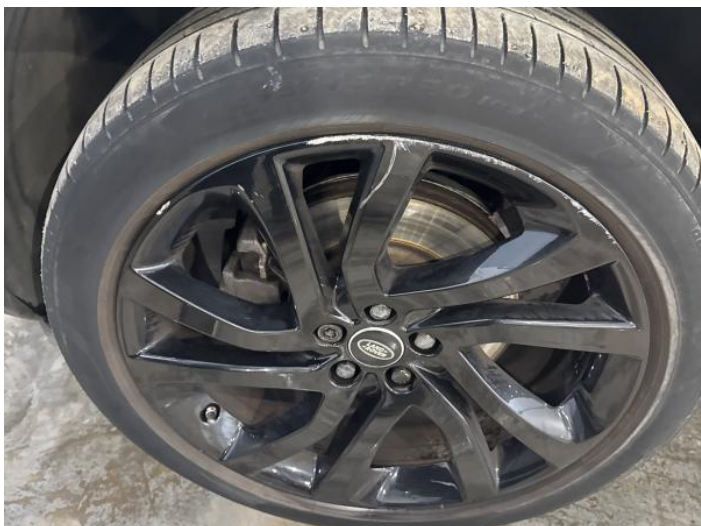
9: Wheel nsf
Scratched
Over 50mm

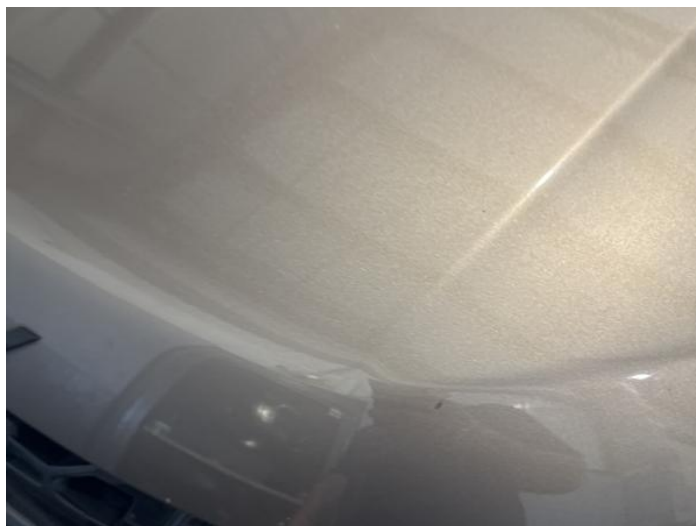
10: Bonnet
Chipped
1 To 5

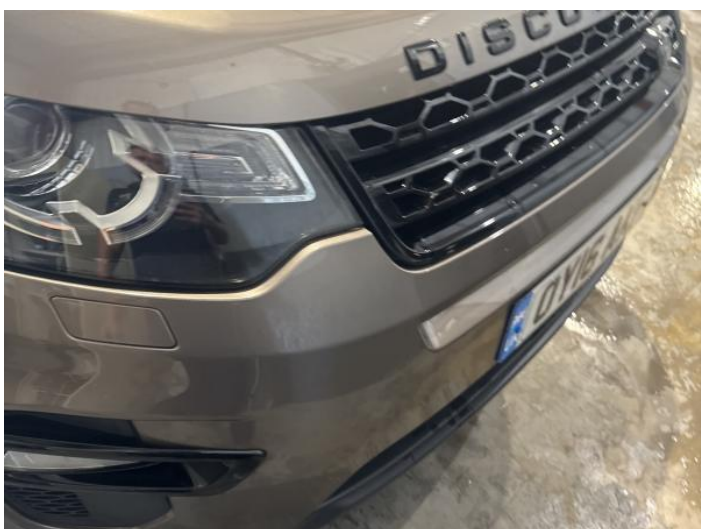
11: Bumper Front
Chipped
Multiple Chips

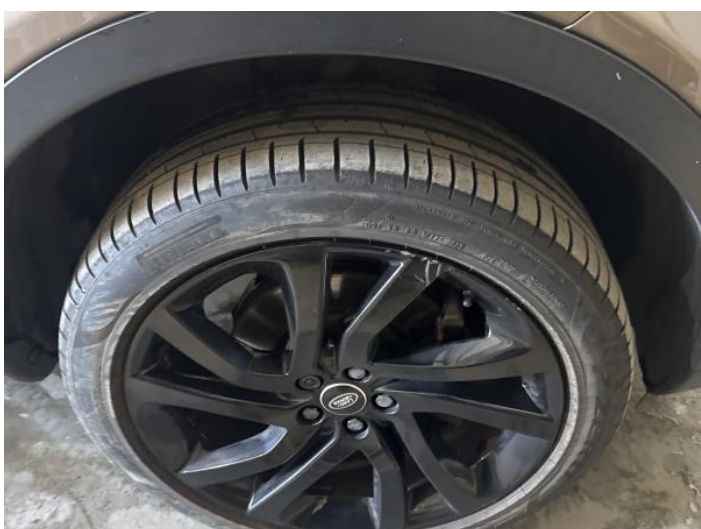
13: Wheel osf
Scratched
Over 50mm

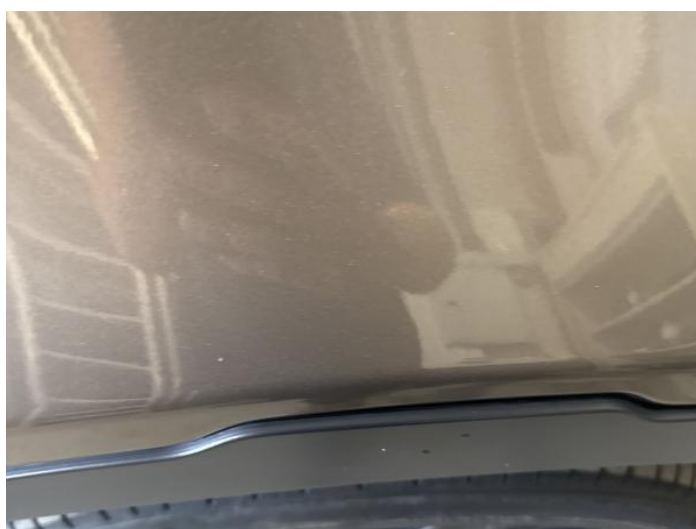
14: Wing osf
Chipped
1 To 5

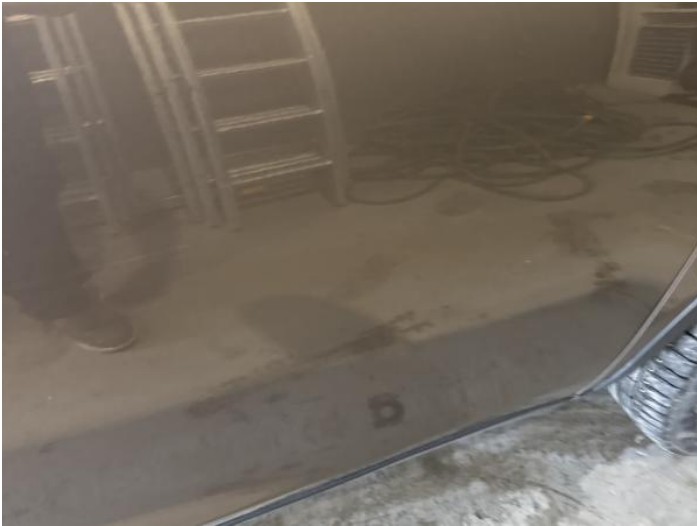
15: Door osf
Chipped
1 To 5

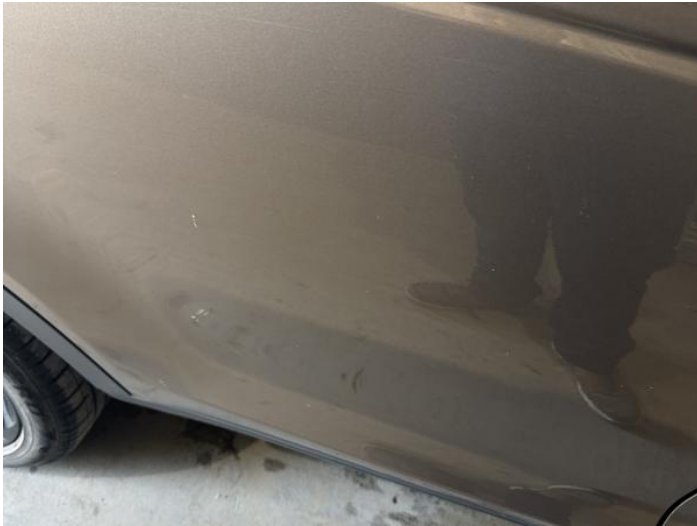
16: Door osr
Chipped
1 To 5

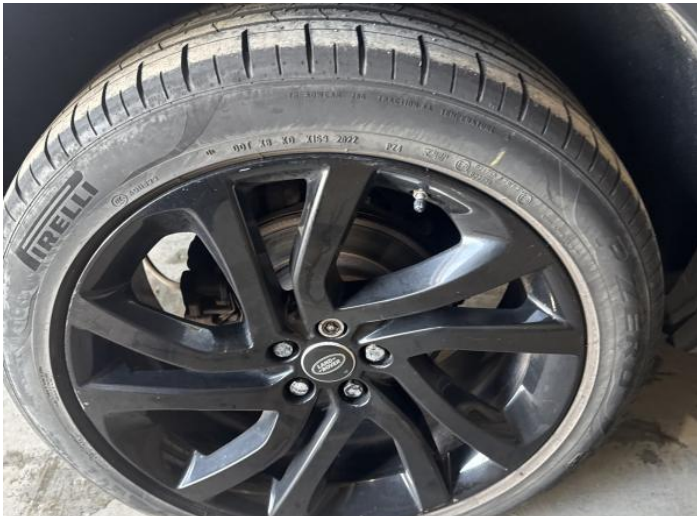
18: Wheel osr
Scratched
Up To 50mm
