# VEHICLE INSPECTION REPORT

**GY640BE**

## Nissan Juke 1.2 DiG-T Tekna 5dr

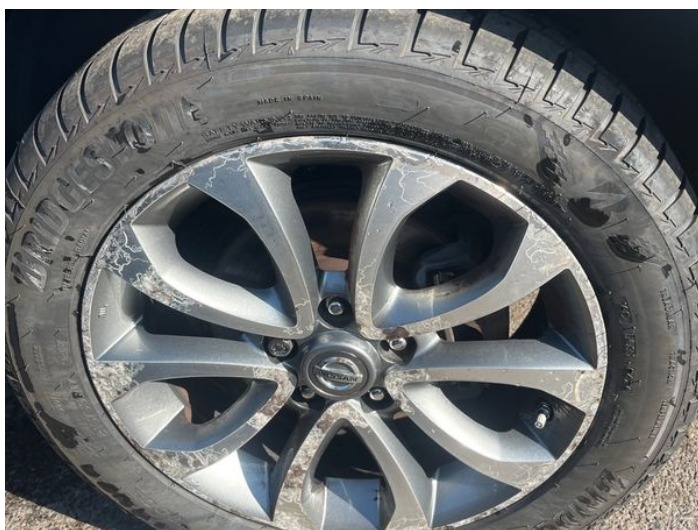
1: Wheel of front left  
Scratched  
Over 50mm

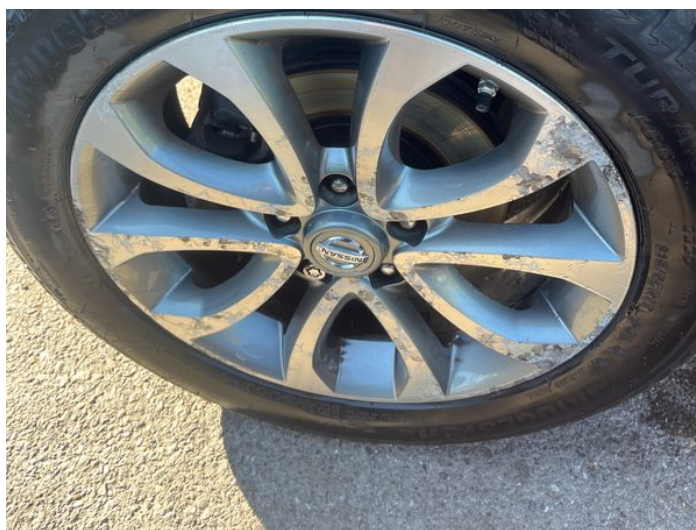
2: Wheel of front right  
Scratched  
Over 50mm

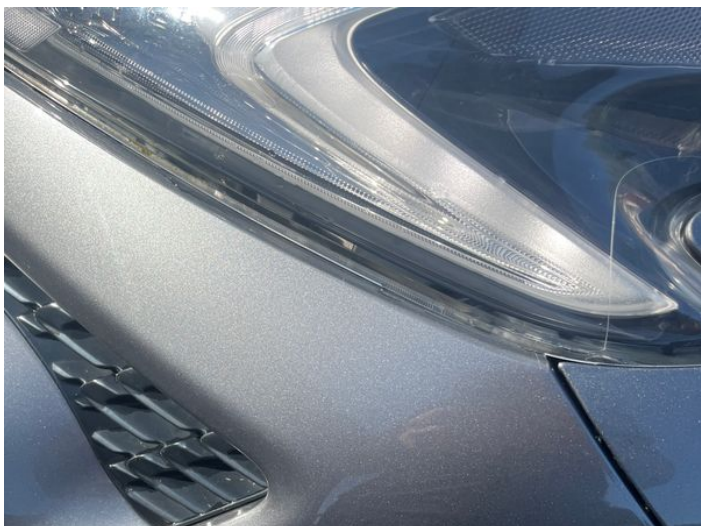
3: Bumper Front  
Scratched  
25 to 100mm Thru Paint

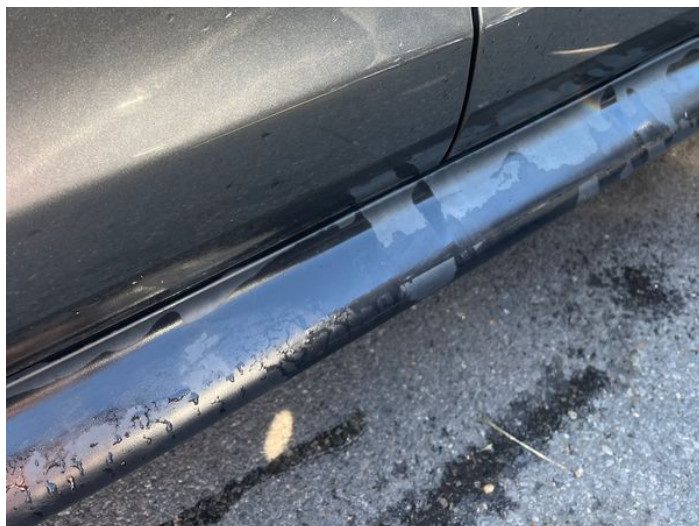
4: Door nsf  
Scratched  
Over 25mm Thru Paint

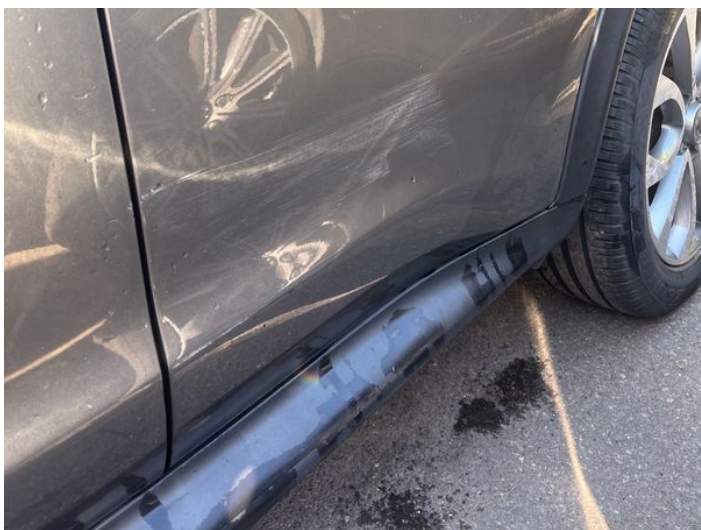
5: Door nsr  
Scratched  
Over 25mm Thru Paint

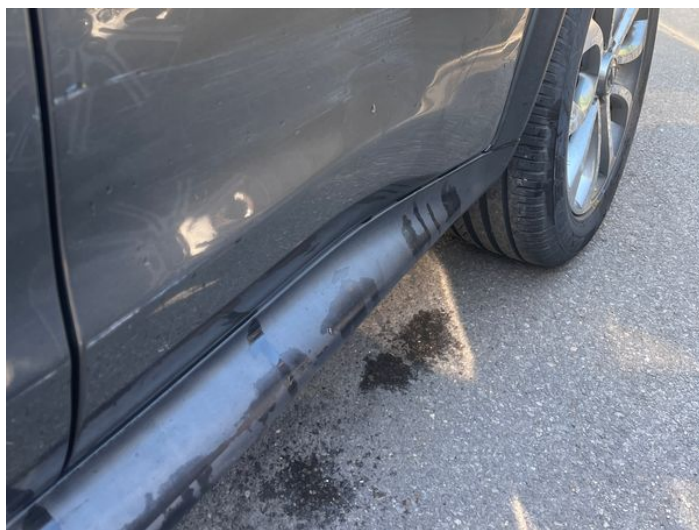
6: Door nsr  
Dented  
Between 10mm + 30mm

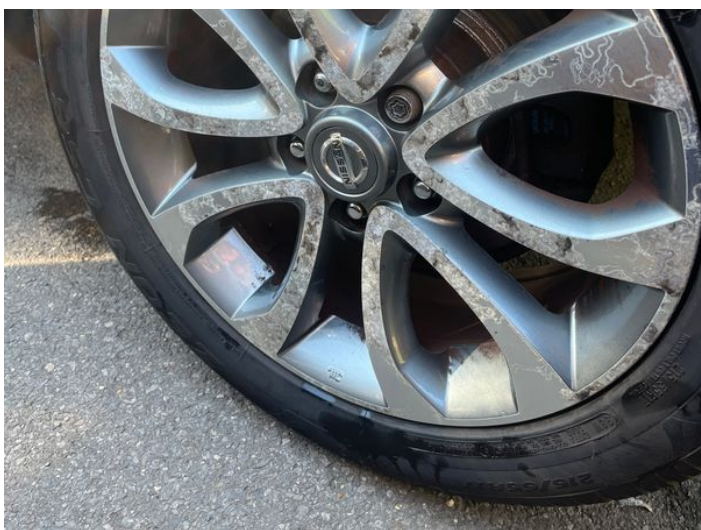
7: Wheel nsr  
Corroded  
Light

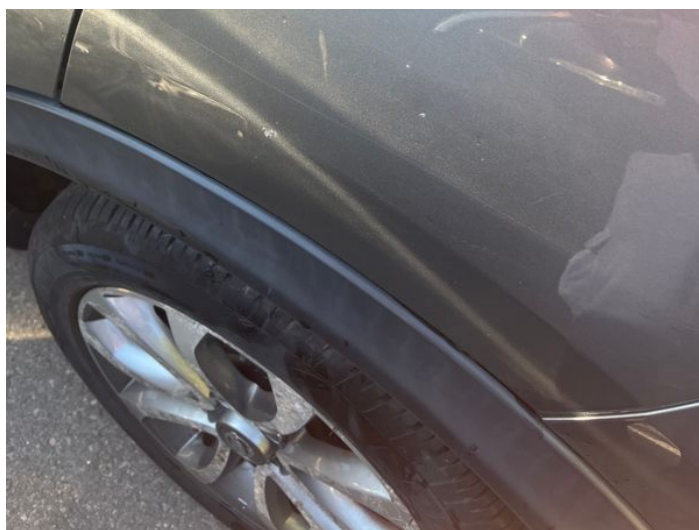
8: Qtr Panel nsr  
Scratched  
UpTo 25mm Thru Paint

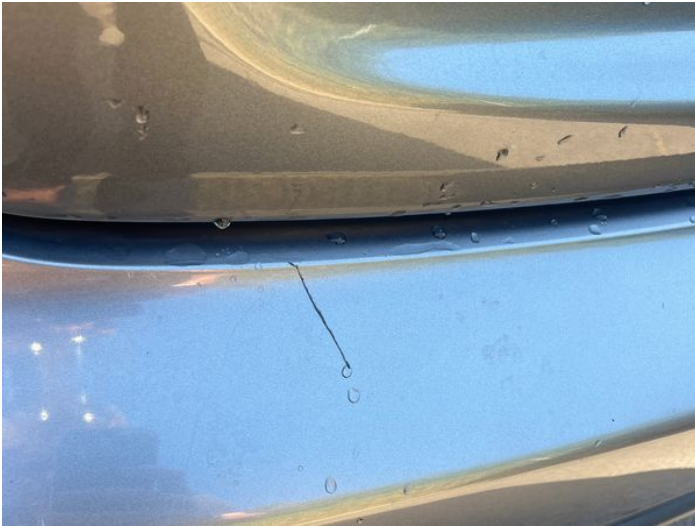
9: Bumper Rear  
Scratched  
Over 100mm Thru Paint

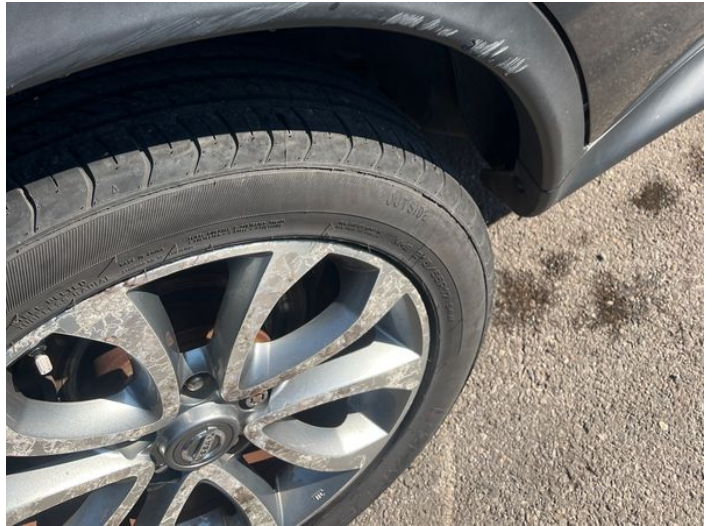
10: Wheel Trim osr  
Scratched  
Over 50mm

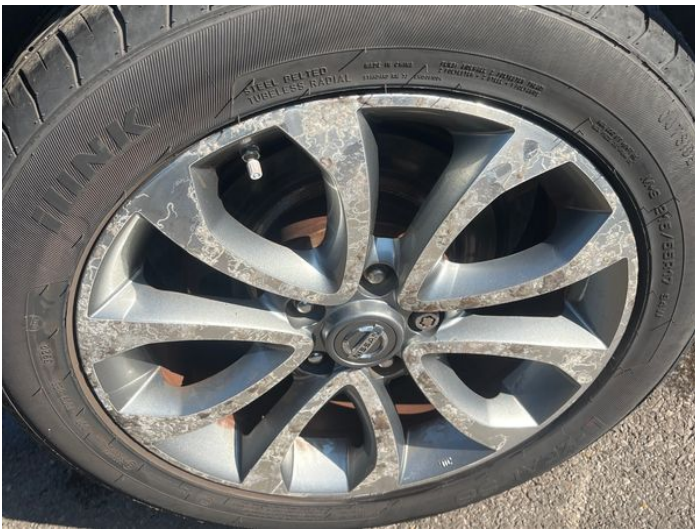
11: Wheel osr  
Corroded  
Light

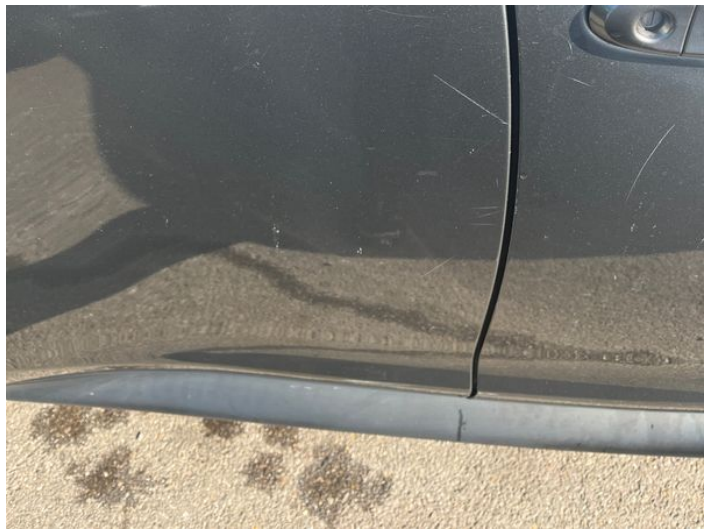
12: Door osr  
Scratched  
Over 25mm Thru Paint

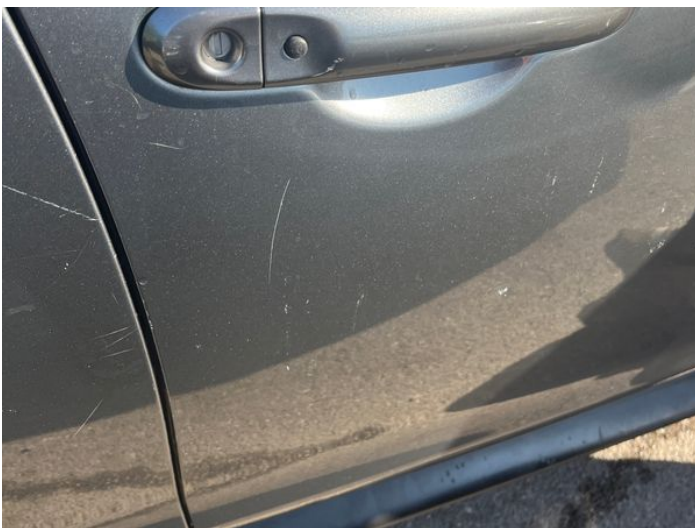
13: Door osf  
Scratched  
Over 25mm Thru Paint

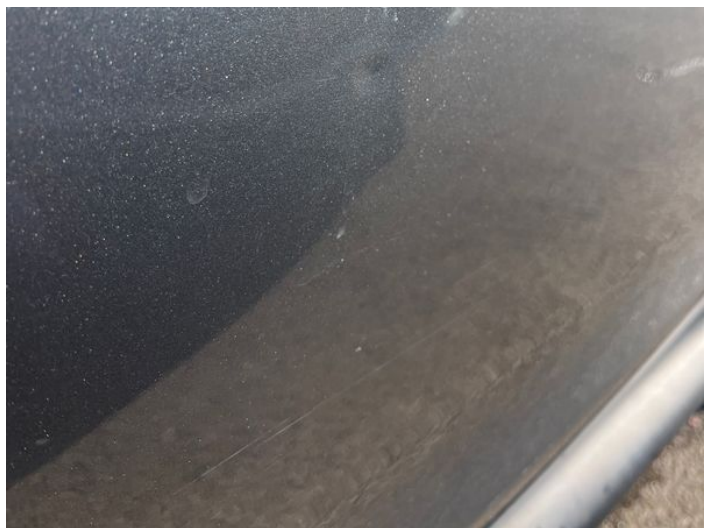
14: Door osf  
Dented  
2 Or Less UpTo 10mm
