# VEHICLE INSPECTION REPORT

**HV64WNX**

## Honda Civic 1.8 i-VTEC S 5dr

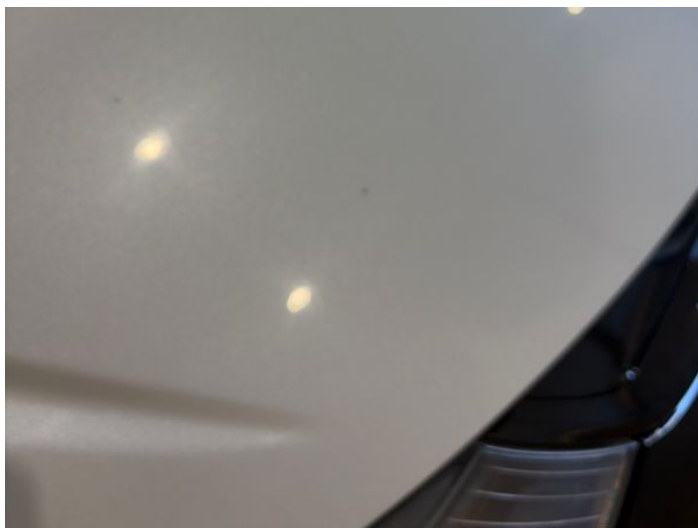
1: Bonnet  
Chipped  
1 To 5

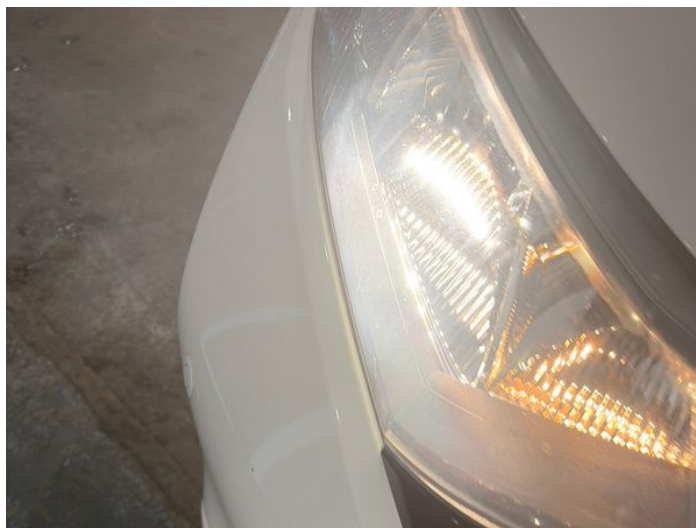
2: Bumper Front  
Chipped  
1 To 5

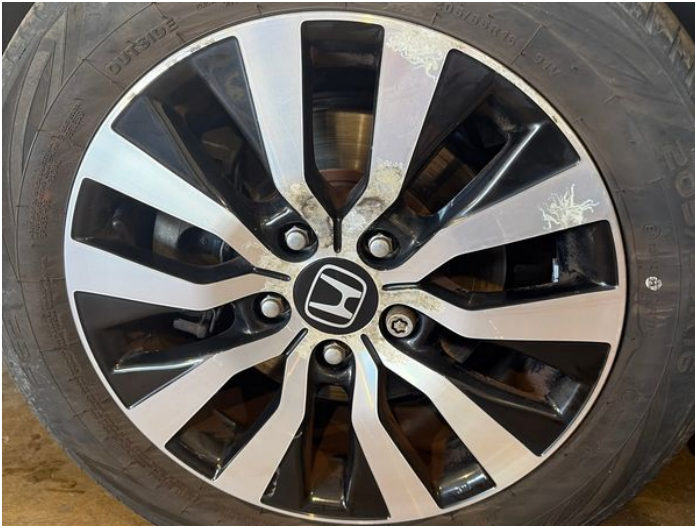
3: Wheel nsf  
Scratched  
Over 50mm

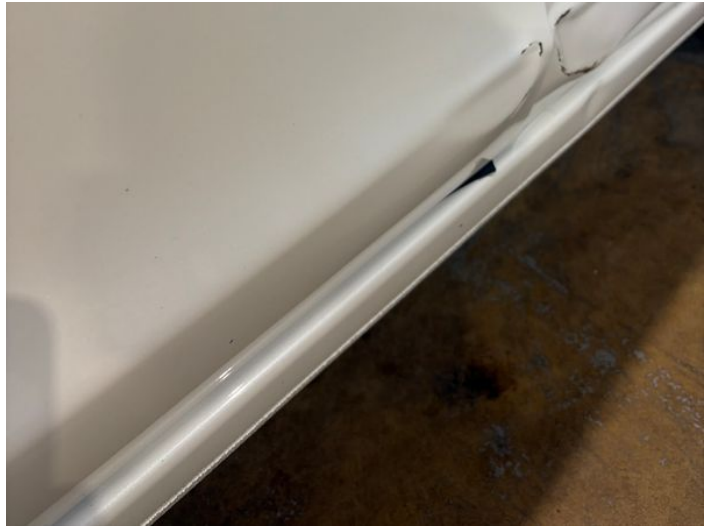
4: Door nsf  
Dented  
With Paint Damage

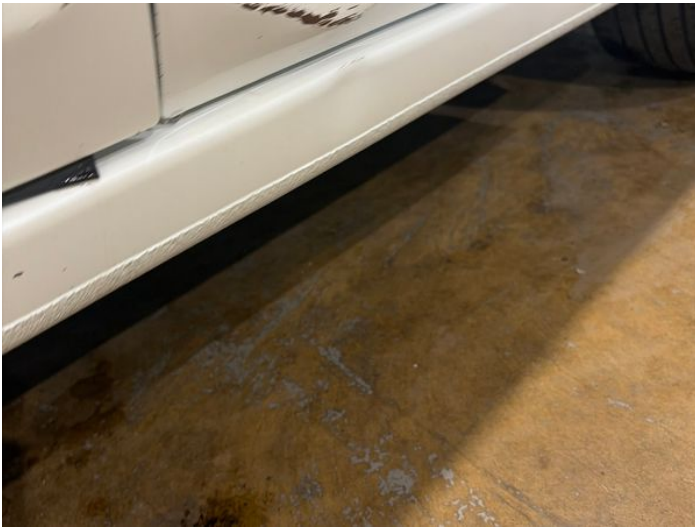
5: Sill ns  
Dented  
Over 30mm

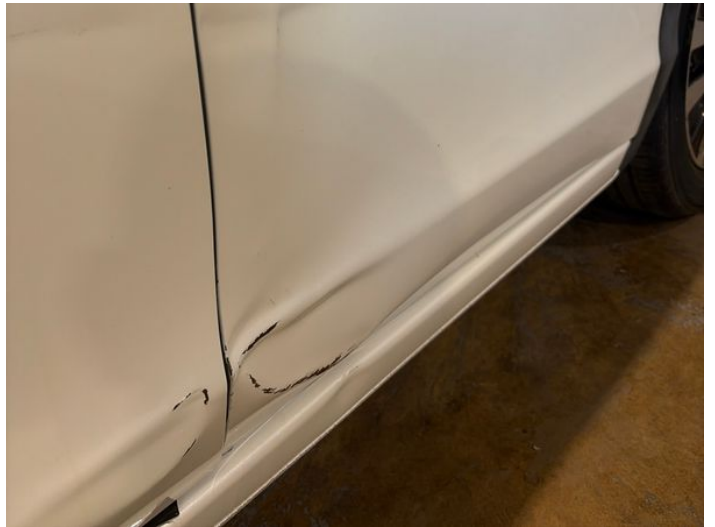
6: Door nsr  
Dented  
With Paint Damage

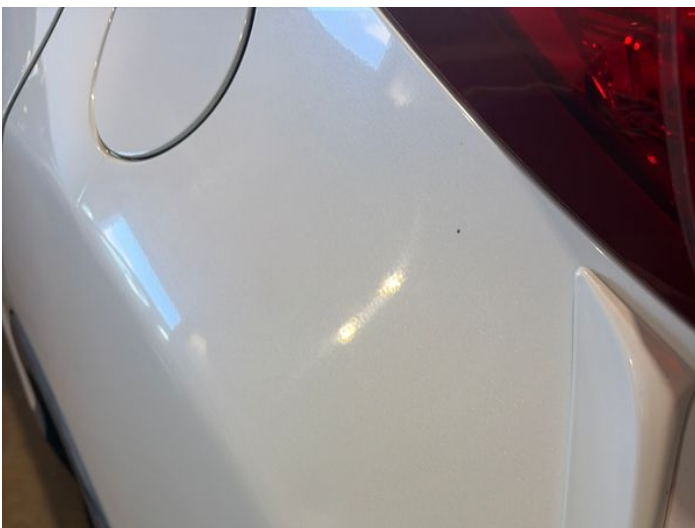
7: Qtr Panel nsr  
Dented  
Between 10mm + 30mm

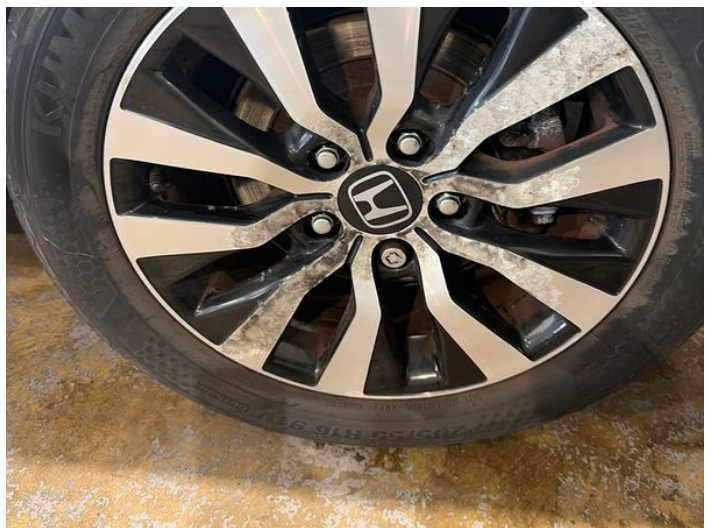
8: Wheel nsr  
Scratched  
Over 50mm

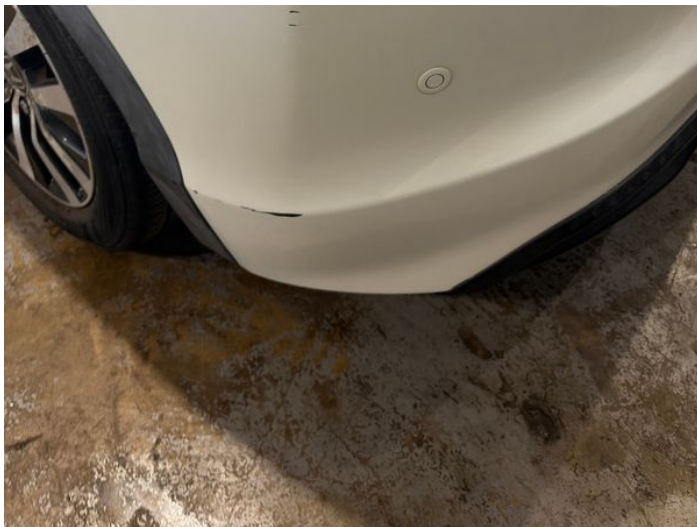
9: Bumper Rear  
Scratched  
25 to 100mm Thru Paint

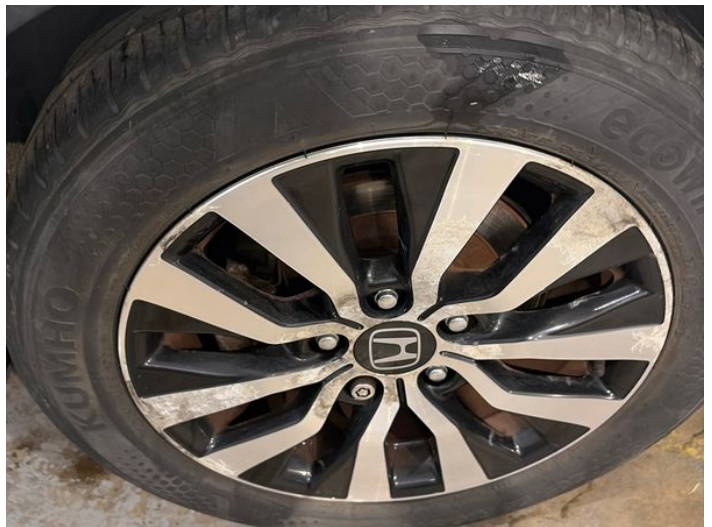
10: Wheel osr  
Scratched  
Over 50mm

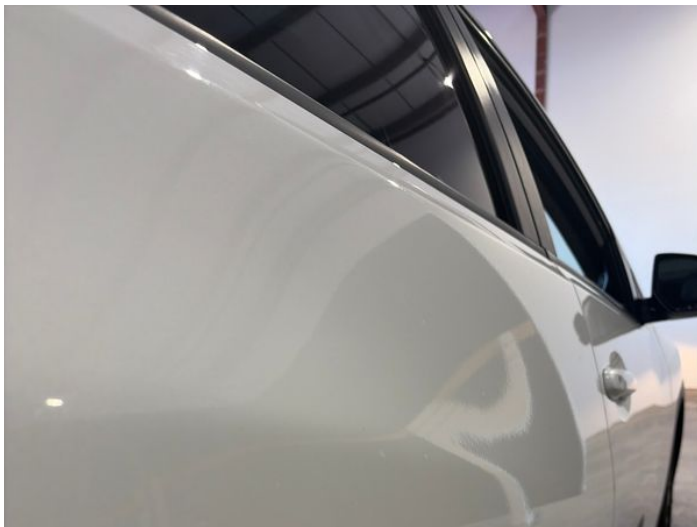
11: Door osr  
Dented  
With Paint Damage

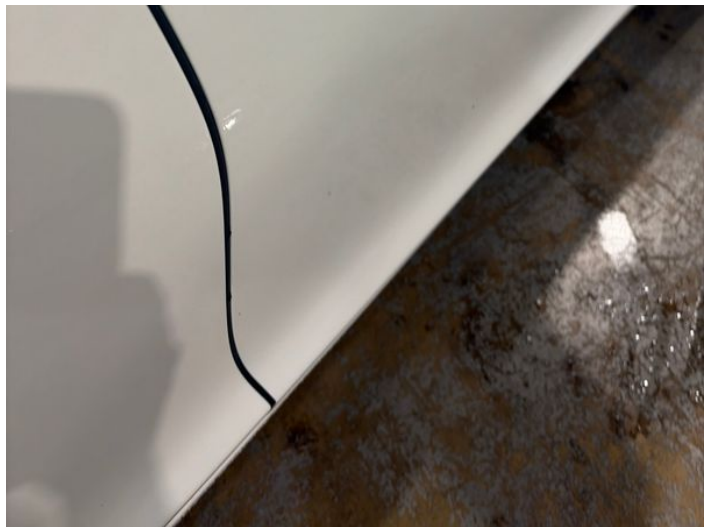
12: Door osf  
Chipped  
Edge Chip

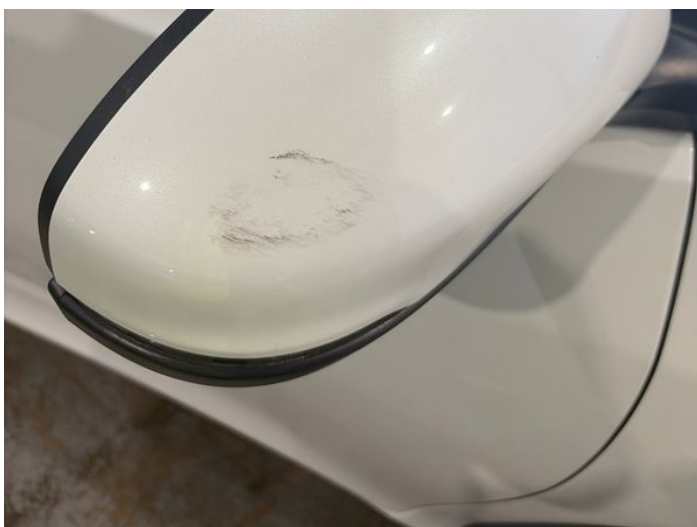
13: Door Mirror Assy osf  
Scratched (Painted)  
Over 25mm Thru Paint

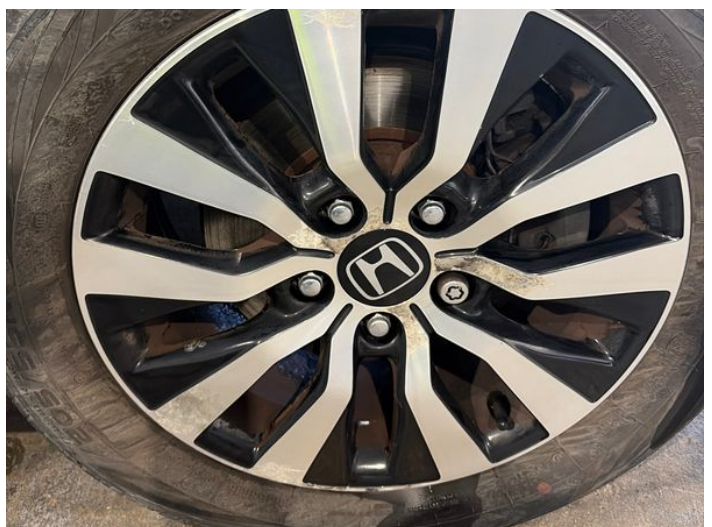
14: Wheel osf  
Scratched  
Over 50mm
