# VEHICLE INSPECTION REPORT

**HX66UAG**

## Kia Picanto 1.25 Sport 5dr

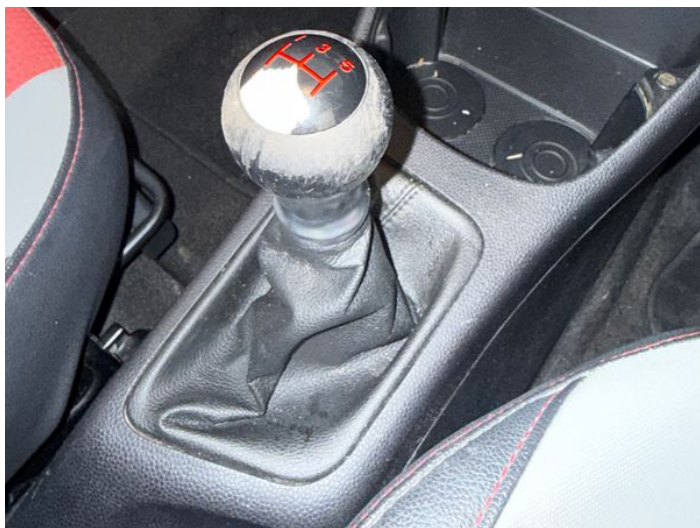
1: Switches And Controls  
Broken  
Replace

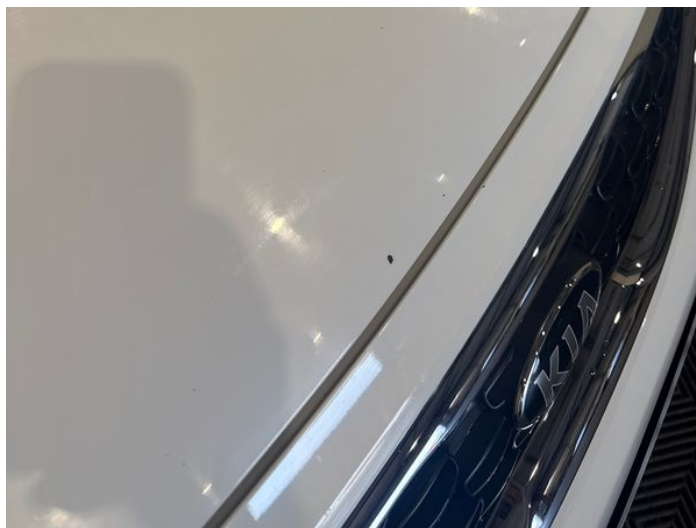
2: Bonnet  
Chipped  
Multiple Chips

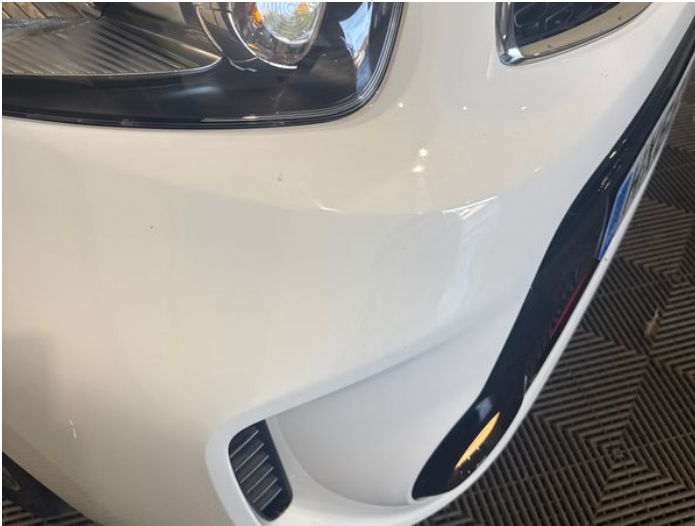
3: Bumper Front  
Poor Previous Repair  
Poor Paint

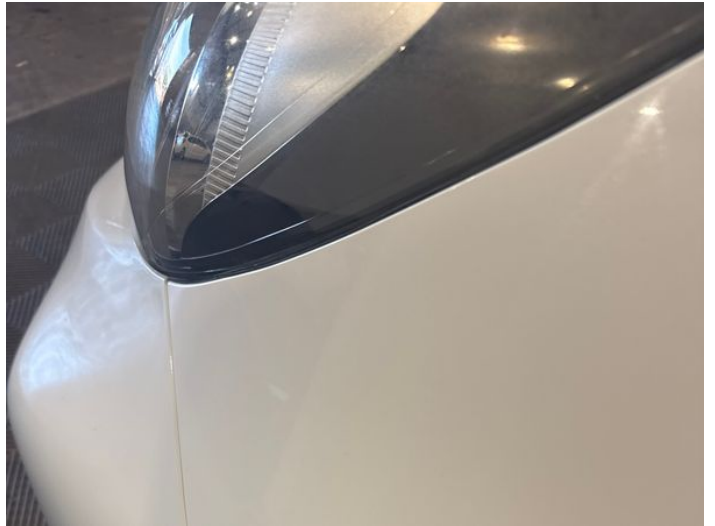
4: Wing nsf  
Scratched  
UpTo 25mm Thru Paint

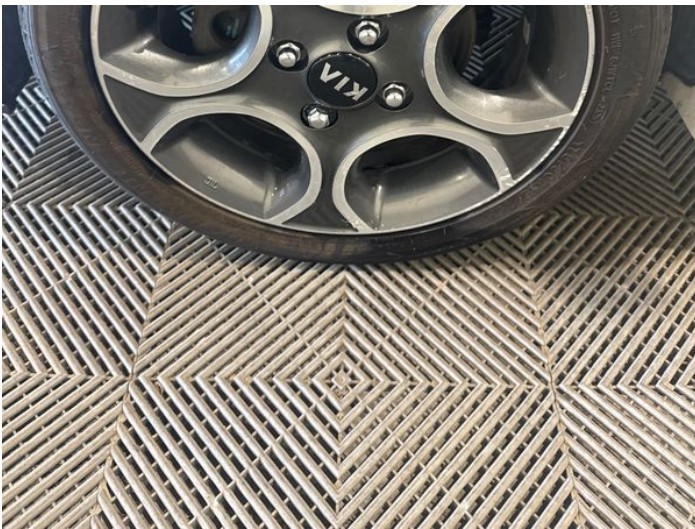
5: Wheel nsf  
Scratched  
Over 50mm

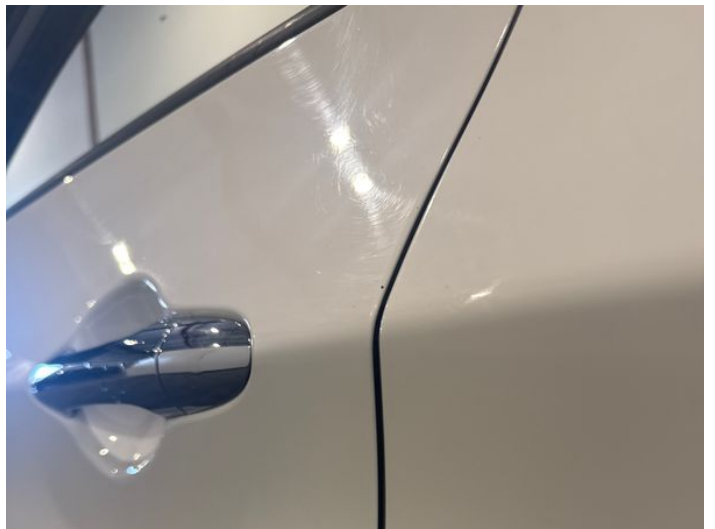
6: Door nsf  
Chipped  
Edge Chip

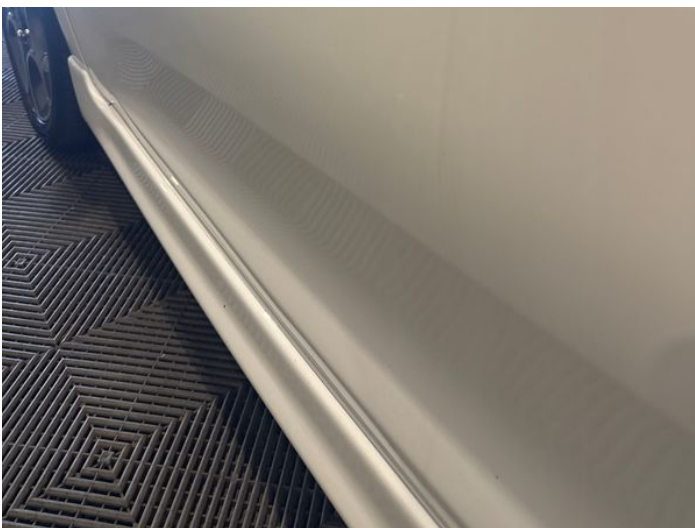
7: Door nsf  
Dented  
2 Or Less UpTo 10mm

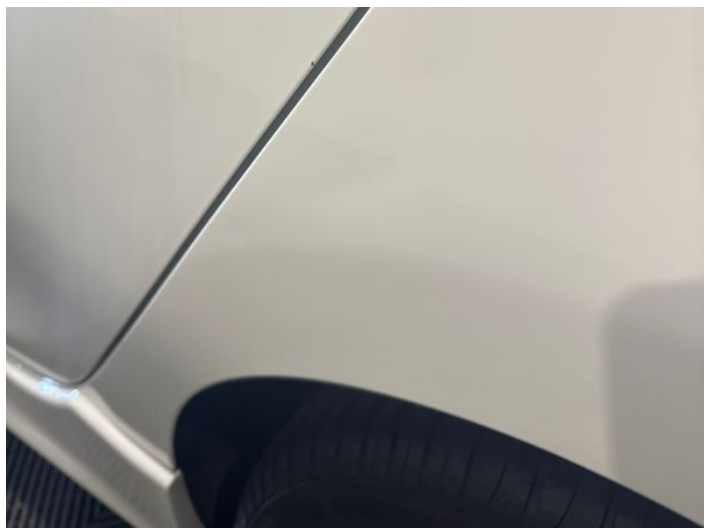
8: Door nsr  
Chipped  
1 To 5

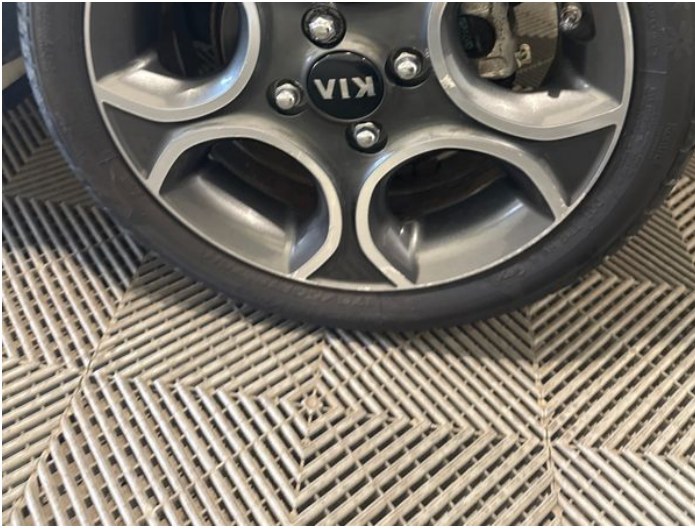
9: Wheel nsr  
Scratched  
Over 50mm

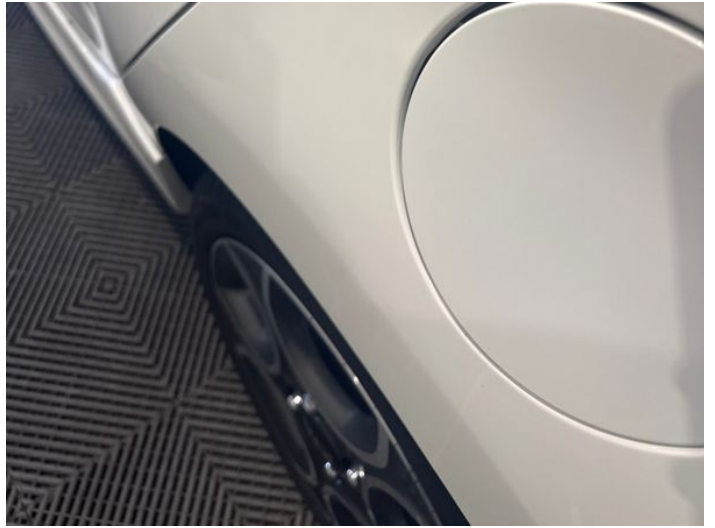
10: Qtr Panel nsr  
Dented  
Between 10mm + 30mm

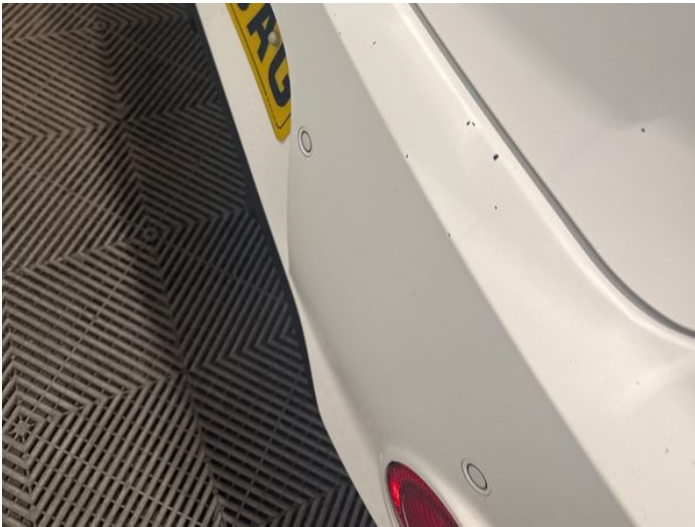
11: Bumper Rear  
Scratched  
Over 100mm Thru Paint

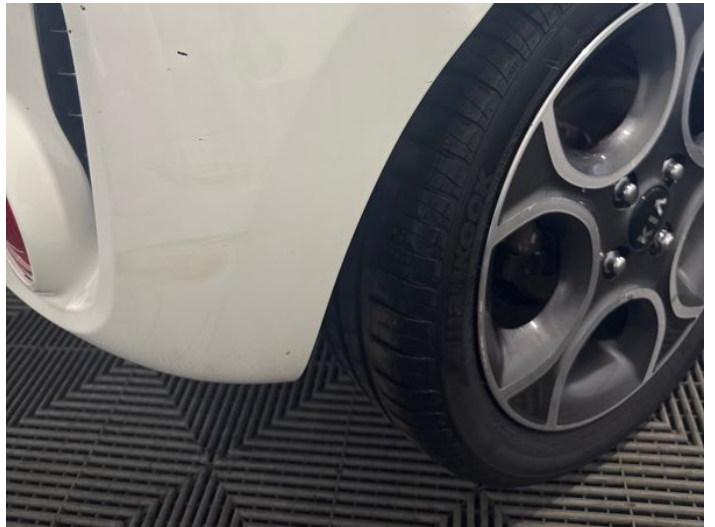
12: Bumper Rear  
Dented  
Between 10mm + 30mm

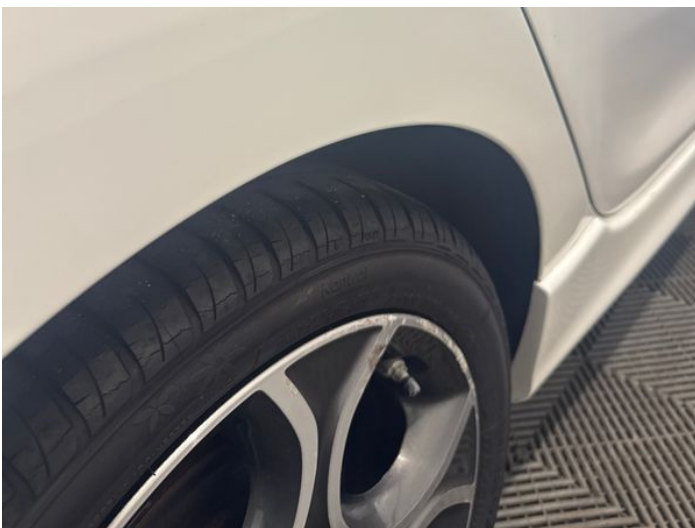
13: Qtr Panel osr  
Dented  
Between 10mm + 30mm

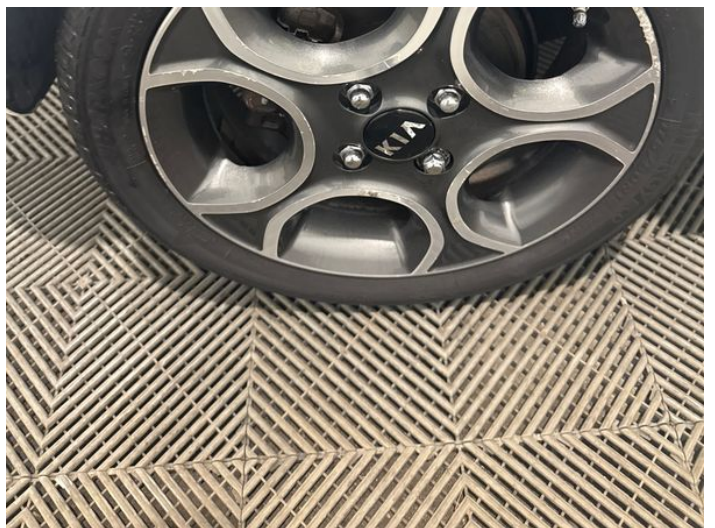
14: Wheel osr  
Scratched  
Over 50mm

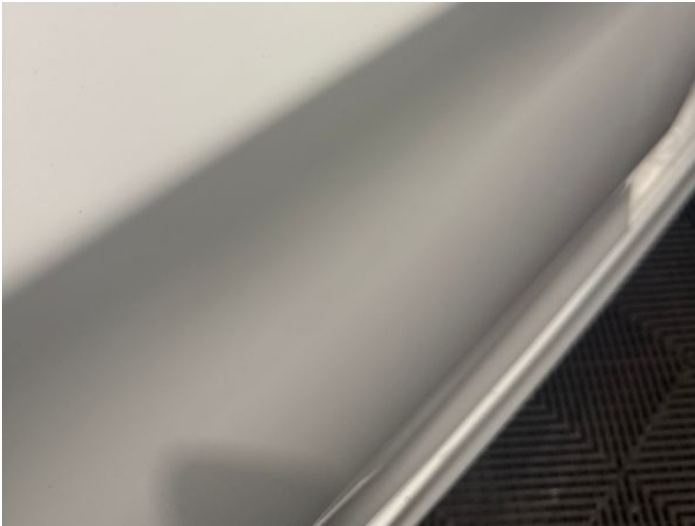
15: Door osr  
Chipped  
1 To 5

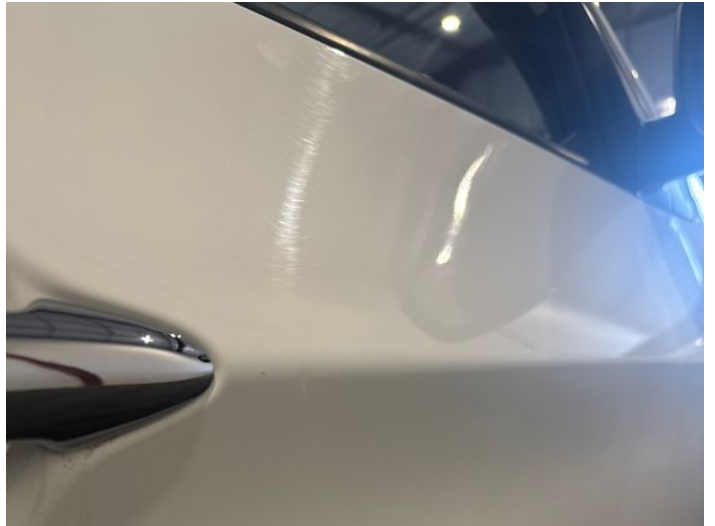
16: Door osf  
Dented  
Between 10mm + 30mm

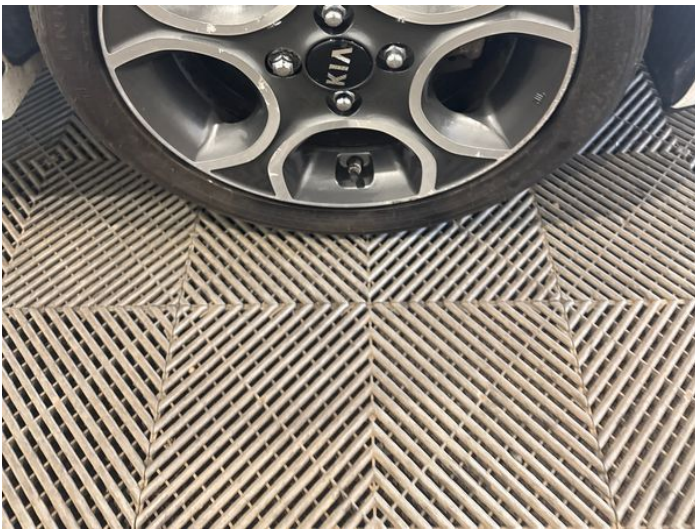
17: Wheel osf  
Scratched  
Over 50mm

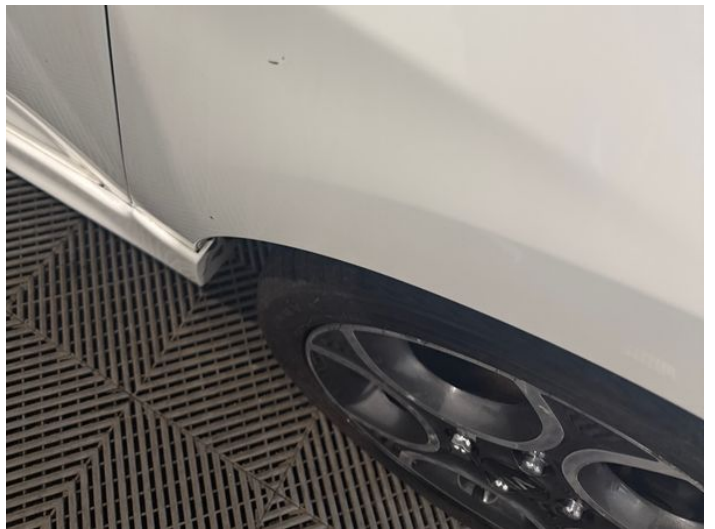
18: Wing osf  
Scratched  
UpTo 25mm Thru Paint

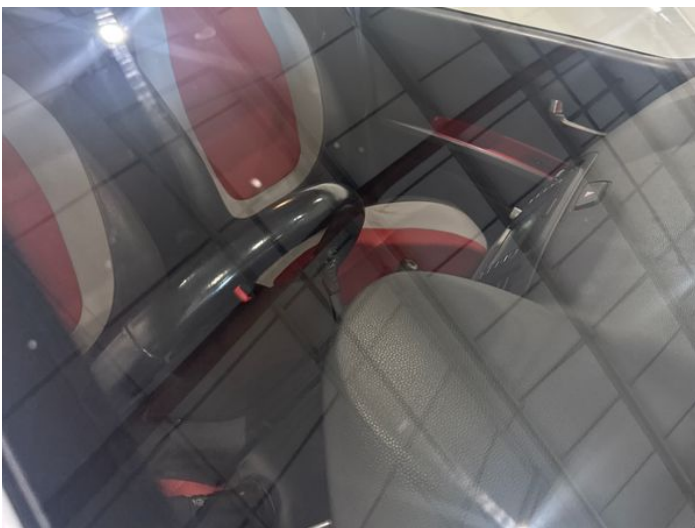
19: Screen Front  
Cracked  
Replace
