# VEHICLE INSPECTION REPORT

**MF66XOL**

## Kia Sportage 1.6 GDi 1 5dr

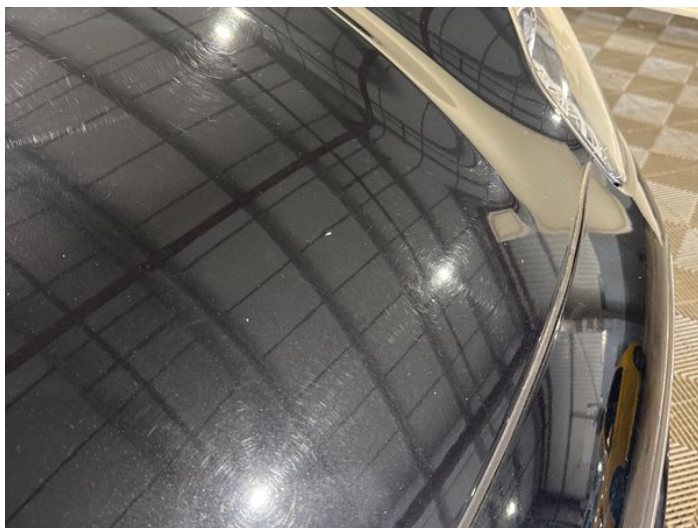
1: Bonnet  
Chipped  
Multiple Chips

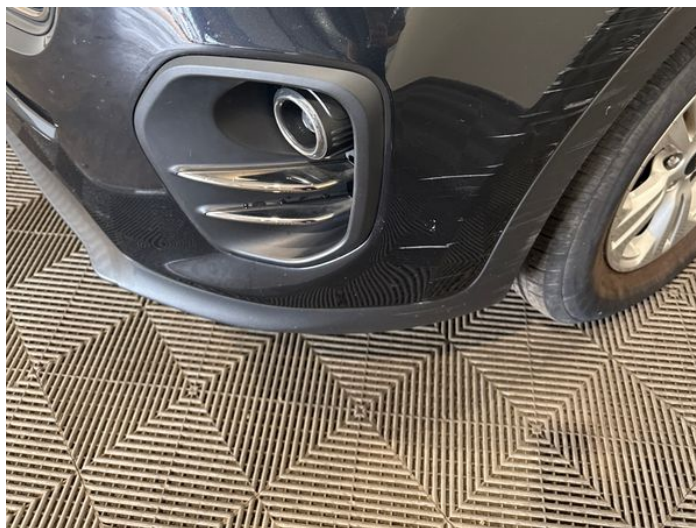
2: Bumper Front  
Scratched  
Over 100mm Thru Paint

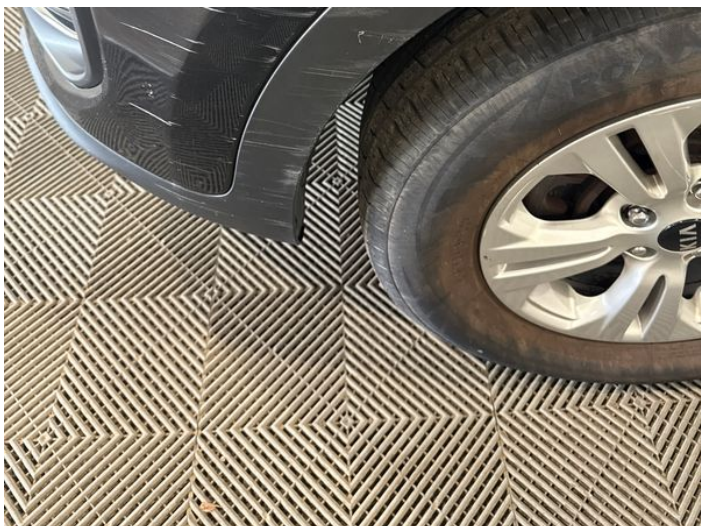
3: Wing Front Arch Extension ns  
Scuffed (Unpainted)  
Over 100mm

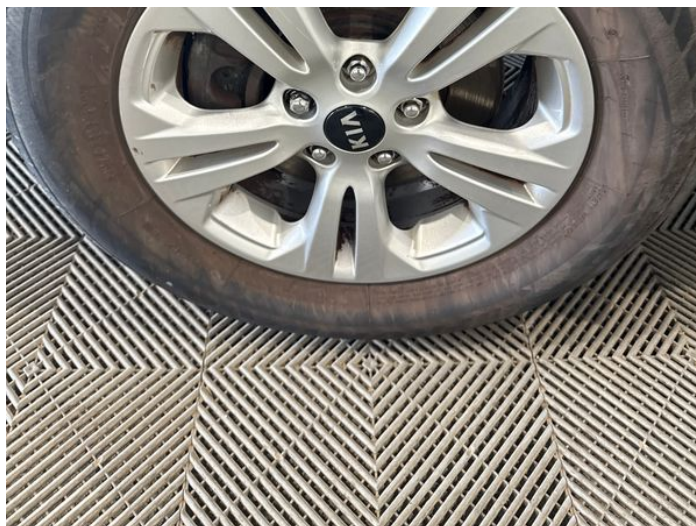
4: Wheel nsf  
Scratched  
Over 50mm

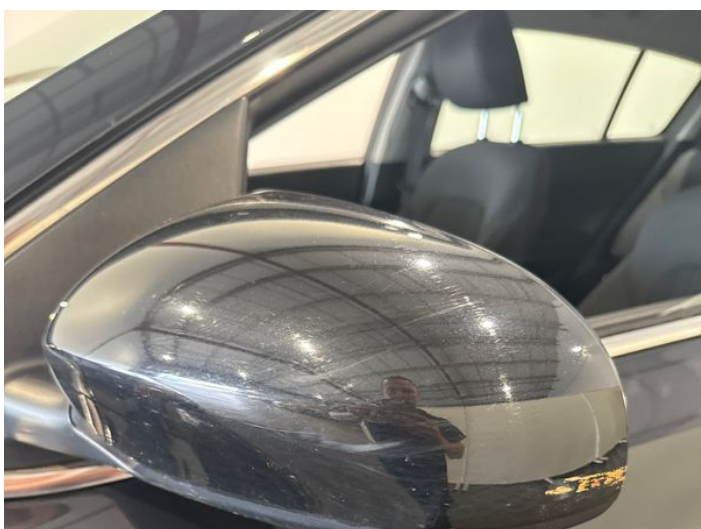
5: Door Mirror Assy nsf  
Scratched (Painted)  
Over 25mm Thru Paint

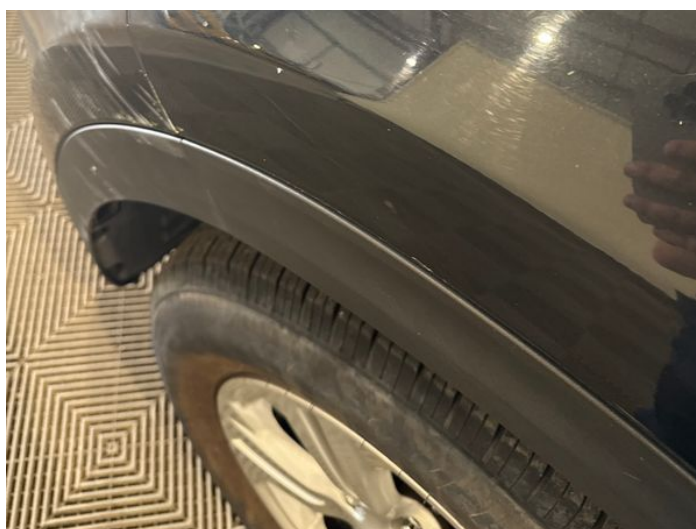
6: Wing nsf  
Chipped  
1 To 5

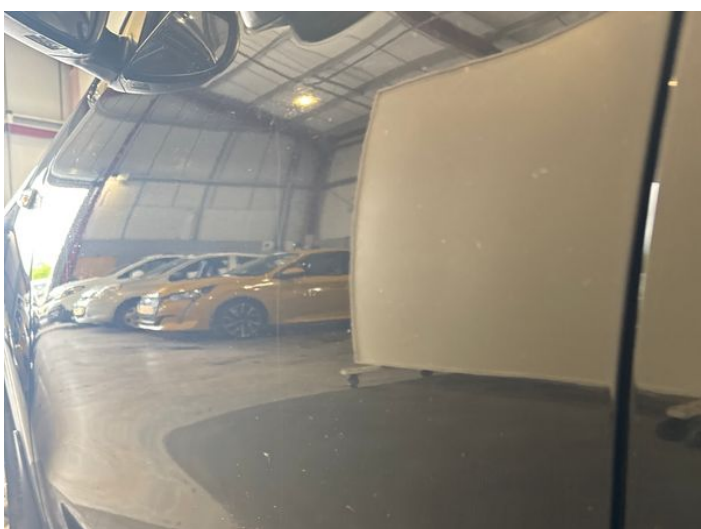
7: Door nsf  
Poor Previous Repair  
Rippled UpTo 30%

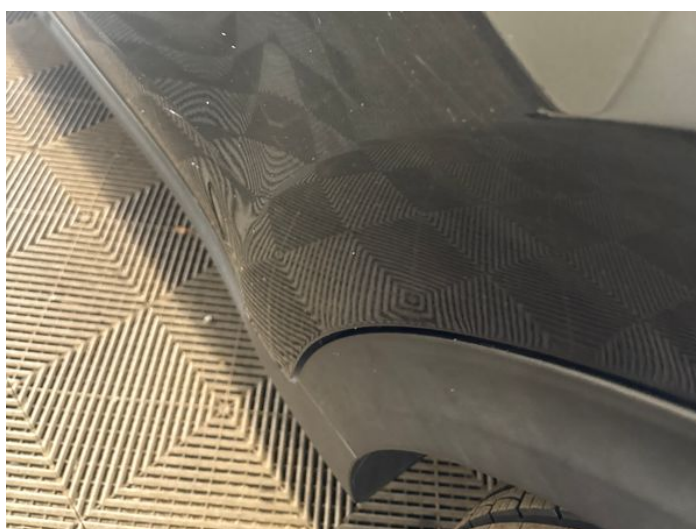
8: Door nsr  
Chipped  
Multiple Chips

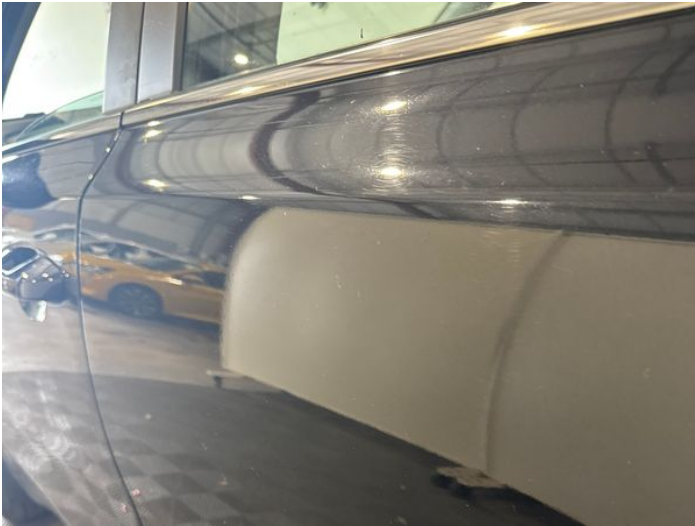
9: Door nsr  
Dented  
Over 30mm

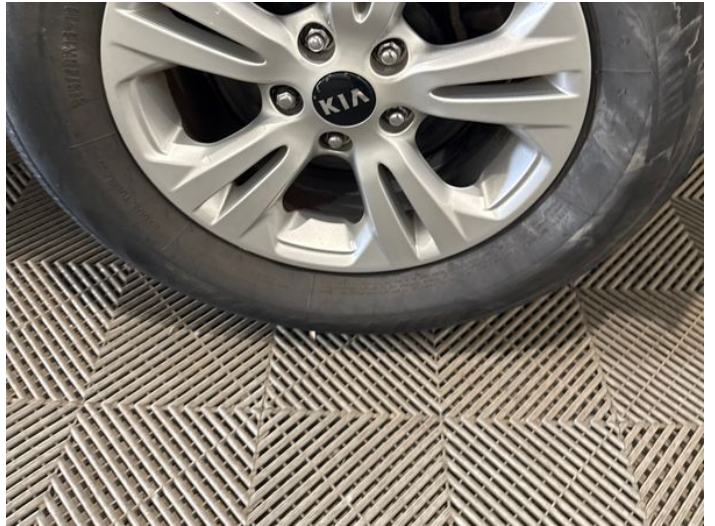
10: Wheel nsr  
Scratched  
Up To 50mm

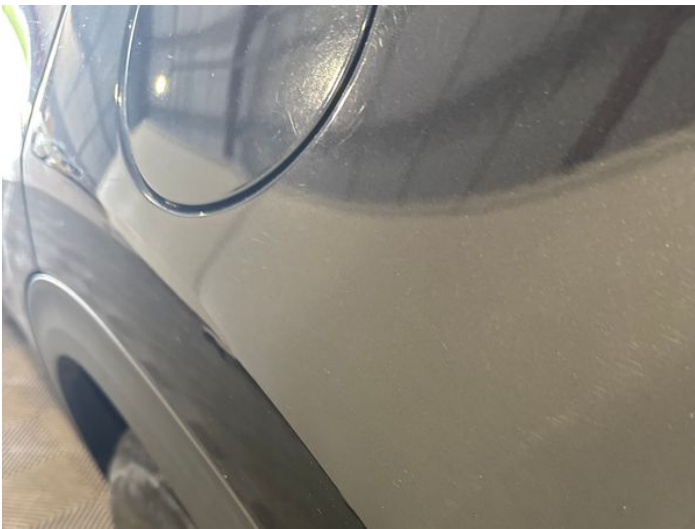
11: Qtr Panel nsr  
Dented  
Between 10mm + 30mm

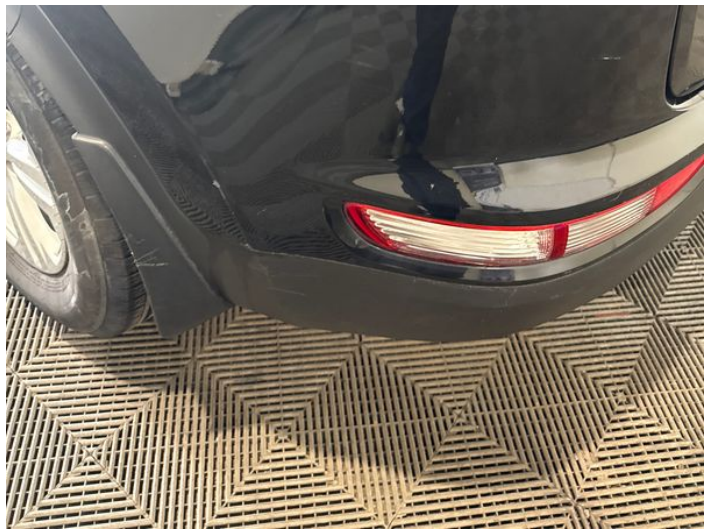
12: Bumper Rear  
Scratched  
Over 100mm Thru Paint

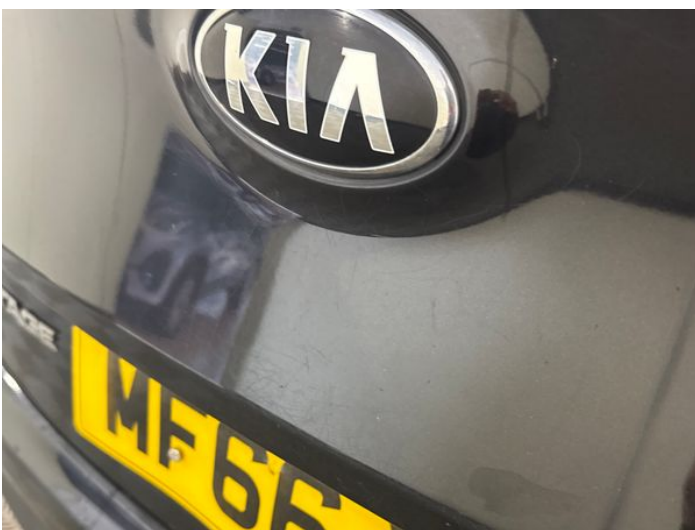
13: Tailgate  
Scratched  
Over 25mm Thru Paint

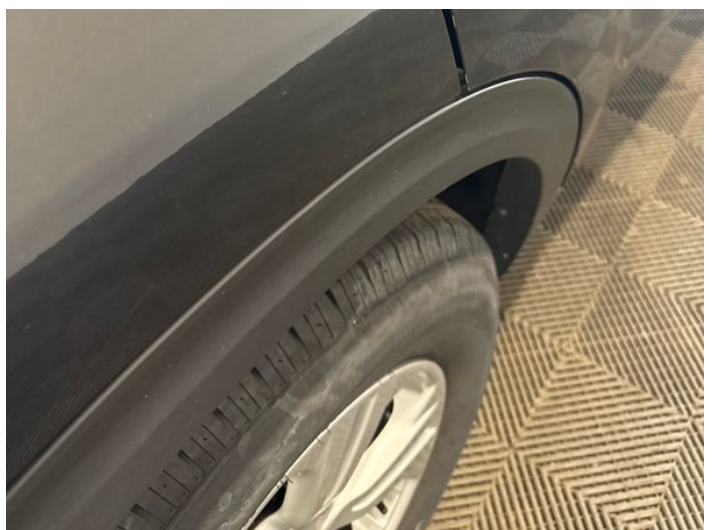
14: Qtr Panel osr  
Dented  
Between 10mm + 30mm

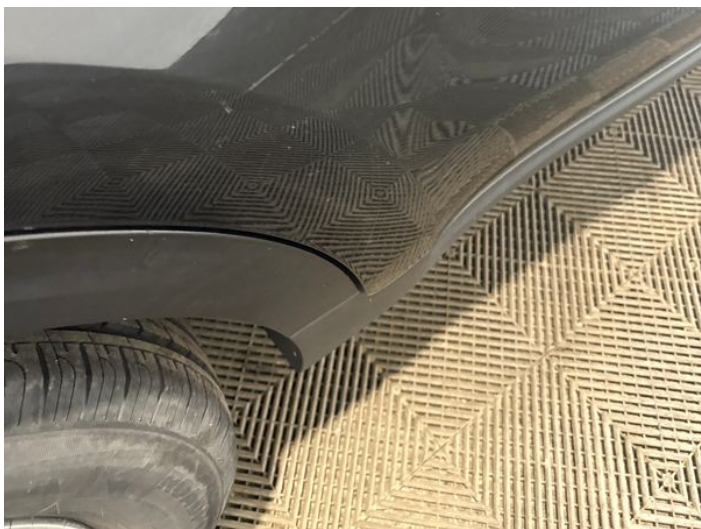
15: Door osr  
Scratched  
Over 25mm Thru Paint

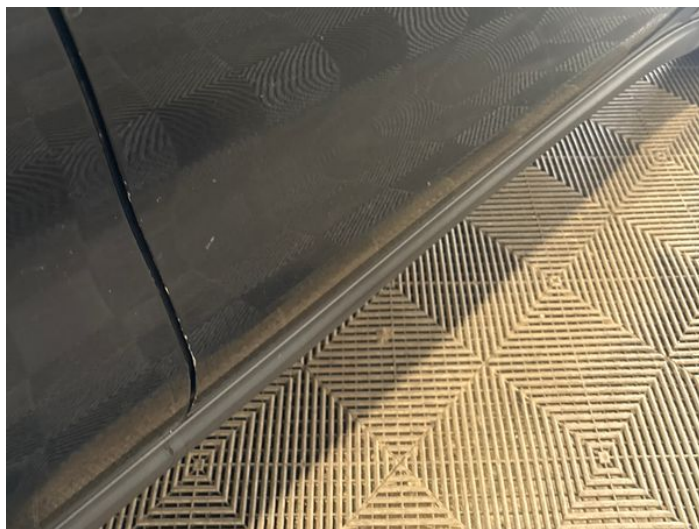
16: Door osf  
Chipped  
Multiple Chips

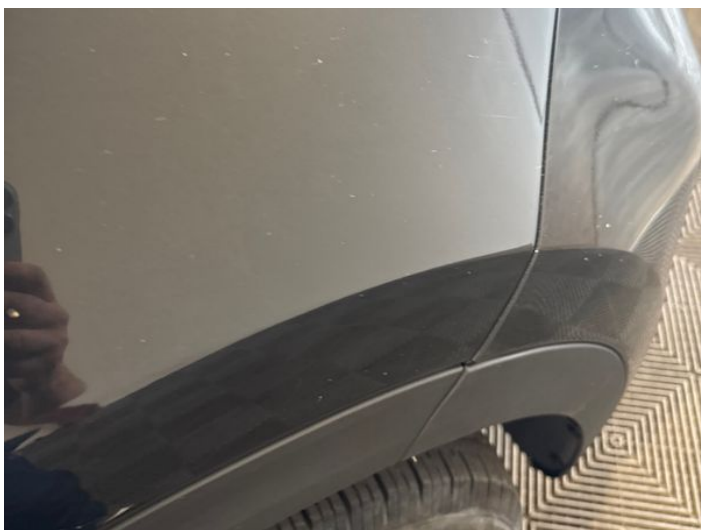
17: Wing osf  
Chipped  
1 To 5

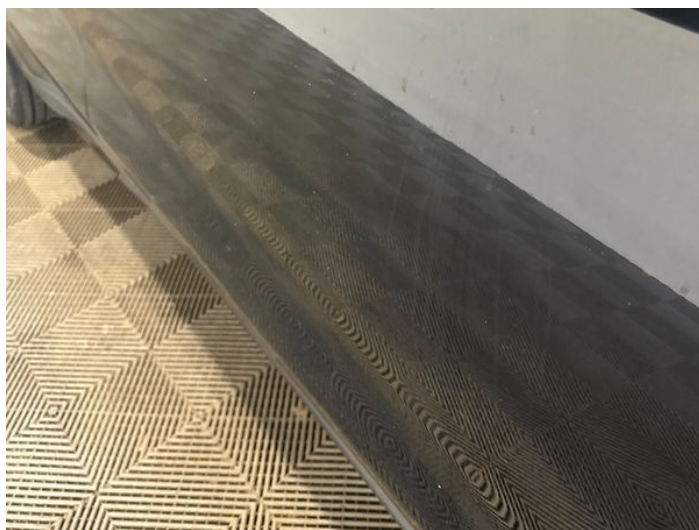
18: Door osf  
Dented  
Over 30mm

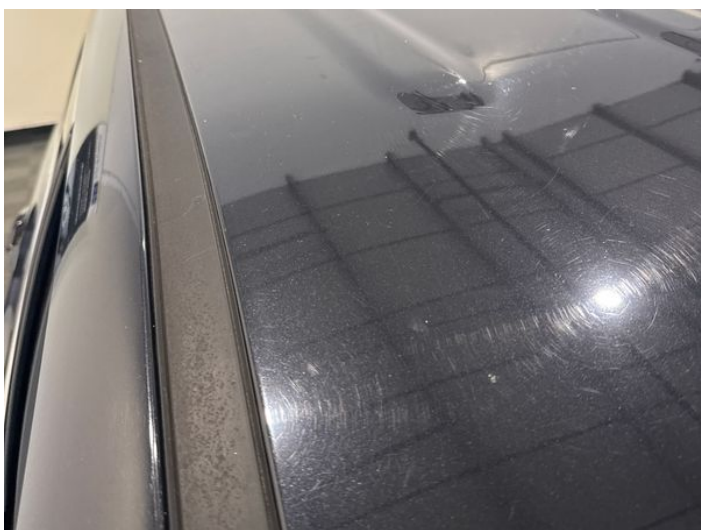
19: Roof  
Dented  
Between 10mm + 30mm
