## VEHICLE INSPECTION REPORT

**YS65UMH**

### Hyundai Tucson 2.0 CRDi SE Nav 5dr Auto

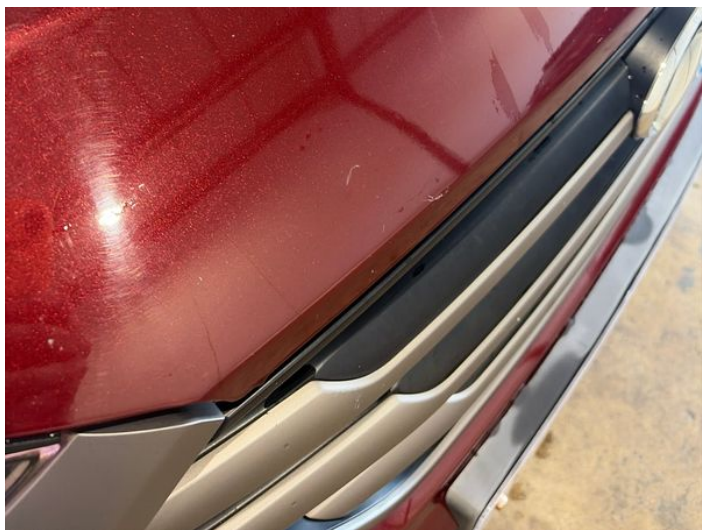
1: Bonnet  
Dented  
Between 10mm + 30mm

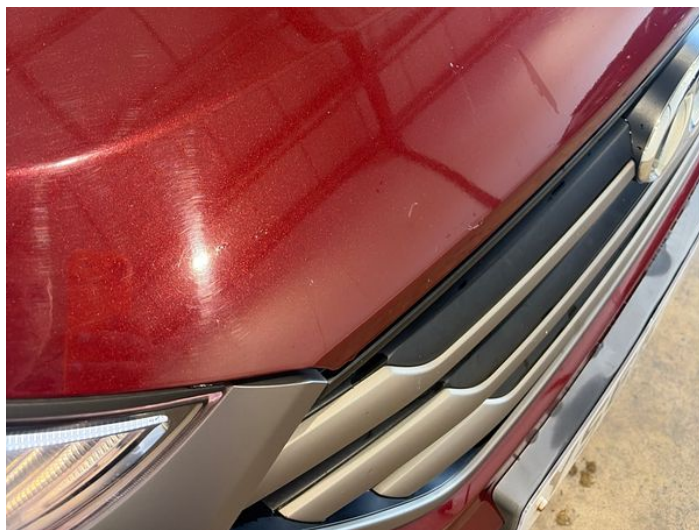
## 2: Bonnet Chipped Multiple Chips

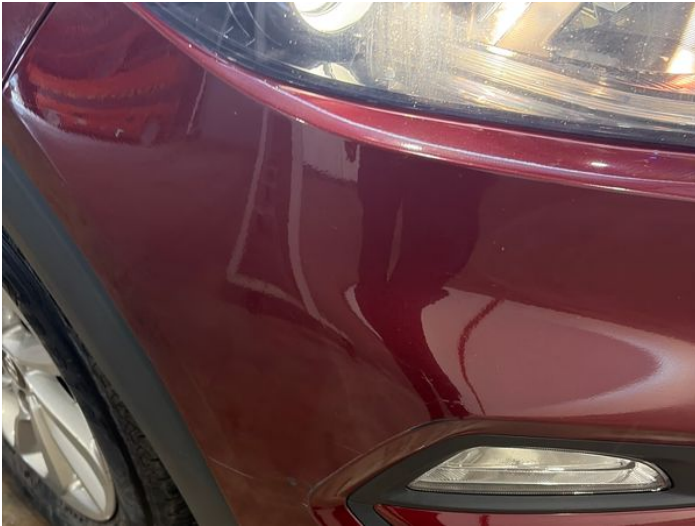
3: Bumper Front  
Scratched  
Over 100mm Thru Paint

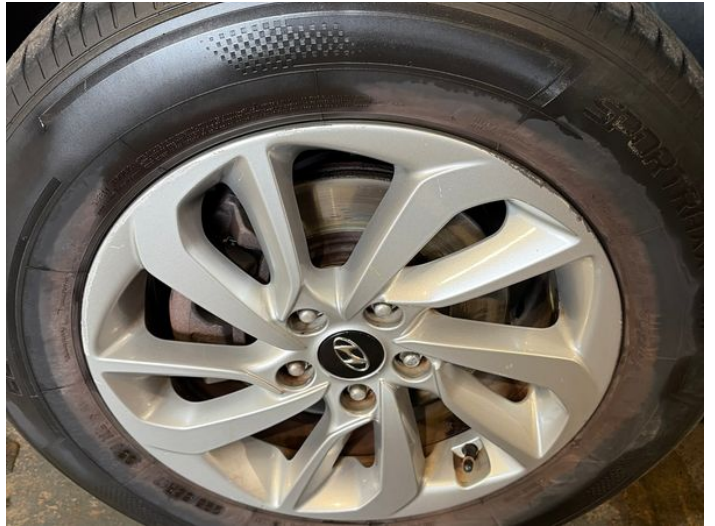
4: Wheel nsf  
Scratched  
Over 50mm

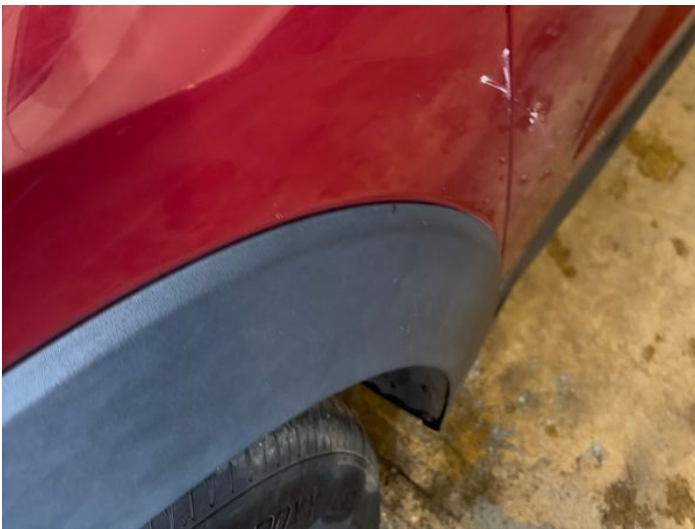
5: Wing nsf  
Scratched  
Over 25mm Thru Paint

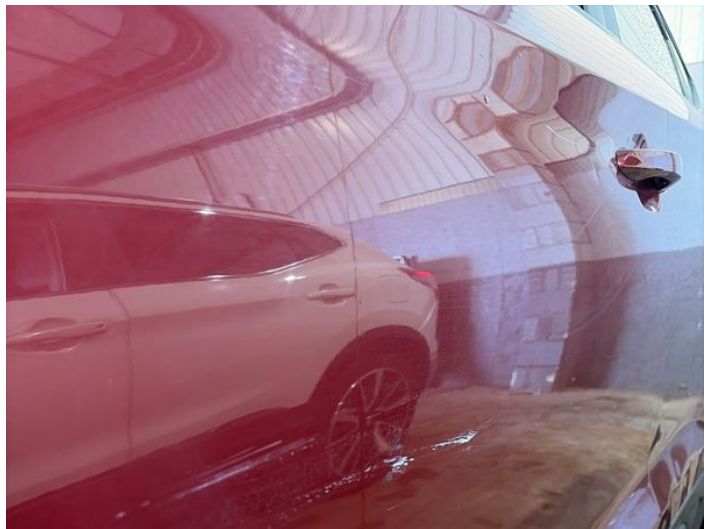
6: Door nsf  
Dented  
With Paint Damage

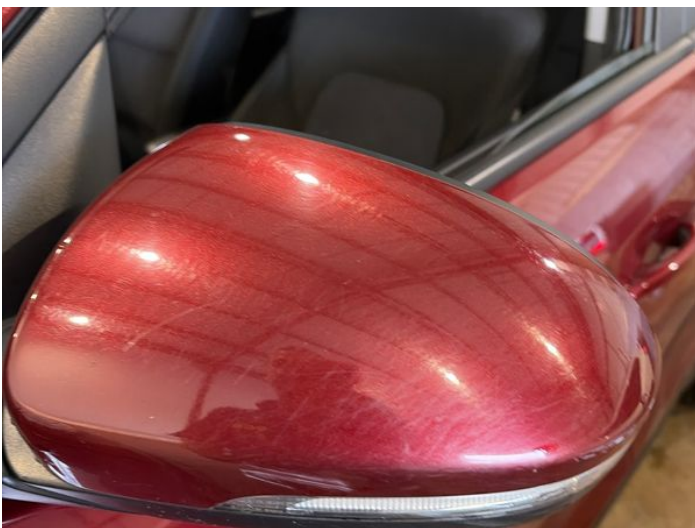
7: Door Mirror Assy nsf  
Scratched (Painted)  
Over 25mm Thru Paint

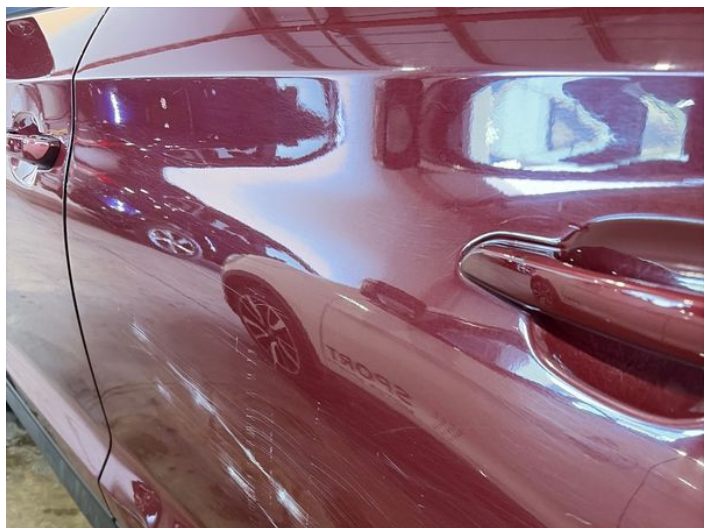
8: Door nsr  
Dented  
With Paint Damage

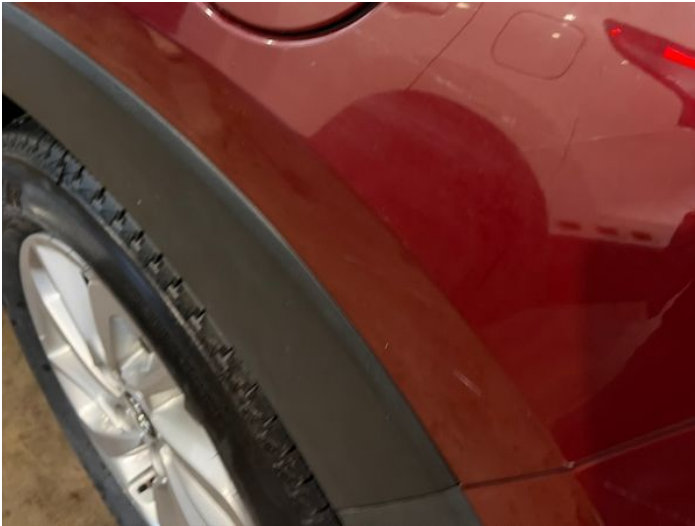
9: Qtr Panel nsr  
Scratched  
Over 25mm Thru Paint

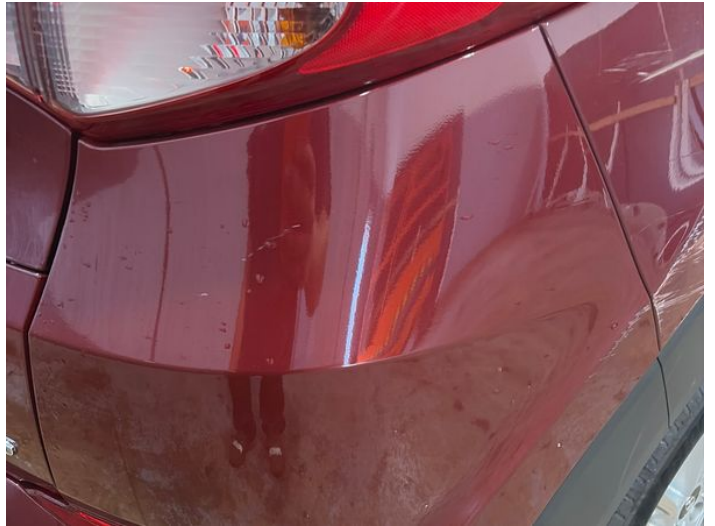
10: Bumper Rear  
Scratched  
Over 100mm Thru Paint

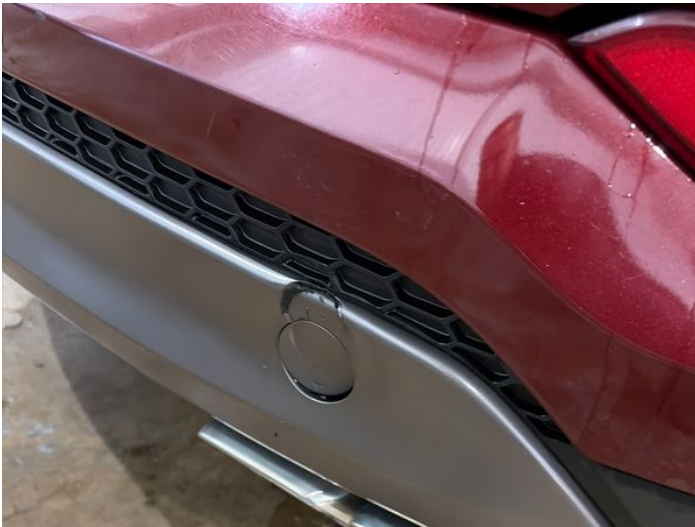
11: Bumper Rear Moulding  
Broken  
Replace

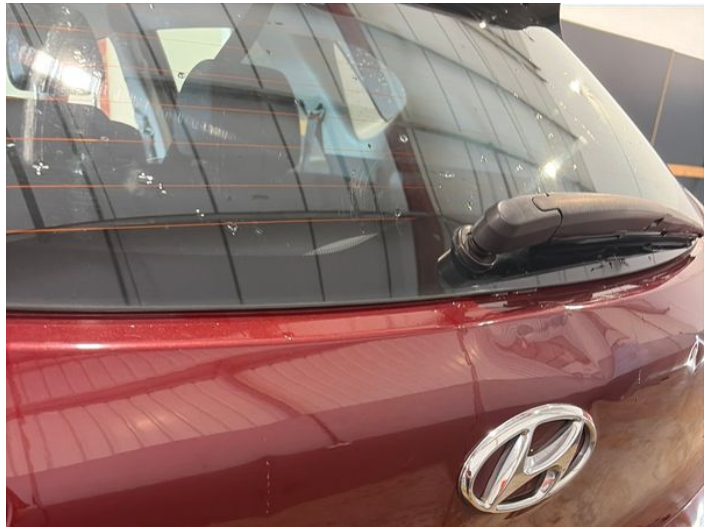
12: Tailgate  
Dented  
With Paint Damage

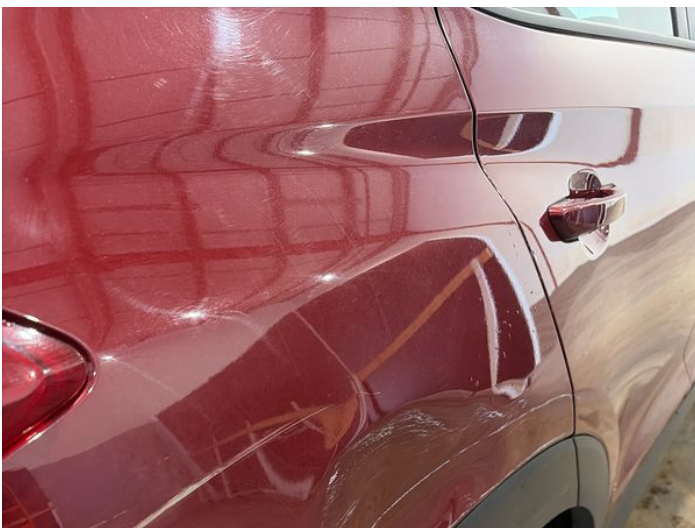
13: Qtr Panel osr  
Dented  
With Paint Damage

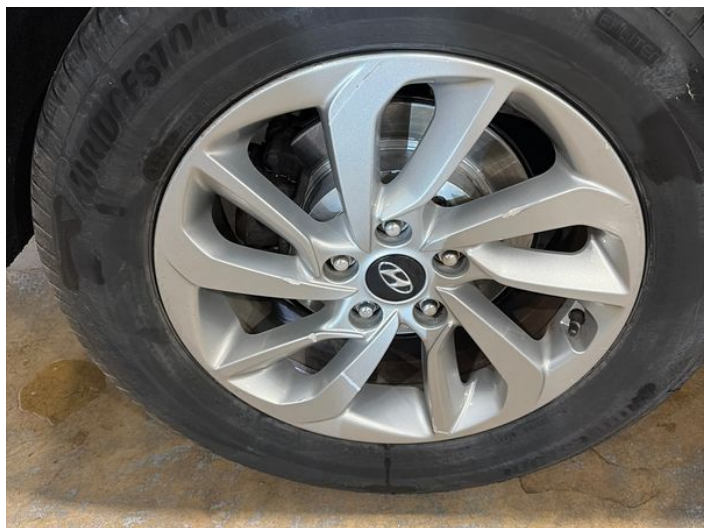
14: Wheel osr  
Scratched  
Over 50mm

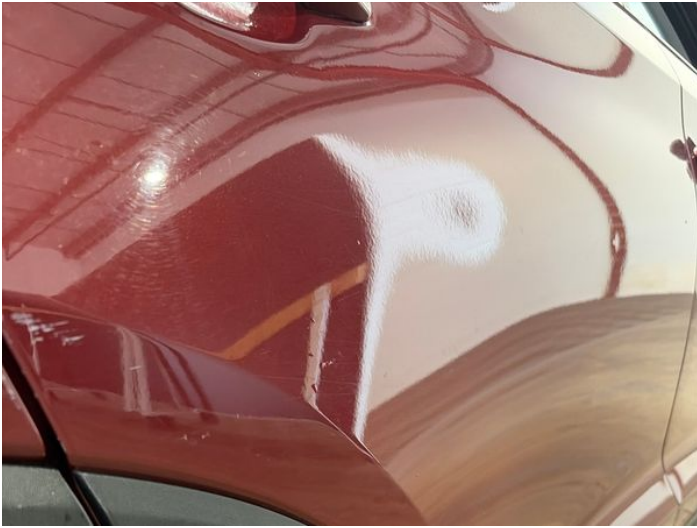
15: Door osr  
Scratched  
Over 25mm Thru Paint

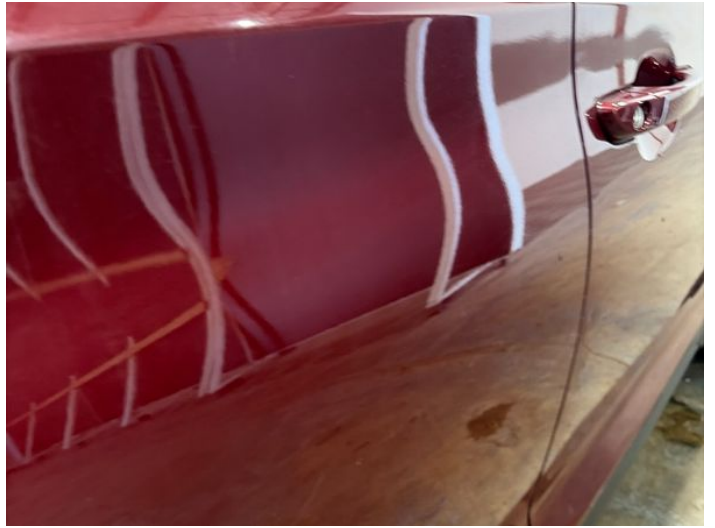
16: Door osr  
Dented  
Between 10mm + 30mm

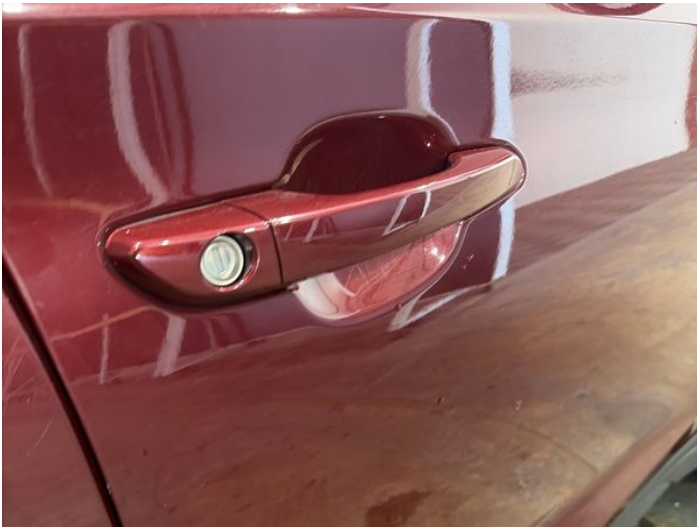
17: Door osf  
Dented  
Between 10mm + 30mm

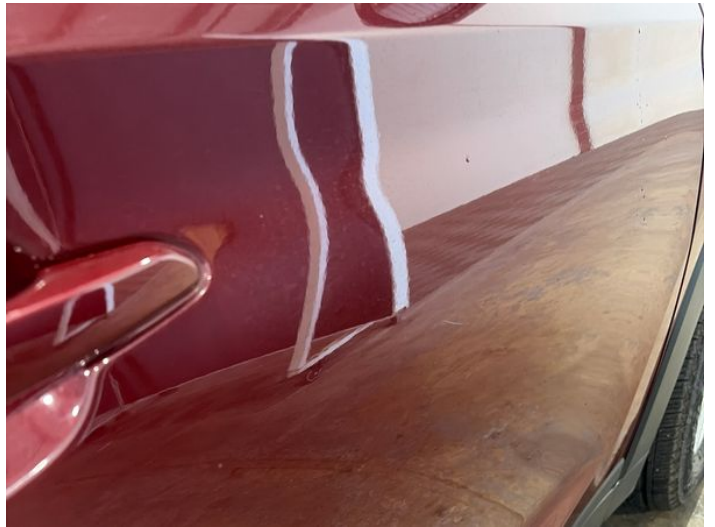
18: Door osf  
Scratched  
Over 25mm Thru Paint

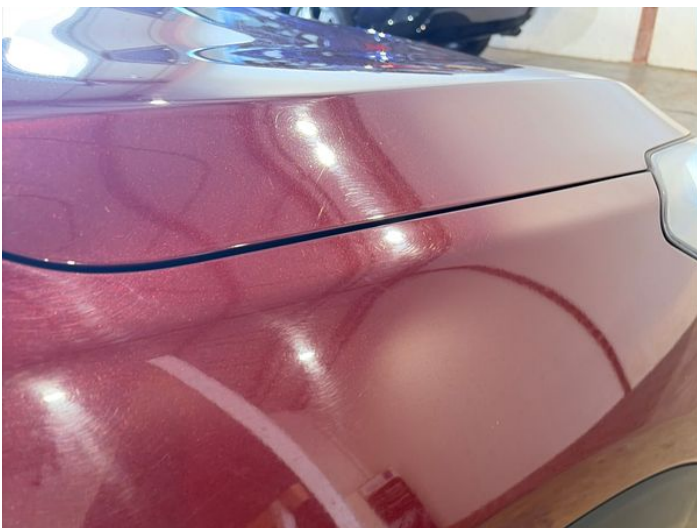
19: Wing osf  
Scratched  
UpTo 25mm Thru Paint

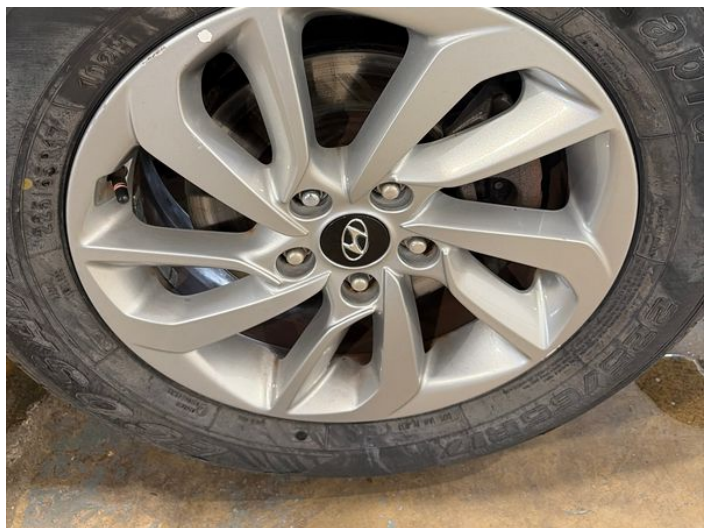
20: Wheel osf  
Scratched  
Over 50mm

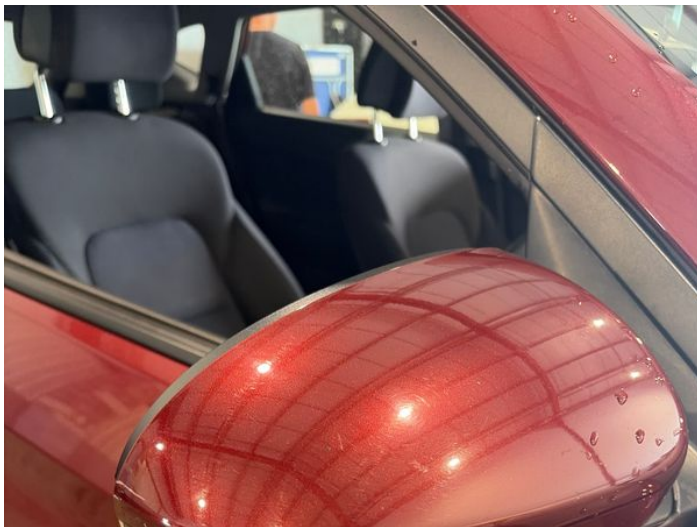
21: Door Mirror Assy osf  
Scratched (Painted)  
Over 25mm Thru Paint

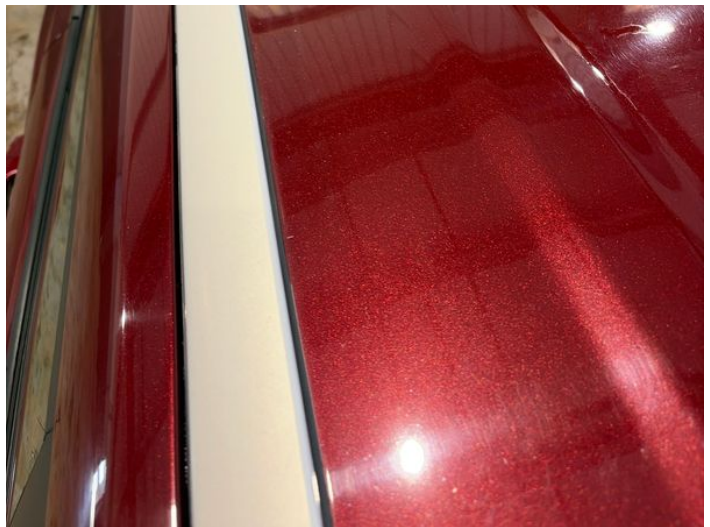
22: Roof  
Dented  
Over 30mm
