# VEHICLE INSPECTION REPORT

**BT67UXF**

## Peugeot 3008 1.6 BlueHDi 120 GT Line 5dr

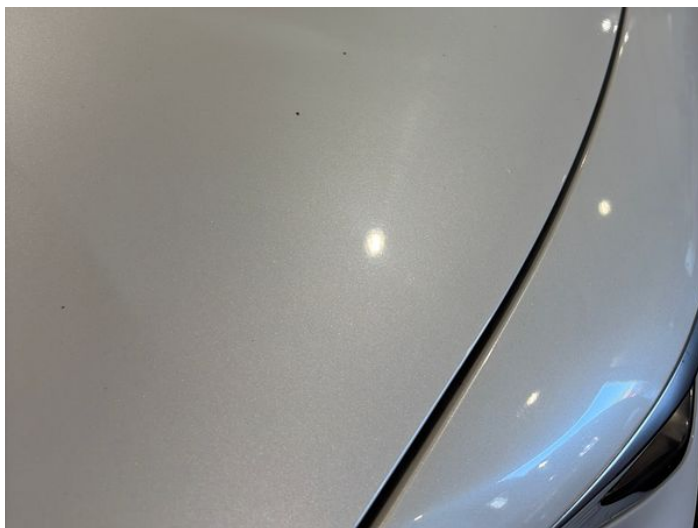
1: Bonnet  
Chipped  
Multiple Chips

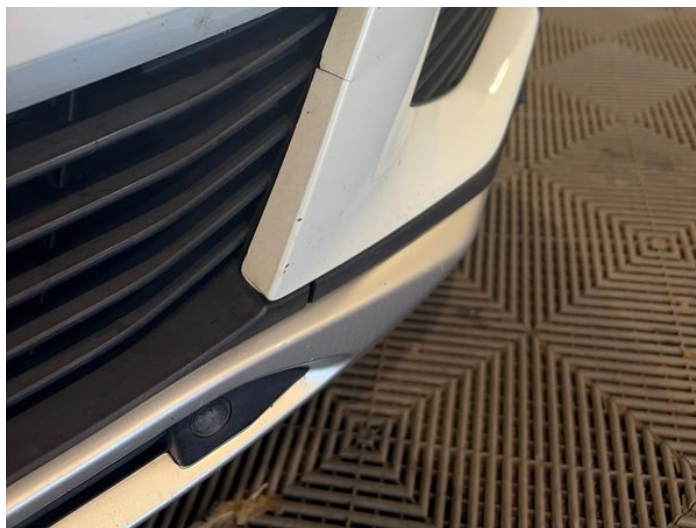
2: Bumper Front  
Cracked  
UpTo 25mm

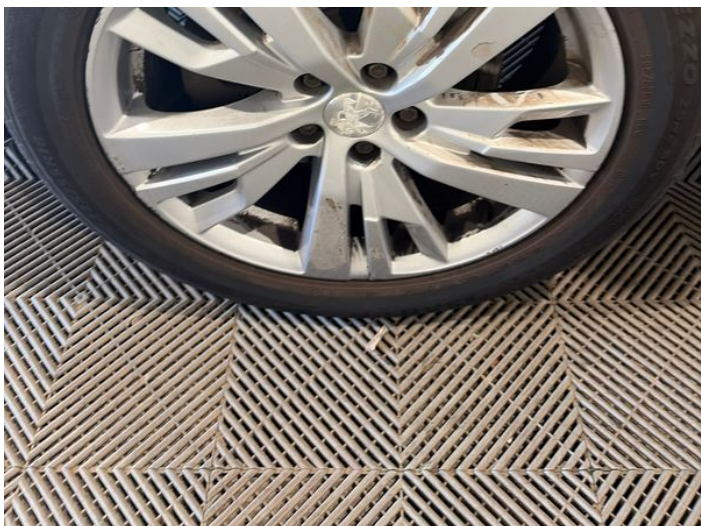
3: Wheel nsf  
Scratched  
Over 50mm

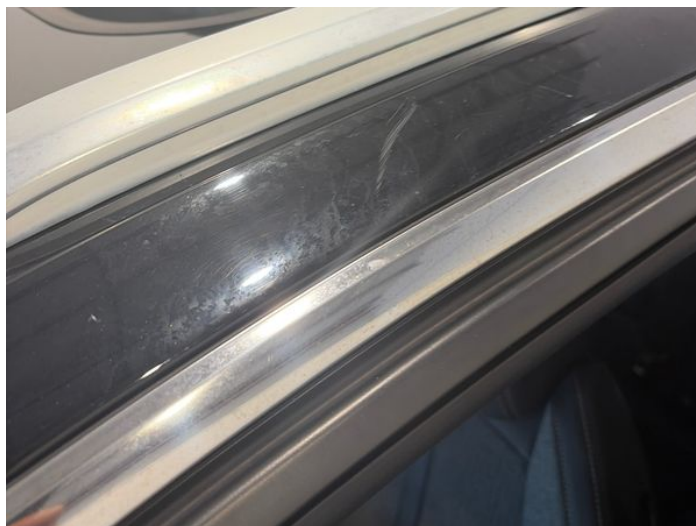
4: A Post ns  
Scratched  
Over 25mm Thru Paint

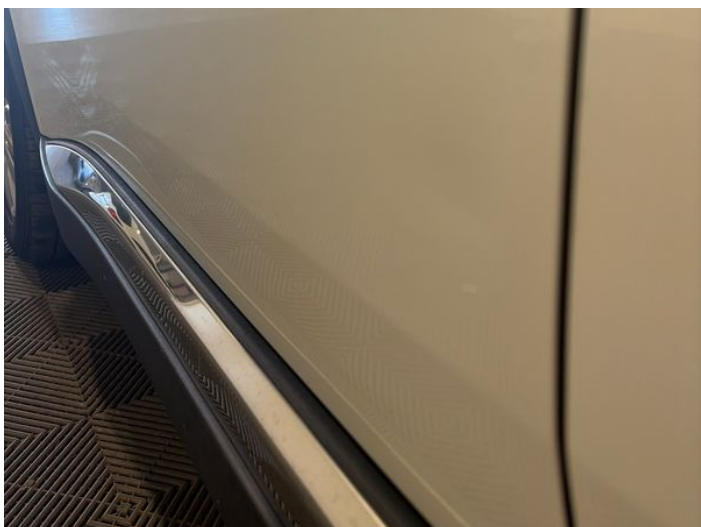
5: Door nsf  
Dented  
Between 10mm + 30mm

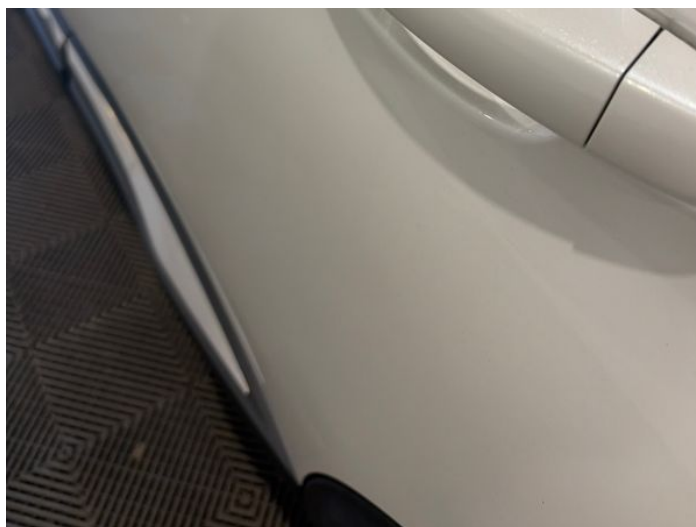
6: Door nsr  
Dented  
Between 10mm + 30mm

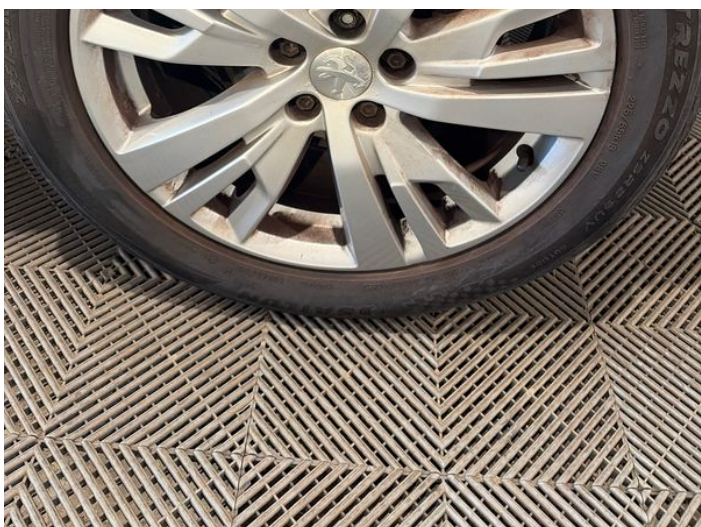
7: Wheel nsr  
Scratched  
Over 50mm

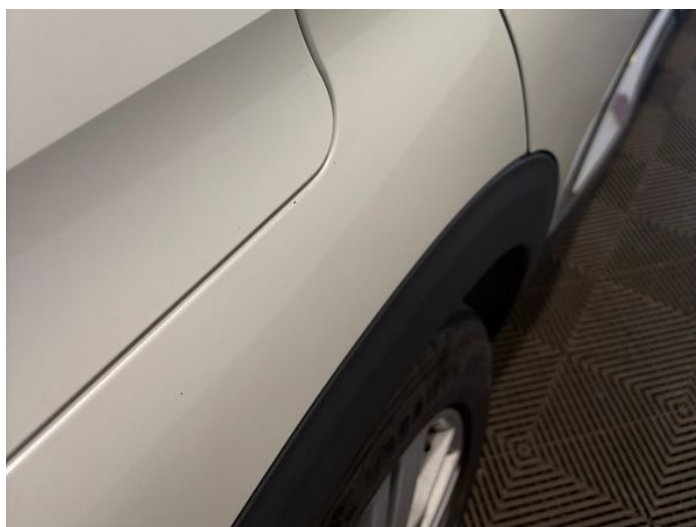
8: Qtr Panel osr  
Dented  
Between 10mm + 30mm

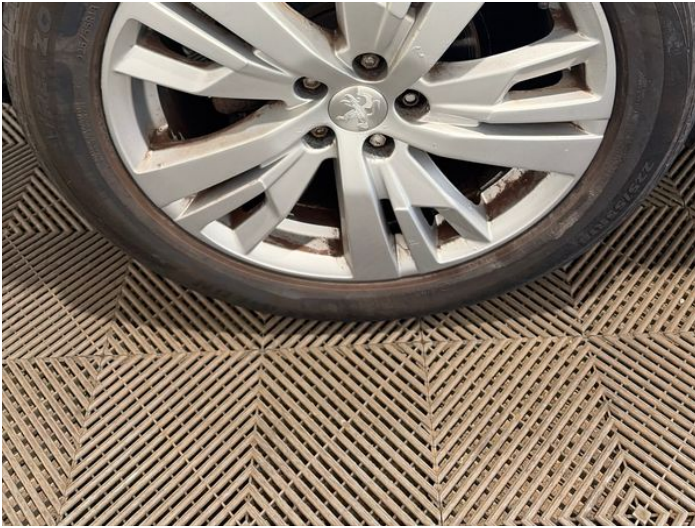
9: Wheel osr  
Corroded  
Light

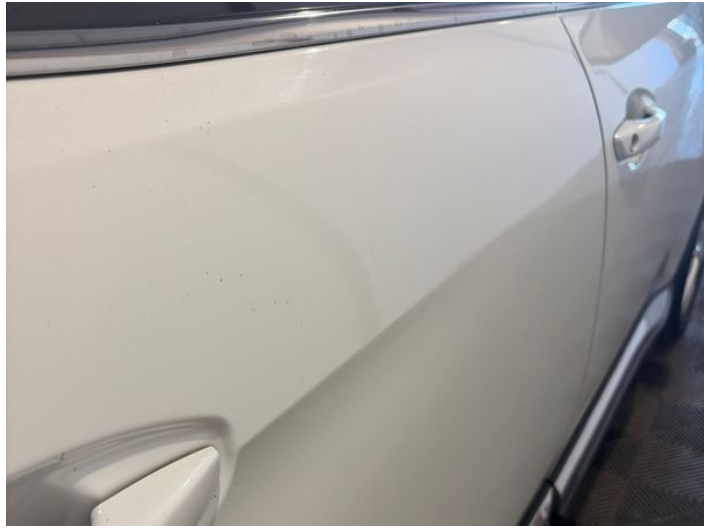
10: Door osr  
Poor Previous Repair  
Rippled UpTo 30%

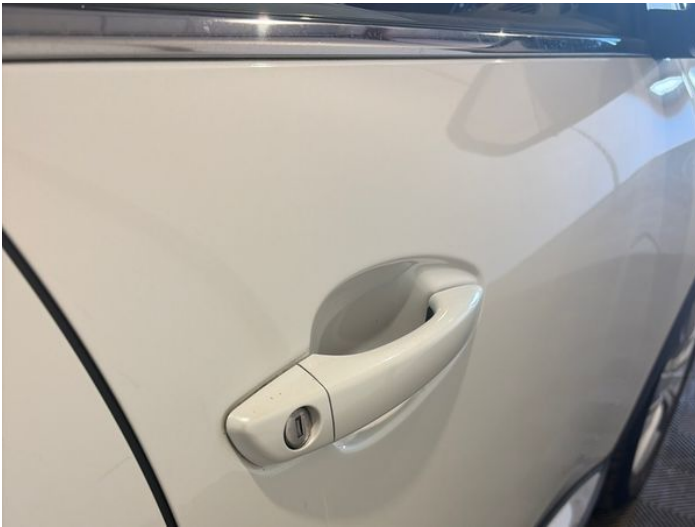
11: Door osf  
Dented  
Between 10mm + 30mm

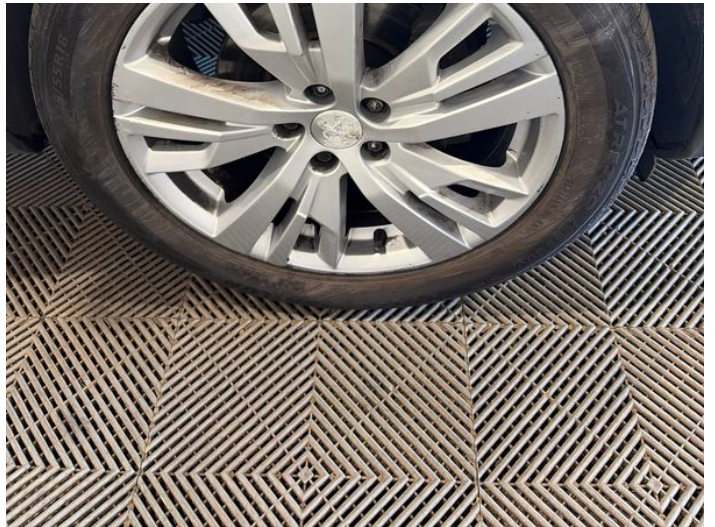
12: Wheel osf  
Scratched  
Over 50mm

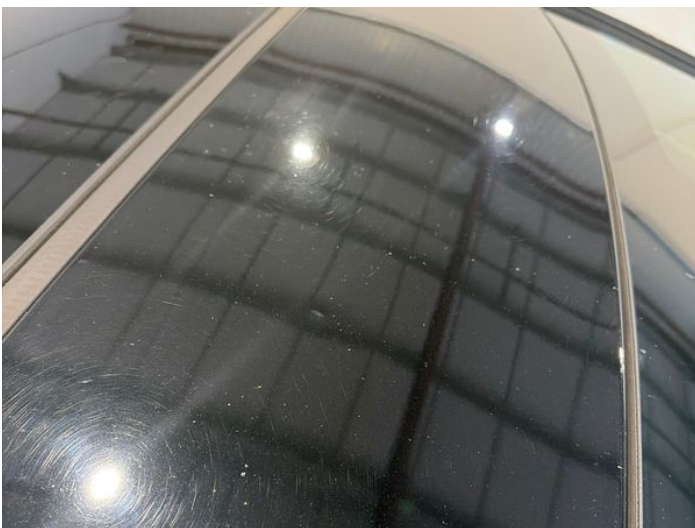
13: Roof  
Dented  
Between 10mm + 30mm
