# VEHICLE INSPECTION REPORT

**GY66CEU**

## Volkswagen Golf 2.0 TDI R-Line Edition 5dr DSG

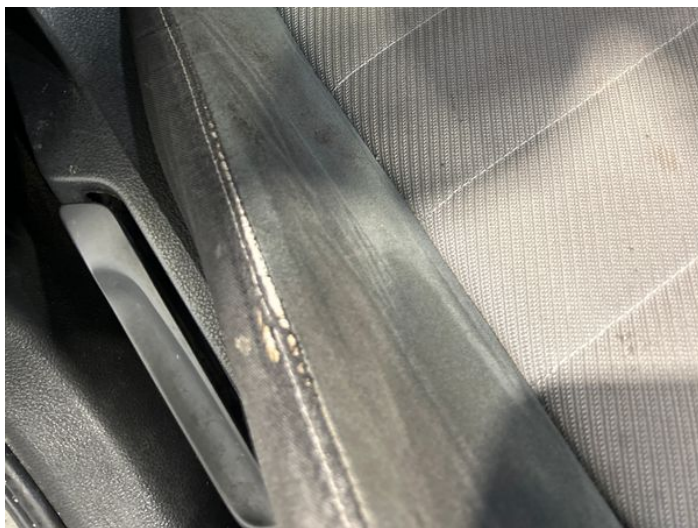
1: Seat Base Cover osf  
Scuffed  
Over 25mm

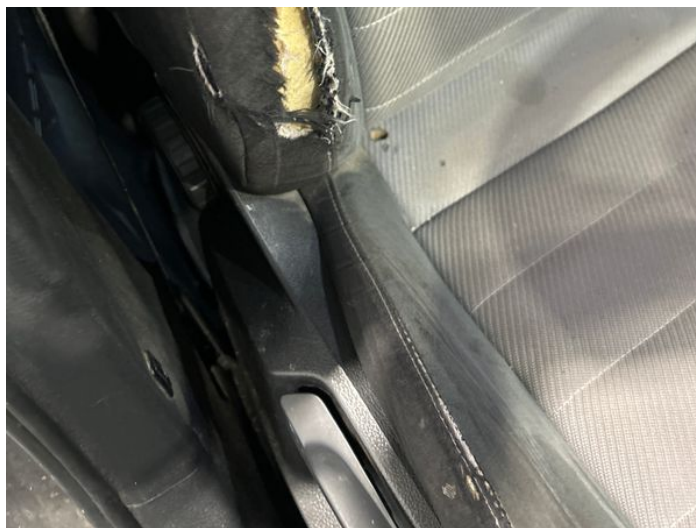
2: Seat Back Cover osf  
Torn  
Over 3mm

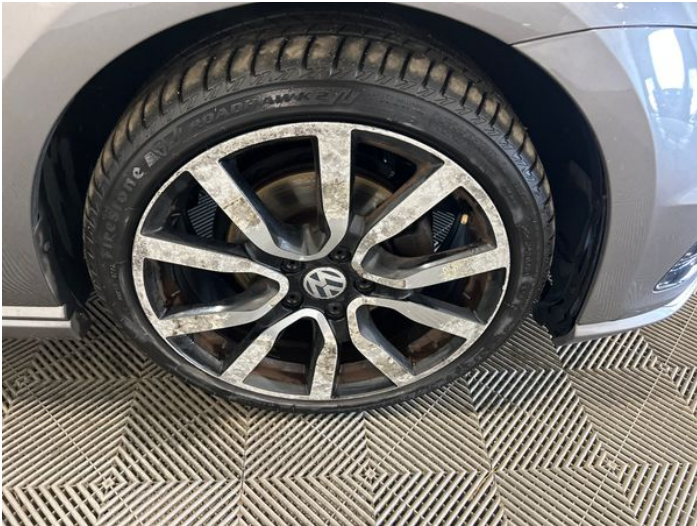
3: Wheel osf  
Corroded  
Light

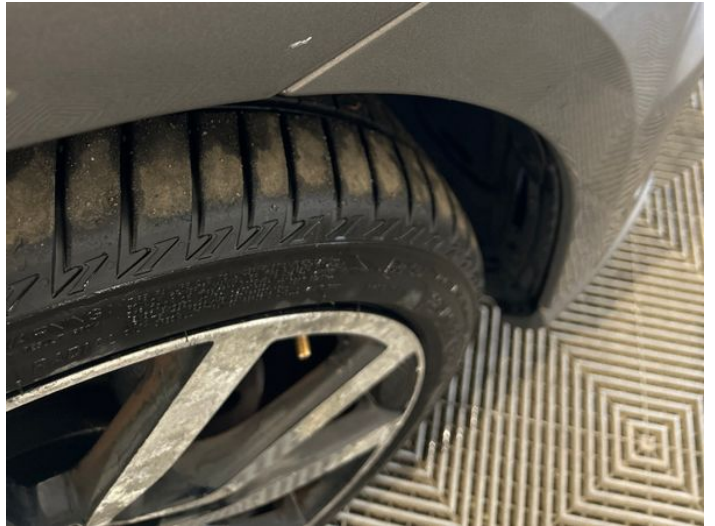
4: Wing osf  
Chipped  
1 To 5

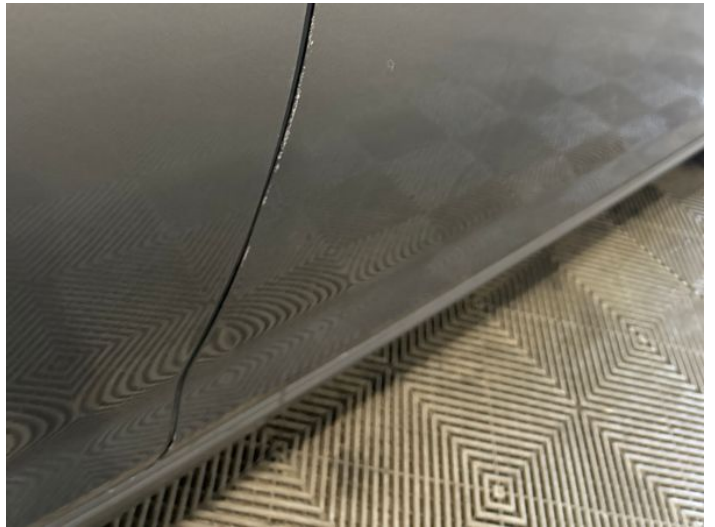
6: Door osf  
Chipped  
Edge Chip

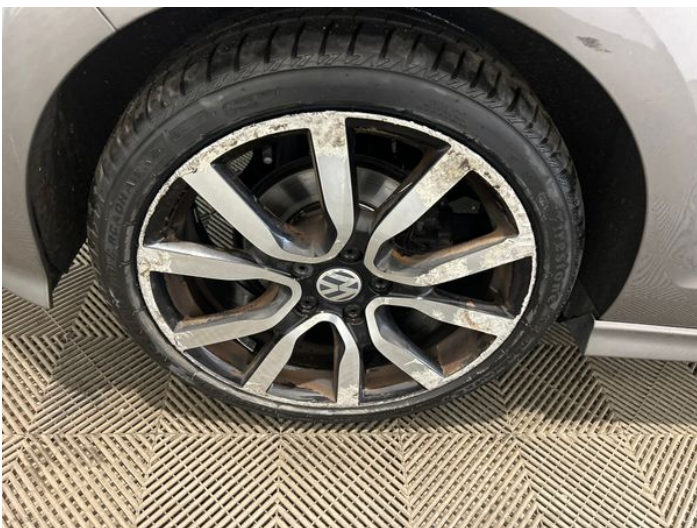
7: Wheel osr  
Corroded  
Light

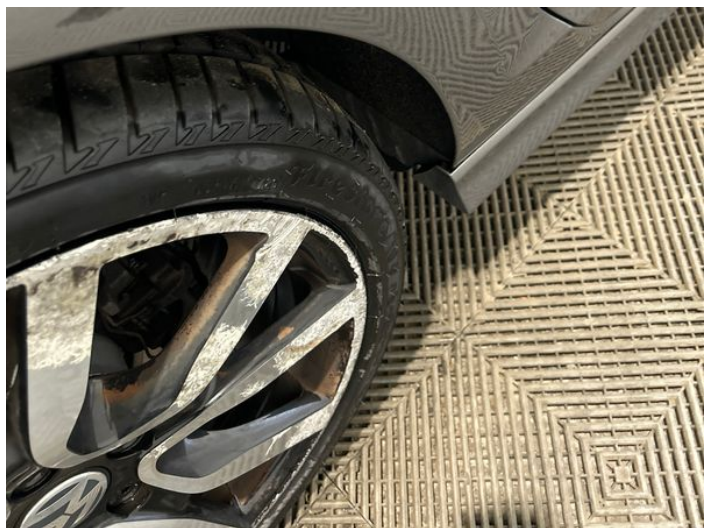
8: Qtr Panel osr  
Dented  
Between 10mm + 30mm

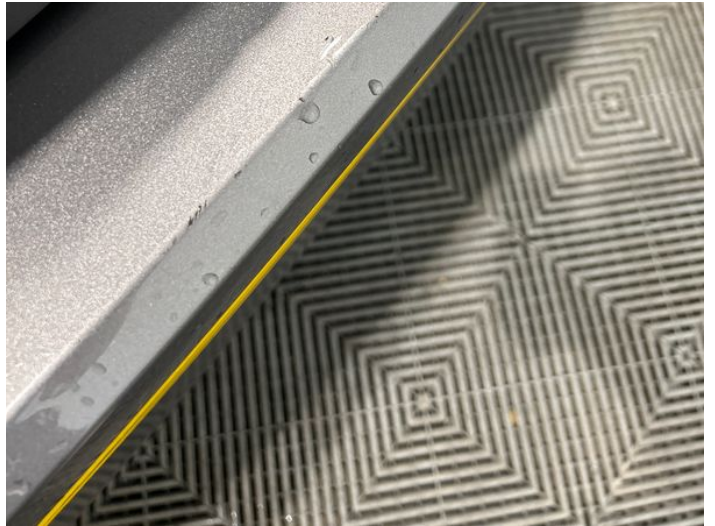
10: Bumper Rear  
Chipped  
Multiple Chips

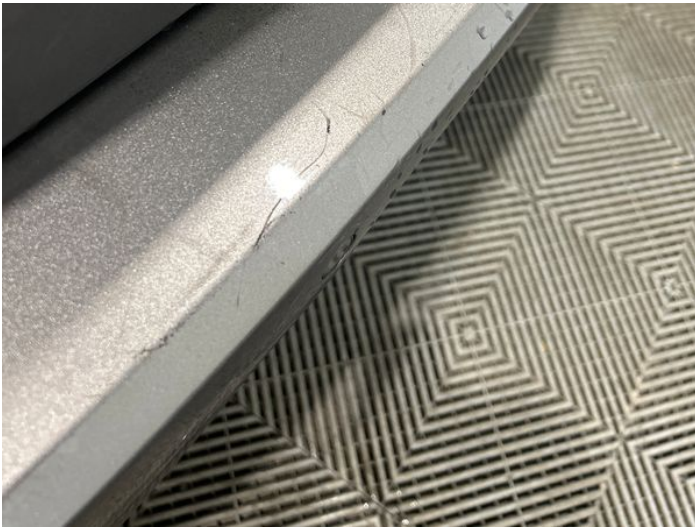
11: Bumper Rear  
Scratched  
25 to 100mm Thru Paint

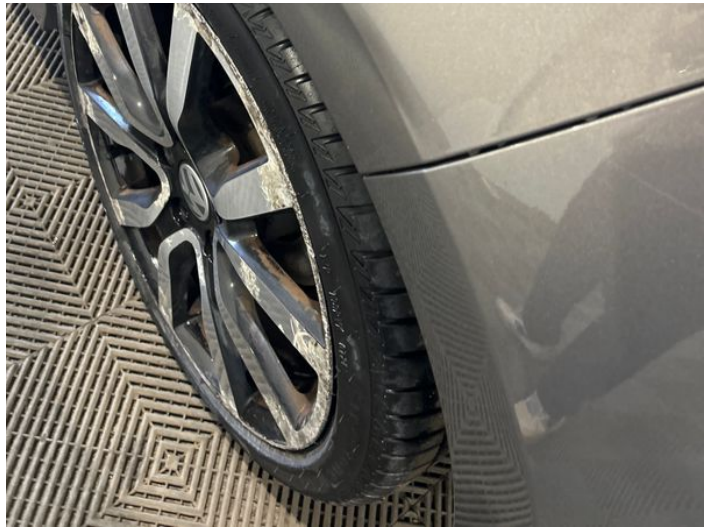
12: Qtr Panel nsr  
Dented  
Over 30mm

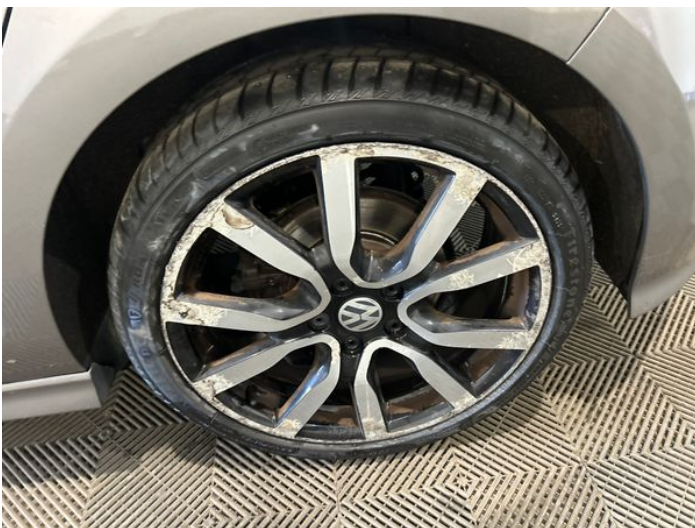
13: Wheel nsr  
Corroded  
Light

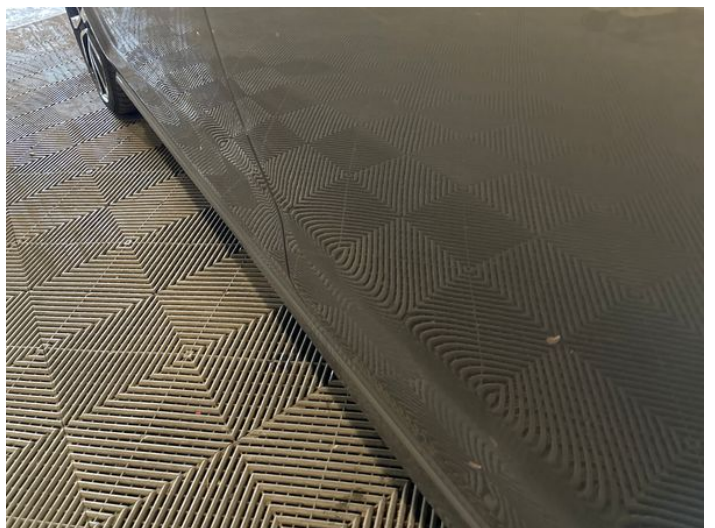
14: Door nsr  
Dented  
Between 10mm + 30mm

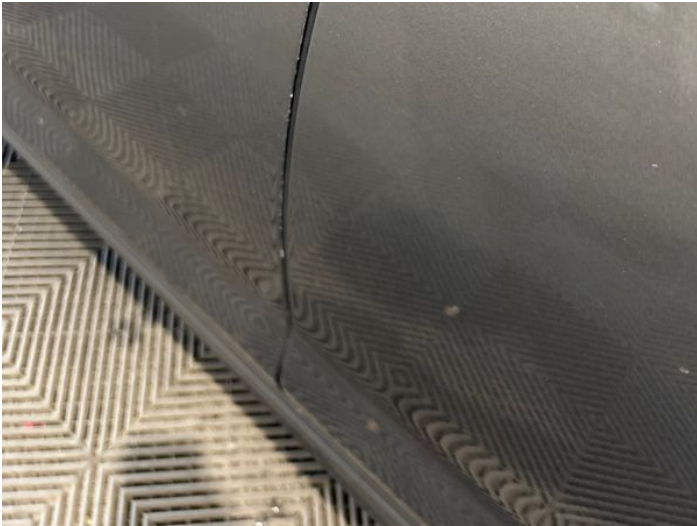
15: Door nsr  
Scratched  
UpTo 25mm Thru Paint

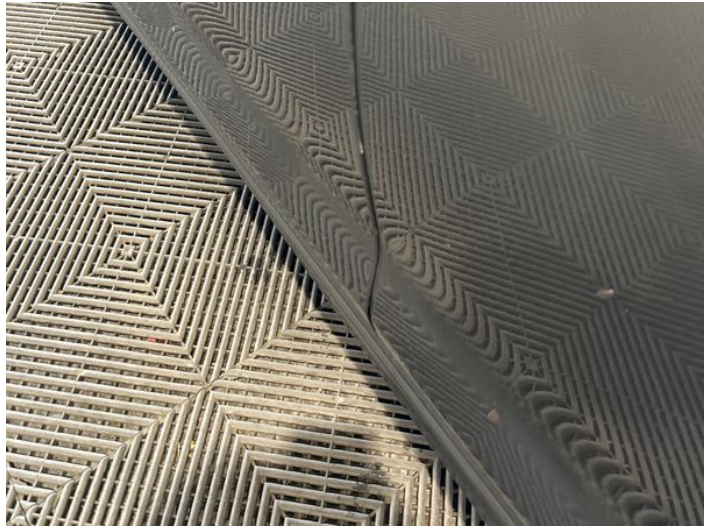
16: Door nsf  
Chipped  
Edge Chip

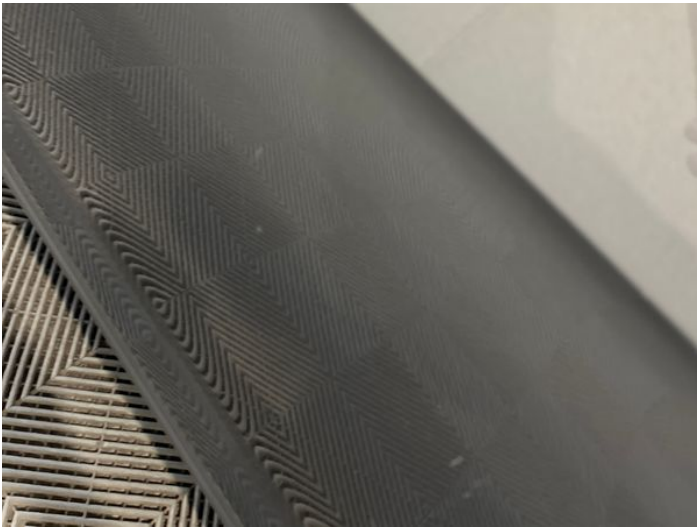
17: Door nsf  
Chipped  
1 To 5

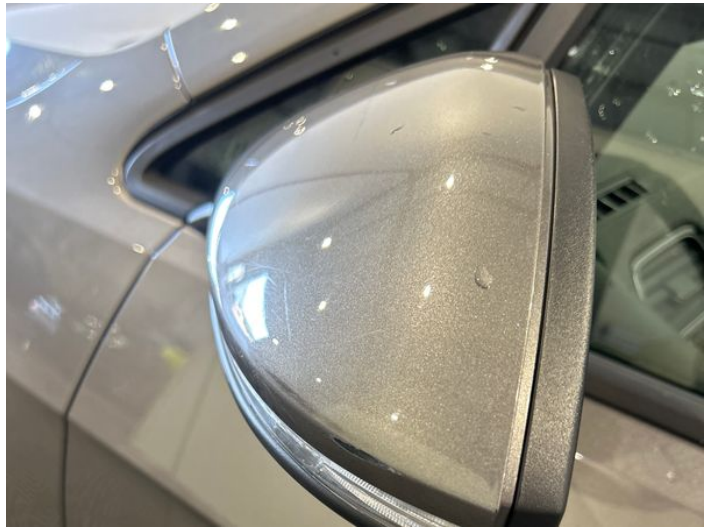
18: Door Mirror Assy nsf  
Scratched (Painted)  
UpTo 25mm Thru Paint

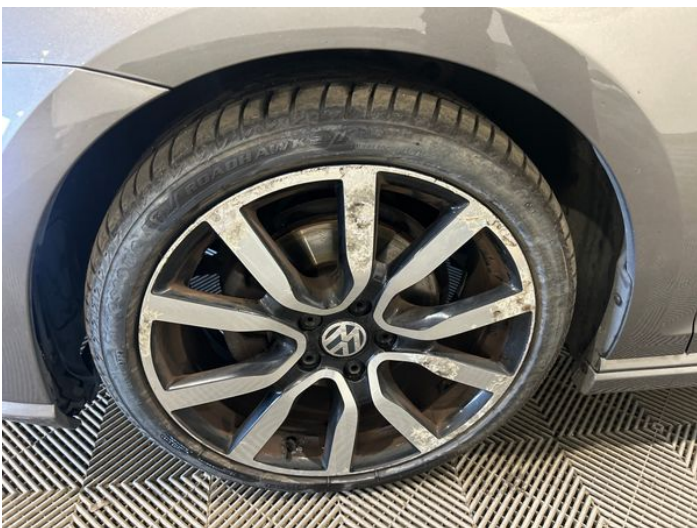
19: Wheel nsf  
Corroded  
Light

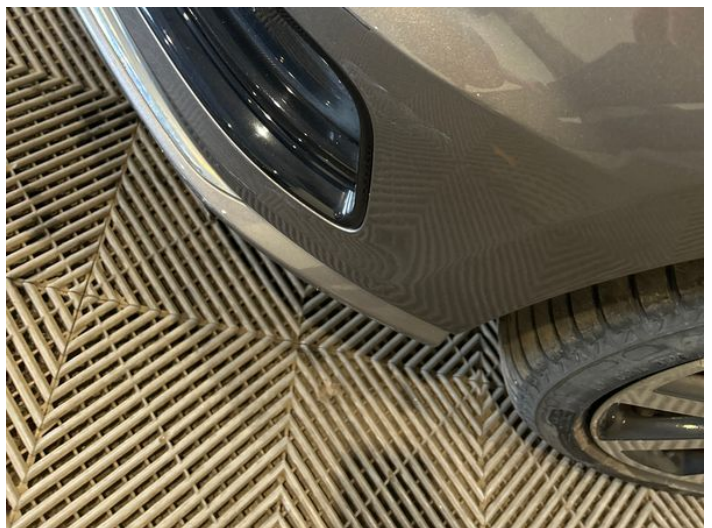
20: Bumper Front  
Scratched  
Over 100mm Thru Paint

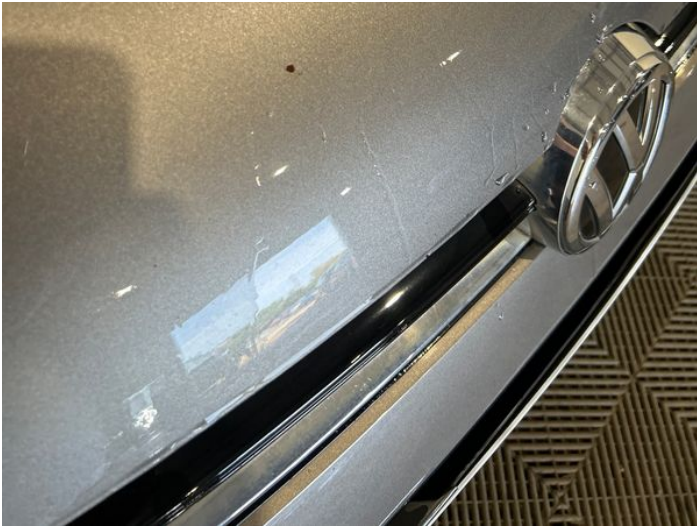
21: Bonnet  
Chipped  
1 To 5

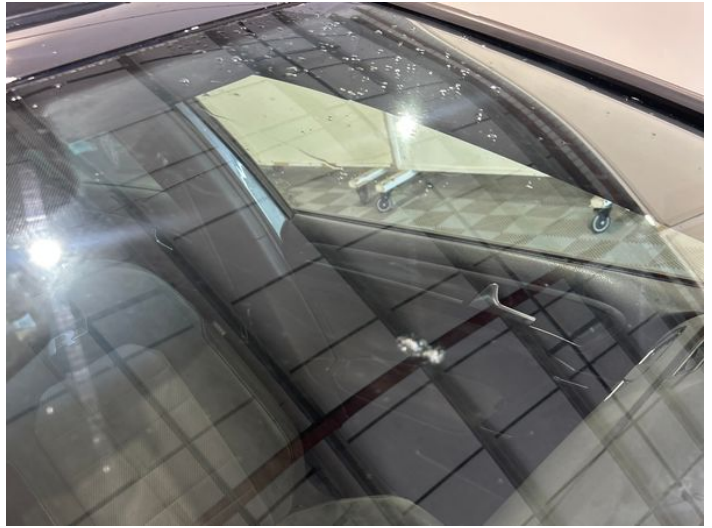
22: Screen Front  
Cracked  
Replace

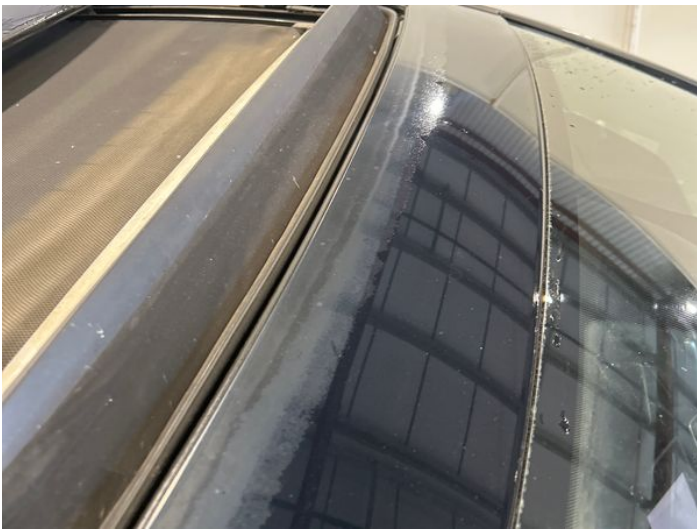
23: Roof  
Scratched  
Over 25mm Thru Paint

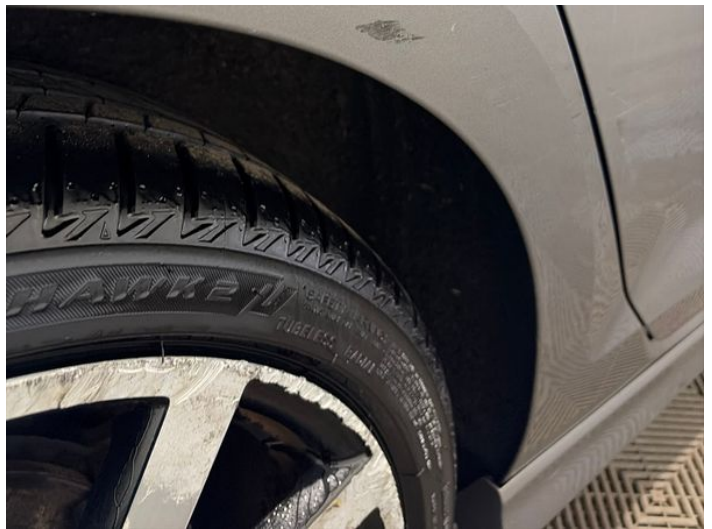
24: Qtr Panel osr  
Scratched  
Over 25mm Thru Paint
