# VEHICLE INSPECTION REPORT

**WK66WSF**

## Kia Sportage 1.7 CRDi ISG 3 5dr

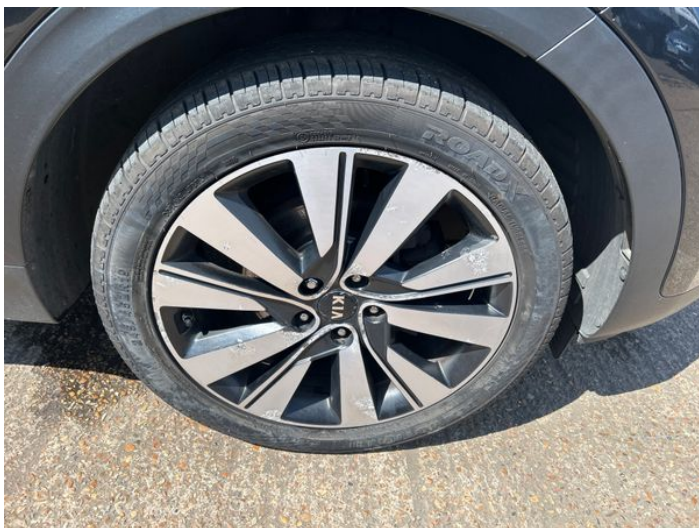
1: Wheel osf  
Corroded  
Light

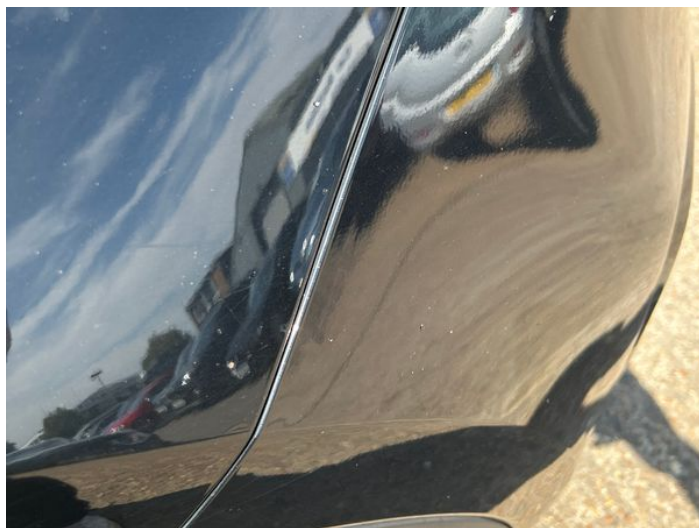
2: Wing osf  
Chipped  
1 To 5

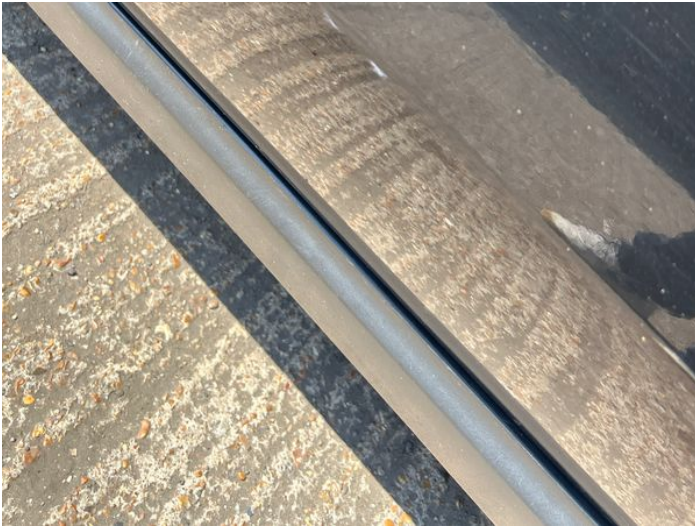
3: Door osf  
Chipped  
1 To 5

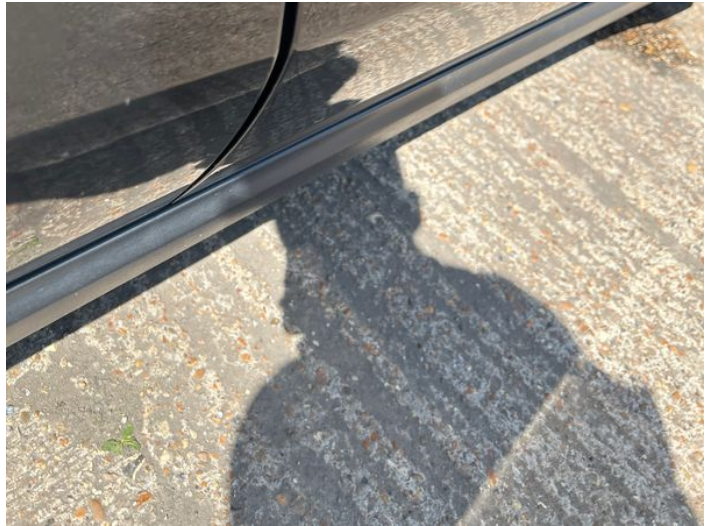
4: Door osf  
Chipped  
Edge Chip

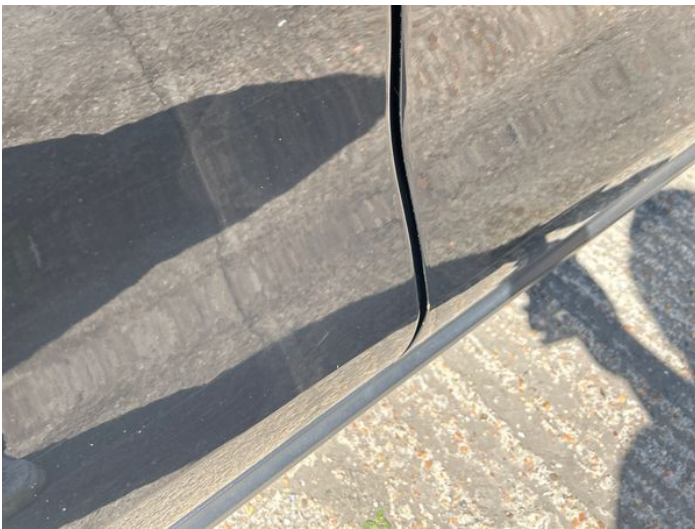
5: Door osr  
Chipped  
1 To 5

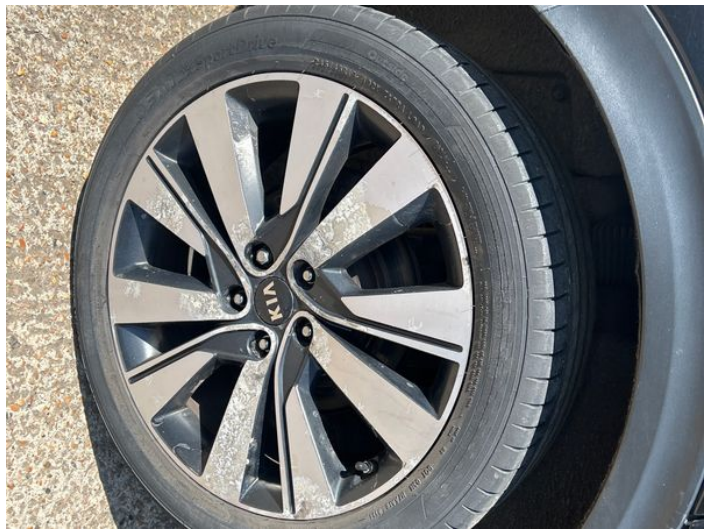
6: Wheel osr  
Corroded  
Light

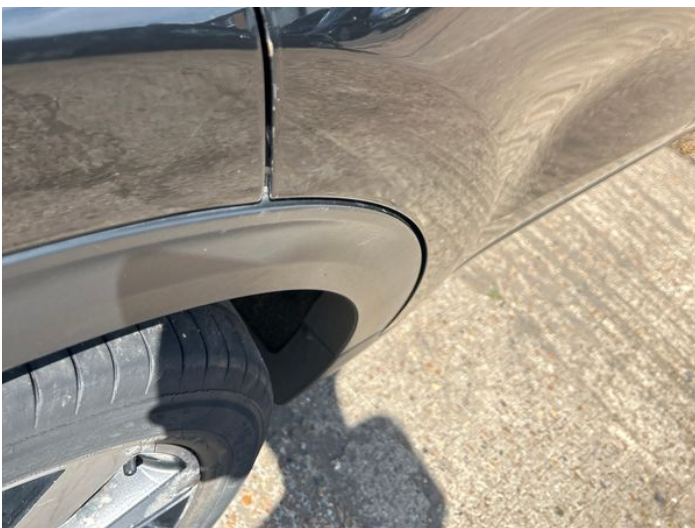
7: Door osr  
Chipped  
Edge Chip

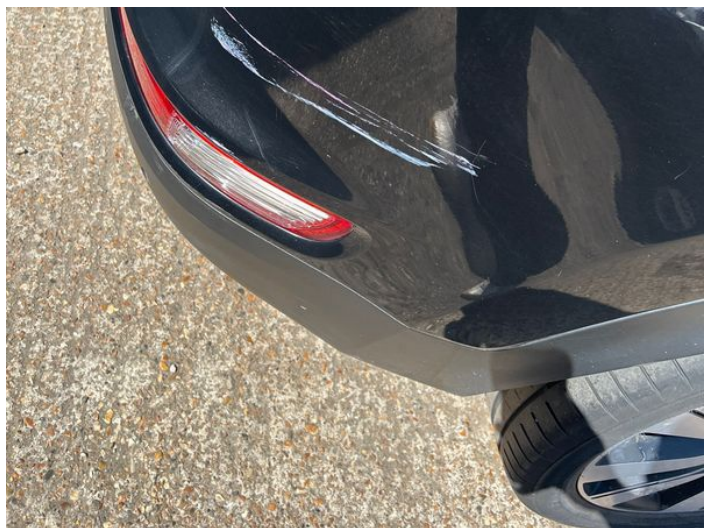
8: Bumper Rear  
Scratched  
25 to 100mm Thru Paint

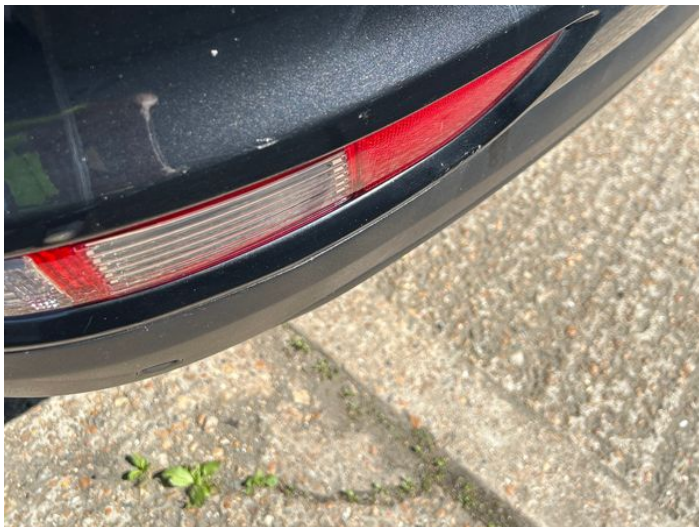
9: Bumper Rear  
Chipped  
1 To 5

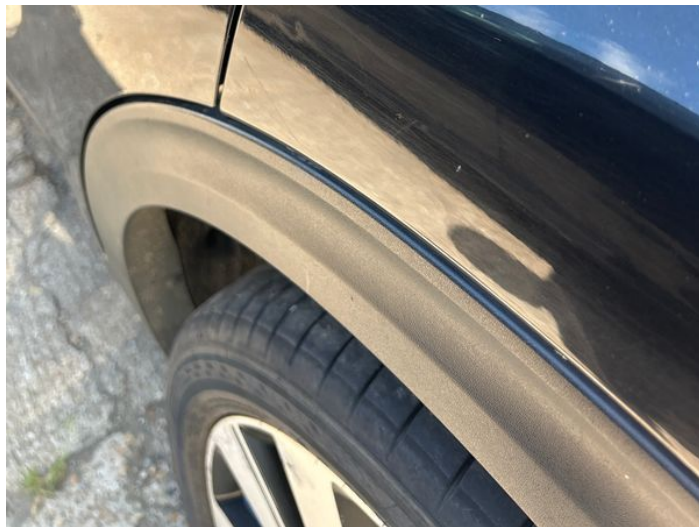
10: Qtr Panel nsr  
Dented  
2 Or Less UpTo 10mm

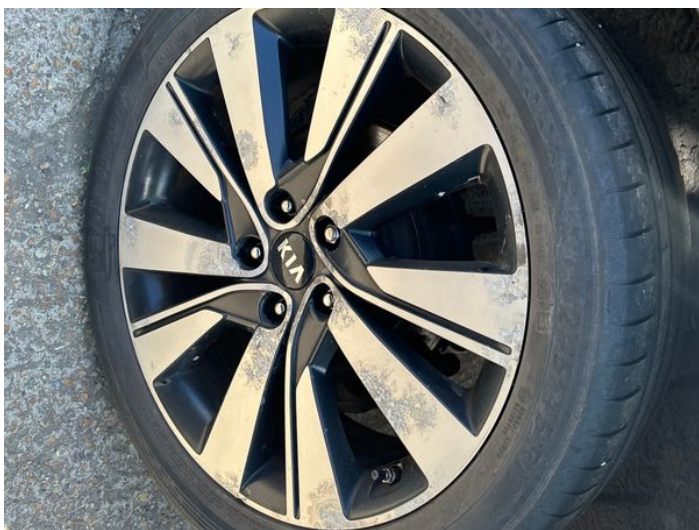
11: Wheel nsr  
Corroded  
Light

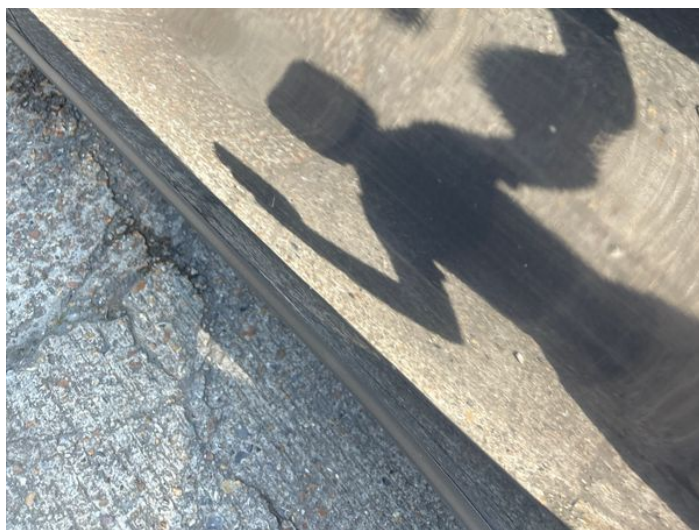
12: Door nsr  
Dented  
2 Or Less UpTo 10mm

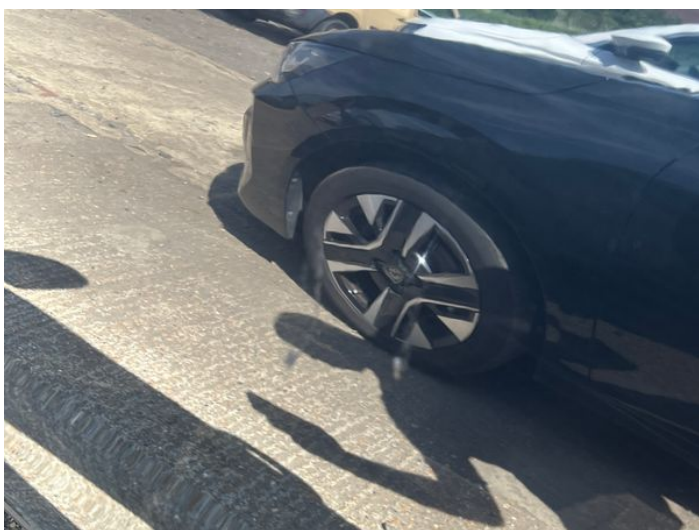
13: Door nsf  
Scratched  
UpTo 25mm Thru Paint

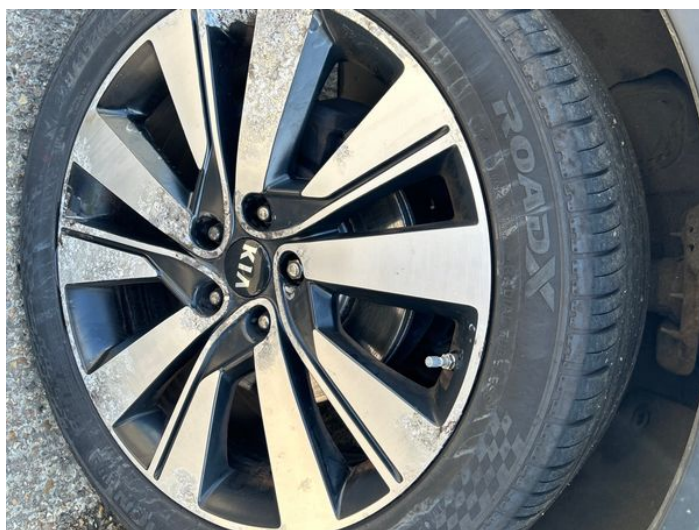
14: Wheel nsf  
Corroded  
Light

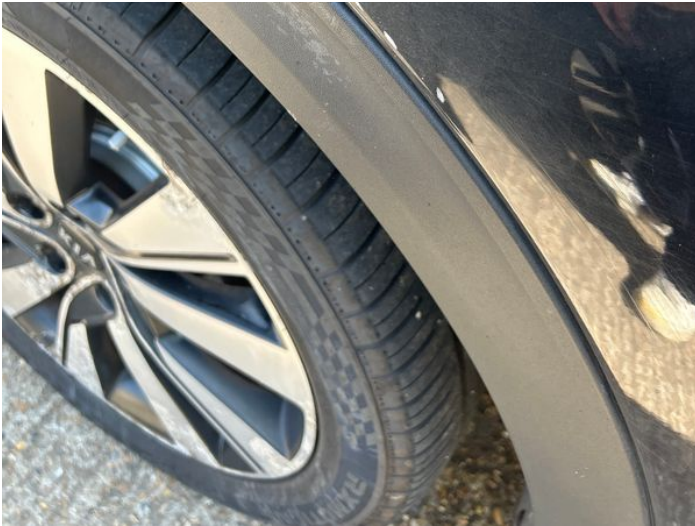
15: Wing nsf  
Chipped  
1 To 5

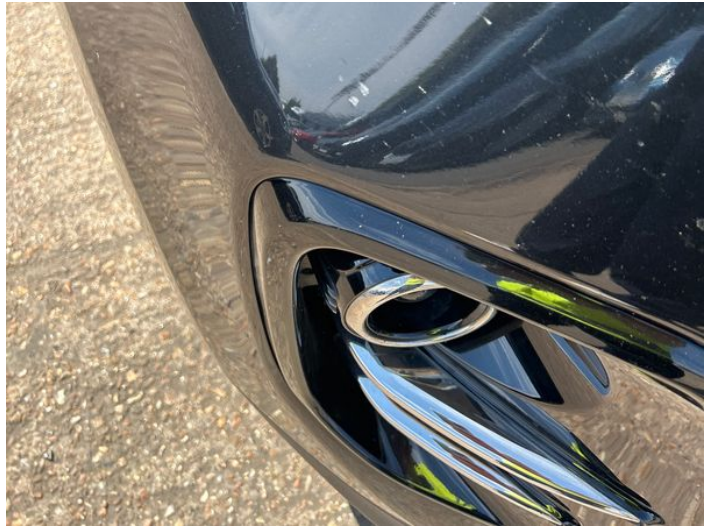
16: Bumper Front  
Chipped  
Multiple Chips

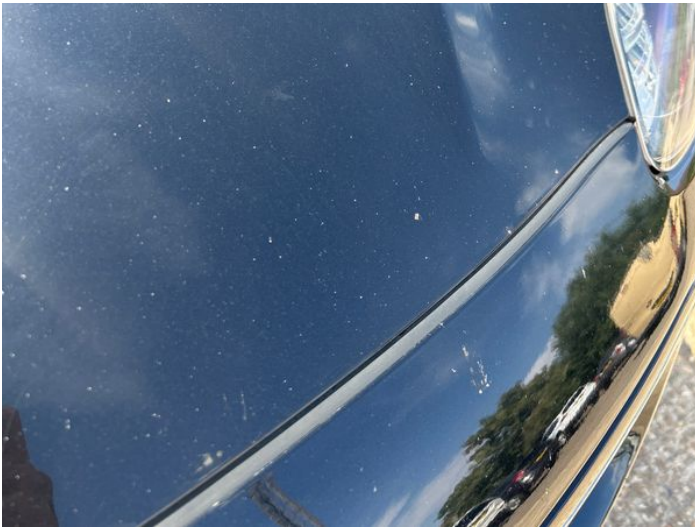
17: Bonnet  
Chipped  
Multiple Chips

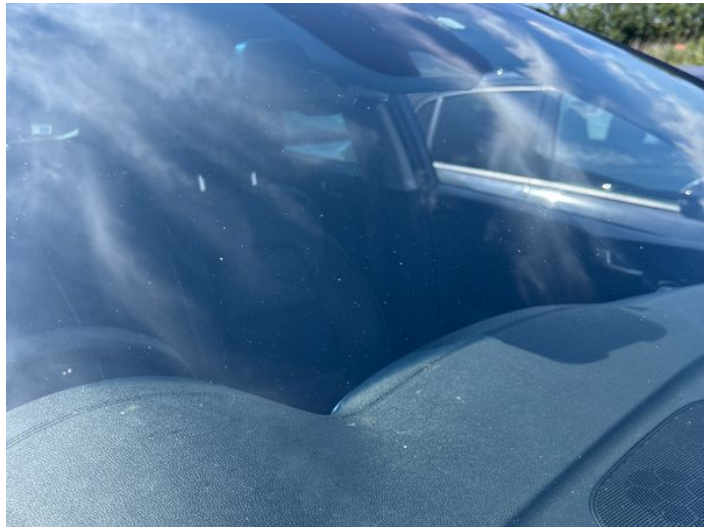
18: Screen Front  
Chipped  
UpTo 10mm

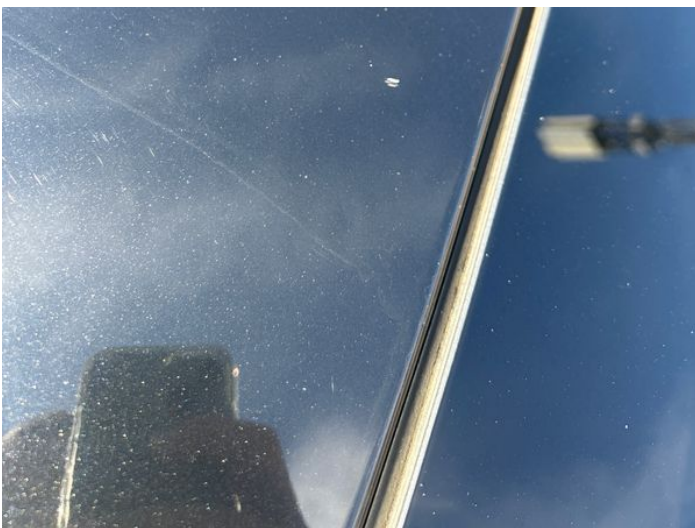
19: Roof  
Chipped  
1 To 5

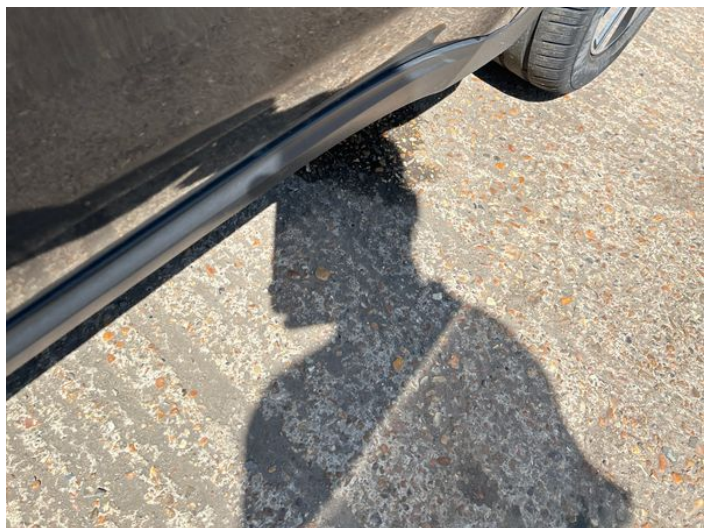
20: Door osf  
Dented  
Between 10mm + 30mm

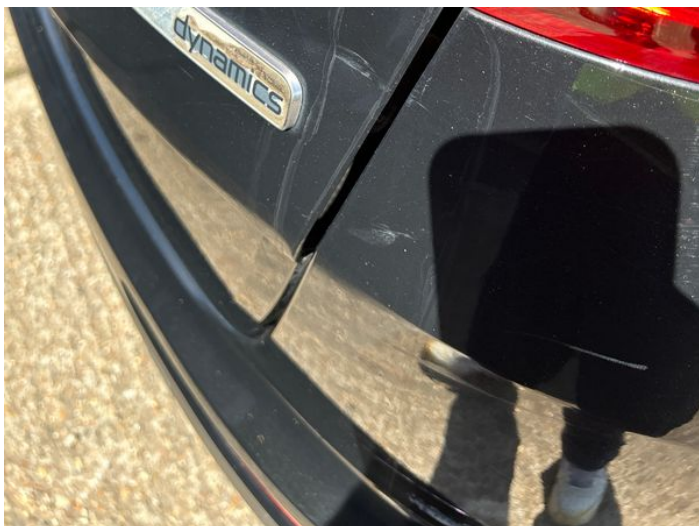
21: Tailgate  
Dented  
Over 30mm

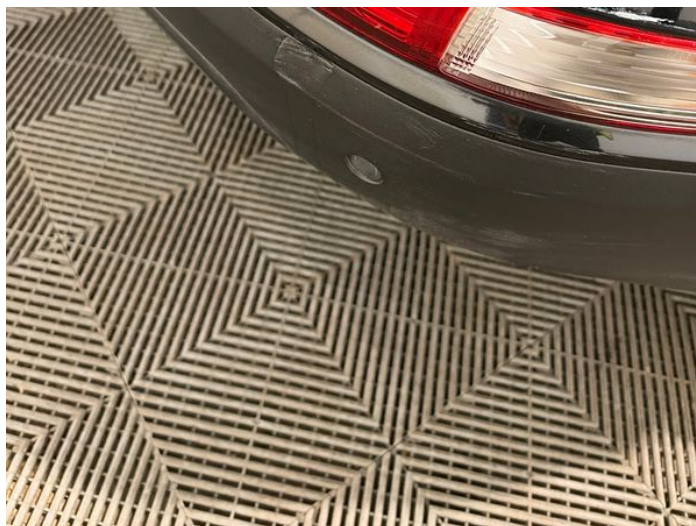
22: Bumper Rear Moulding  
Scuffed (Unpainted)  
Over 100mm
